# Linn Energy Turner A #045

## CLOSURE REPORT

RP-1873

API No. 30-015-28890

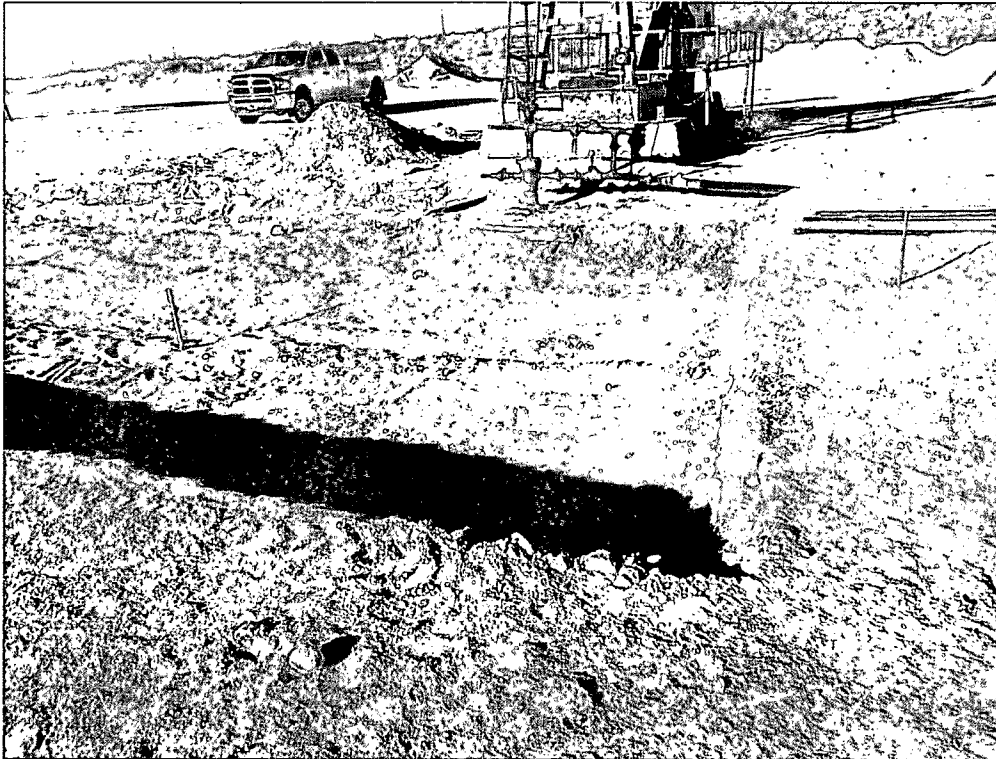
10/26/13

Excavated to 1 ft., facing west

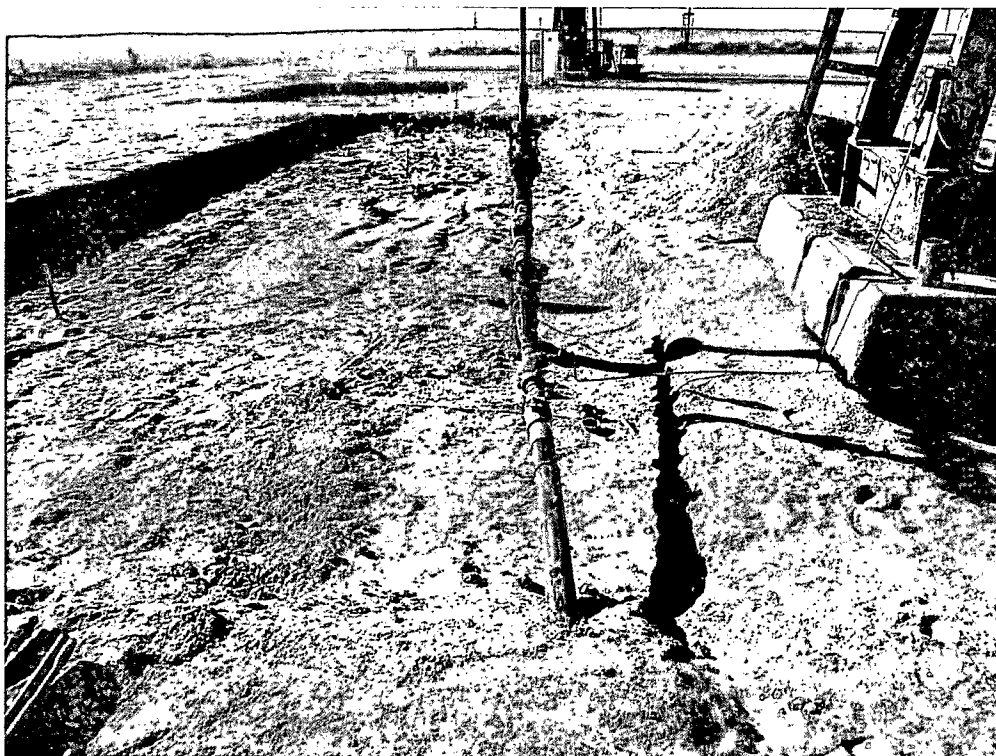
10/26/13

Excavated to 1 ft., facing south

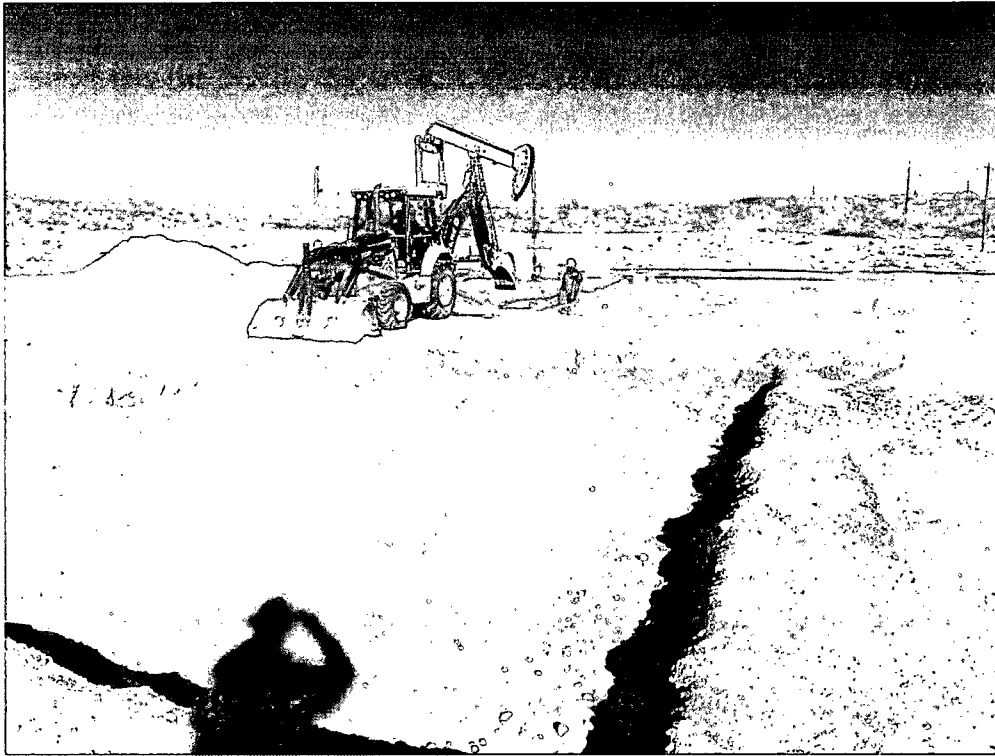
Backfill of excavation 01/13/14

On November 12, 2013, DFSI submitted a plan to excavate and backfill request to NMOCD. On same said date approval was granted via email. The excavated area on the well pad was backfilled with imported caliche and leveled.

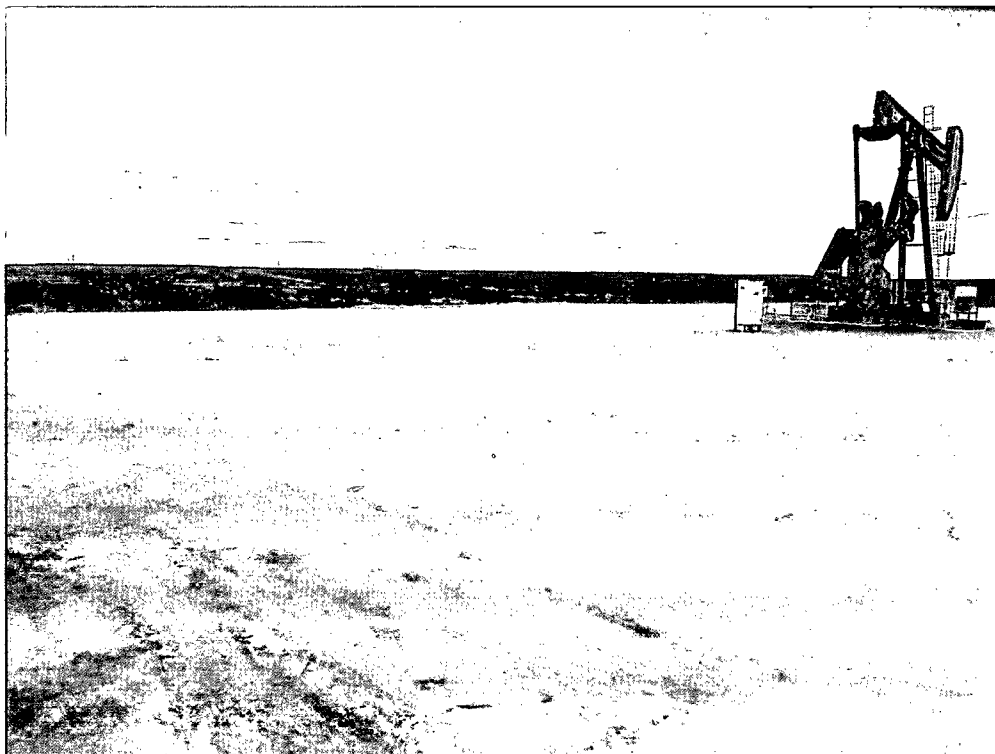
Site at completion 01/22/14
