HE West B #2 Battery/West B #88
(2RP-1189)

Termination Request

Linn Energy – HE West B #2 Battery/West B #88 (2RP-1189)

**LINN H. E. WEST
B #2 BATTERY
(2RP-1189)**

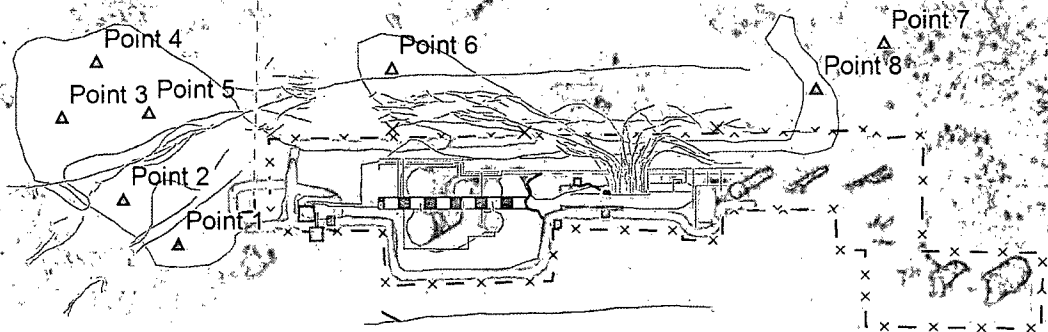
Figure 1

RECS sampled that area outside the battery on beginning on October 8th, 2013. Samples were taken from the surface at seven points within the release area outside the bermed battery and one sample, Point 7, was taken as background sample (Figure 1). The samples were field tested for chlorides and organic vapors and the samples were taken to a commercial laboratory for analysis (Appendix B). All the samples returned chloride values below 1,000 mg/kg, GRO values of non-detect and DRO values below regulatory standards, except for the background sample at Point 7, which returned a DRO value of 5,890 mg/kg.

Initial Sampling Data

CI-	PID	GRO	DRO	B	T	E	X	BTEX
Point 1 Surface	<16	0.4	<10	1110	<0.05	<0.05	<0.05	<0.15	<0.3
Point 2 Surface	80	0.2	<10	2000	<0.05	<0.05	<0.05	<0.15	<0.3
Point 3 Surface	48	0.3	<10	2550	<0.05	<0.05	<0.05	<0.15	<0.3
Point 4 Surface	<16	0.5	<10	2440	<0.05	<0.05	<0.05	<0.15	<0.3
Point 5 Surface	448	3.5	<10	2470	<0.05	<0.05	<0.05	<0.15	<0.3
Point 6 Surface	16	0.2	<10	<10	<0.05	<0.05	<0.05	<0.15	<0.3
Point 7 Surface	96	1.5	<200	5890	<0.05	<0.05	<0.05	<0.15	<0.3
Point 8 Surface	<16	1.9	<10	56.7	<0.05	<0.05	<0.05	<0.15	<0.3

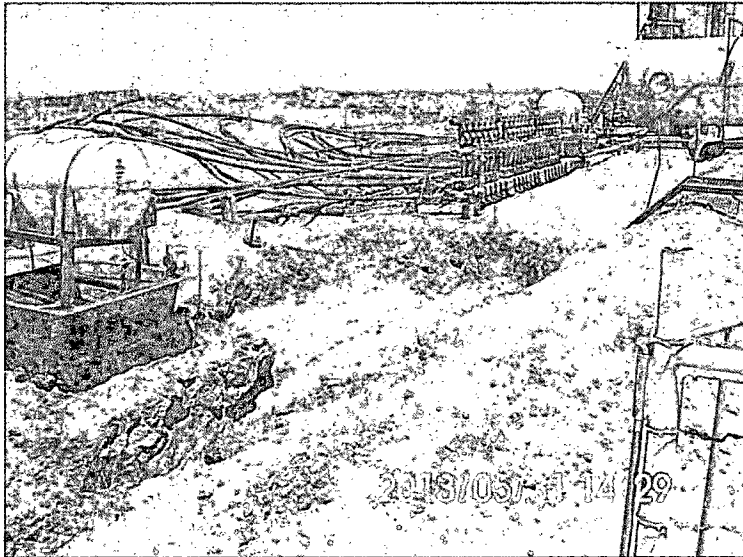
5/31/13

Prior excavation, facing northeast

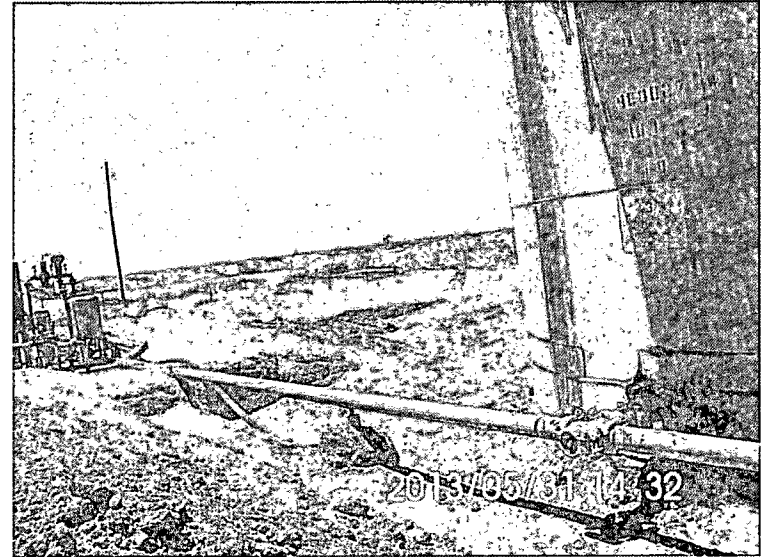
5/31/13

Prior excavation, facing west

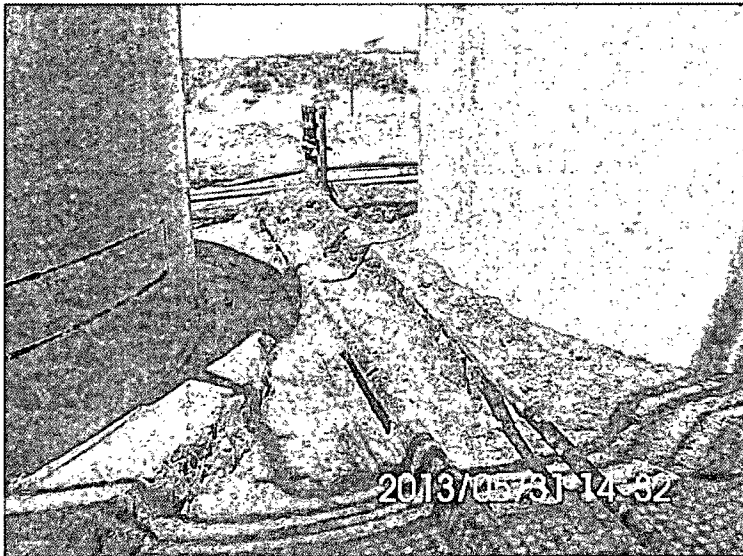
5/31/13

Prior excavation, facing north

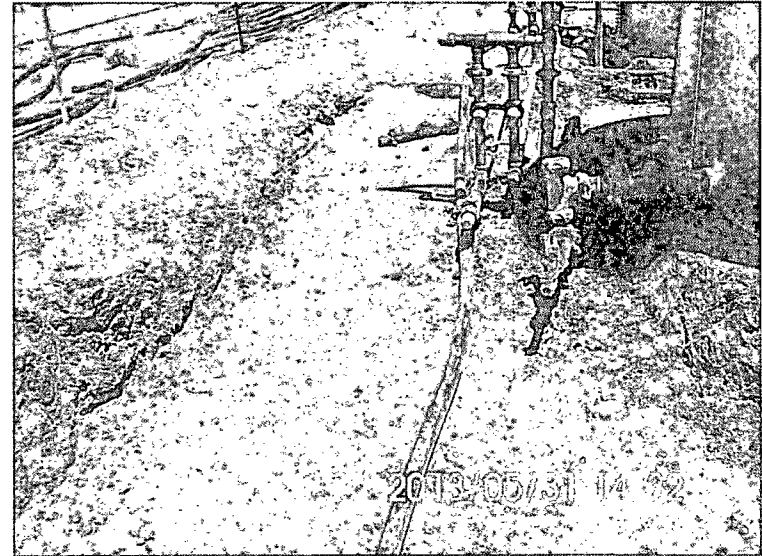
5/31/13

Prior excavation, facing east

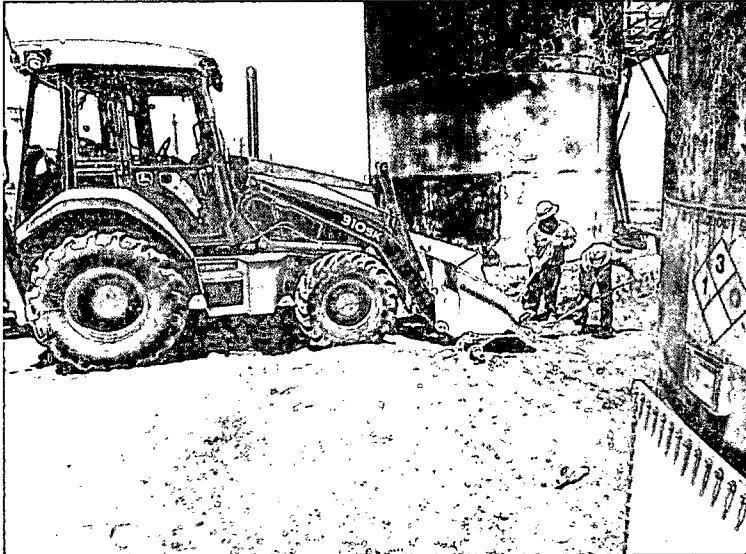
6/4/13

Excavating site, facing northwest

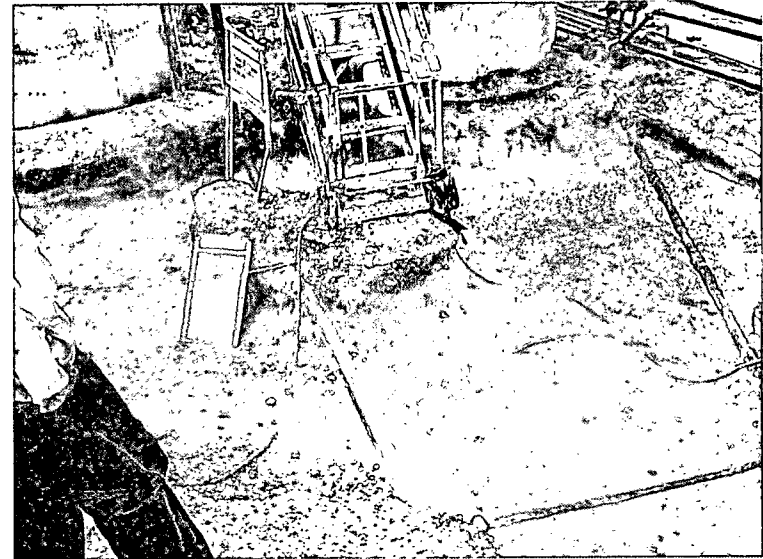
7/25/13

Site after continued excavation, facing northwest

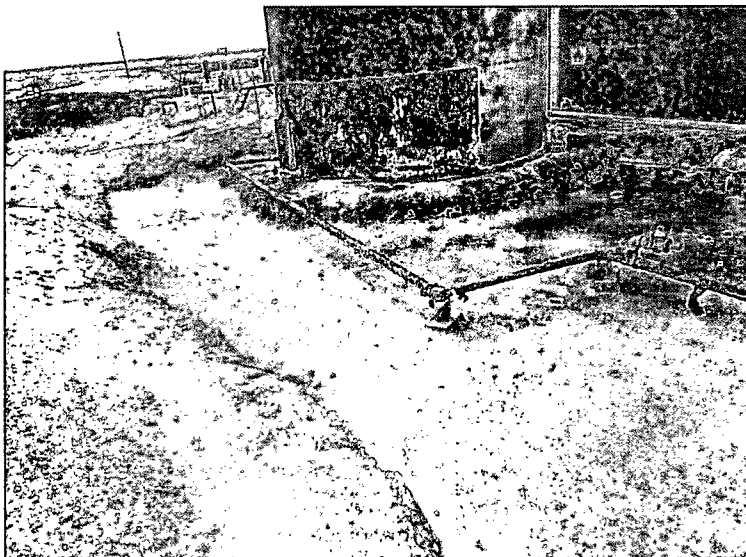
7/25/13

Site after continued excavation, facing west

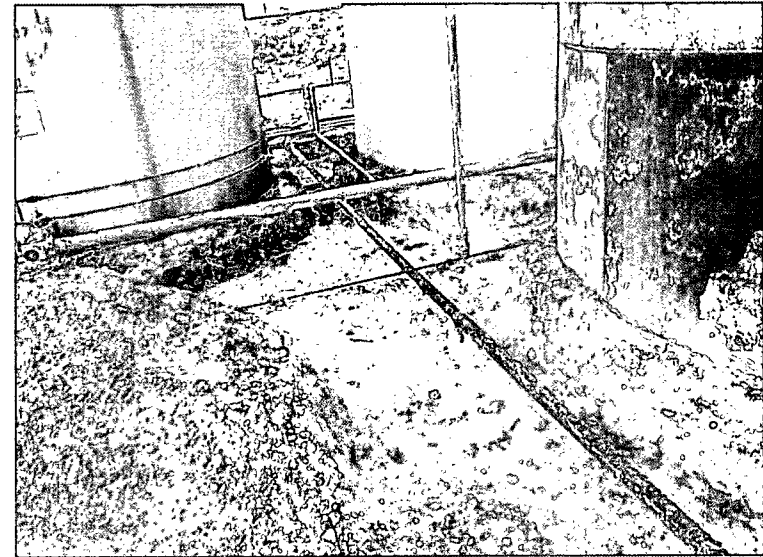
7/25/13

Site after continued excavation, facing north

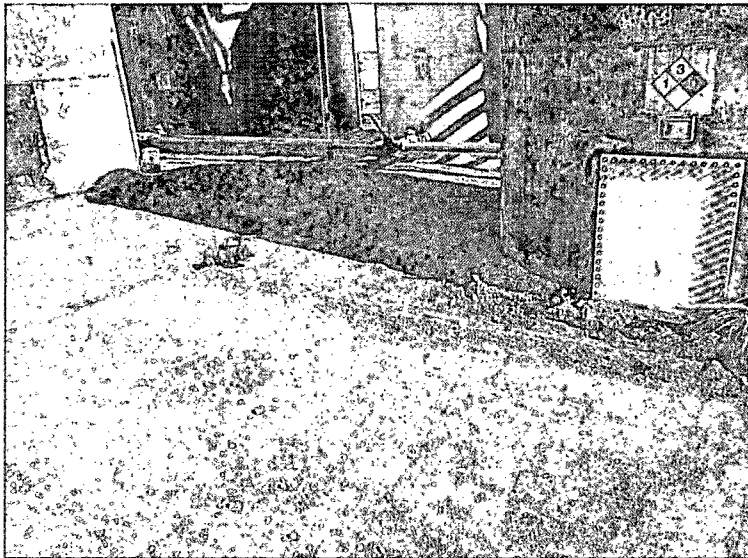
8/16/13

Site after backfilling, facing north

Two other environmental companies worked this site previously to RECS taking over remediation activities. When RECS obtained the site, the battery had already been excavated to 1.5 – 3 ft bgs and a request to backfill the site had been approved by BLM on July 26th, 2013. As part of permission to backfill, BLM had a stipulation that Sample Point 1 needed to be delineated to find closure levels. The site was backfilled and contoured to the surrounding location.

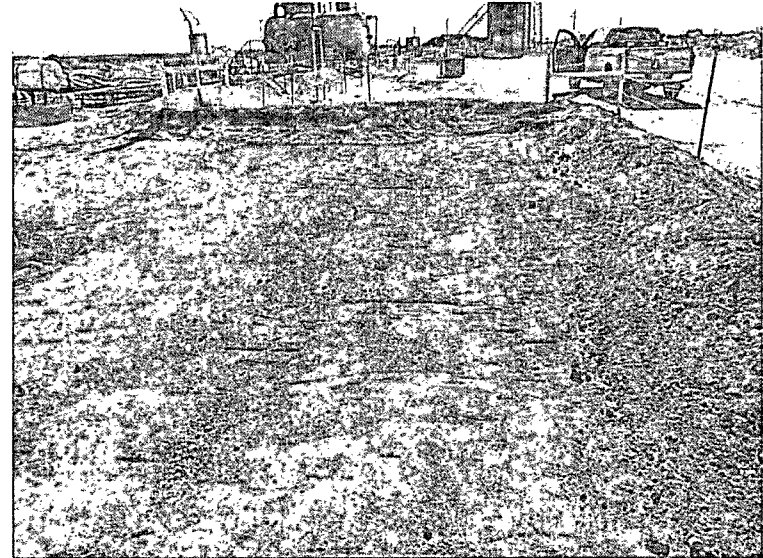
8/16/13

Site after backfilling, facing east

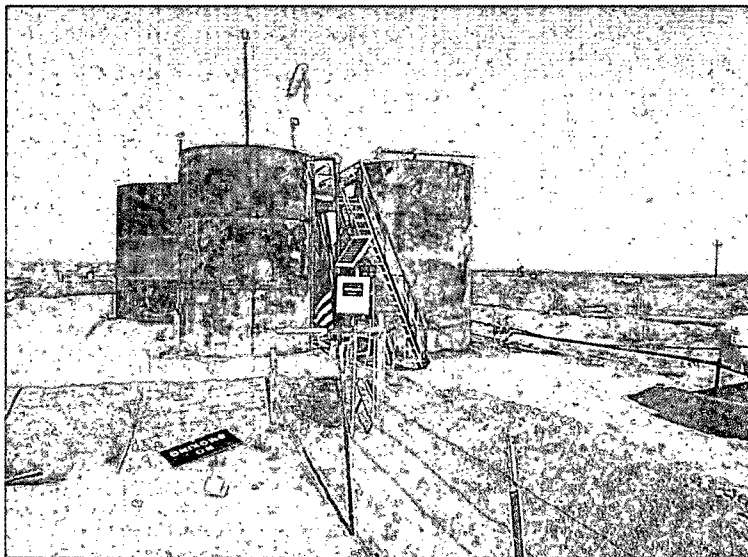
8/16/13

Site after backfilling, facing west

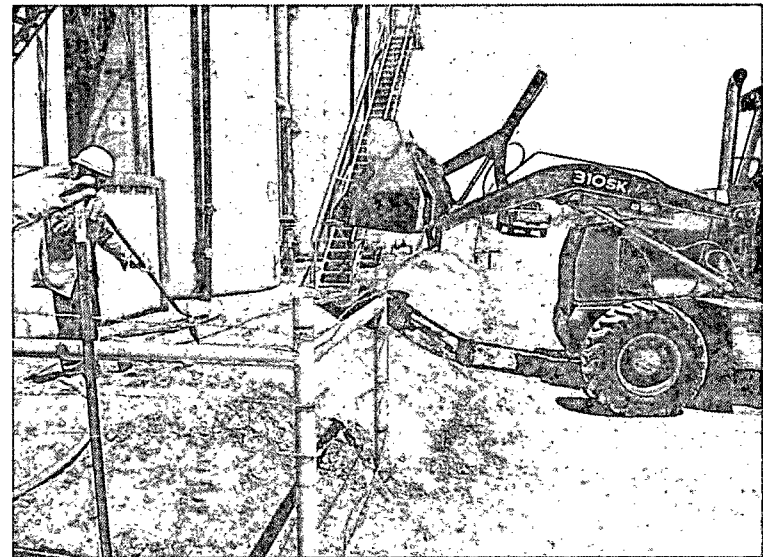
8/20/13

Restoring berms, facing east

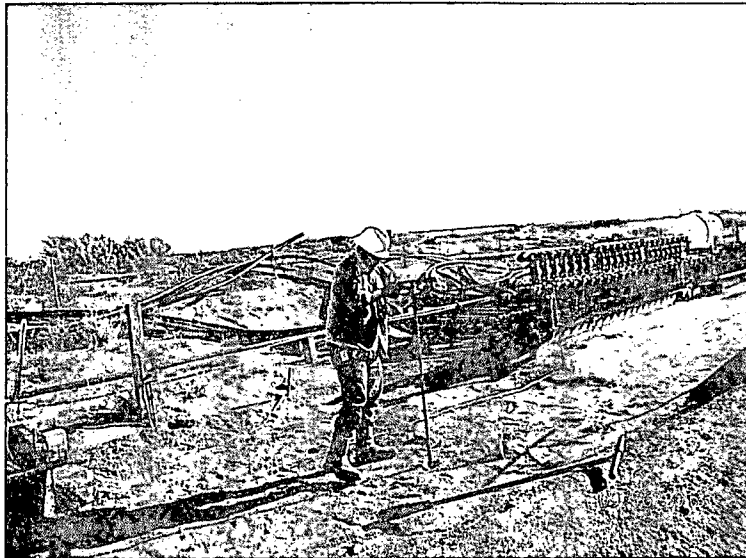
Hand auguring for depth, facing northeast 9/16/13

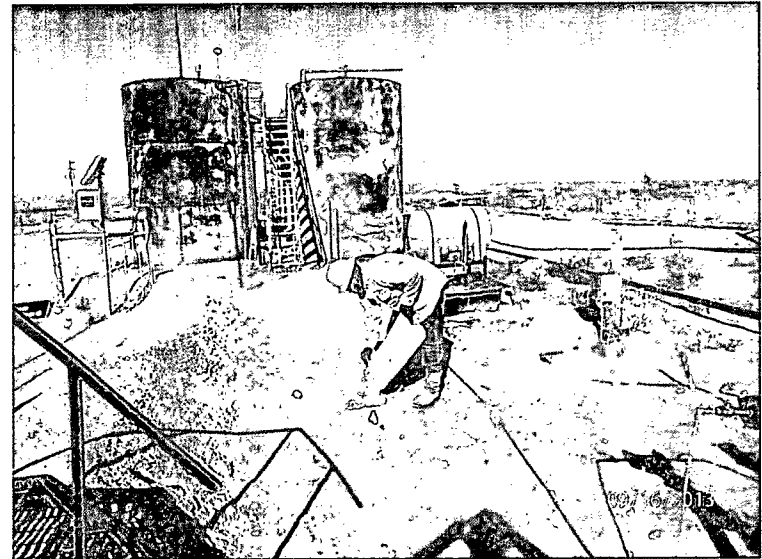
Plugging augur point in total with bentonite, facing west 9/16/13

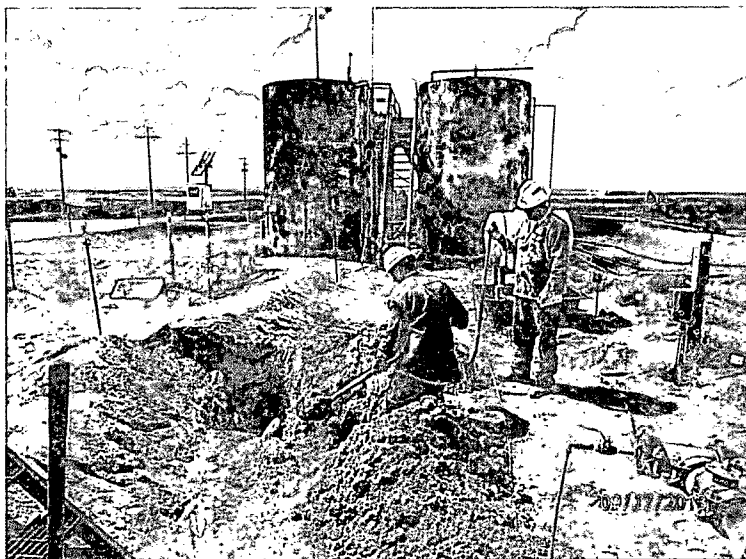
RECS took over the project on August 27th, 2013. A vertical was attempted at Point 1 on September 17th, 2013; however, installation was aborted when a fiberglass line was found below Point 1. On September 20th, 2013, RECS met with NMOCD and NMOCD stated that RECS needed to assess the release outside the bermed battery area. On September 25th, 2013, RECS met with BLM and BLM stated that the work was completed inside the battery and RECS needed to assess the release outside the battery. Both agencies required RECS to submit a CAP to remediate this area.

Fiberglass line, facing west 9/17/13

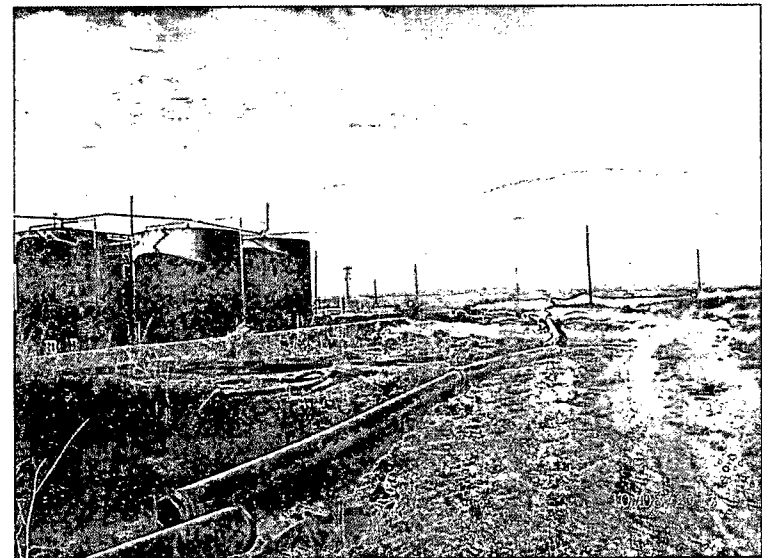
Release area north of battery, facing southwest 10/8/13

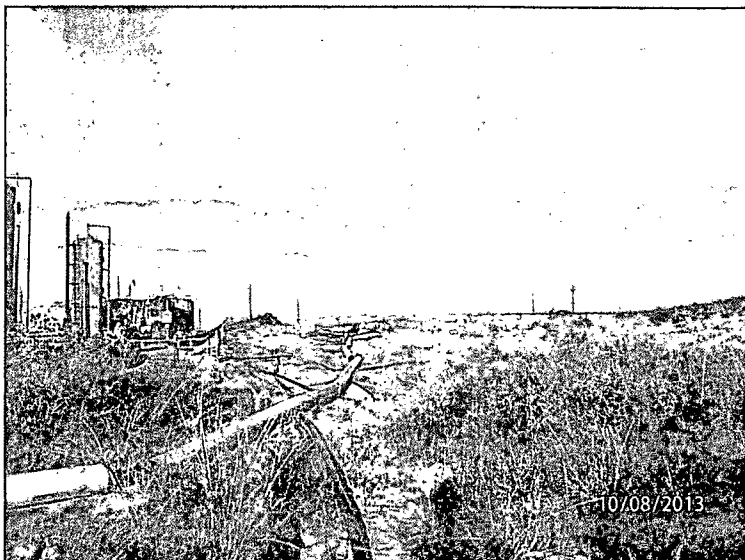
Release area north of battery, facing west 10/8/13

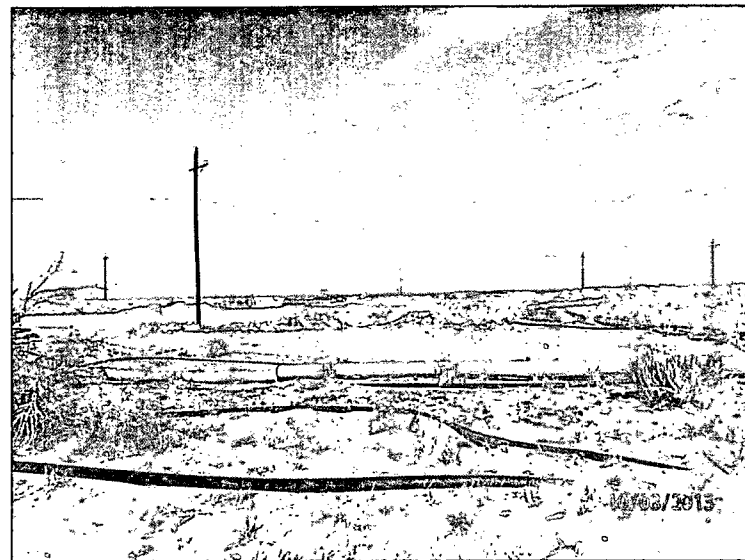
Release area north of battery, facing south 10/8/13

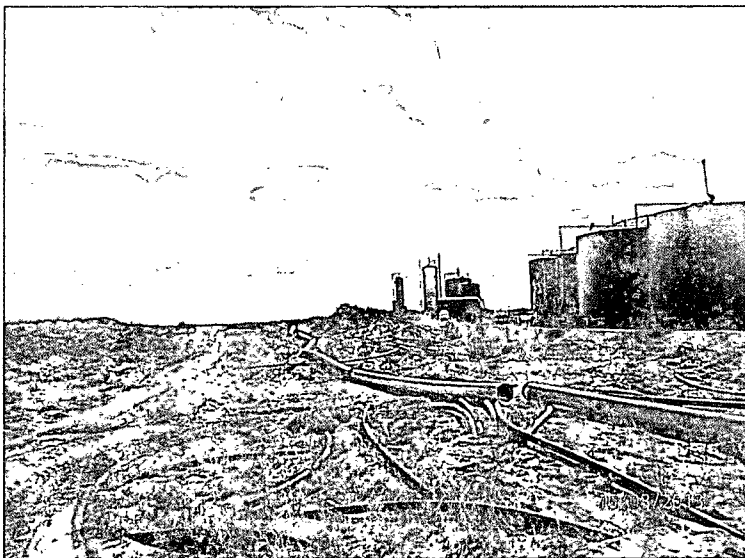
Release area north of battery, facing east 10/8/13

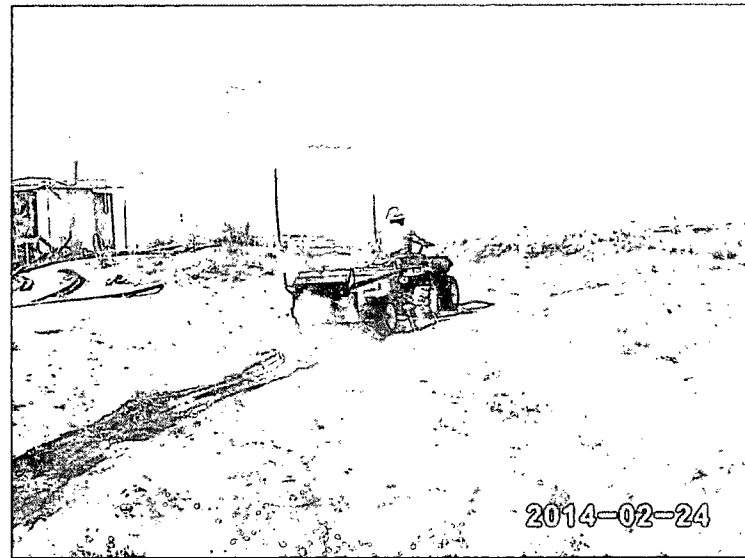
Applying soil amendments, facing west 2/24/14

RECS personnel were on site on February 24th, 2014 to conduct the CAP work. Soil amendments were added to the site and the site was seeded with BLM mix #2 and #4. The remainder of contamination from the release will be addressed at site abandonment. Photo documentation of all activities at the site can be found in Appendix C.

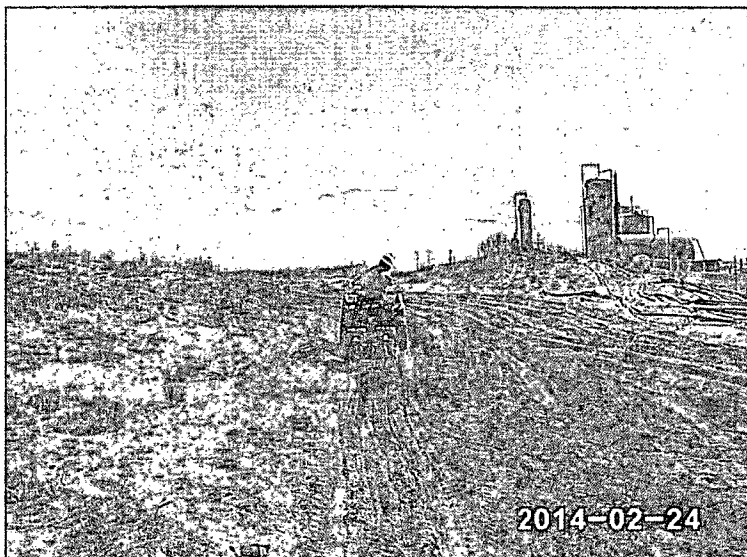
2/24/14

Tilling in soil amendments, facing east

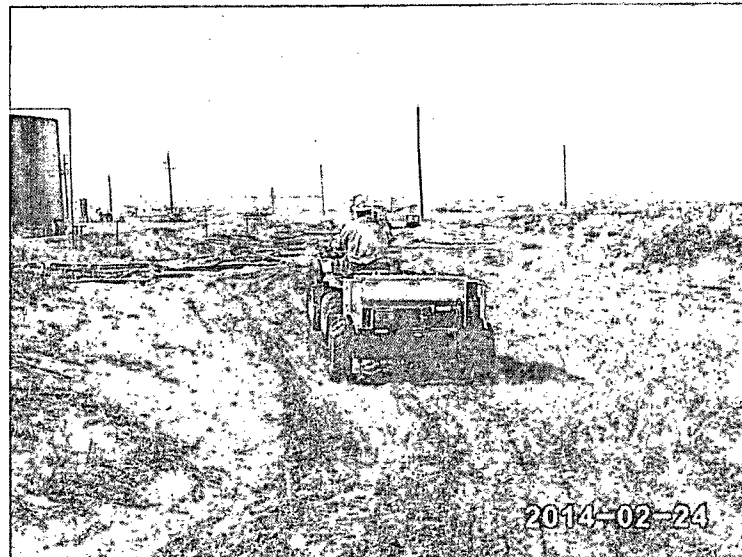
2/24/14

Seeding site, facing west

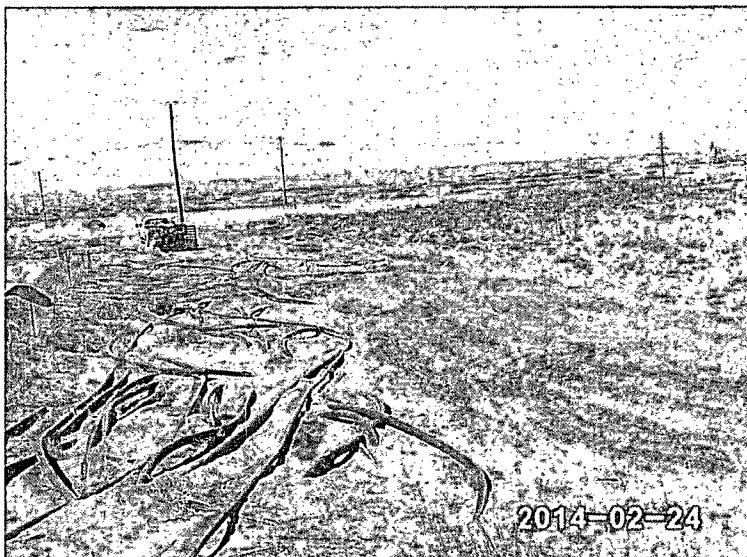
2/24/14

Site completed, facing west

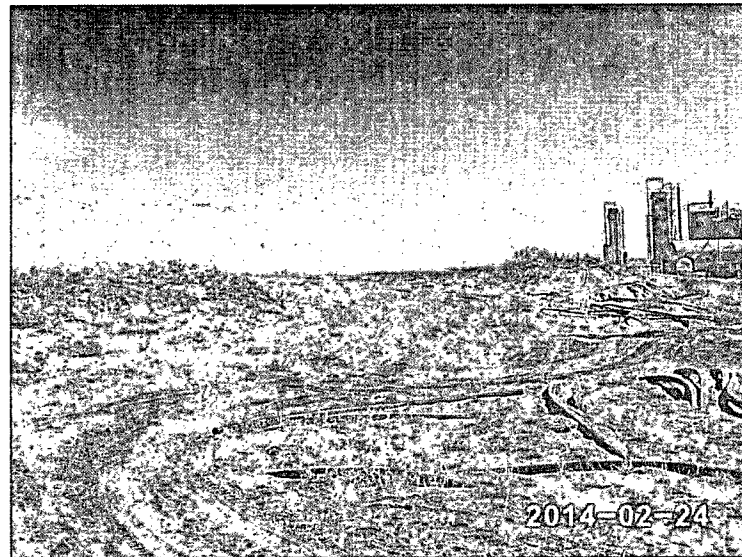
2/24/14

Site completed, facing east
