# Linn Energy Turner B #7

## CLOSURE REPORT

2RP-2176

May 28, 2014

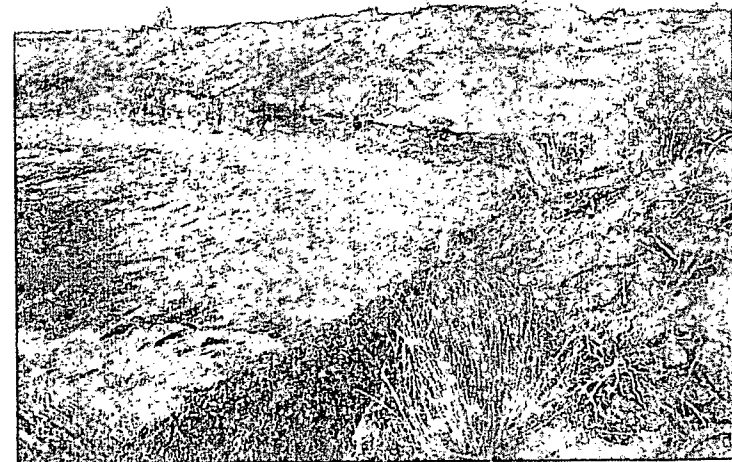
Excavated area 12/9/13
