Release Notification and Corrective Action

WBDU #26  
1RP-11-13-2986

## Termination Request

**Apache Corporation – WBDU #26 (1RP-11-13-2986)**

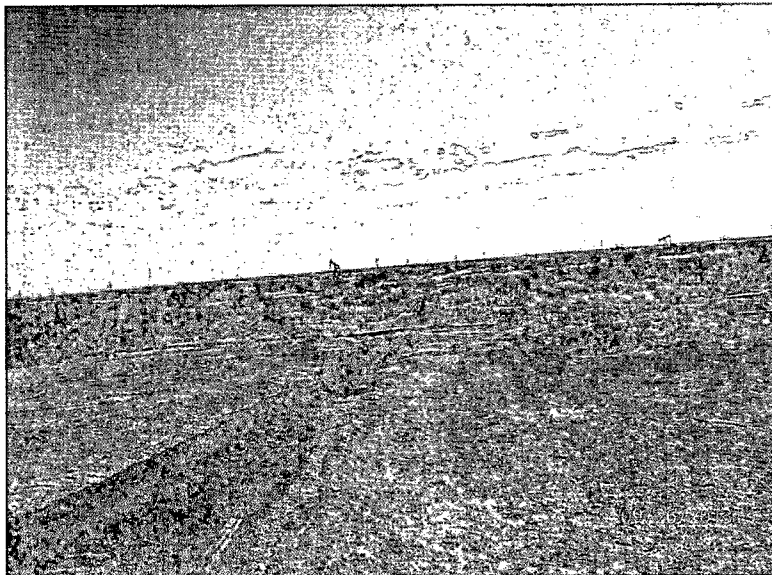
Initial site photo, facing east

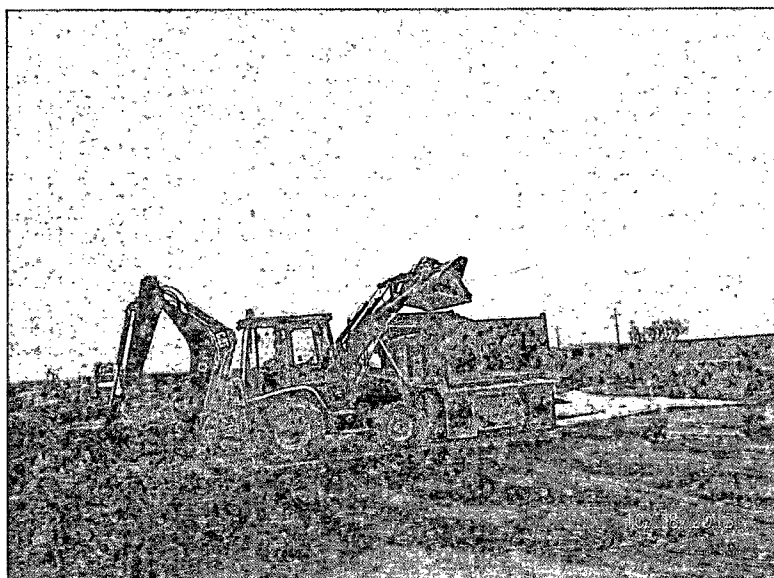
Exporting soil, facing east 10/18/13

The entire release was scraped down 3 inches and a total of 72 yards of soil was taken to a NMOCD approved facility for disposal. A 5 point bottom composite of the scrape was taken to a commercial laboratory for analysis and returned a chloride value of 160 mg/kg, a GRO value of non-detect and a DRO value of 205 mg/kg (Appendix C).

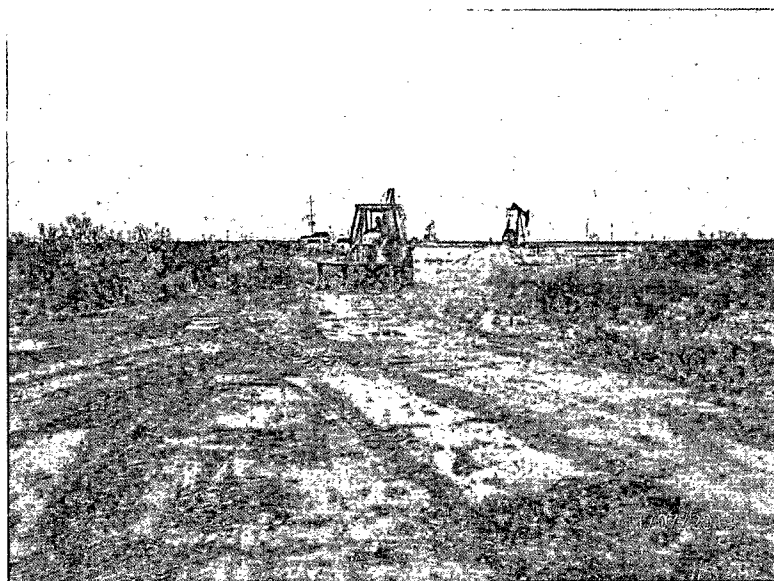
Backfilling site, facing southwest

non-detect (Appendix D). The site was backfilled with the imported material and contoured to the surrounding location. The pasture area was then seeded with a blend of native vegetation.

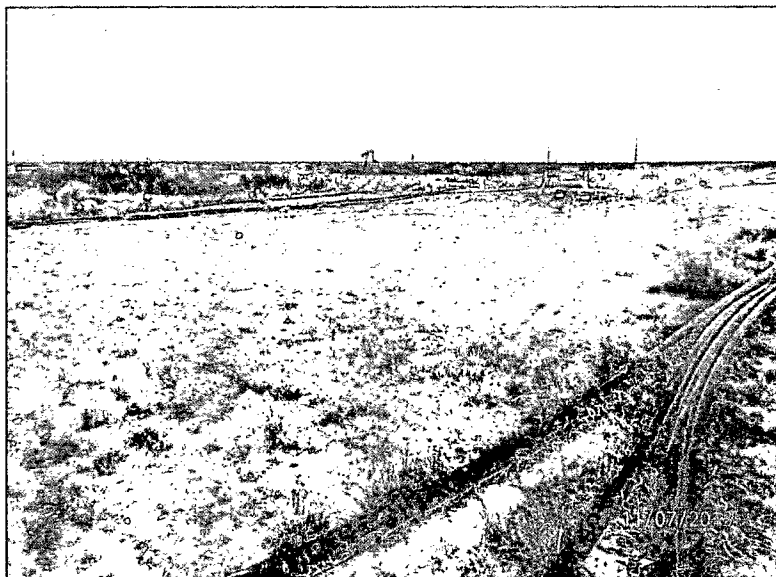
Site backfilled, facing east

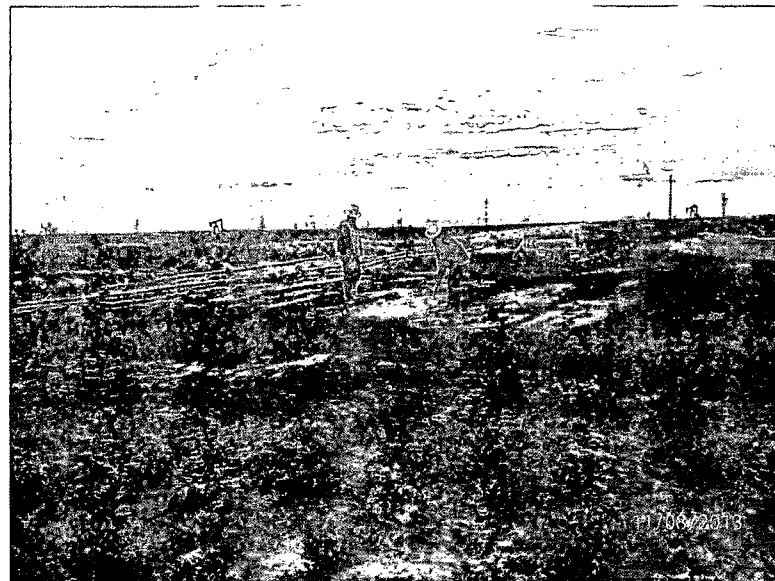
Raking in the seed, facing east

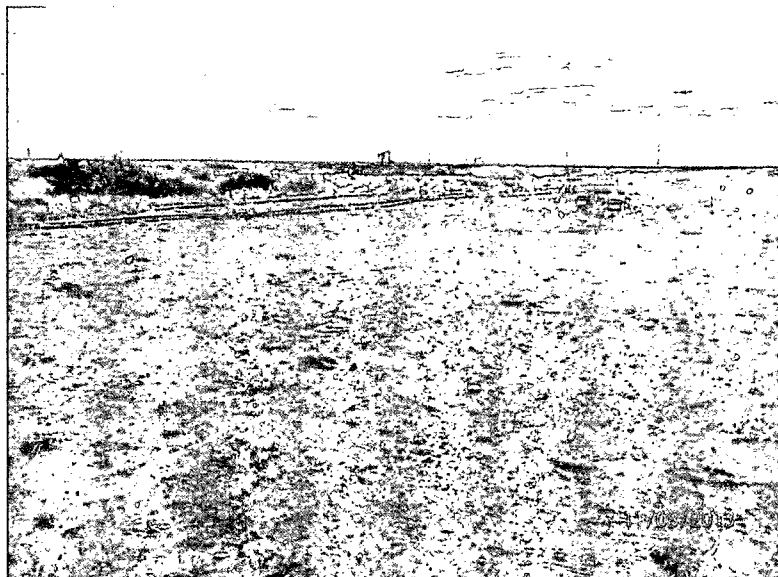
Site completed, facing east

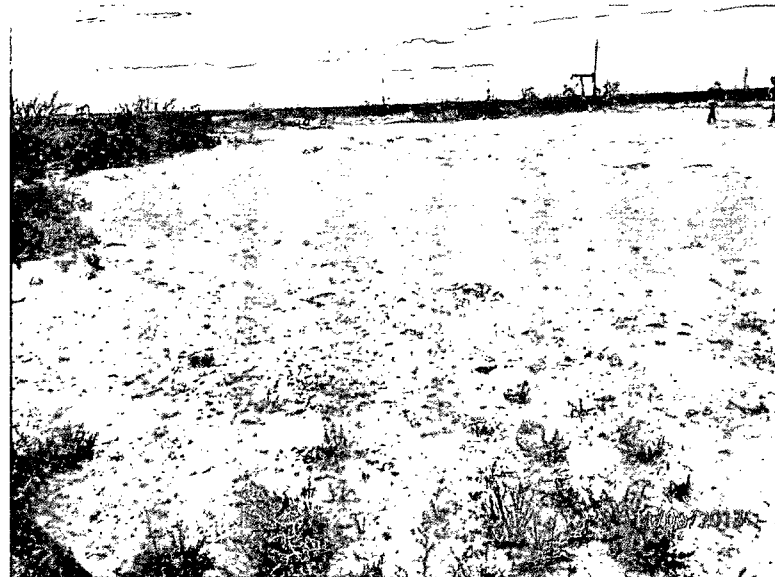
Site completed, facing east
