Lou Wortham #20 AD

Update Report

NMOCD Case #: 1R0711-2726

Unit Letter F, Section 11, Township 22S, Range 37E

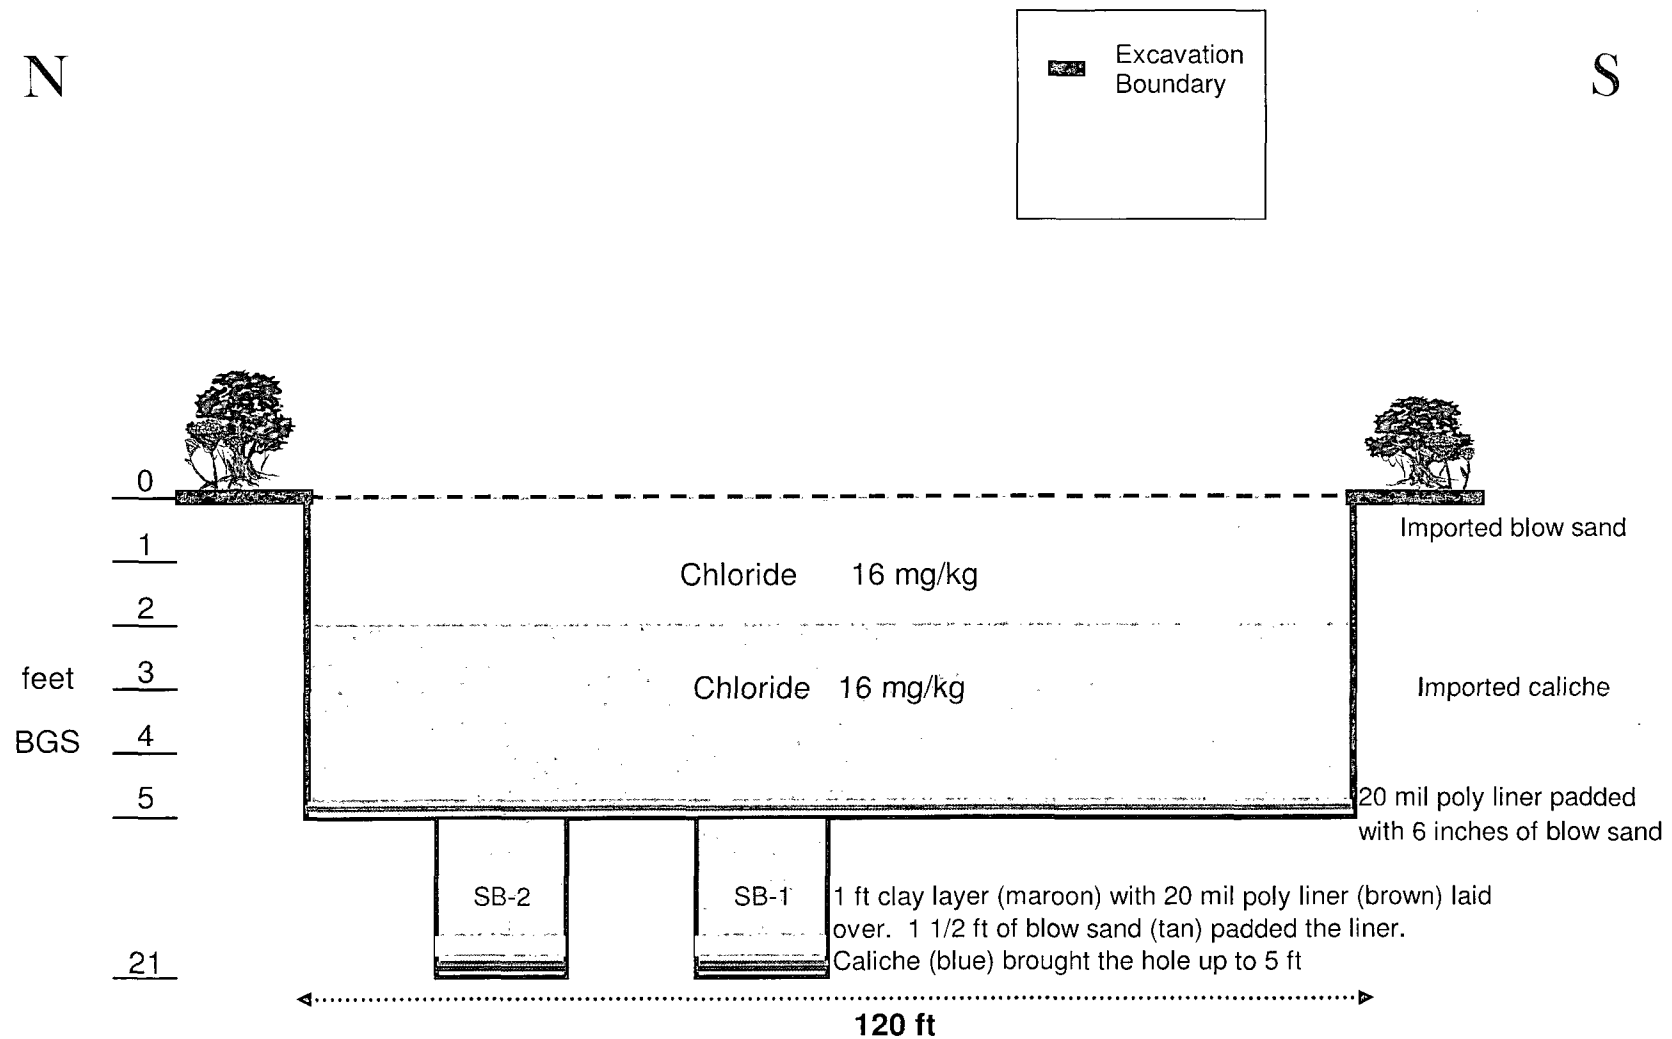
Northwest Excavation Cross-Section

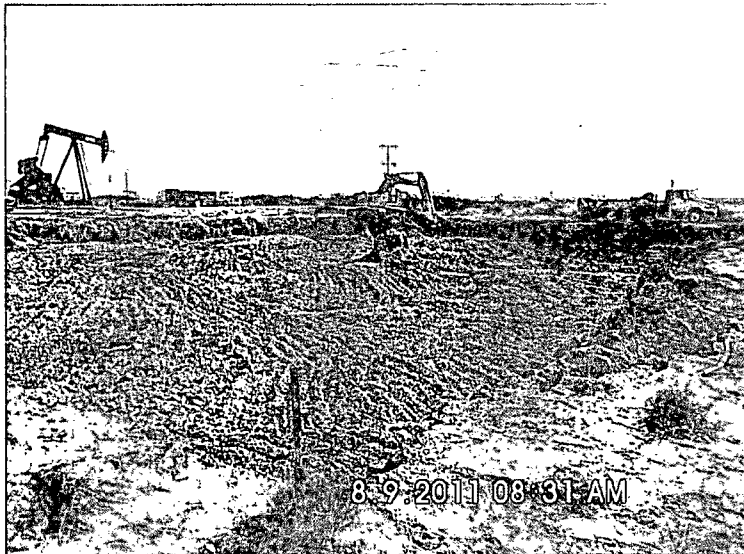
Excavating the site, facing northeast 8/9/11

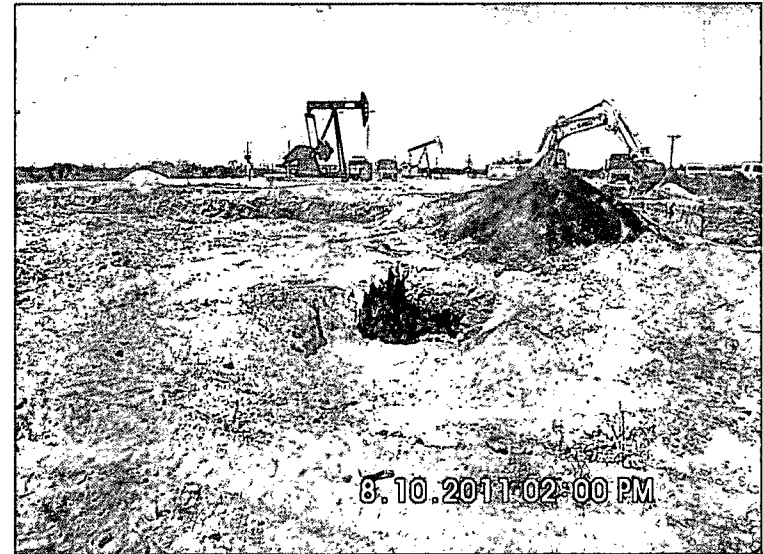
Final excavation around SB-1, facing north 8/10/11

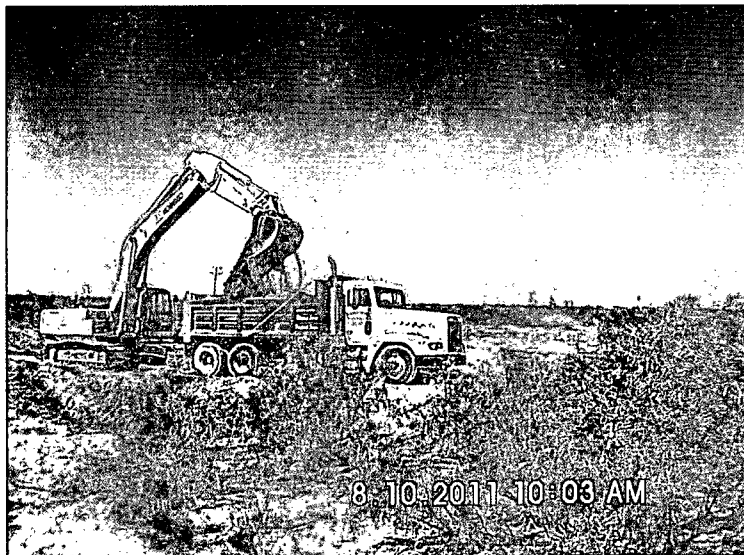
Exporting soil, facing southwest 8/10/11

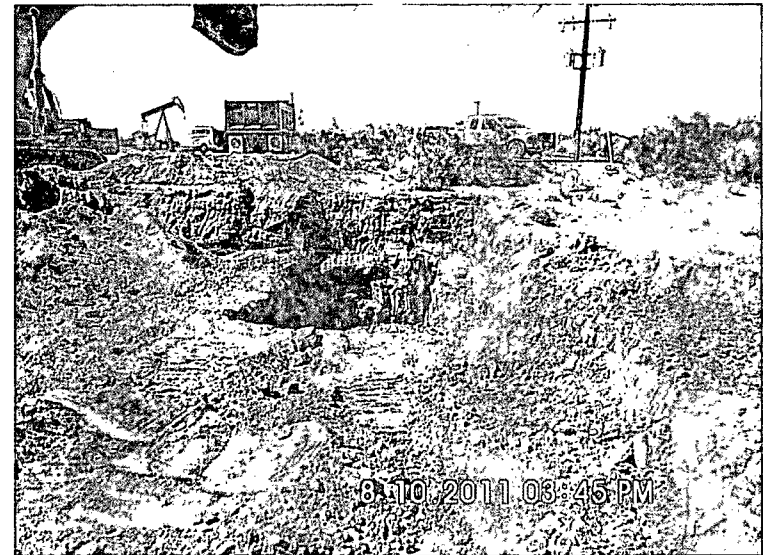
Final excavation around SB-2, facing north 8/10/11

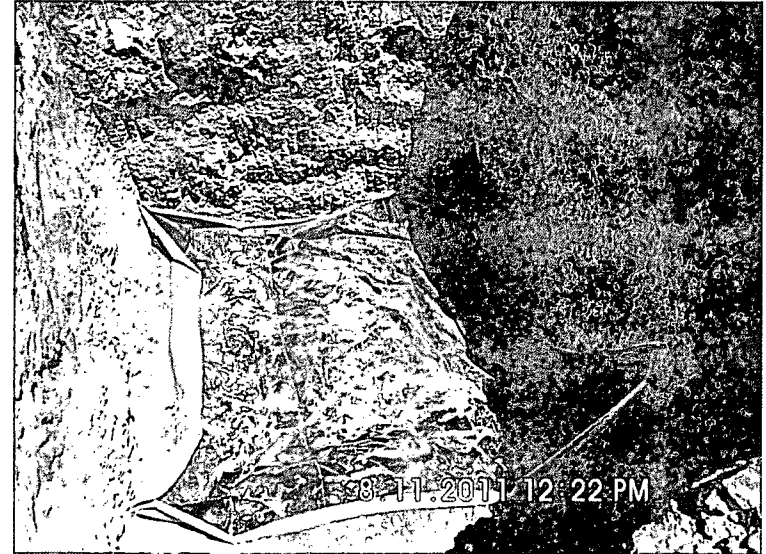
Installing poly liner in SB-1 excavation

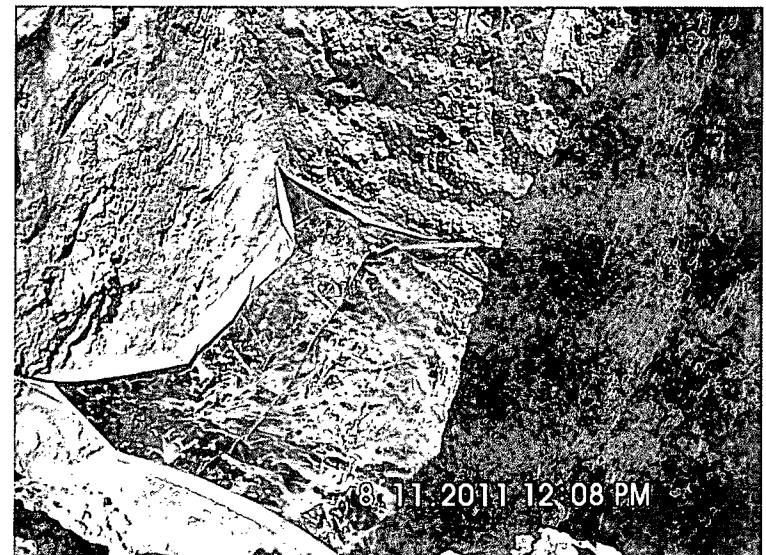
Installing poly liner in SB-2 excavation

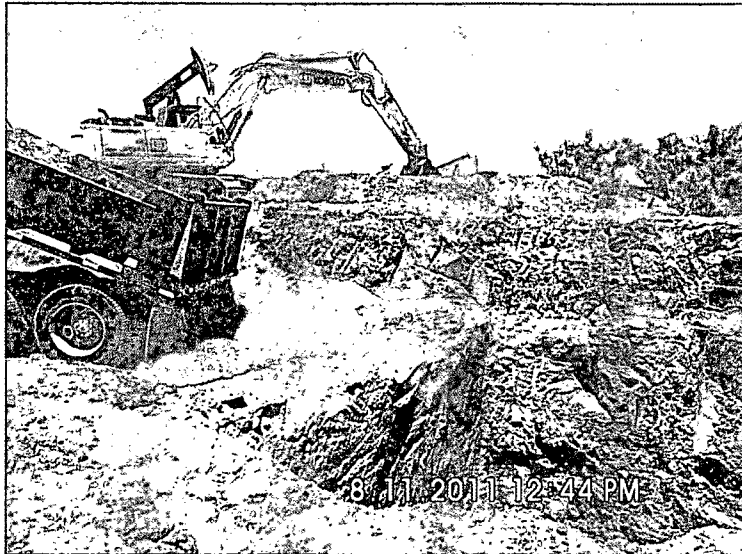
Importing sand to pad liners, facing north 8/11/11

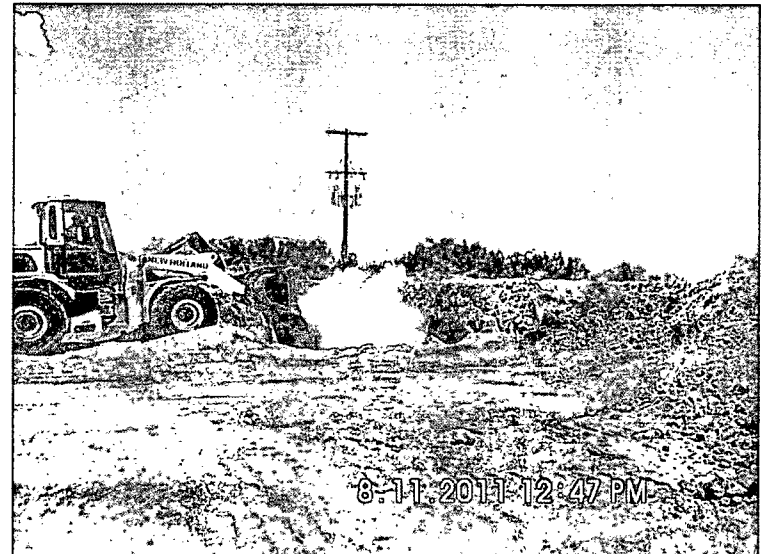
Padding liner in SB-2 excavation, facing NE 8/11/11

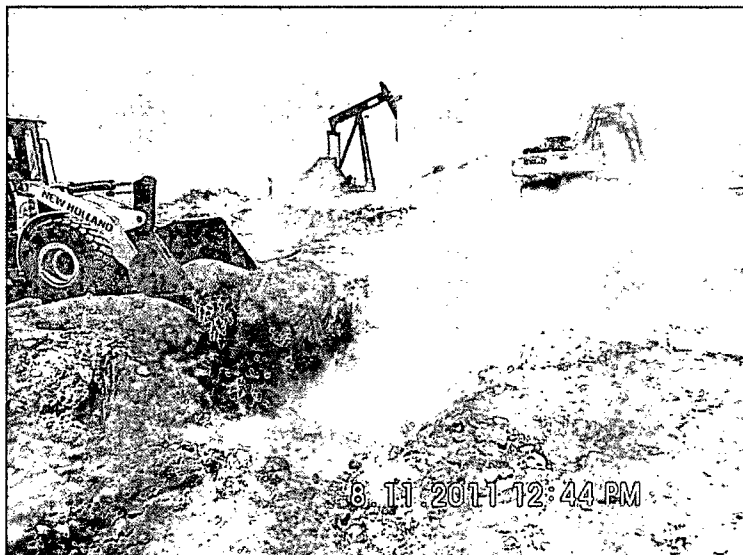
Padding liner in SB-1 excavation, facing north 8/11/11

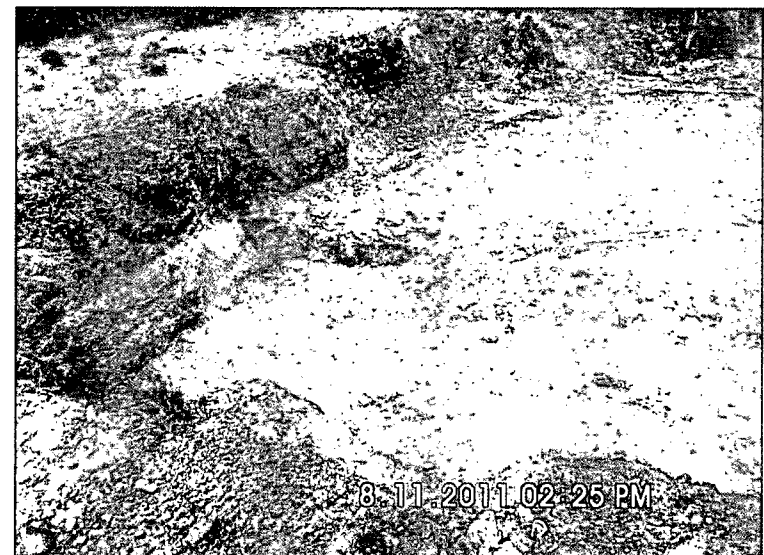
Backfilling SB-1 & 2 excavations with caliche 8/11/11

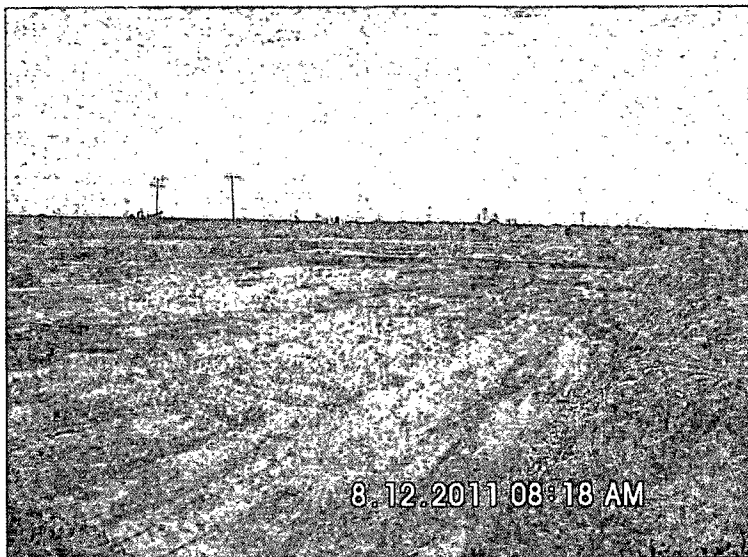
Excavation complete, facing southeast 8/12/11

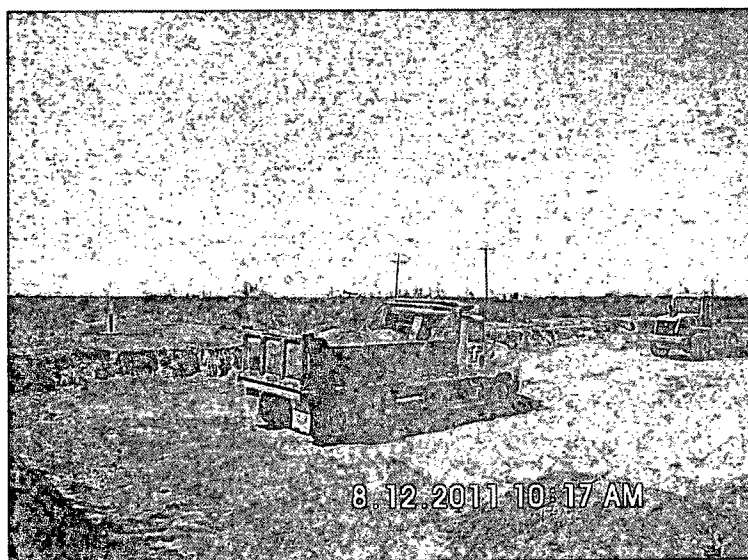
Importing soil to pad liner, facing southwest 8/12/11

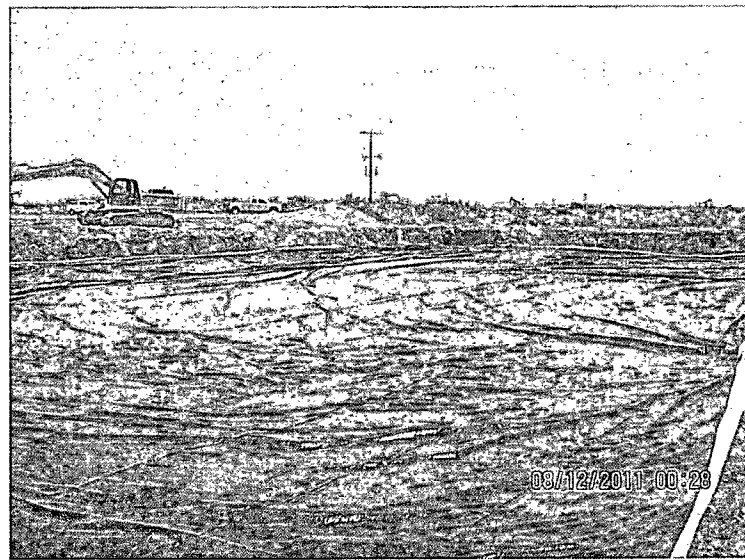
Liner installed, facing northeast 8/12/11

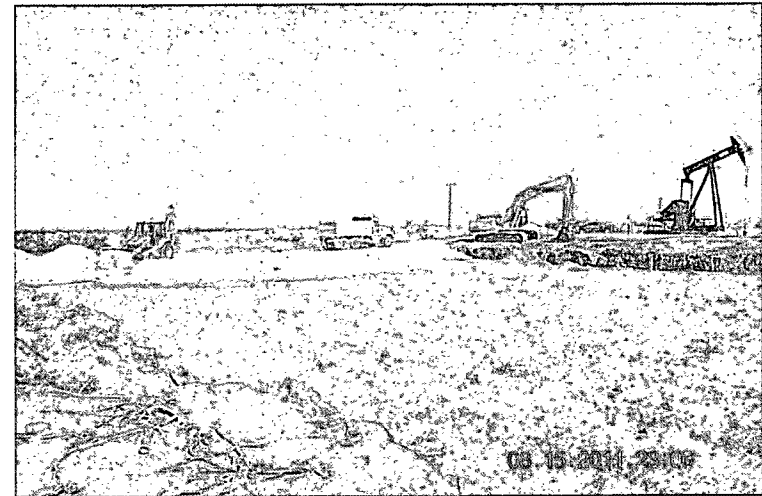
Backfilling site, facing northwest

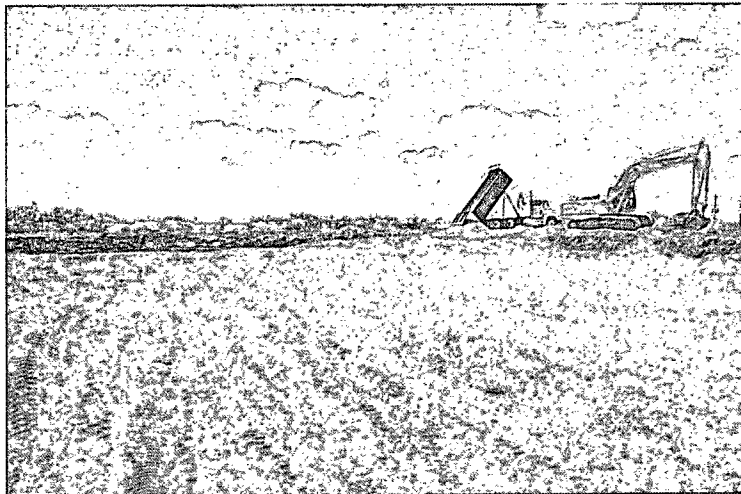
Importing caliche backfill, facing NW

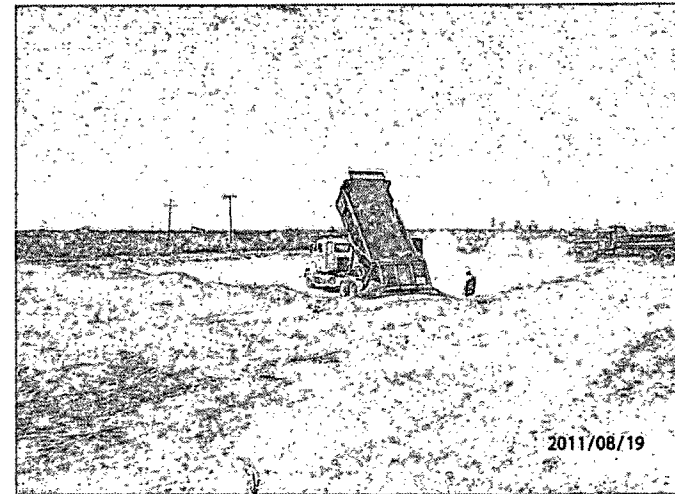
Importing top soil, facing SW

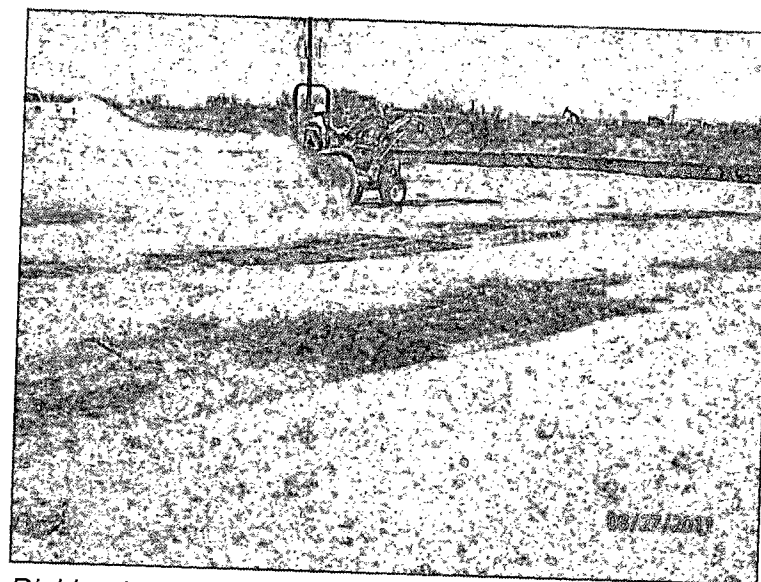
Disking in the soil amendments, facing north 8/27/11

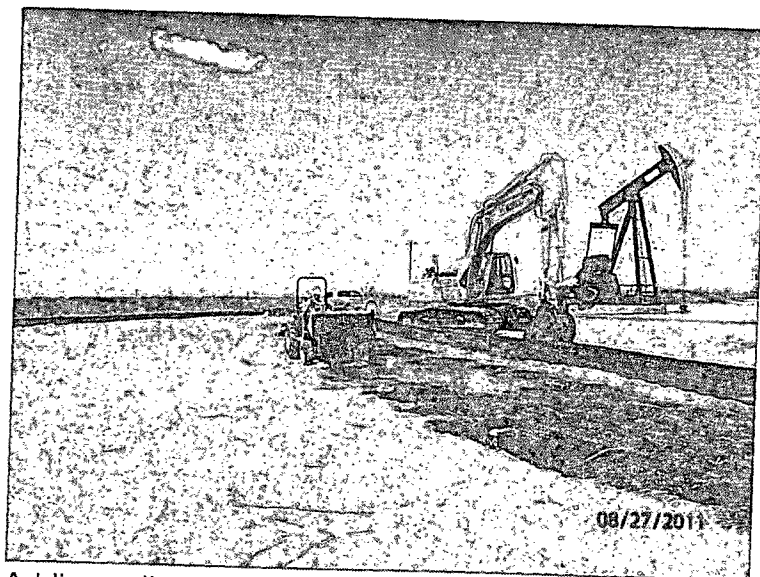
Adding soil amendments, facing west 8/27/11

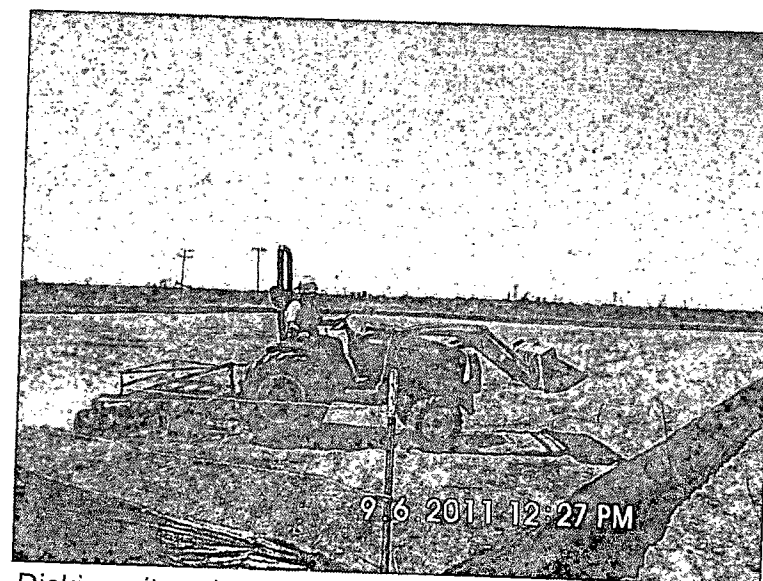
Disking site prior to seeding, facing SW 9/6/11

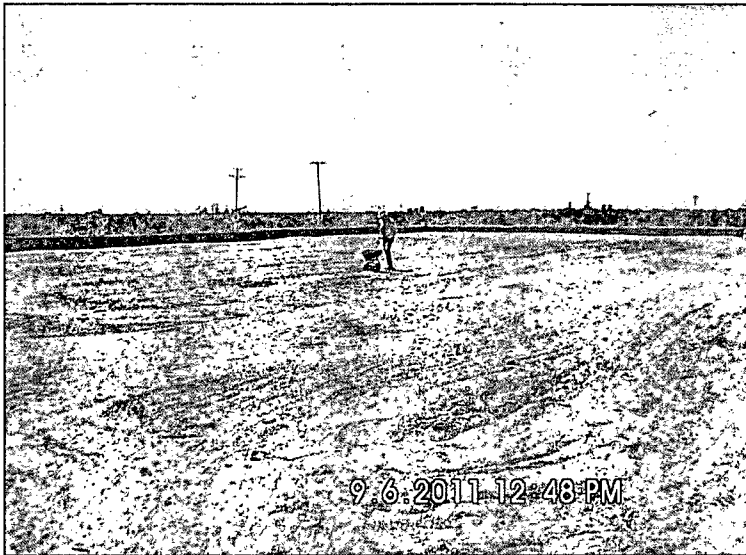
Seeding site, facing southwest

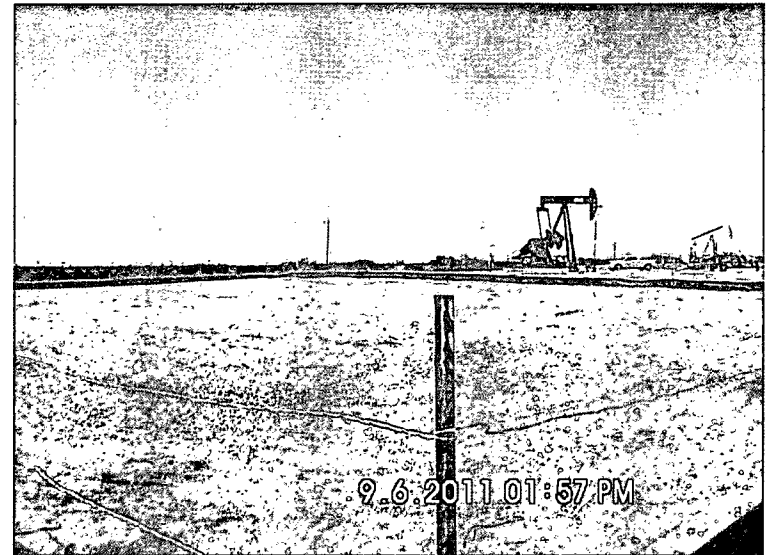
Site complete, facing northwest

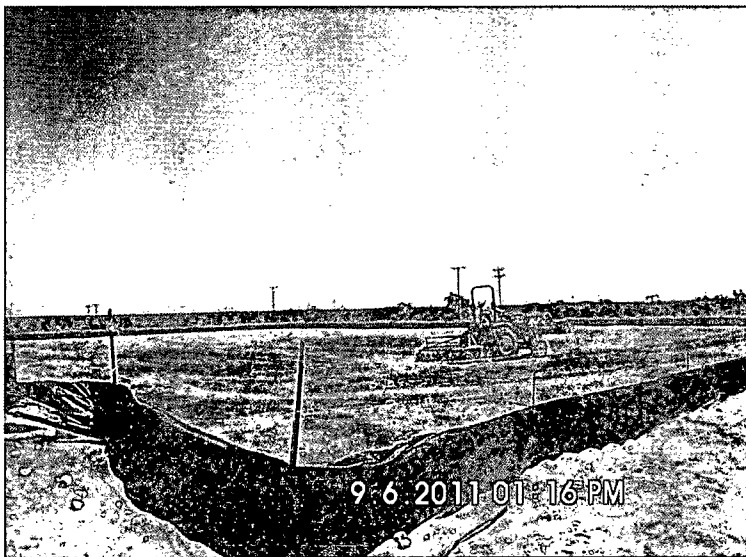
Disking in seed, facing southeast

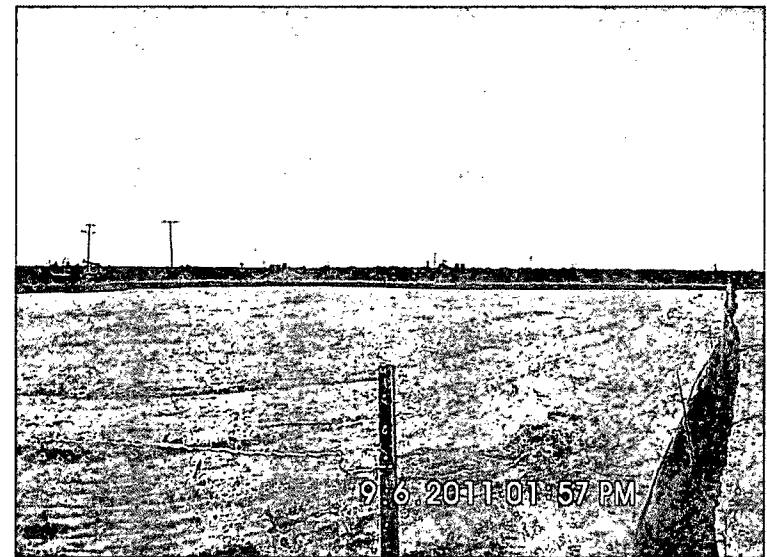
Site complete, facing southwest
