# BOPCO

## Poker Lake Unit Pierce Canyon 5 State No. 1

### CLOSURE REPORT

2RP-1197

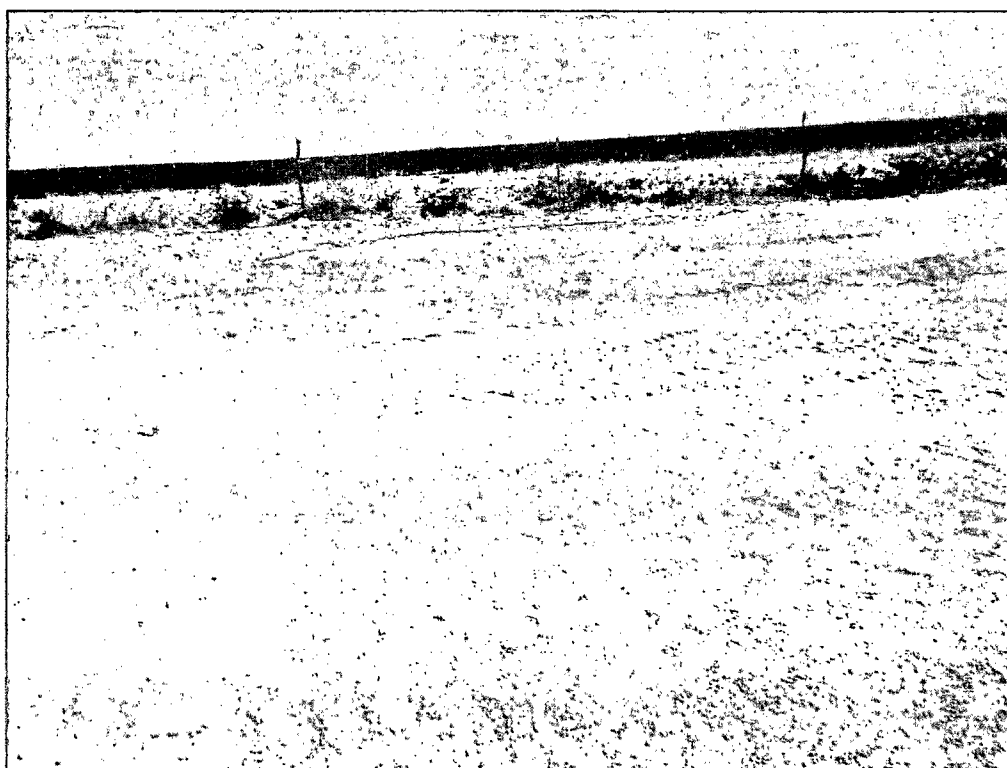
Site at completion misted and compacted 03/26/14

The most significant area of impact was in the lease road at SP1. This was the noted point of release, which lies between two water lines at the east edge of the road. Therefore was excavated to 3ft. bgs and lined with a 20 mil. liner. There was a cumulative total of 36 tons excavated from this area, likewise with the fresh caliche restoring the impacted area. This was backfilled with imported caliche, misted and packed.

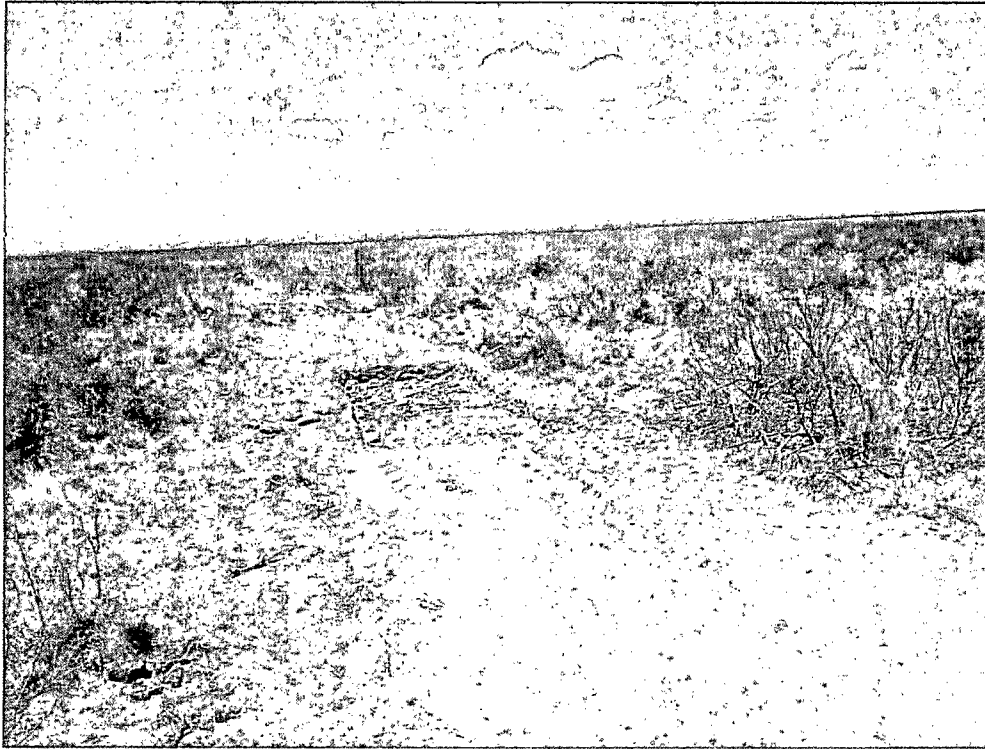
Excavation of impacted pasture area 4/29/14

The highest level of impact in the pasture area was SP8. Utilizing a Hydro-vac for SP7 and SP8; DFSI attempted to excavate to 1ft. bgs., however due to the number of high pressure lines and soil issues this area had to be hand-excavated. 1 ton of impacted top soil was removed and replaced with 1 ton of fresh topsoil from an NMOCD approved facility. The remainder of impacted pasture area was scraped, blended and contoured to the surrounding terrain.

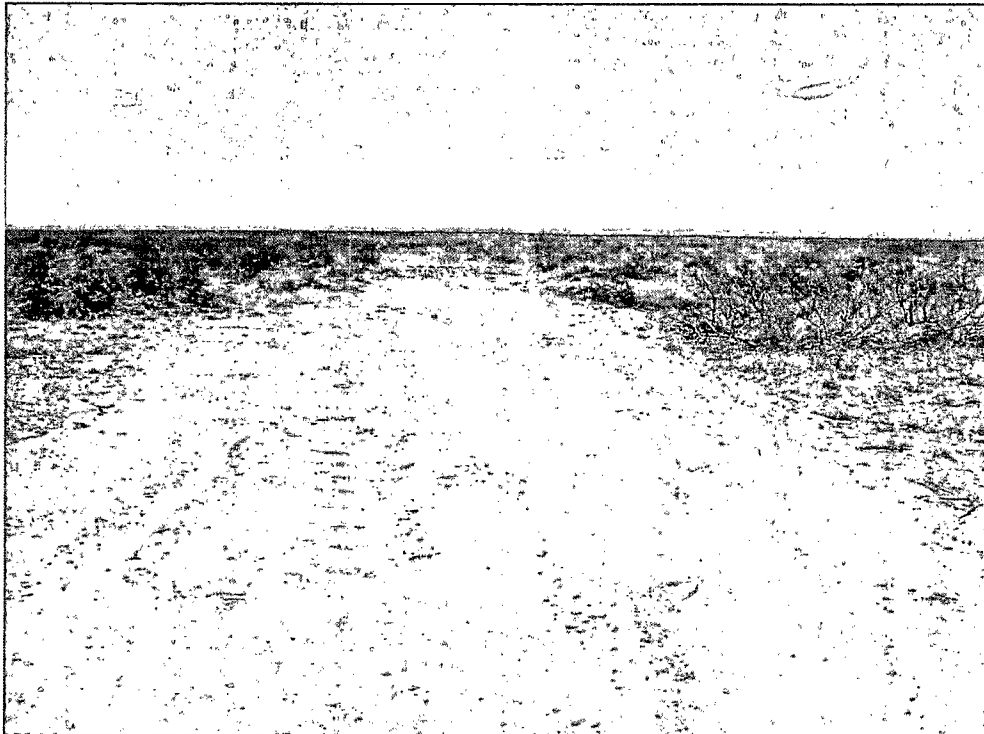
Pasture area at completion 4/29/14
