## NEDU #220 AD

# Closure Report

API 30-025-06358

**RE: TERMINATION REQUEST**

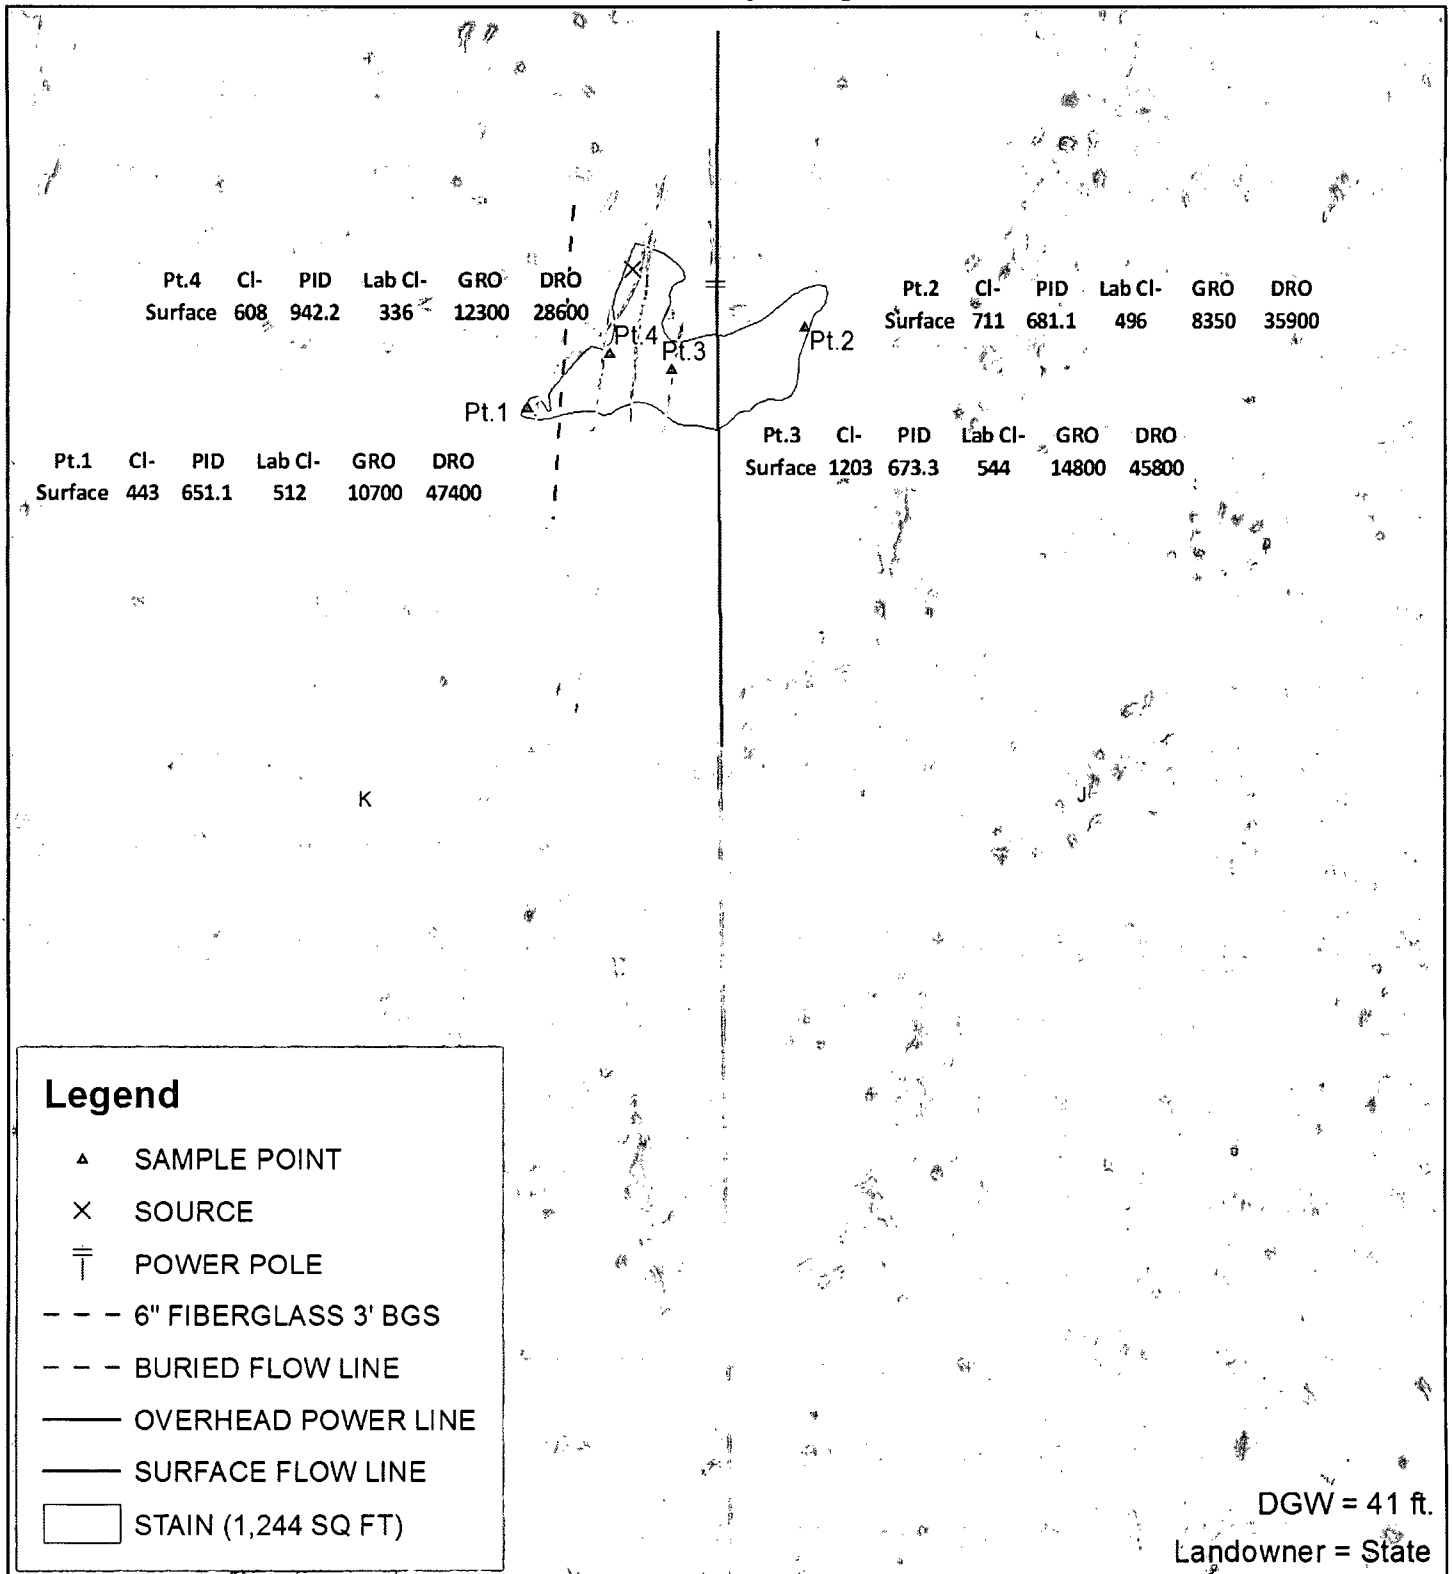
Figure 1

On November 27, 2012, RECS personnel initiated work on the NEDU #220. Initial soil samples were collected from ground surface (Figure 1). The samples were field tested for chloride. Headspace measurements were also taken in the field using a Photo Ionization Detector (PID). The samples were submitted to a commercial laboratory for chloride and TPH (GRO/DRO) analyses (Appendix C). Chloride ranged from 336 mg/kg to 544 mg/kg, GRO ranged from 8,350 mg/kg to 14,800 mg/kg, and DRO ranged from 28,600 mg/kg to 47,400 mg/kg.

# Initial Sampling Data

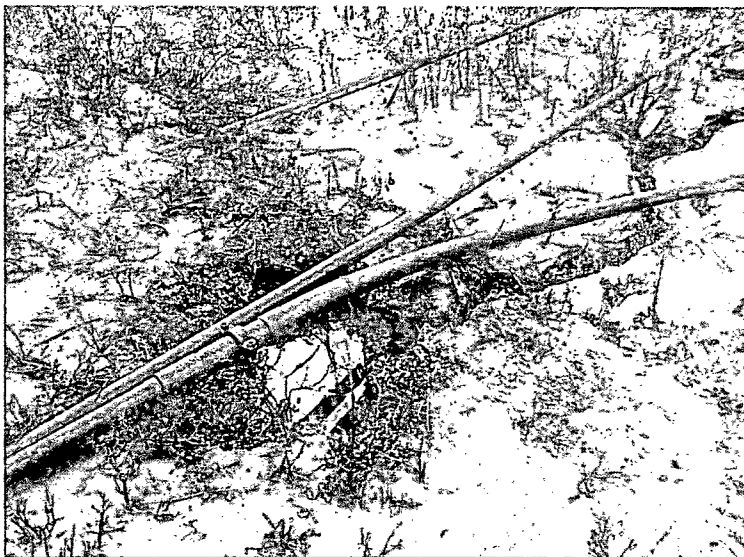
Release source, facing east

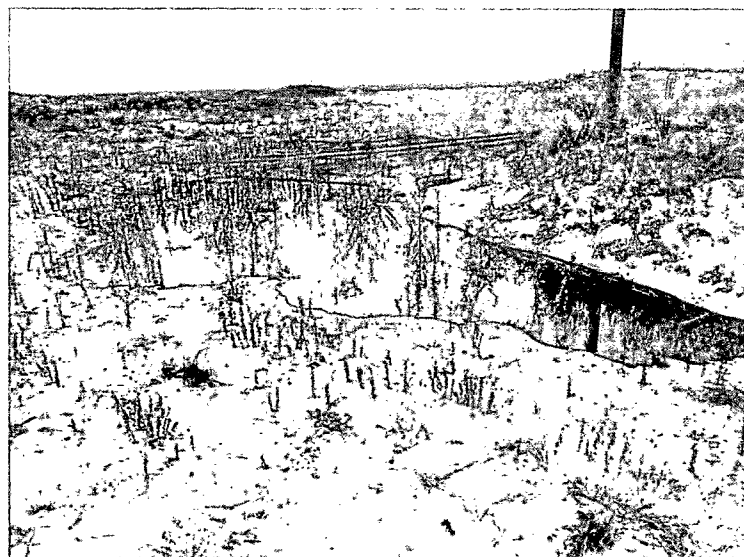
Initial release area, facing west

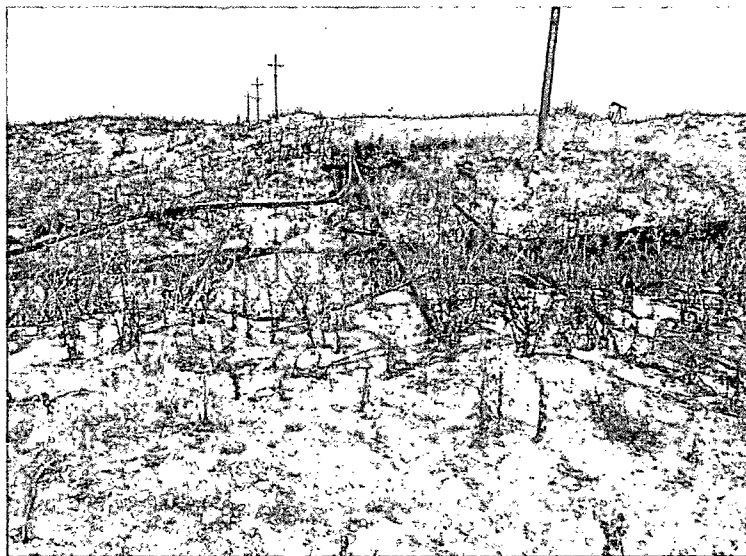
Initial release area, facing north

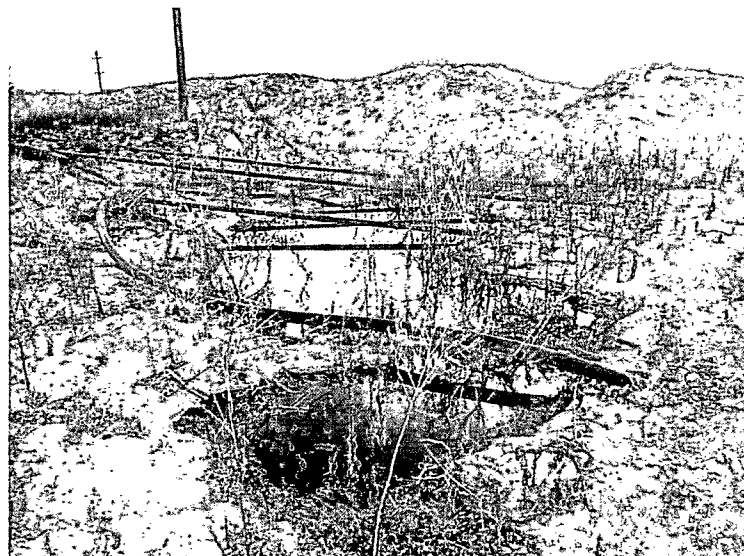
Initial release area, facing east

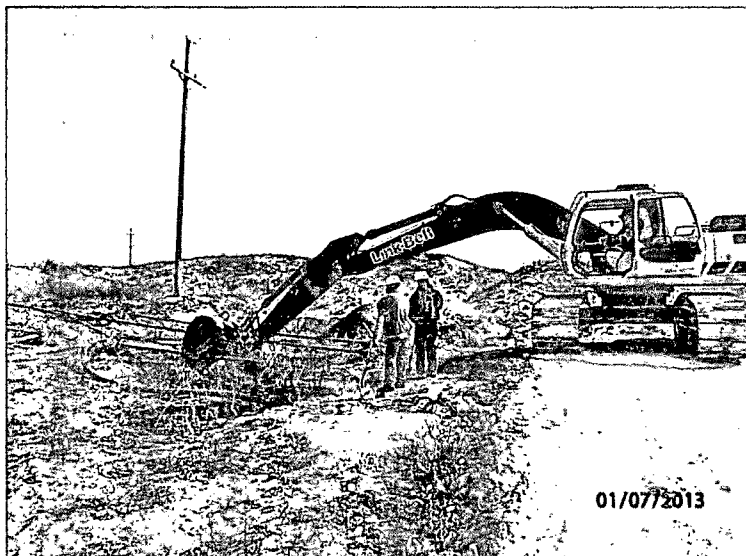
Excavating, facing east

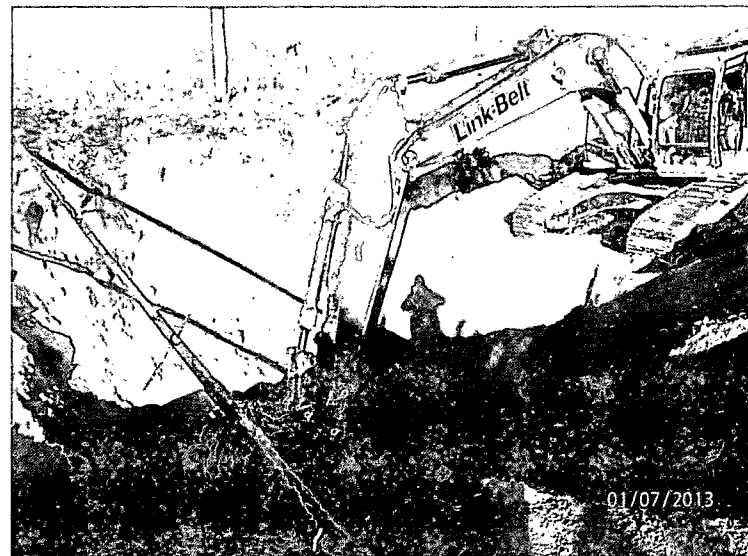
Digging Vertical #1, facing northeast

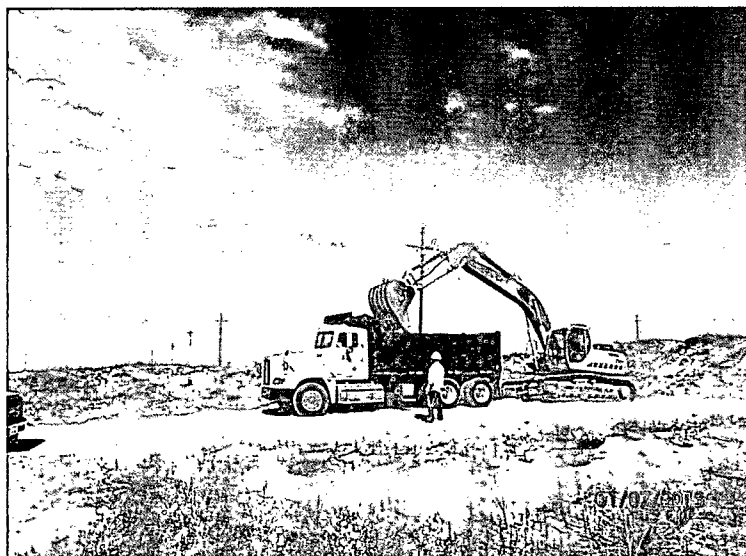
Exporting soil, facing northeast

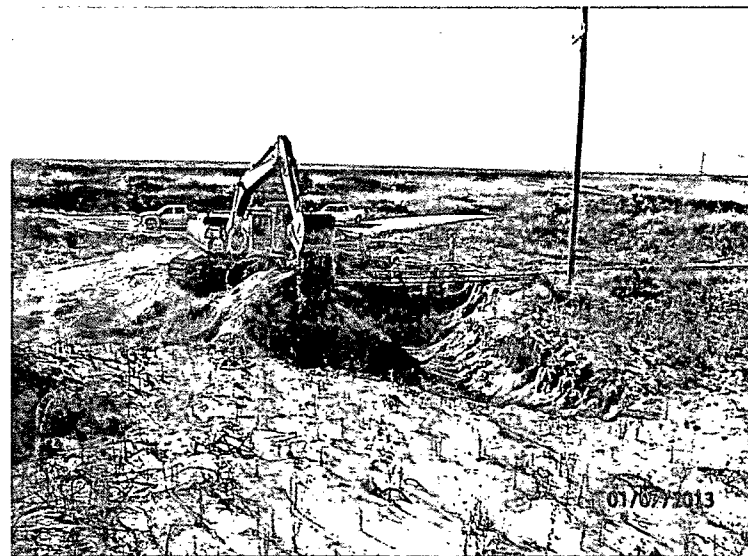
Excavating, facing west

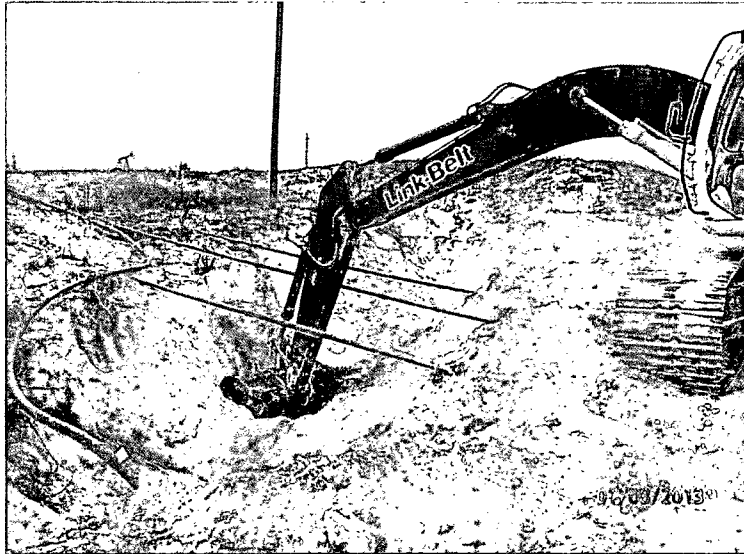
Digging Vertical #2, facing northeast

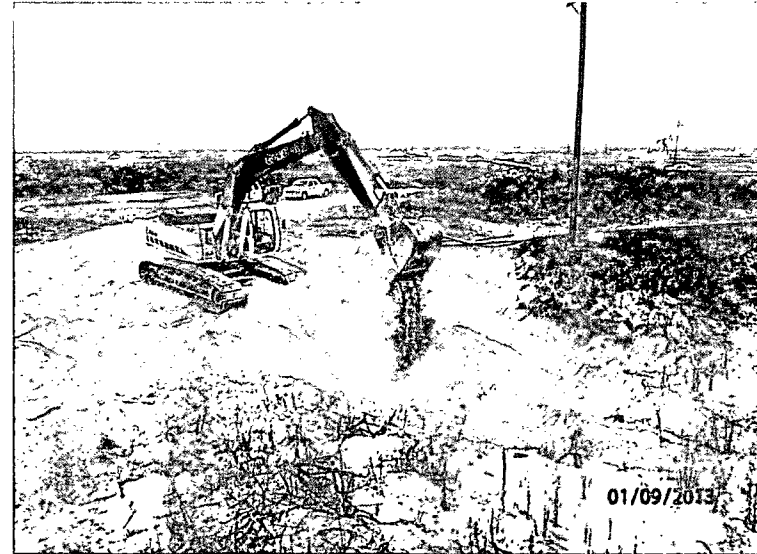
Backfilling excavation, facing west

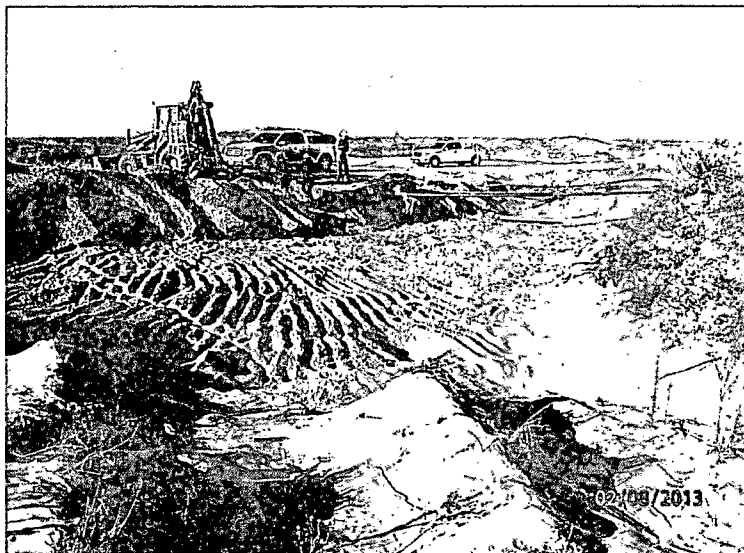
Excavation backfilled to 4 ft. bgs, facing south

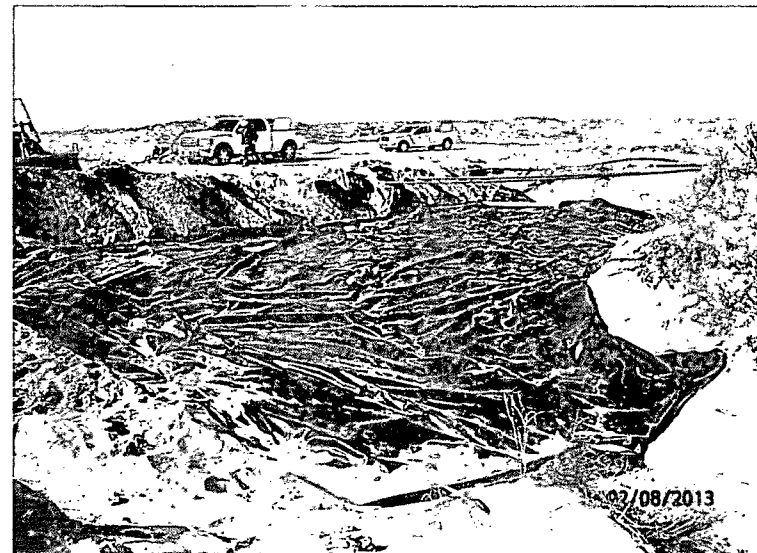
Liner installed, facing south

Impacted soils were removed to a NMOCD approved disposal facility. The excavation was backfilled to a depth of 4 ft. bgs. A 20 mil reinforced plastic liner was installed at 4 ft bgs, and the remaining excavation was backfilled with clean soil from the surrounding sand dunes.

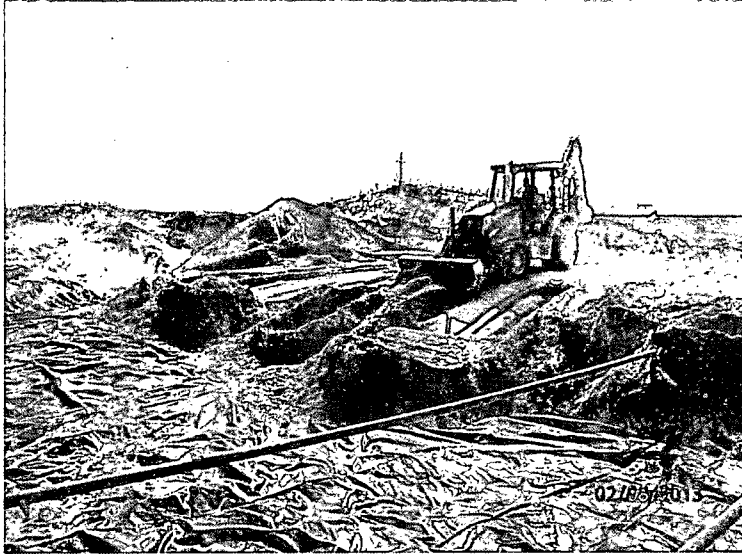
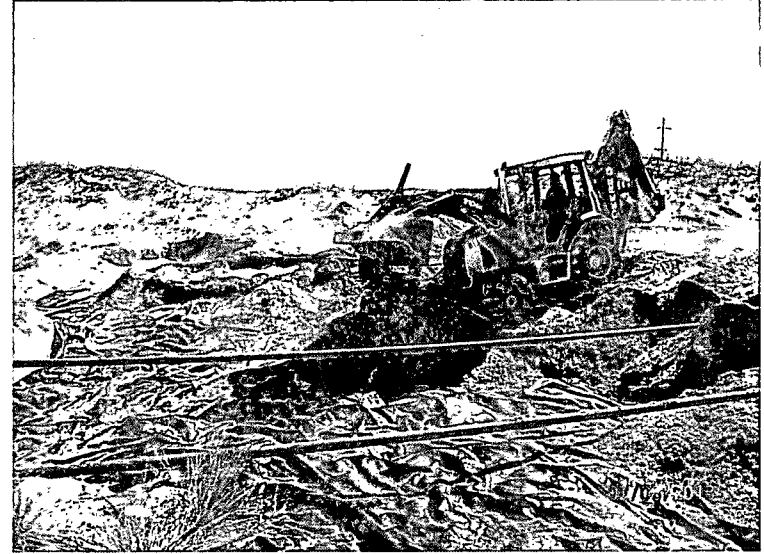
Backfilling above liner, facing east

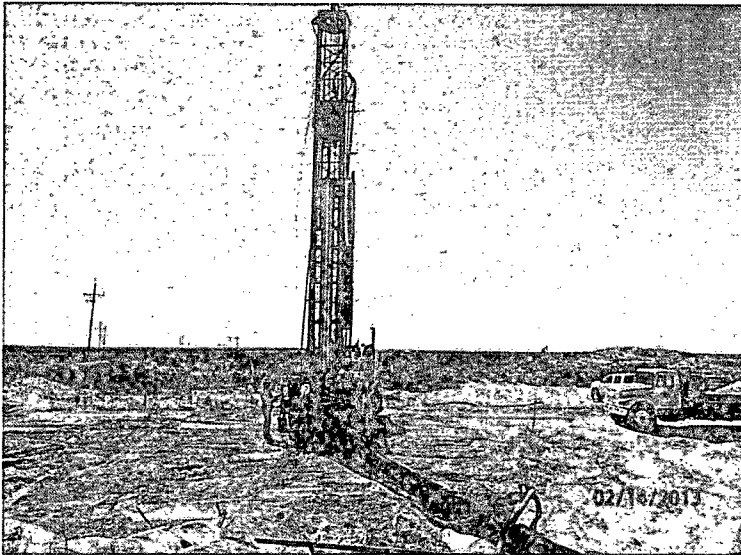
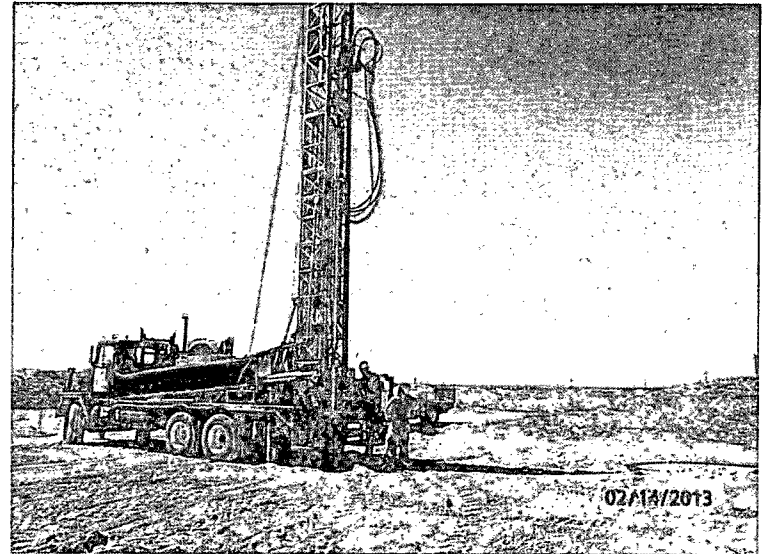
Drilling SB1, facing south

Drilling SB1, facing west

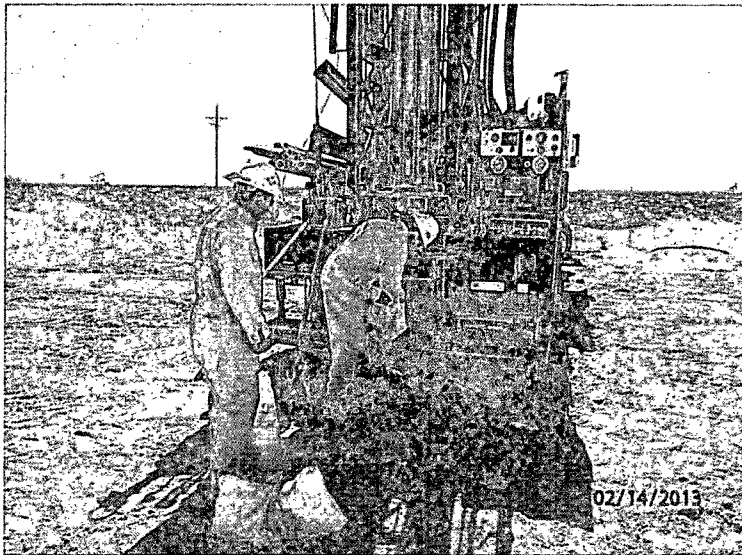
Plugging SB1 with bentonite, facing south

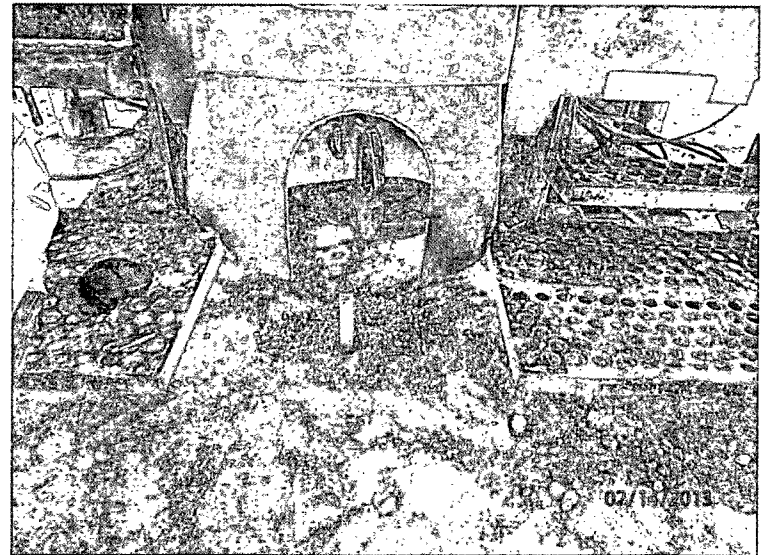
SB1 complete, facing south
