REMEDIATION SUMMARY AND RISK-BASED SITE CLOSURE REQUEST

**BOPCO, LP
JAMES RANCH UNIT #55 WELL PAD
Eddy County, New Mexico
Unit Letter "F" (SE/NW), Section 17, Township 23 South, Range 31 East
Latitude 32.306285° North, Longitude 103.801920° West
NMOCD References #2RP-548 & 1177**

June 2014

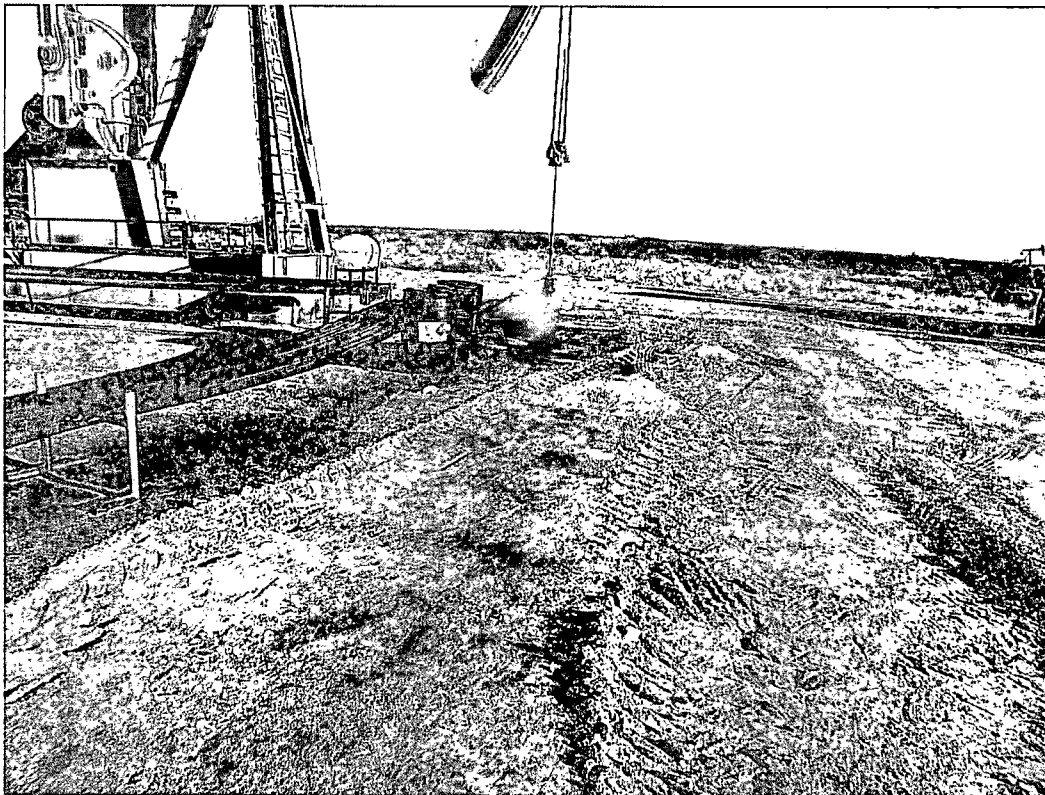
Photograph of surface staining from the March 9, 2013, release at the JRU #55 Well Pad.

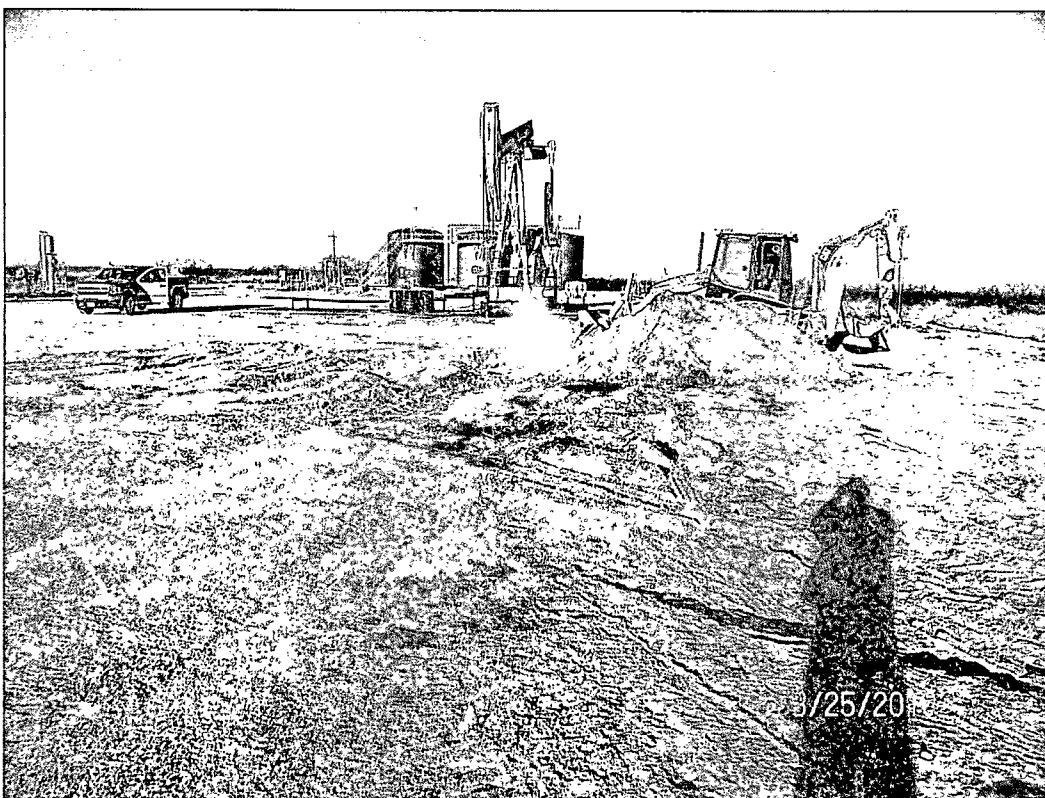
Photograph of remediation activities associated with the March 9, 2013, release at the JRU #55 Well Pad.

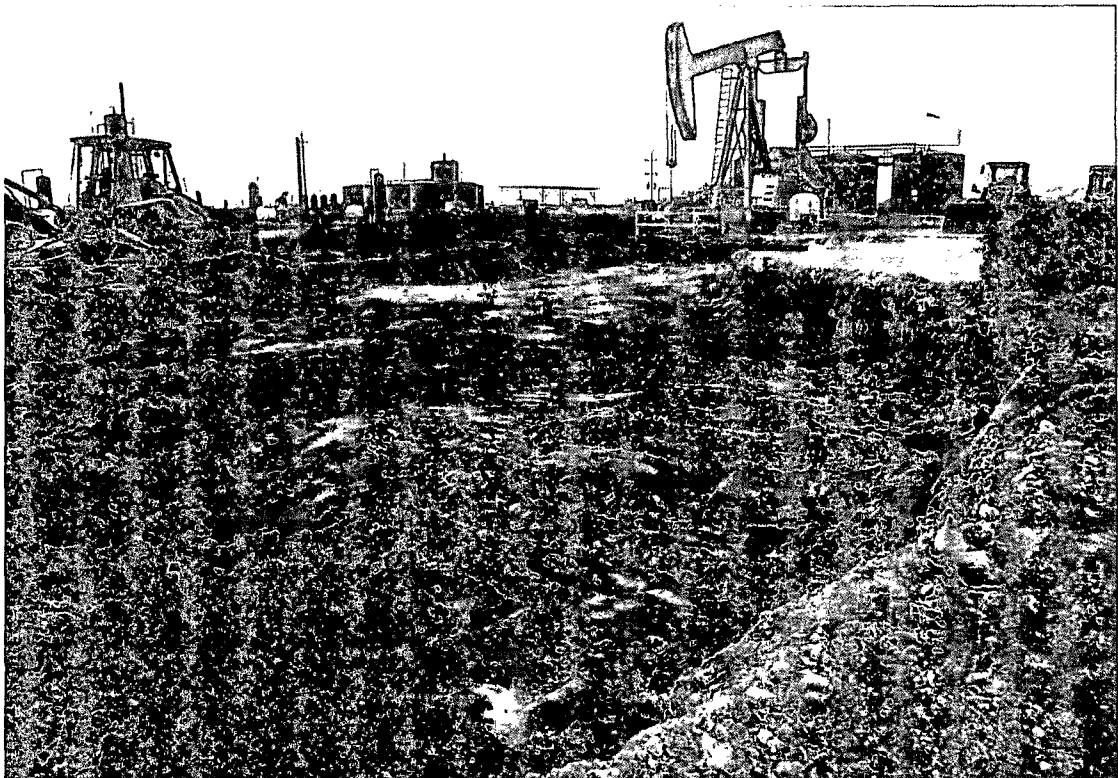
Photograph of the excavated area at the JRU #55 Well Pad.

Between May 22 and 28, 2014, approximately seven hundred and forty cubic yards (740 yd³) of impacted material was transported to Lea Land, LLC (NMOCD Permit #WM-01-035), for disposal. Prior to backfilling, the final dimensions of the excavation were approximately twelve (12) to thirty feet (30') in width, one hundred and thirty feet (130') in length and two (2) to four feet (4') in depth.

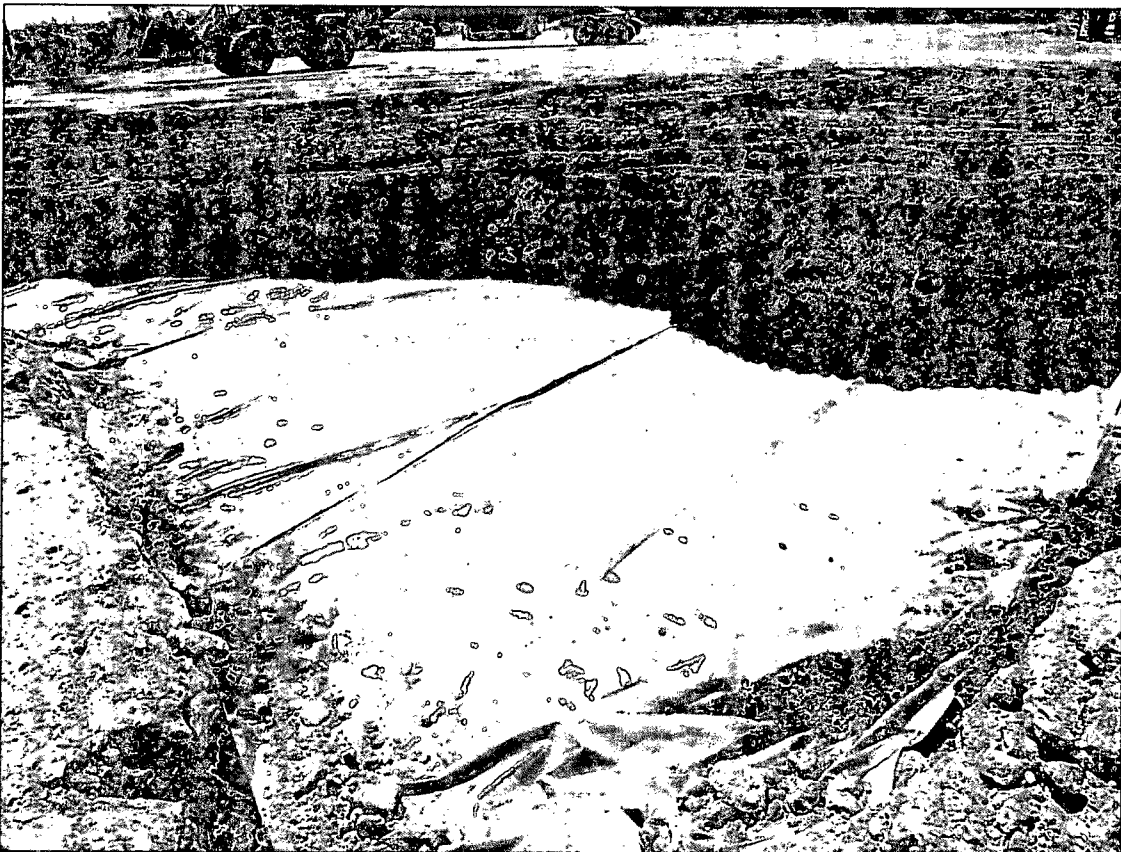
Photograph of backfilling activities at the JRU #55 Well Pad.

On May 28, 2014, upon receiving NMOCD approval, a 20-mil polyurethane liner was installed in the floor of the excavation atop areas exhibiting chloride concentrations above NMOCD regulatory standards. This engineering control was designed to inhibit the vertical migration of contaminants left in-situ and help mitigate any future releases on the well pad. Upon installing the approved liner, the remaining portion of the excavation was backfilled with non-impacted caliche.
