**Release Report/ General
Correspondence**

Trunk 2B Gathering line

**Enterprise Products
Trunk 2B Pipeline Release
Latitude: North 36.594763 Longitude: West -108.053748
SW ¼, NW ¼ (UNIT E) Section 7 T27N R11W
San Juan County, New Mexico**

December 31, 2013

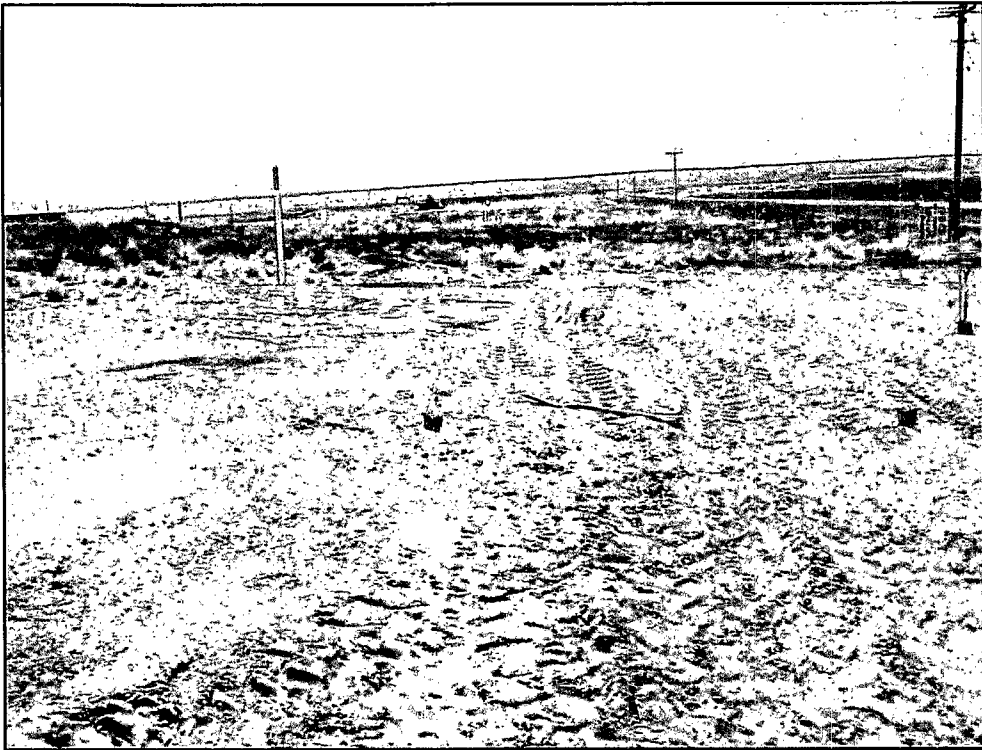
Photo 1: View of hand auger locations (blue flags) during the May 28th, 2013 site visit.

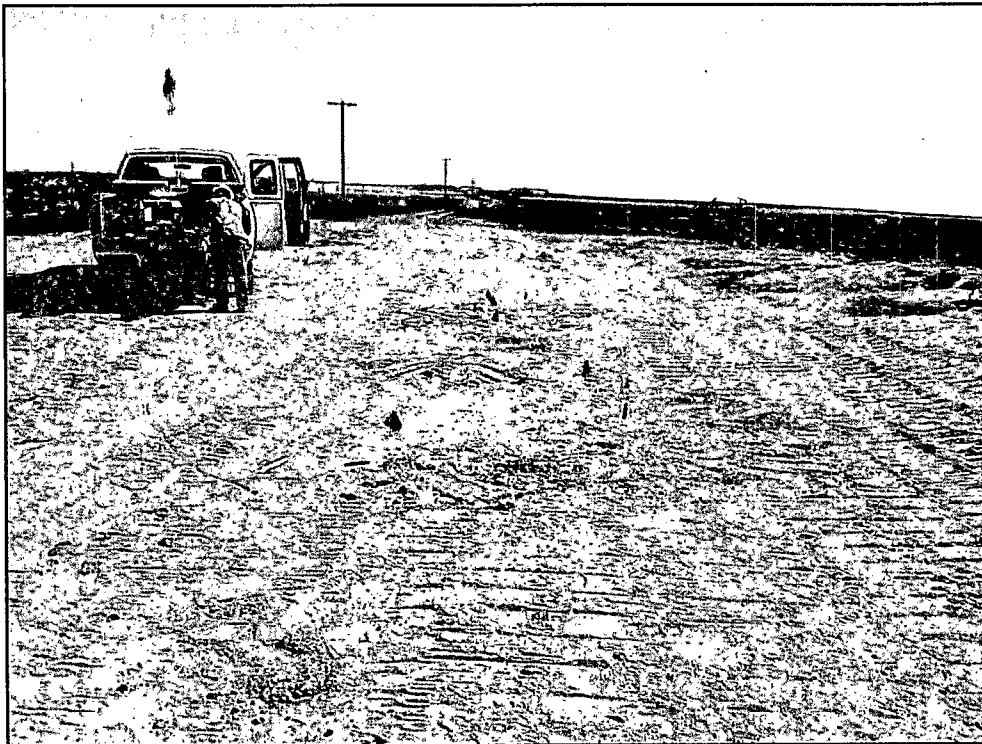
Photo 2: View of additional hand auger locations during the October 2nd, 2013 site visit.

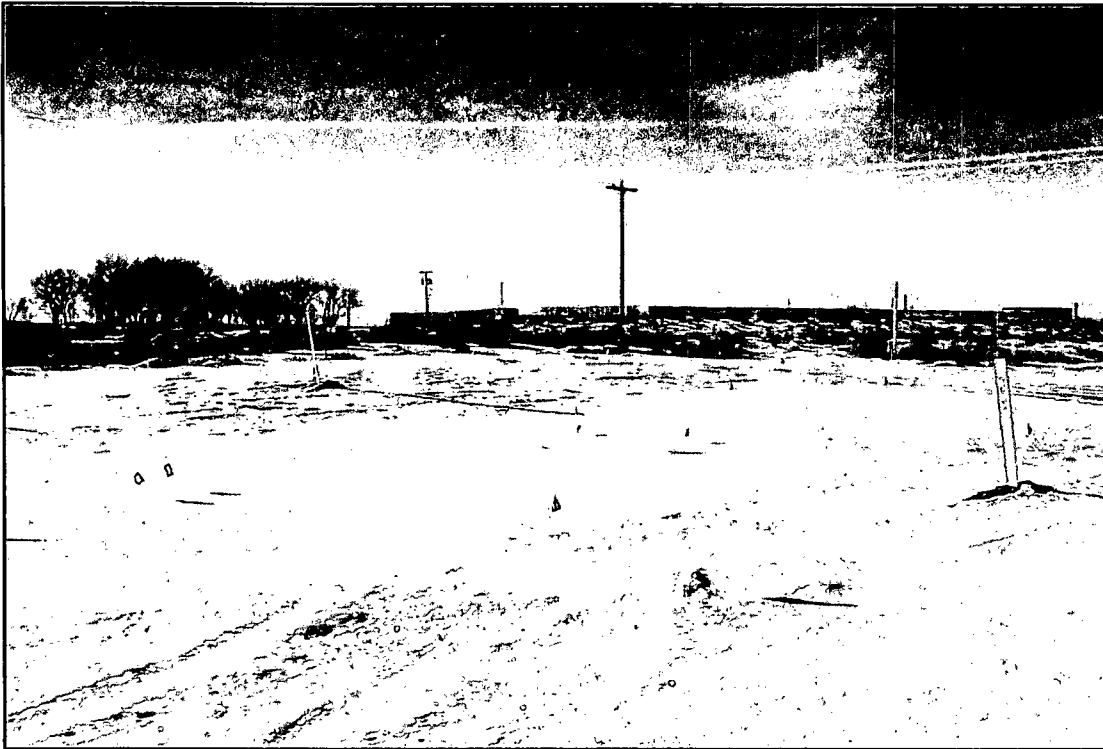
Photo 3: View of the site (looking southwest) prior to field work on December 16th, 2013.

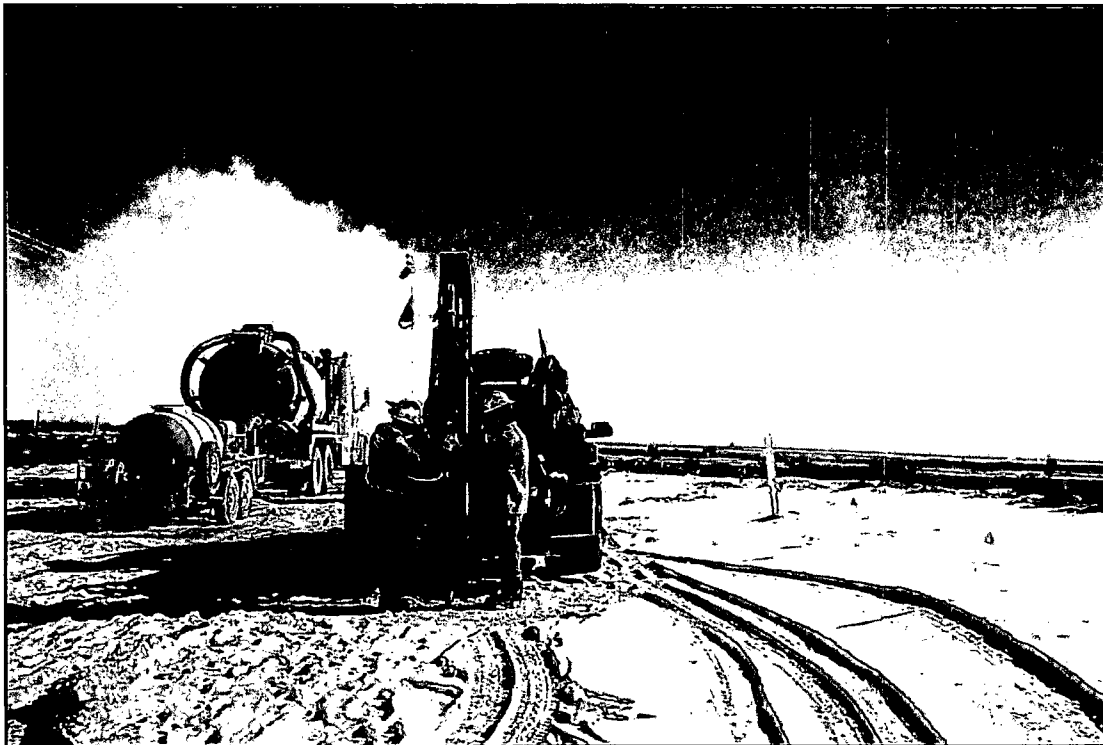
Photo 4: View of the potholing and drilling activities during the December 16th, 2013 field activities.
