**Release Report/ General  
Correspondence**

## **CORRECTIVE ACTION REPORT**

**Lateral 2A-3 Pipeline Release  
NW 1/4, S27 T27N R10W  
San Juan County, New Mexico**

Apex Project No. 7030414G005

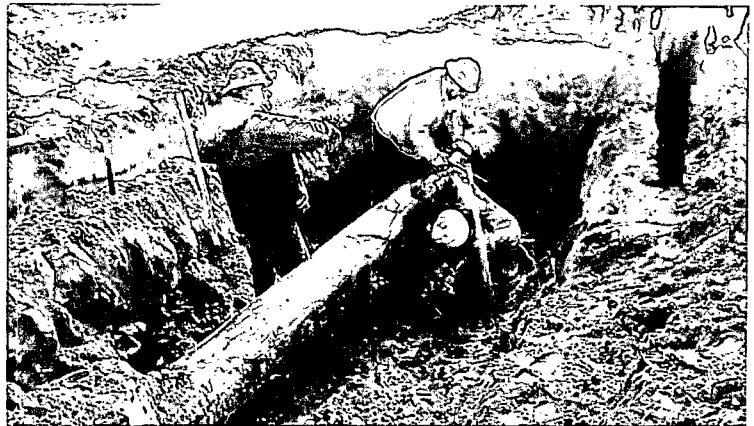
**Photograph 2**

Leak is located after using pressurized nitrogen.

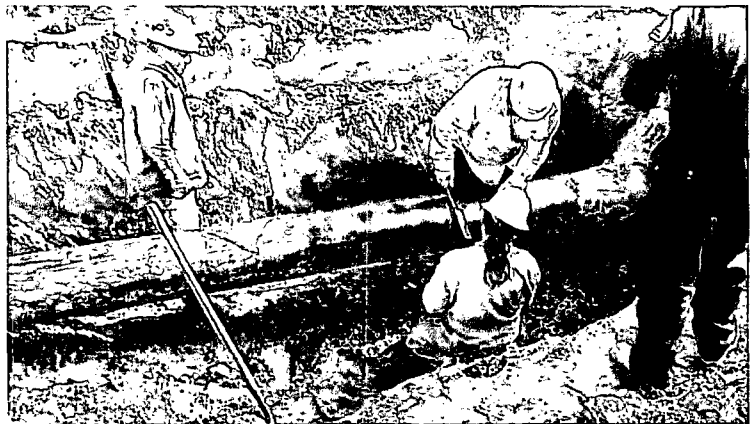
**Photograph 3**

Pipeline is cleaned for repair.

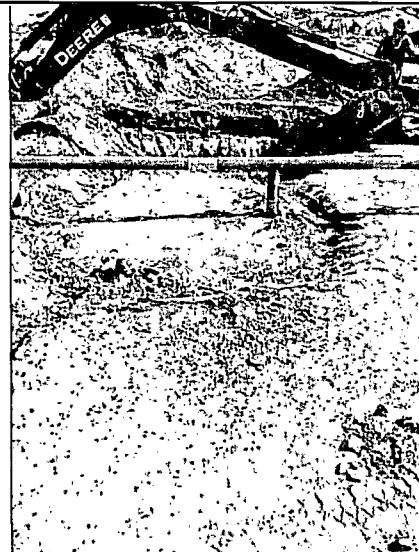
**Photograph 6**

General view of surface release area after removal of affected soils by hand tools.
