REMEDIATION SUMMARY AND SITE CLOSURE REQUEST

BOPCO, LP
POKER LAKE UNIT #387 FRAC SPILL
Eddy County, New Mexico
Unit Letter "D" (NW/NW), Section 12, Township 25 South, Range 30 East
Latitude 32.14954° North, Longitude 103.84270° West
NMOCD Reference #2RP-2077

November 2013

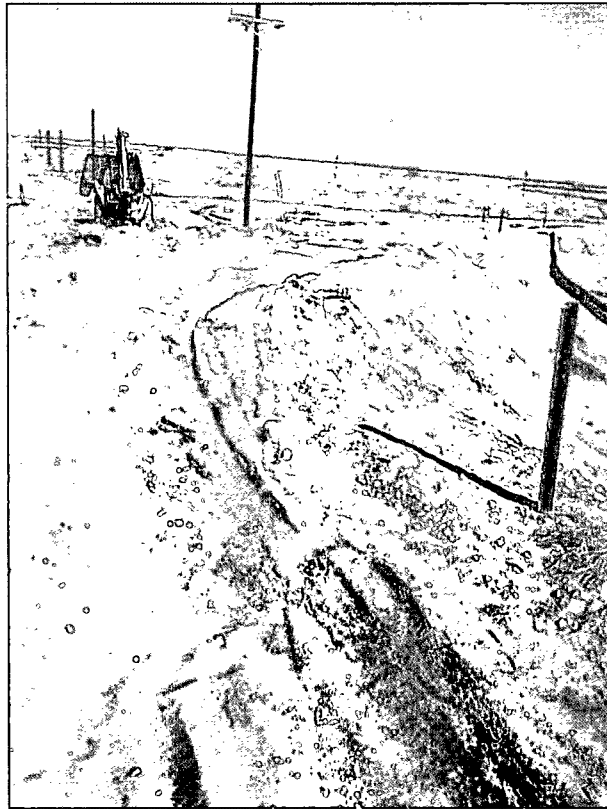
Photograph of the initial release at the PLU #387 Release Site. (Looking Southwest)

On November 18, 2013, BOPCO discovered a release had occurred on an eight-inch (8") frac hose being used to transfer produced water from the Harrison SWD to the PLU #387H. The release was attributed to a small damaged area near one of the Victaulic connections. The release was reported to the New Mexico Oil Conservation Division (NMOCD) Artesia District Office and BLM immediately upon discovery. The "Release Notification and Corrective Action" (Form C-141) indicated approximately sixty-five barrels (65 bbls) of produced water was released, affecting approximately sixteen hundred square feet (1,600 ft²) of pasture land. During initial response activities, the affected segment of hose was repaired and a vacuum truck was utilized to recover approximately fifteen barrels (15 bbls) of produced water. The Form C-141 is provided as Appendix A. General photographs of the release site are provided as Appendix B.

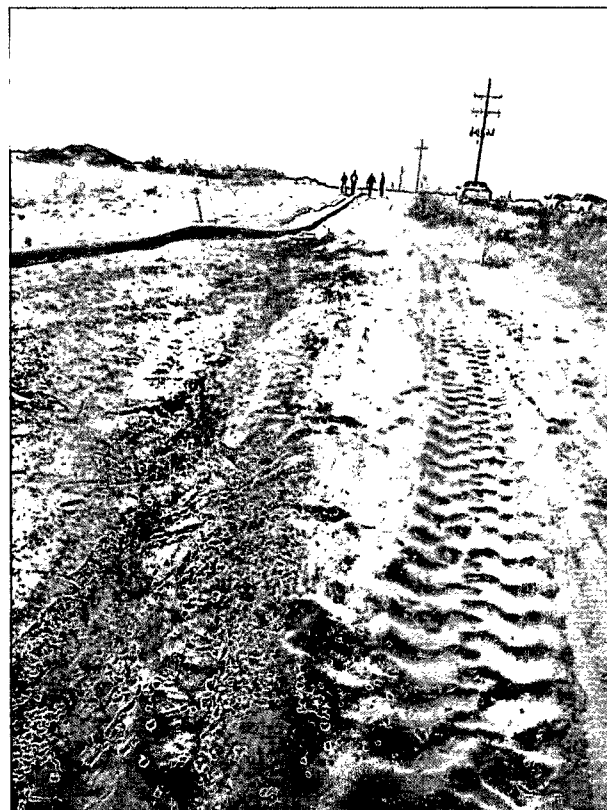
Photograph of the initial release and narrow flowpath at the PLU #387 Release Site. (Looking South)

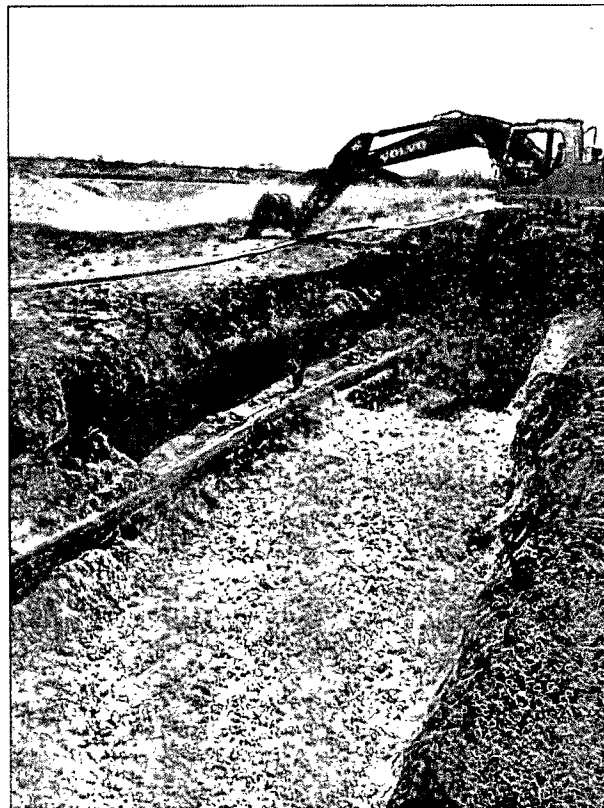
Photograph of excavation activities at the PLU #387 Release Site. (Looking Southeast)

On November 19, 2013, Basin began excavating impacted soil at the release site. The floor and sidewalls of the excavation were advanced until field tests suggested concentrations of benzene, toluene, ethylbenzene and xylene (BTEX), total petroleum hydrocarbons (TPH) and chloride were less than NMOCD Regulatory Standards. Confirmation soil samples were collected at fifty-foot (50') intervals and submitted to Cardinal Laboratories of Hobbs, New Mexico, for analysis of BTEX concentrations in accordance with EPA Method SW-846-8021b, TPH concentrations in accordance with EPA Method SW-846-8015M and/or chloride in accordance with EPA Method 4500 Cl-b. A summary of "Concentrations of Benzene, BTEX, TPH and Chloride in Soil" is provided in Table 1. A "Site and Sample Location Map" is provided as Figure 2. Laboratory analytical reports are provided as Appendix C.

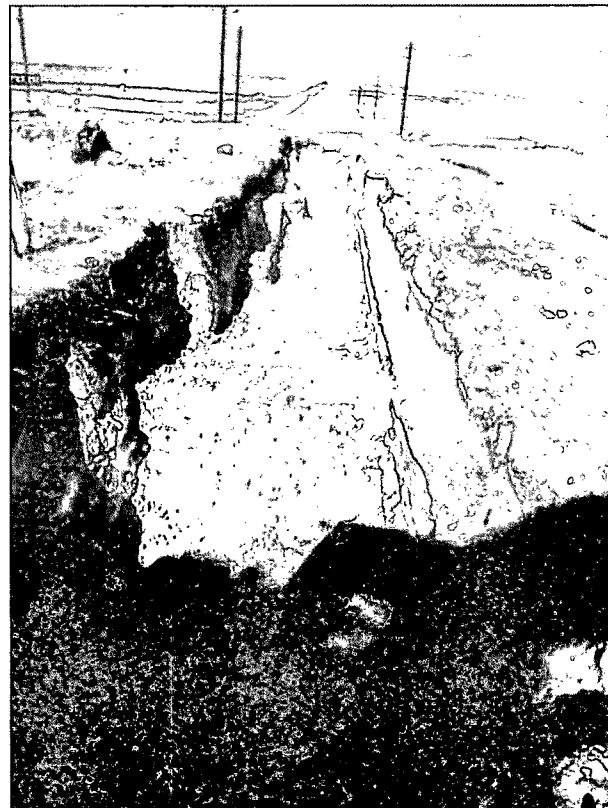
Photograph of the excavation at the PLU #387 Release Site. (Looking North)

The final dimensions of the excavation were approximately eight feet (8') to fifteen feet (15') in width, two hundred and seventy feet (270') in length and three feet (3') to ten feet (10') in depth.

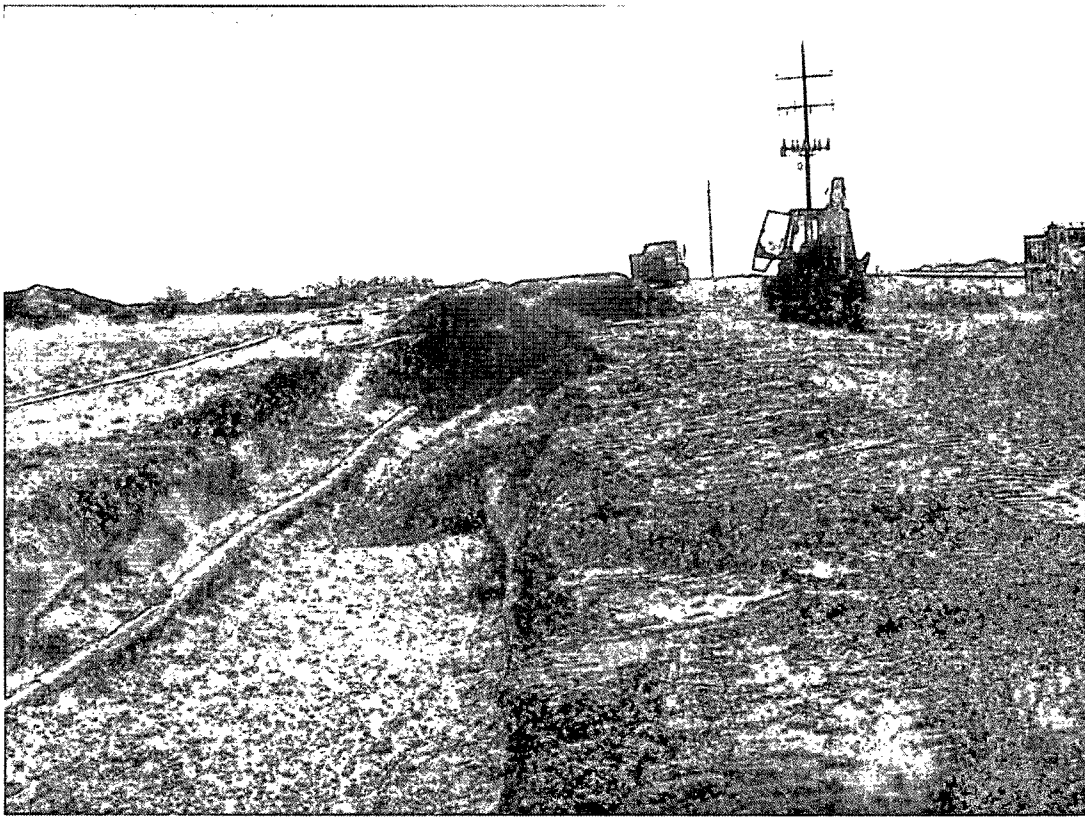
Photograph of backfilling activities at the PLU #387 Release Site. (Looking South)

On December 9, 2013, upon receiving laboratory analytical data from confirmation soil samples and NMOCD permission, Basin began backfilling the excavation with locally purchased, non-impacted material. Following backfilling, areas affected by the remediation activities were contoured to fit the surrounding topography.

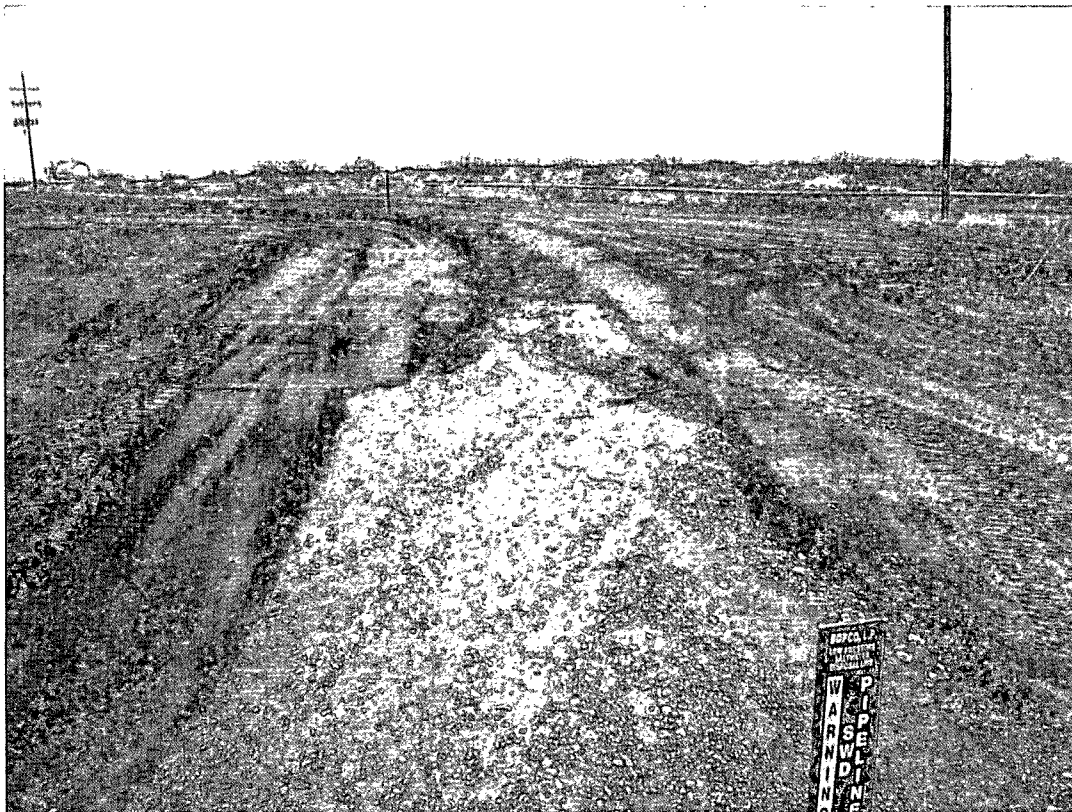
Photograph of PLU #387 Release Site after remediation activities. (Looking Southwest)

The site will be reseeded at a time conducive to germination.

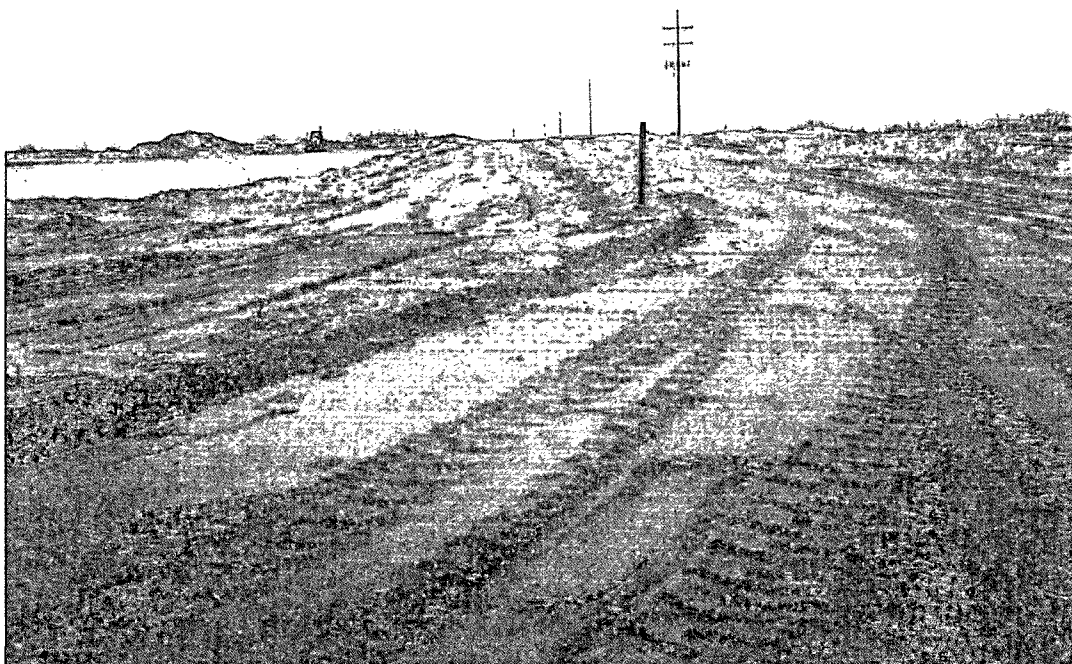
Photograph of PLU #387 Release Site after remediation activities. (Looking South)
