Linn Energy Skelly #273

CLOSURE REPORT

BLM Event #NU14008MB

December 19, 2013

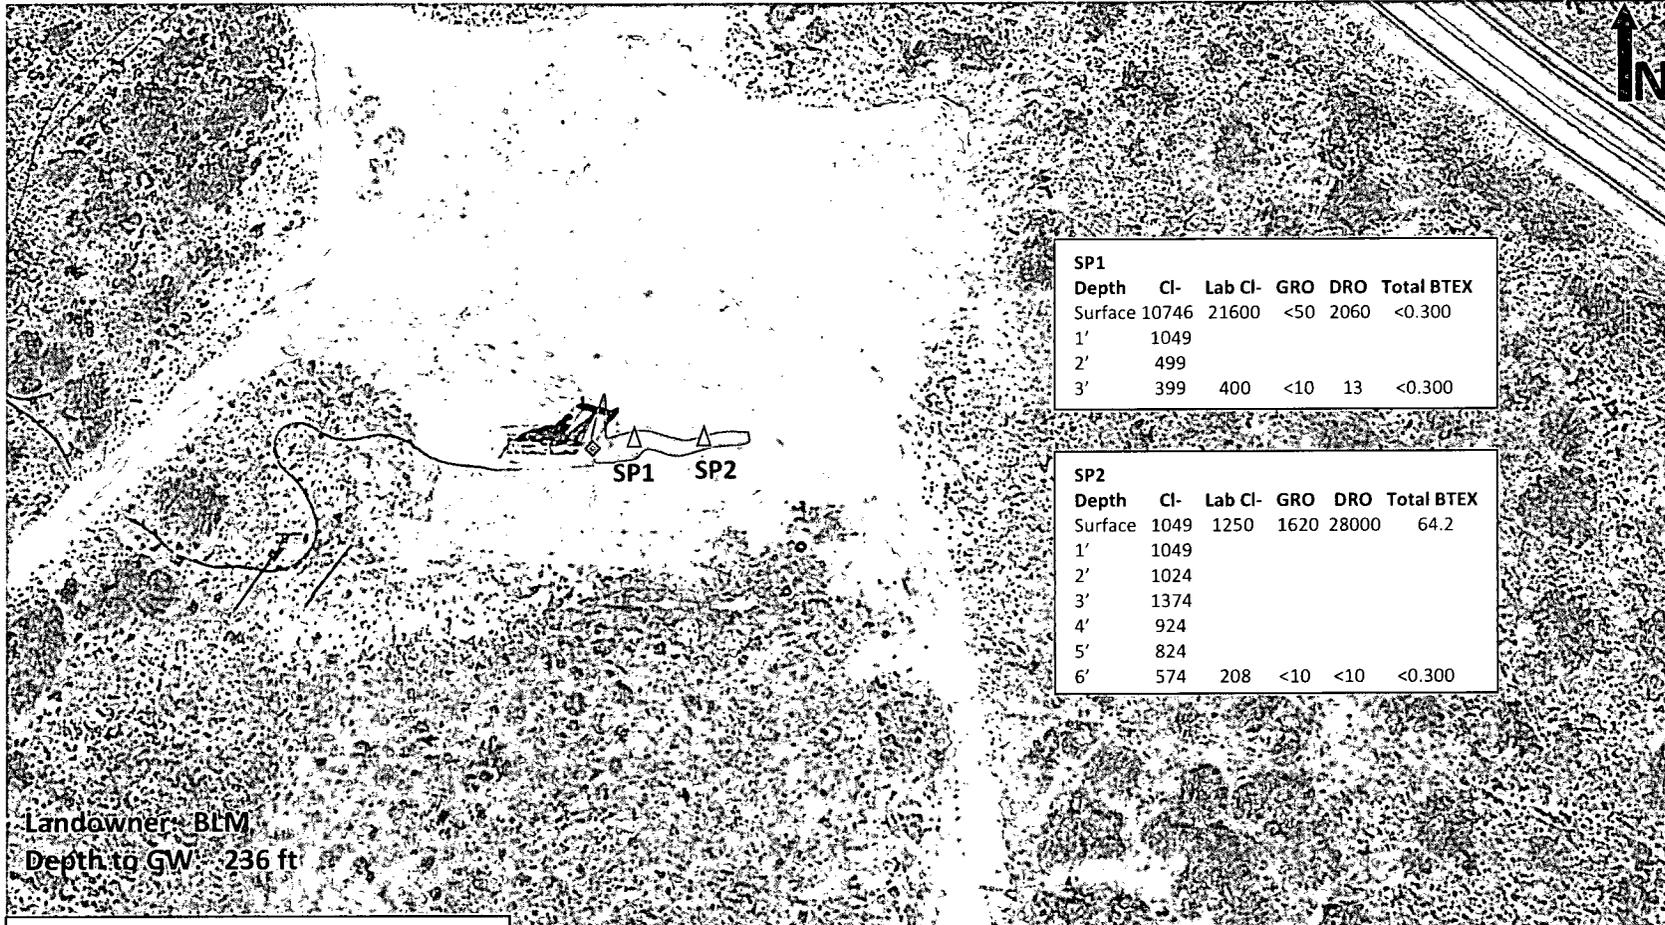
Site Diagram with Sample Data

SP1					
Depth	Cl-	Lab Cl-	GRO	DRO	Total BTEX
Surface	10746	21600	<50	2060	<0.300
1'	1049				
2'	499				
3'	399	400	<10	13	<0.300

SP2					
Depth	Cl-	Lab Cl-	GRO	DRO	Total BTEX
Surface	1049	1250	1620	28000	64.2
1'	1049				
2'	1024				
3'	1374				
4'	924				
5'	824				
6'	574	208	<10	<10	<0.300

Landowner: BLM
 Depth to GW: 236 ft

Stained Area (total 250 ft²)
-

Leak Source
-

On October 31, 2013, DFSI personnel collected surface soil samples from the site (Figure). The samples were field screened for chloride and showed elevated levels in all of the sample points. On November 11, 2013 DFSI field personnel returned to the site and conducted simultaneous field testing by hand auger revealing low chloride and hydrocarbon levels at 1 to 6 ft. below ground surface (bgs). Chloride levels indicated a reduction at 208 mg/kg at 6 ft. bgs near the well head on the pad. The samples were submitted to a commercial laboratory for chloride, TPH, and BTEX analyses (Appendix IV)

On November 13, 2013, a BLM representative approved backfill of the excavation. Impacted soils were excavated throughout the entire leak area and removed to a NMOCD approved disposal facility. The excavated area on the well pad was backfilled and capped with imported caliche. DFSI personnel bladed and leveled the site. Photographs of site activities can be viewed in Appendix II.

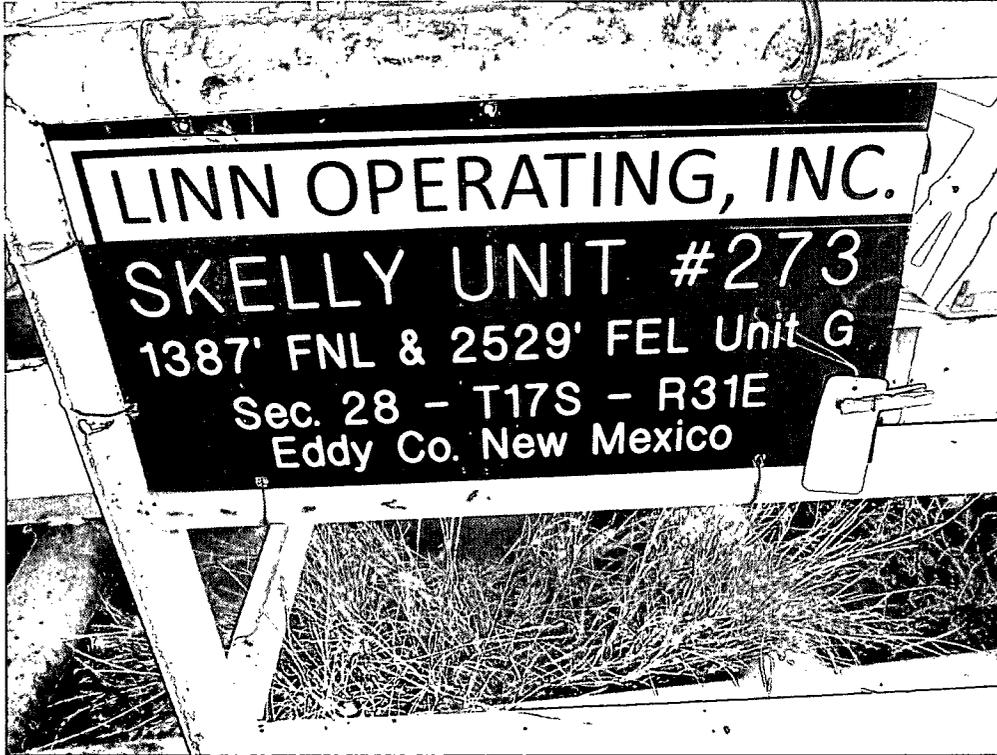
Sign marking location

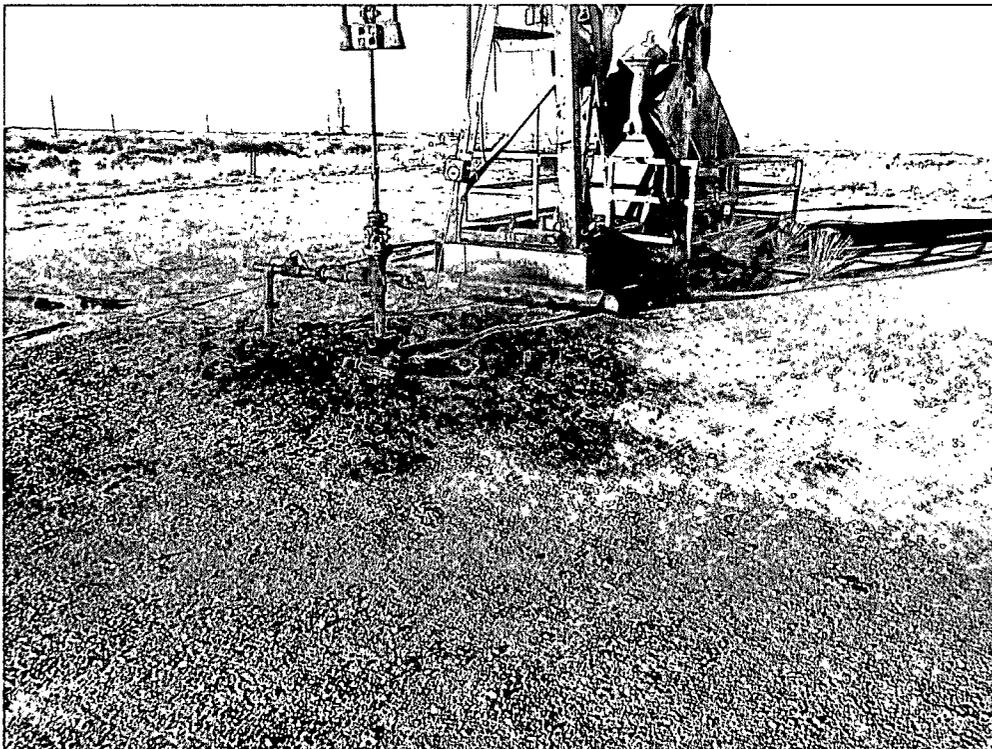
Leak at stuffing box

The site is located west of Maljamar NM, in Eddy County. The site resulted from a produced water and oil leak at the stuffing box. The leak released fluids onto the well pad. The packing was repaired, and standing fluids were recovered. A form C-141 was submitted to the BLM on October 23, 2013 (Appendix I).

Describe Cause of Problem and Remedial Action Taken.*: Drove up to well #273 at around 7:00am and found well leaking from stuffing box. Back pressure valve was plugged with with a piece of packing rubber and caused the well to pressure up and blow packing.

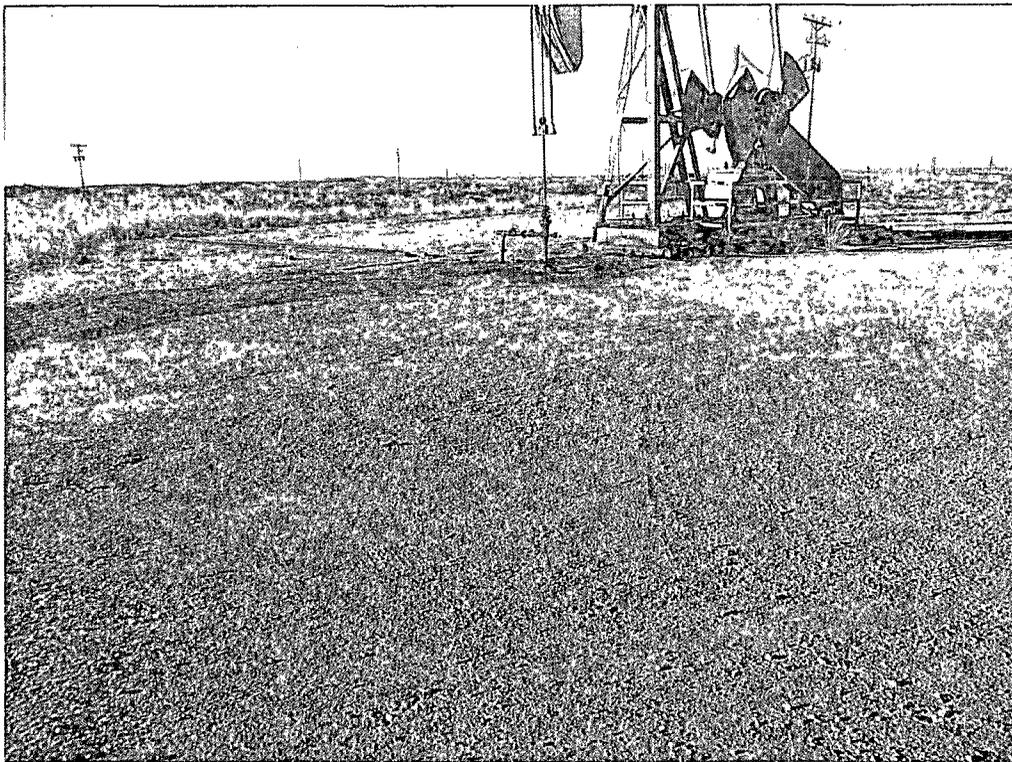
East leg of leak extending from well head 11/12/13

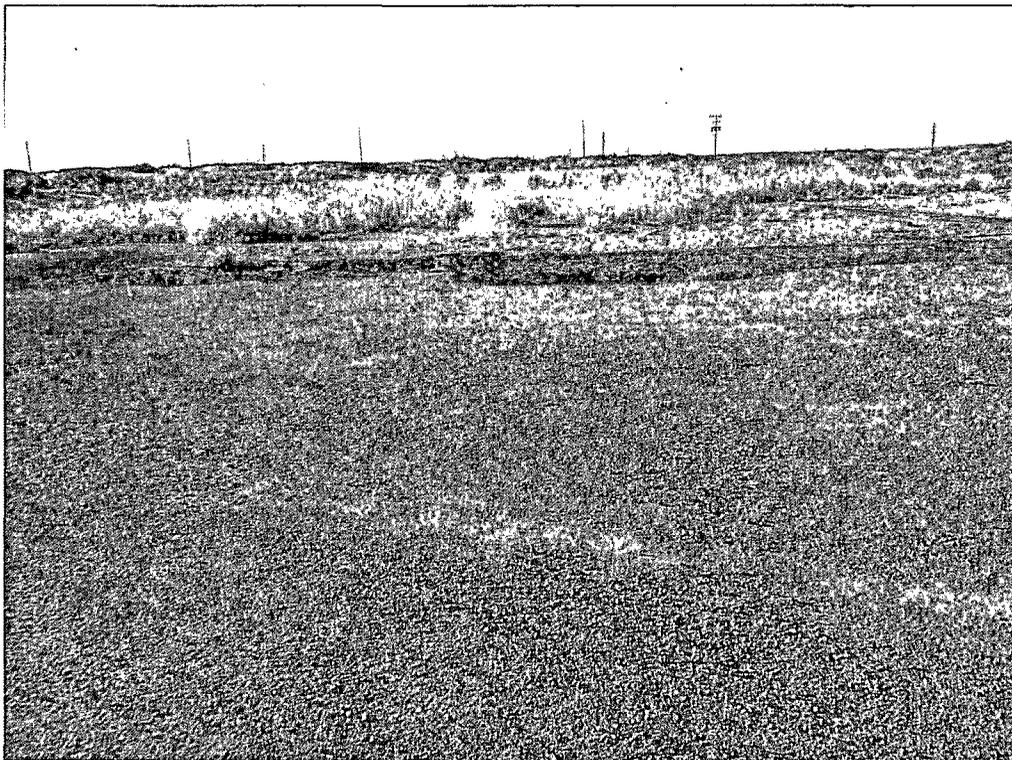
40 ft. East of well head 11/02/13

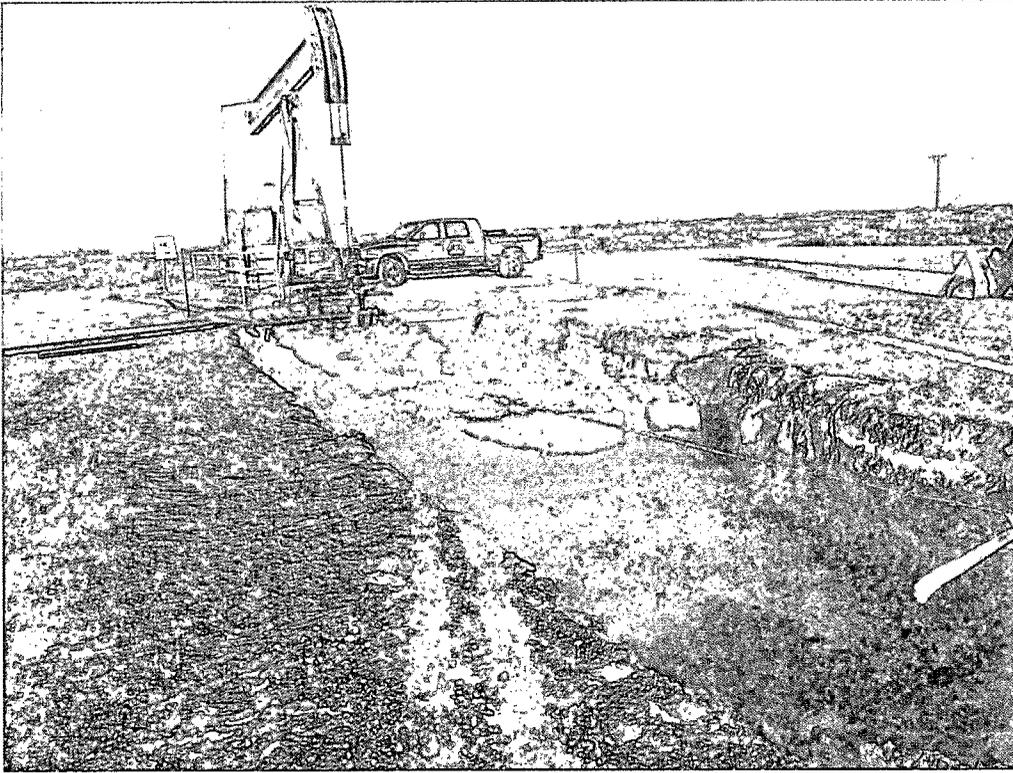
Site excavation 12/03/13

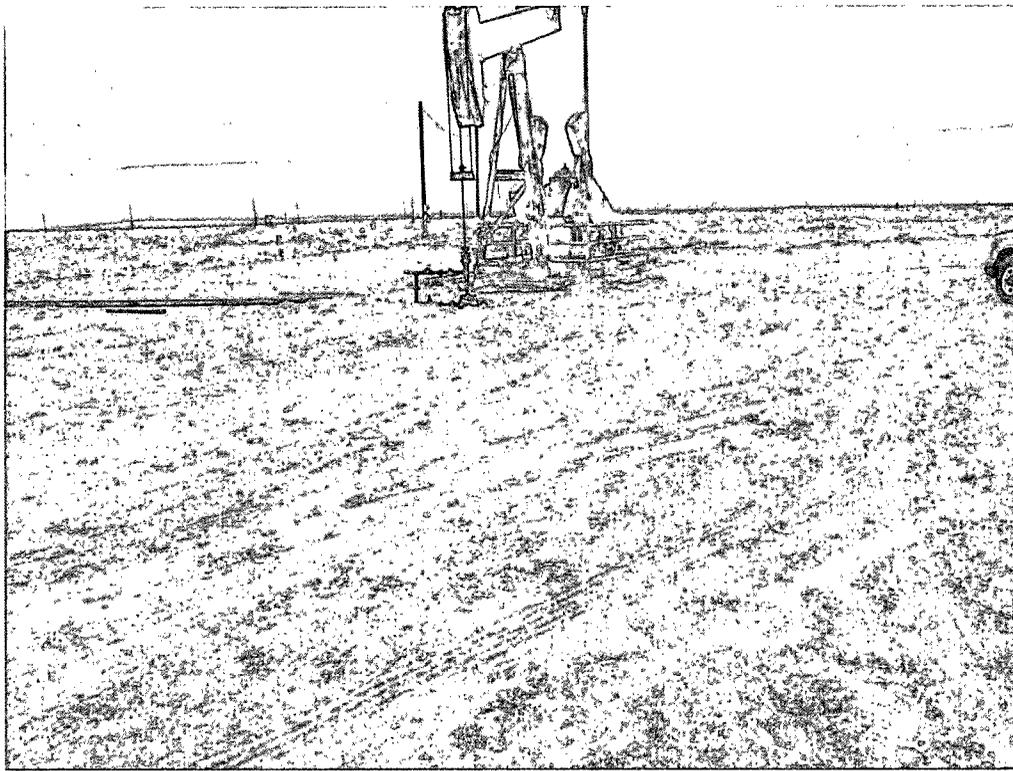
Site at completion 12/03/13
