3R-1011

**Release Report/ General
Correspondence**

Enterprise Products
Rachel #2 Meter Run Release
Latitude North 36.441389°, Longitude West -108.093382°
Unit I Section 34 T26N R12W
San Juan County, New Mexico
July 9, 2014

Enterprise Products
Lateral 2B-28 Pipeline Release
Latitude North 36.692349°, Longitude West -107.842714°
SW/SW (Unit M) Section 25 T29N R10W
San Juan County, New Mexico
September 8, 2014

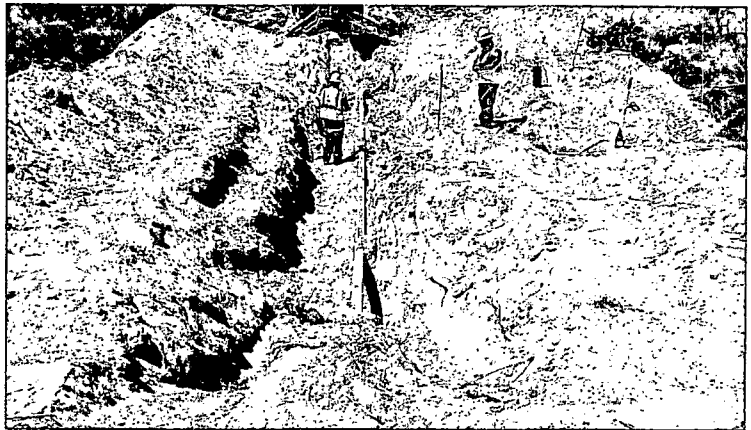
Photograph 2

View of final pipeline repair access excavation, facing southwest.

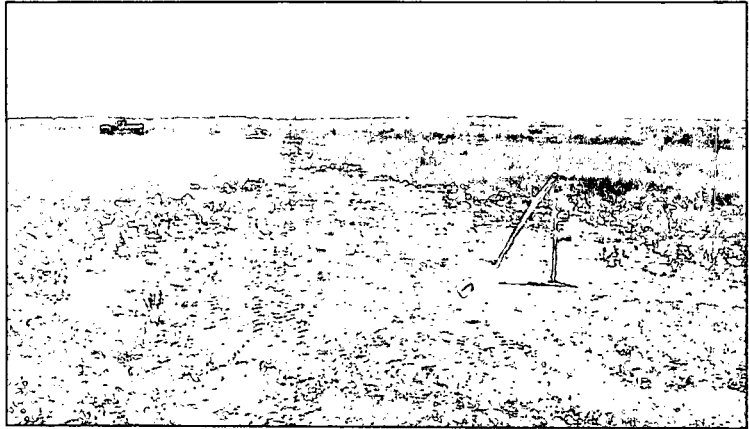
Photograph 1

View of site prior to excavation activities, facing west.

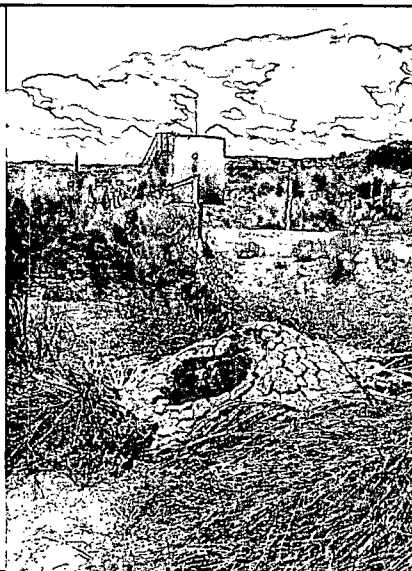
Photograph 1

View of site prior to excavation activities, facing south-southwest.
