3R-1011

**Release Report/ General
Correspondence**

Enterprise SJ

Date: Apr-Jun 2013

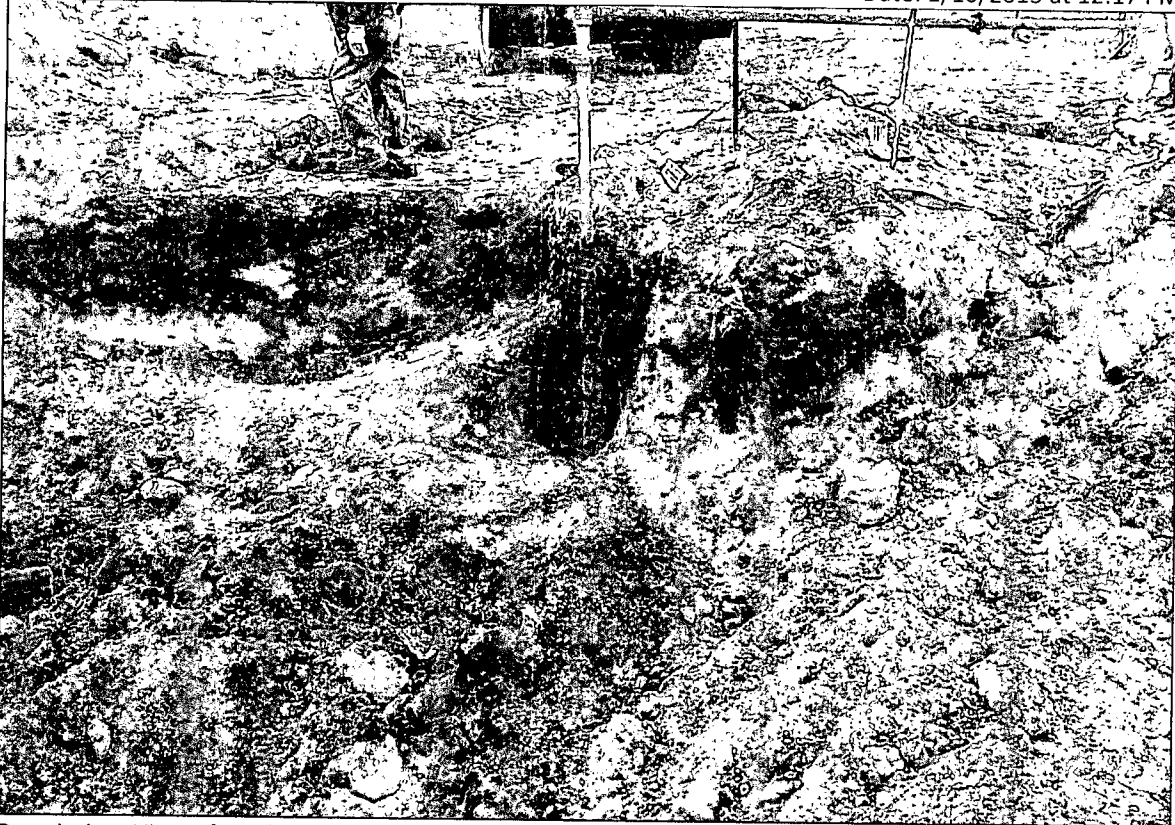
Description: View of northeast corner of initial excavation.

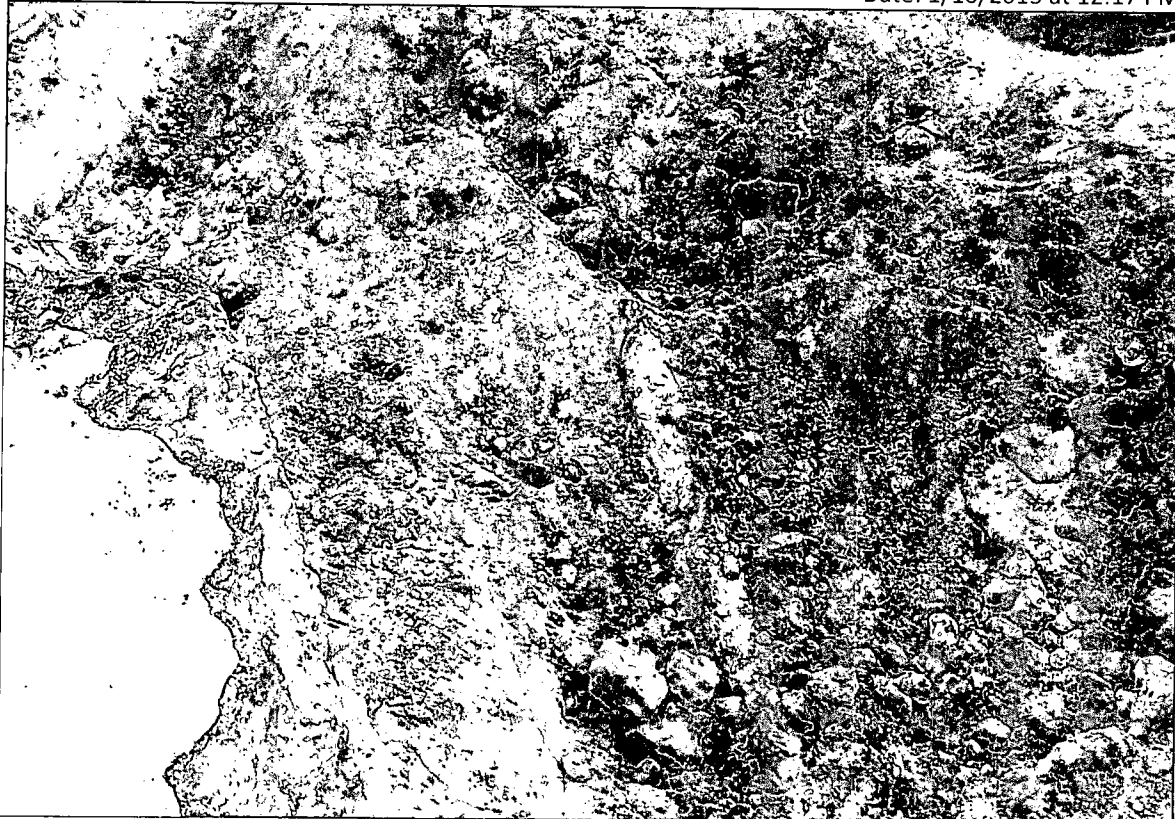
Photo #2

Description: View of base of initial excavation showing green staining from historical release.

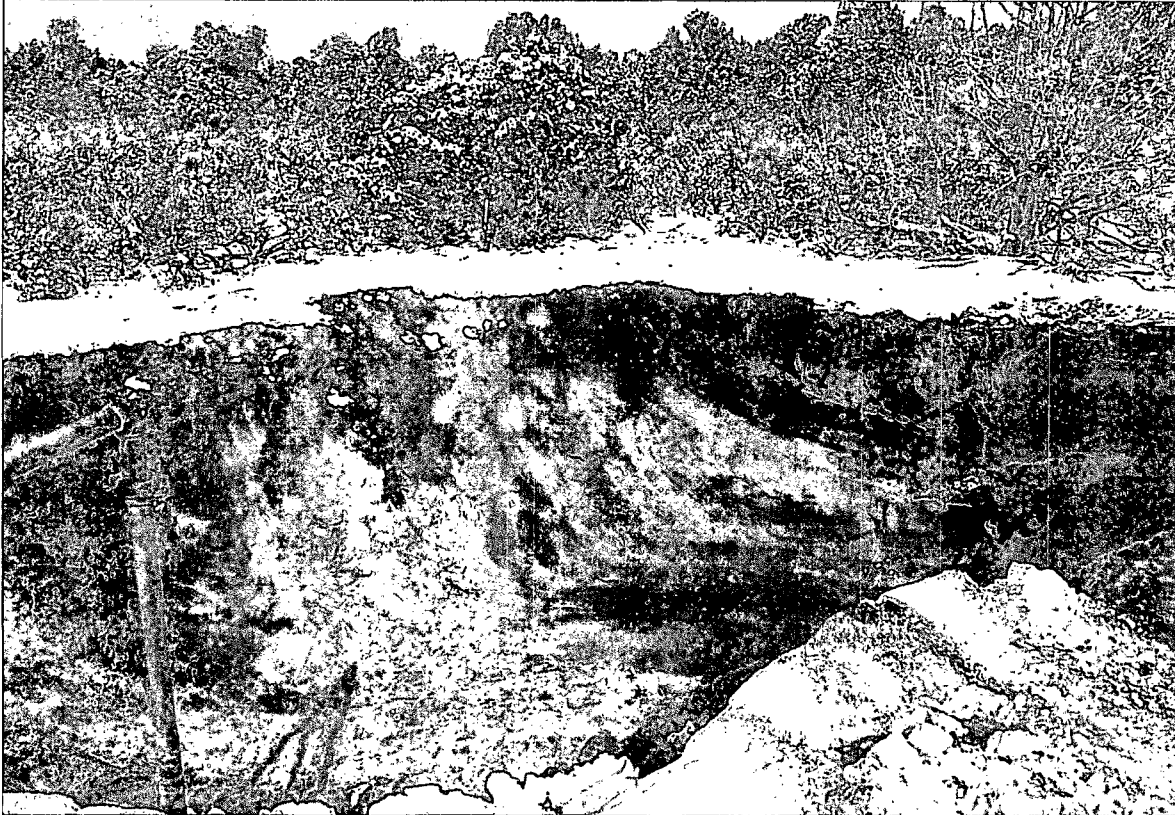
Photo #3

Description: View north of completed portion of final excavation.

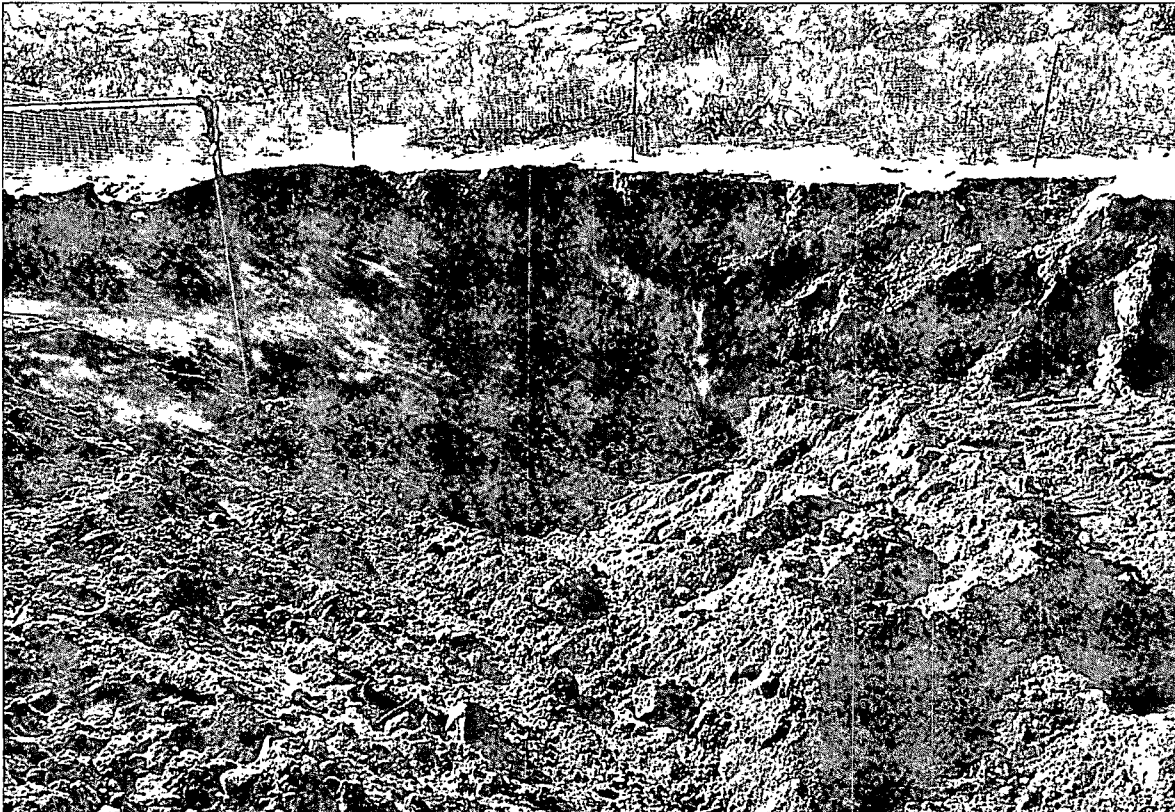
Photo #4

Description: View southeast of portion of completed excavation.

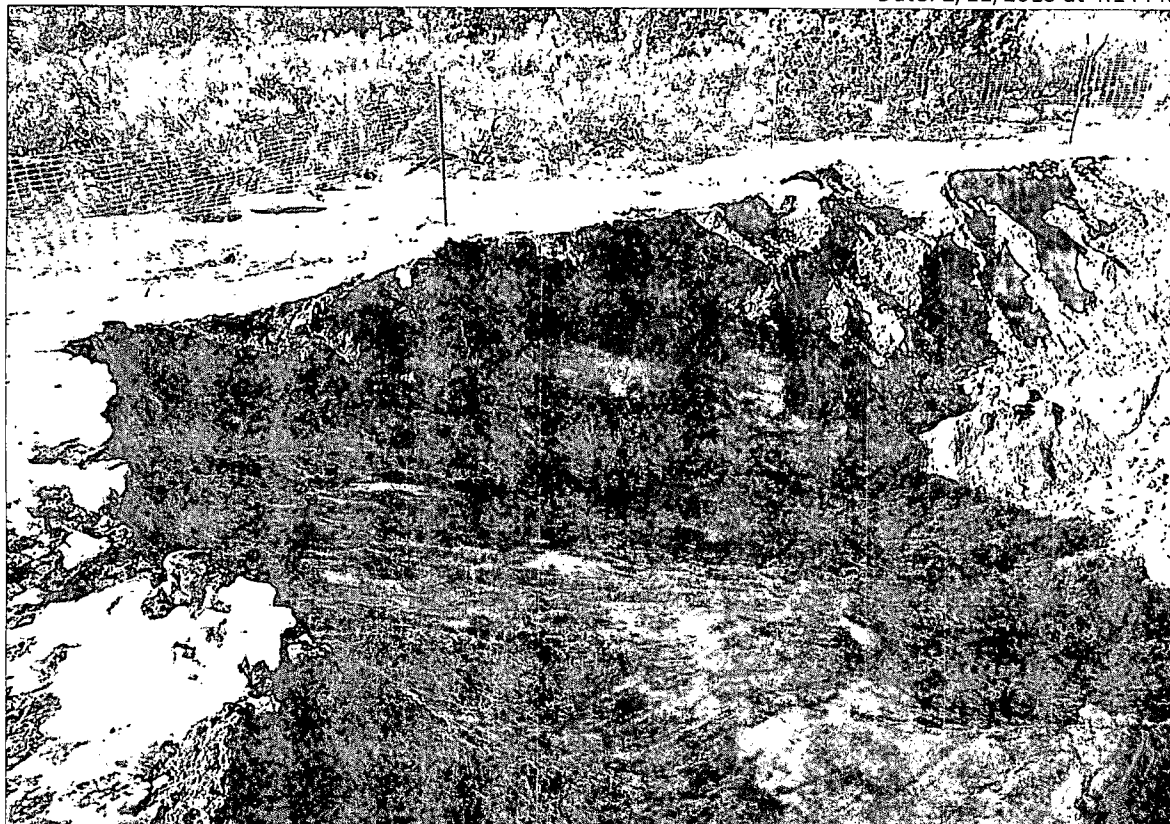
Photo #5

Description: View northwest of portion of completed excavation.

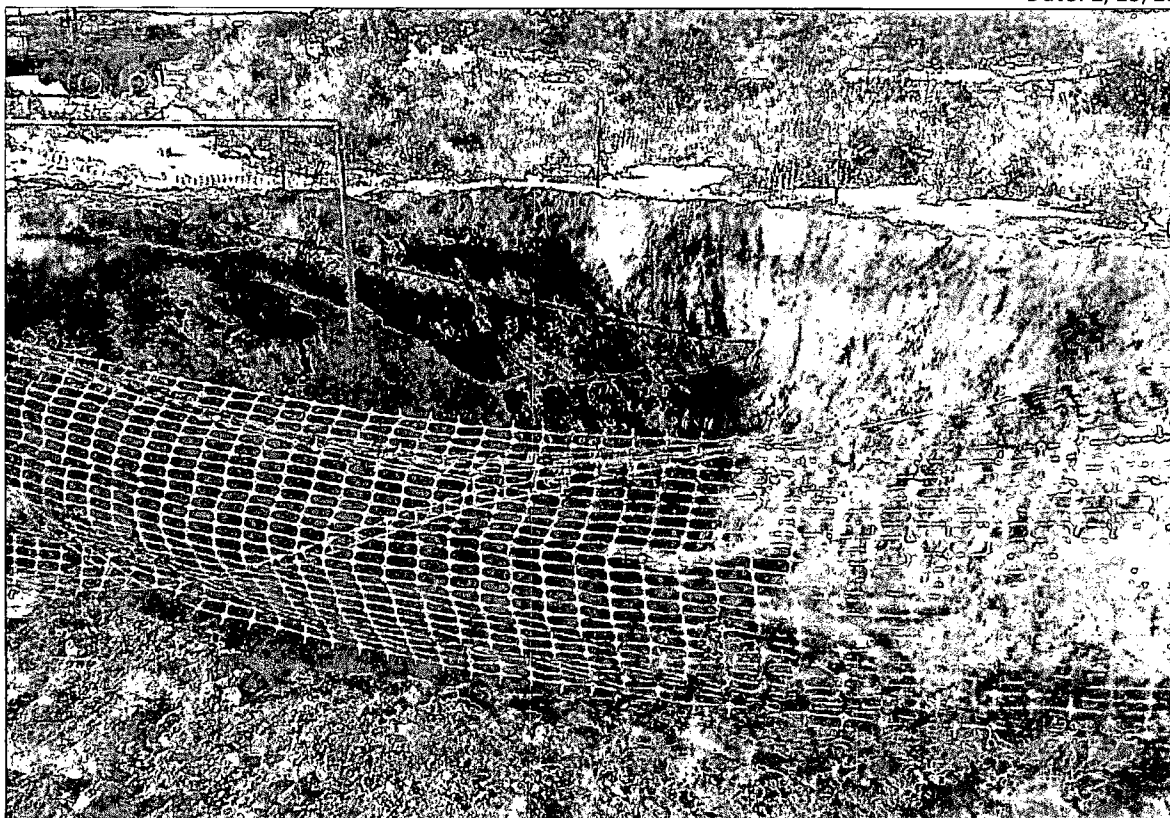
Photo #6

Description: Application of potassium permanganate.

Based on field observations, field screening and laboratory analytical results for benzene, total BTEX, and TPH, along with the completed application of potassium permanganate to the base of the excavation and NMOCD approval to backfill, no further work is recommended for the SJG 200A Tank/Hubbard LS #2 release area

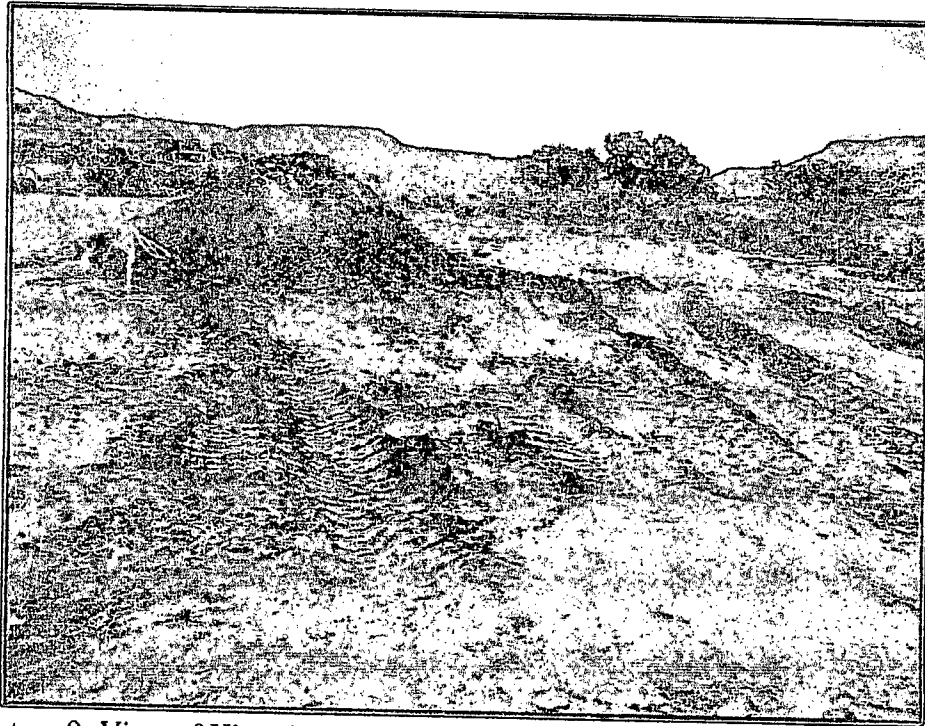
Picture 9: View of Historical Staining During Excavation (View 1) – 9/13/12

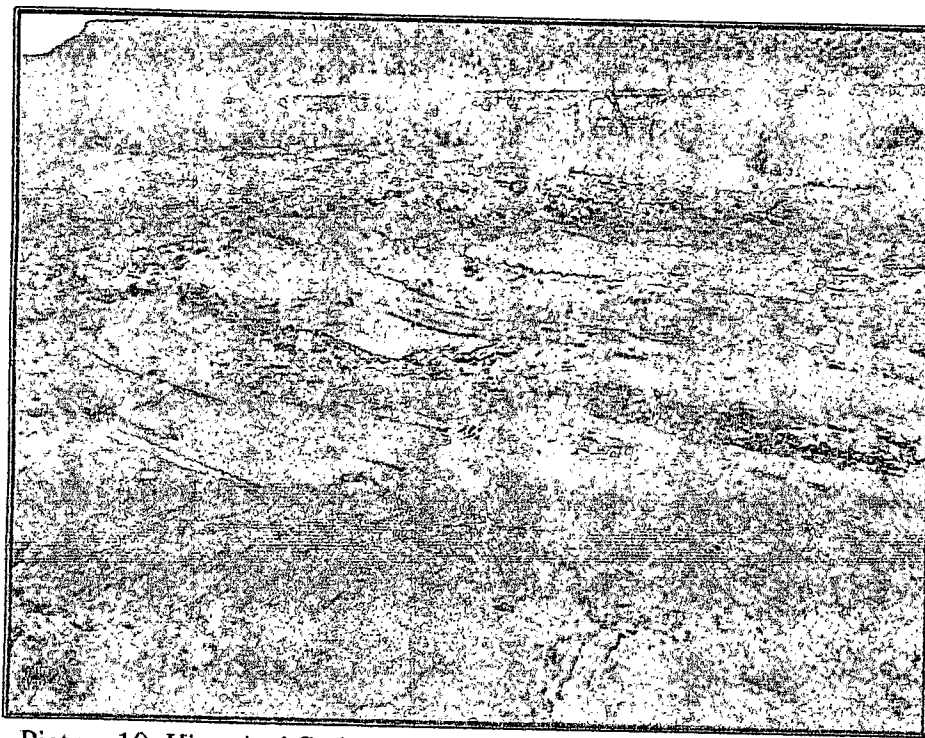
Picture 10: Historical Staining During Excavation (View 2) – 9/13/12

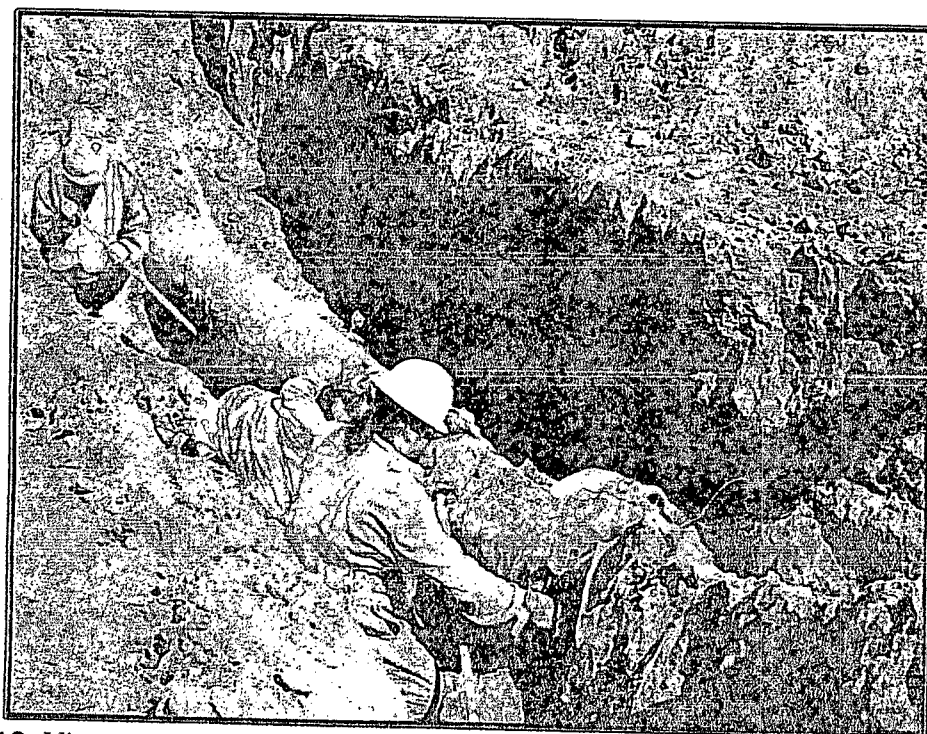
Picture 12: View 1 of Exposed Pipeline for Leak Inspection by EMS Personnel – 9/13/12

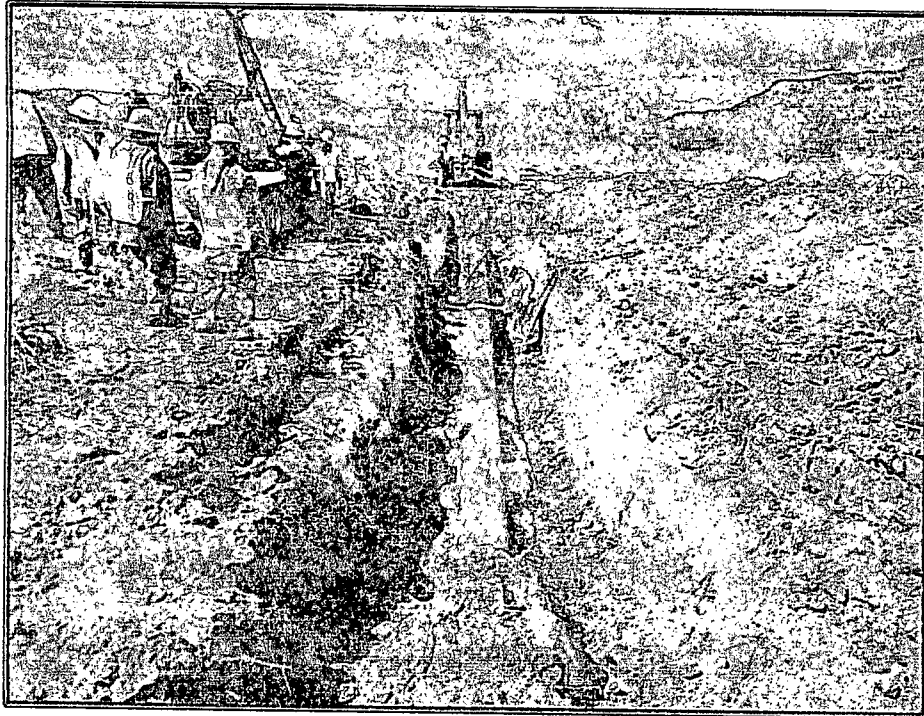
Picture 13: View 2 of Exposed Pipeline for Leak Inspection by EMS Personnel – 9/13/12

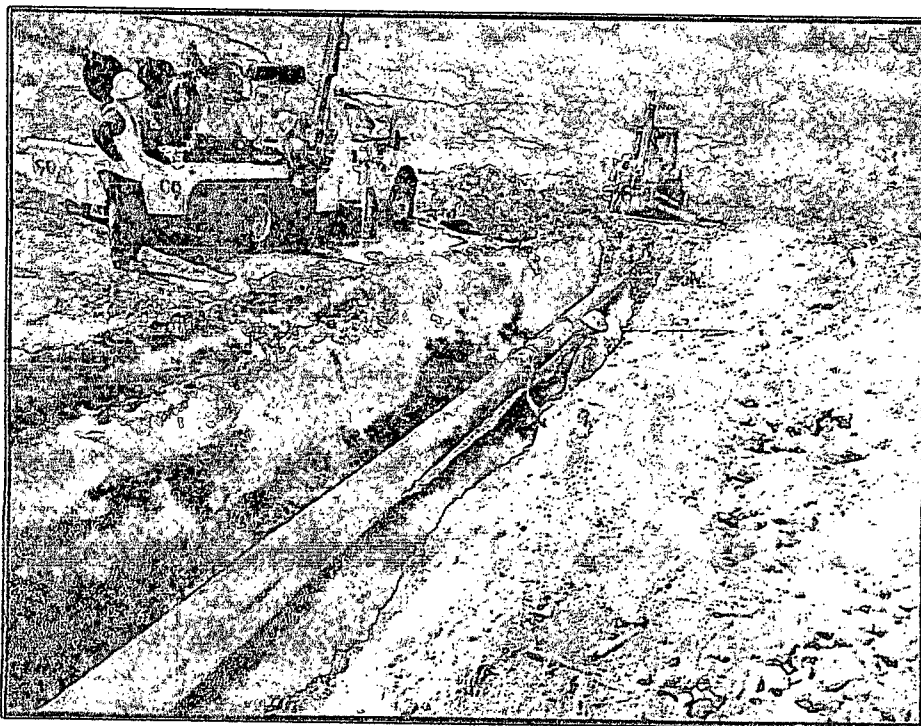
Picture 14: View of Trunk K Being Repaired by EMS Personnel – 9/13/12

Describe Cause of Problem and Remedial Action Taken.* Natural Gas Condensate and produced water was released from the Trunk K Pipeline. Due to the close proximity of the pipeline to Largo Canyon Wash (approximately 160 feet away from release location), the NRC and NMOCD were contacted, environmental emergency personnel contacted, an emergency one-call initiated. The release area was contained and initial cleanup response began once the pipeline was blown down. The pipeline section was repaired after the multiple corrosion holes were located on this section of pipe.

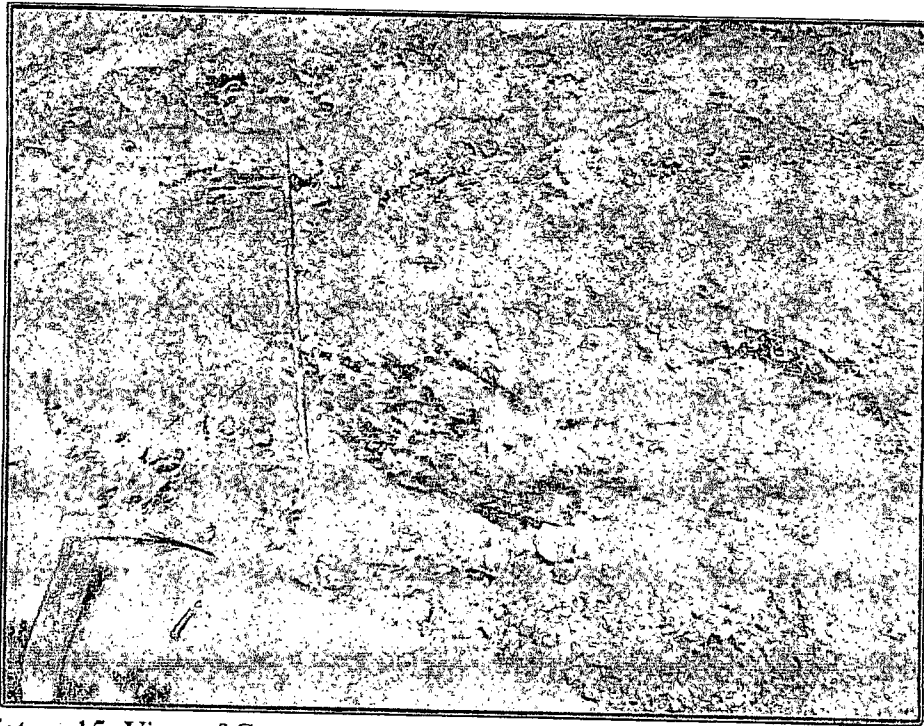
Picture 15: View of Contaminated Center on East Wall of Trench – 9/13/12

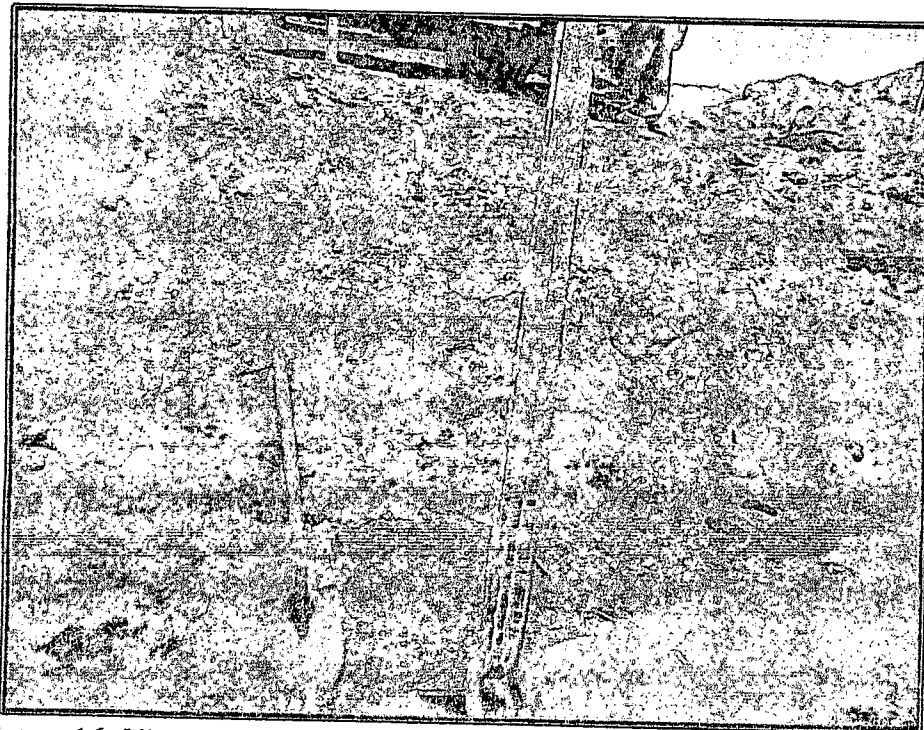
Picture 16: View of Contaminated Center on West wall of Trench – 9/13/12

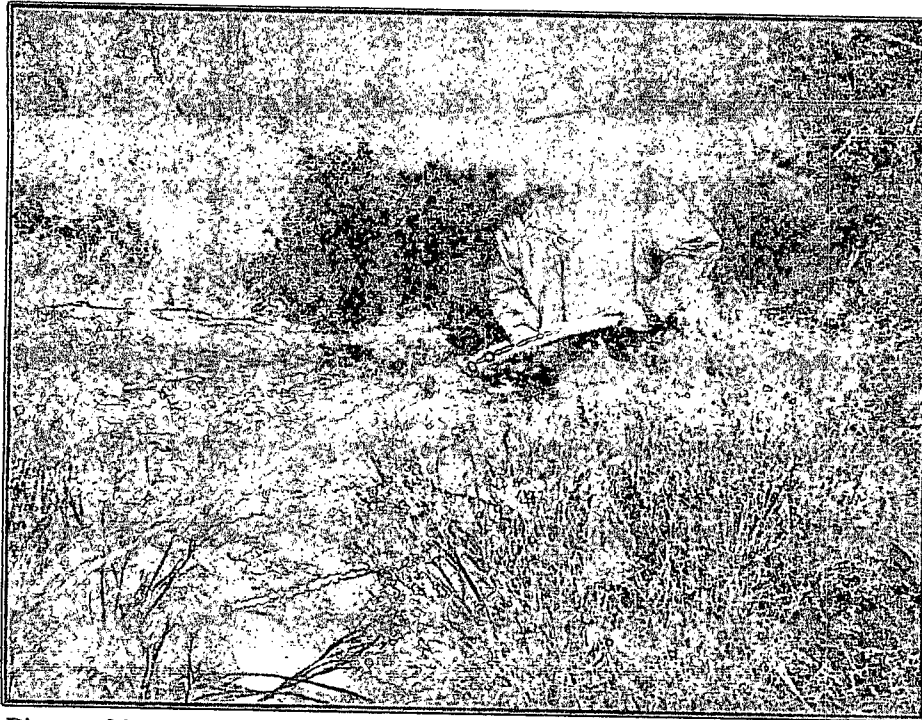
Picture 23: View 2 of Micro Blaze Treatment at Lower Wash – 9/28/12

right-of-way; see enclosed *Table 1, Summary of Analytical Results – Spill Cleanup Samples* and *Table 2, Summary of Analytical Results – Closure Samples* and *Appendix A, Analytical Results*. Due to the lower wash (bottom) being located less than 200 feet from Largo Wash, the BLM and Enterprise Products requested that no heavy excavation be performed in that area. Envirotech, Inc recommended applying Micro Blaze to areas above regulatory standards in the lower wash area.

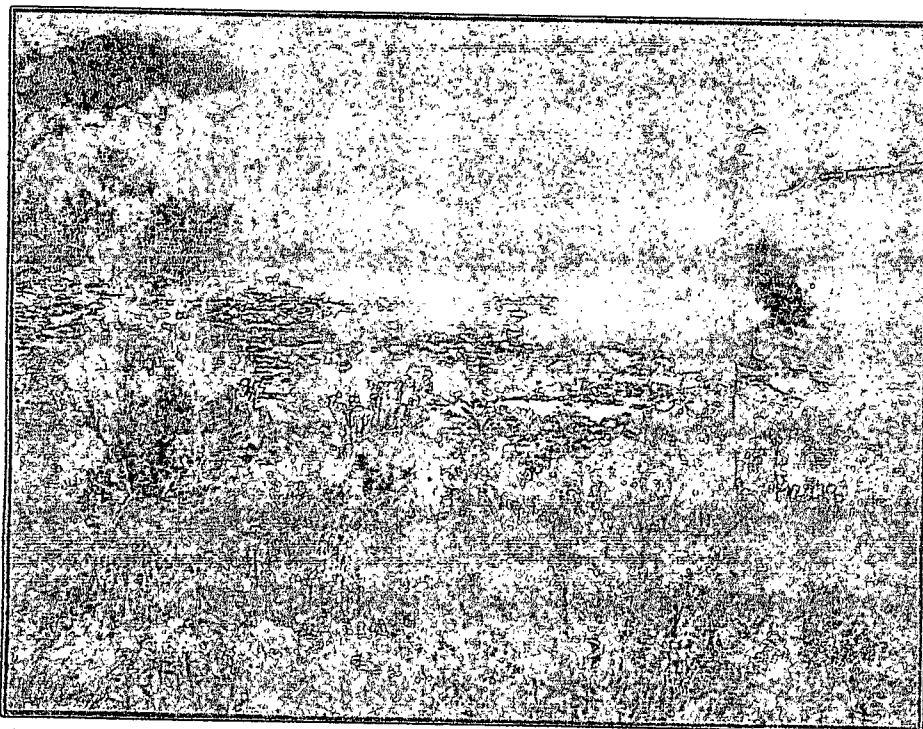
Picture 24: View 3 of Micro Blaze Treatment at Lower Wash – 9/28/12
