3R-1011

**Release Report/ General
Correspondence**

Enterprise SJ

Release Notification and Corrective Action

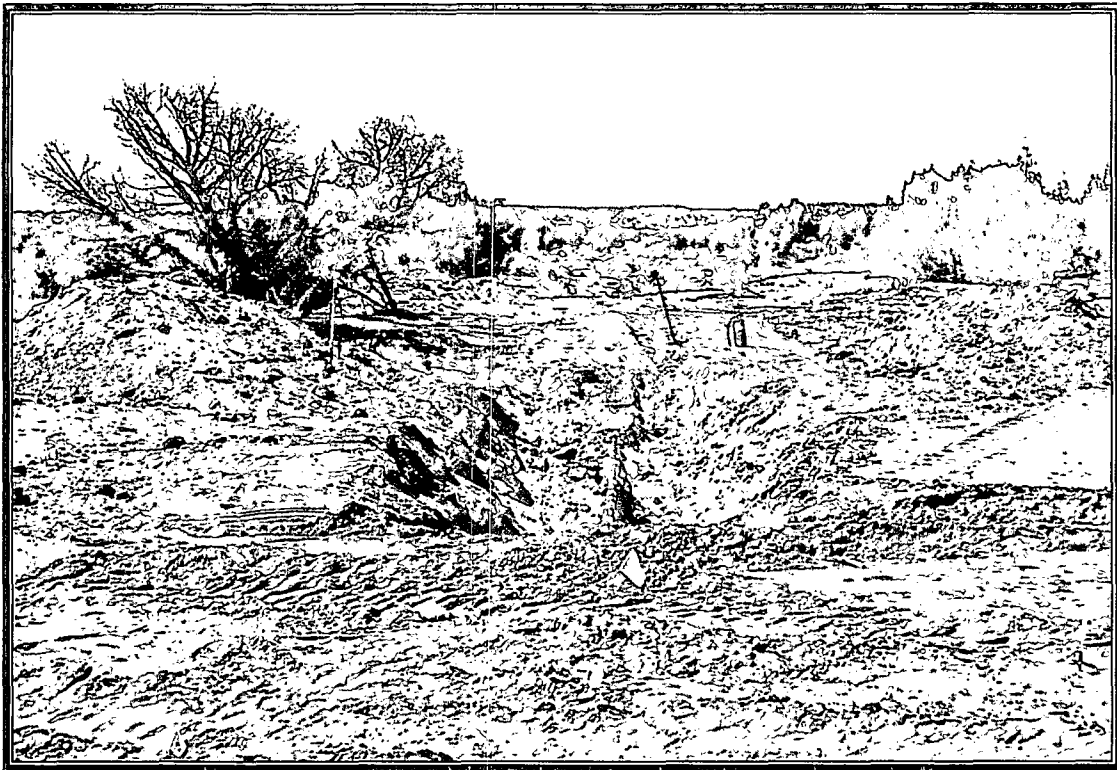
Photo 1: View of the pipeline and excavation for the northern release.

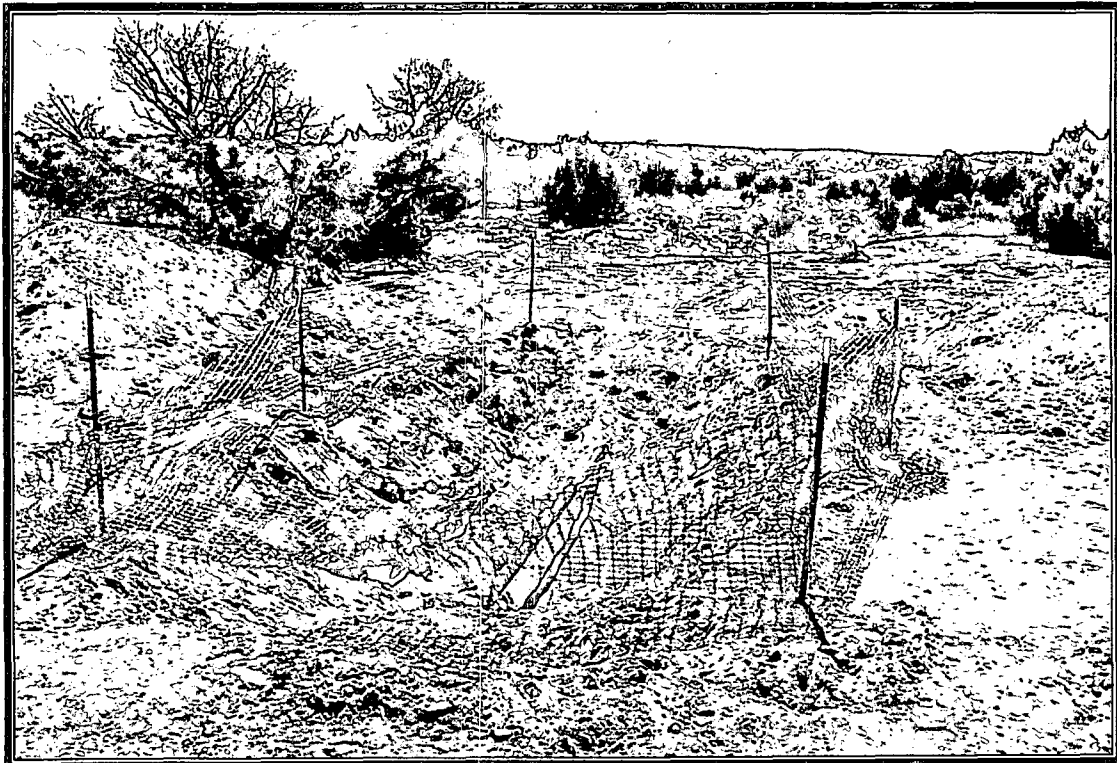
Photo 2: View of the excavation for the northern release.
