**3R-1011**

**Release Report/ General  
Correspondence**

**Enterprise SJ**

**Release Notification and Corrective Action**

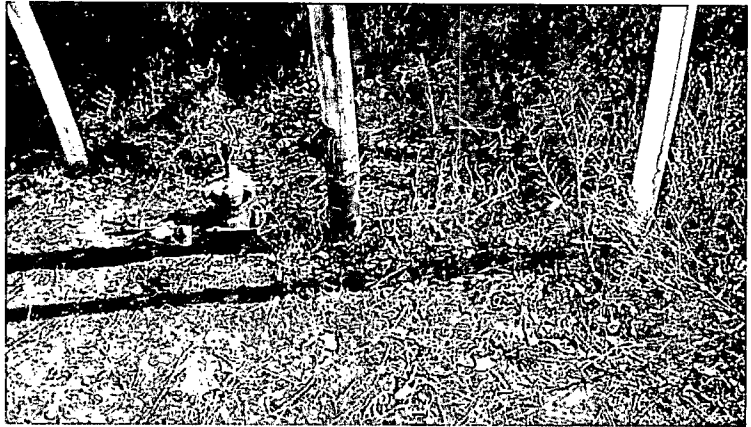
Staining at base of Riser.

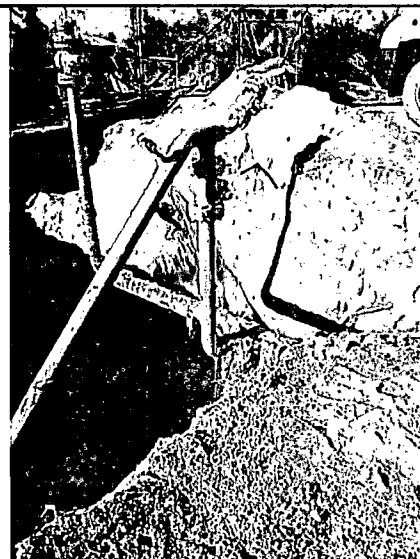
**Photograph 3**

General view of final excavation facing southwest. Note the backfill in SW corner to prevent sloughing near fence.

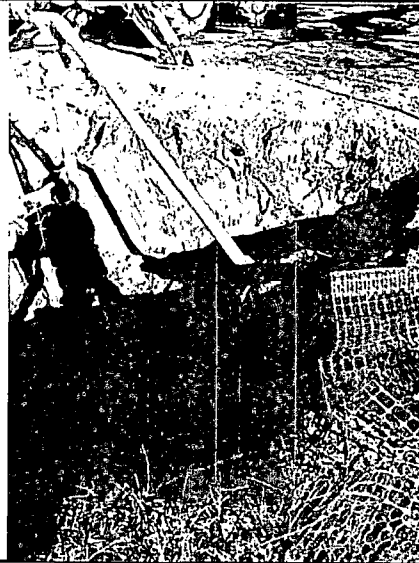
## Photograph 4

General view of final excavation (east half) facing northwest.

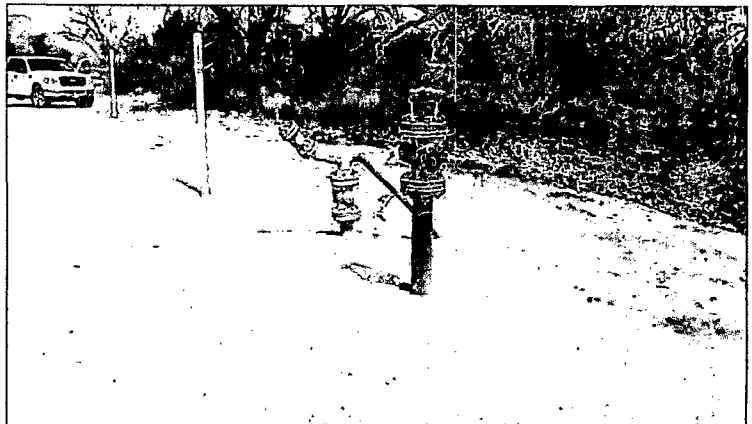
## Photograph 5

View after completion of corrective actions (facing north).

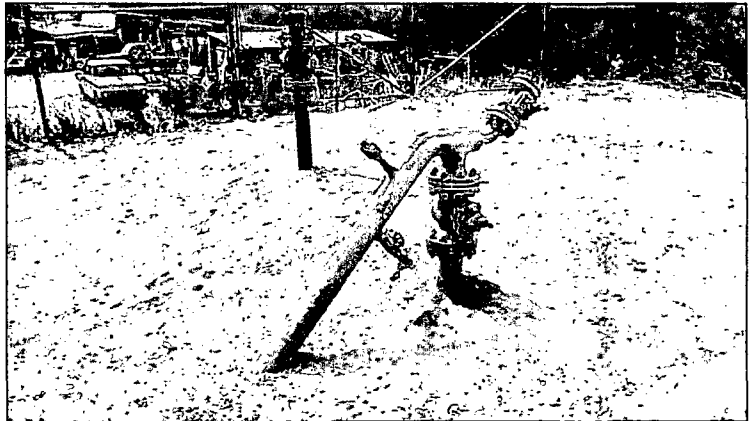
## Photograph 6

View after the completion of corrective actions (facing southwest).

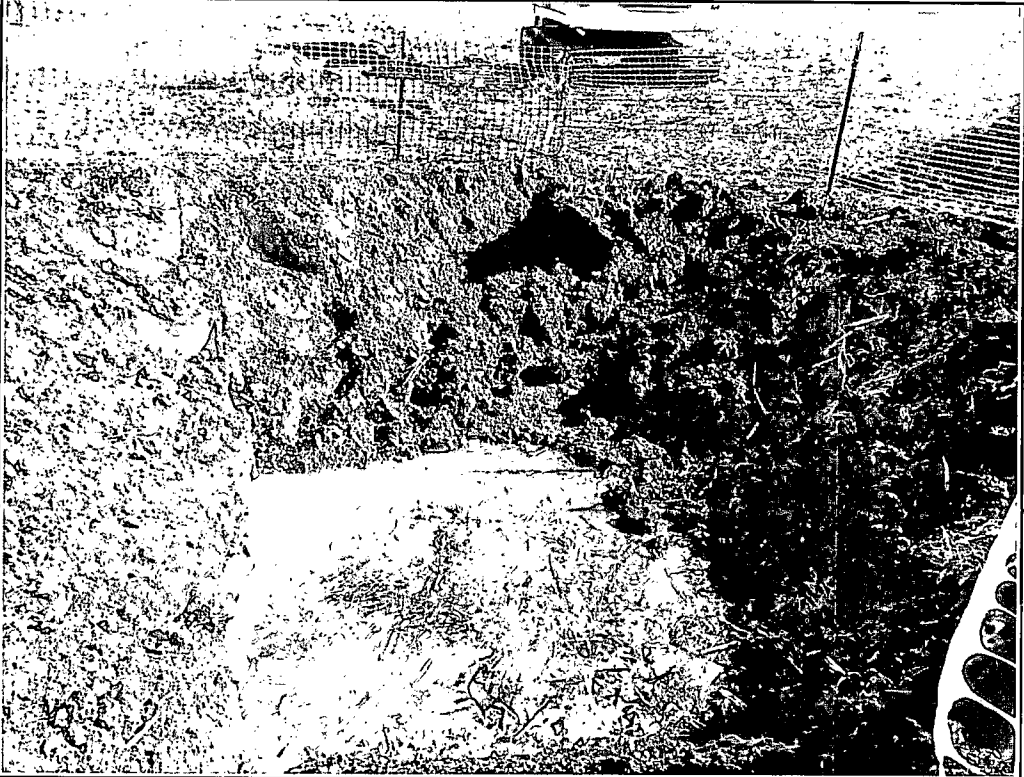
Photo #1

Client: Enterprise Field Services, LLC	
Project: Lateral 10A-5 Pipeline Release	
Taken by: Heather Woods	
Date: February 20, 2014	
AES Project No. 140216	Description: View of initial excavation looking southeast.

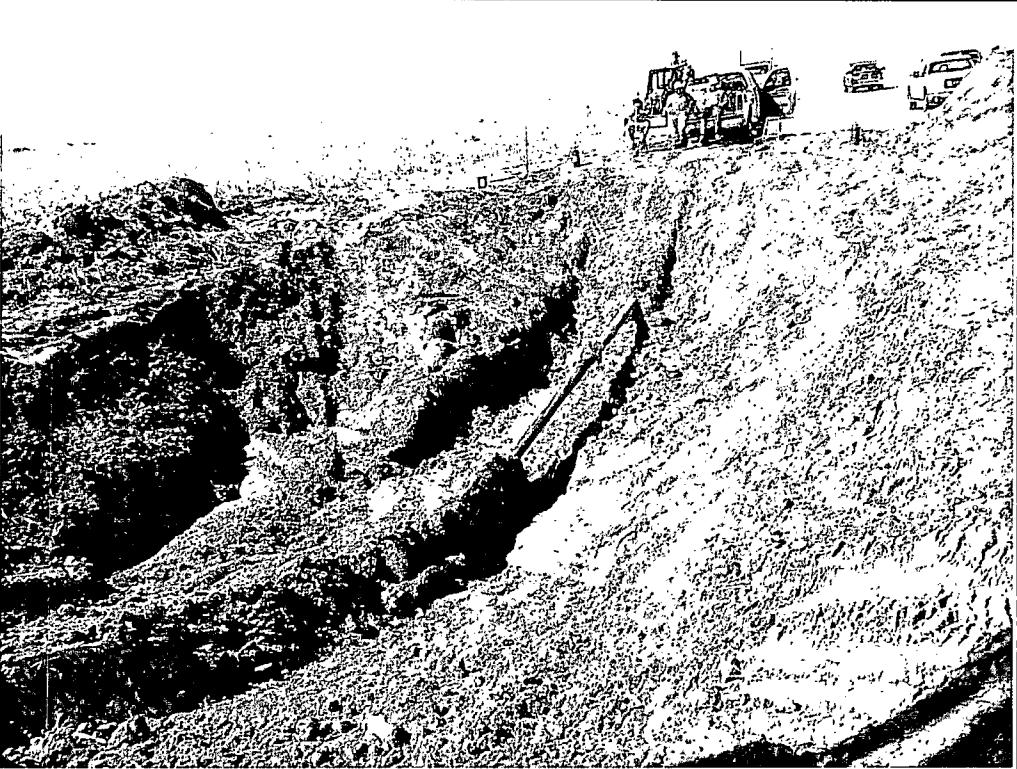
Photo #2

Client: Enterprise Field Services, LLC	
Project: Lateral 10A-5 Pipeline Release	
Taken by: Heather Woods	
Date: February 25, 2014	
AES Project No. 140216	Description: View of final excavation looking northwest.

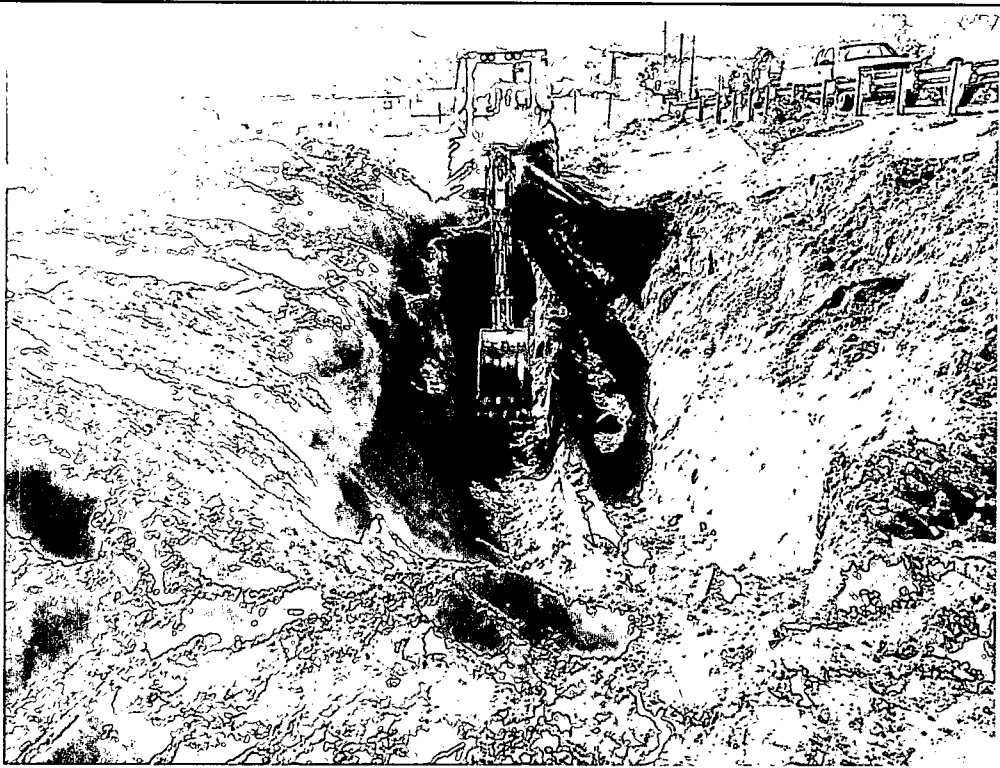
Photo #1

Client: Enterprise Field Services, LLC	
Project: Lateral 5D-2	
Taken by: Heather Woods	
Date: September 26, 2013	
AES Project No. 130928	Description: View looking east during pipeline excavation.

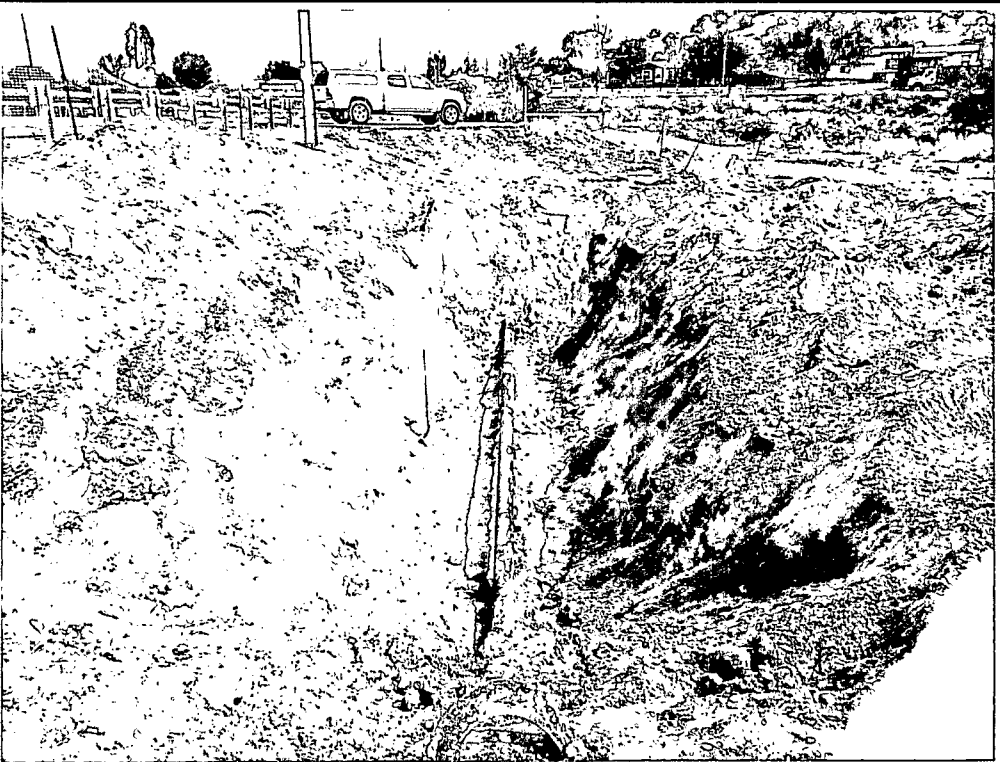
Photo #2

Client: Enterprise Field Services, LLC	
Project: Lateral 5D-2	
Taken by: Heather Woods	
Date: September 27, 2013	
AES Project No. 130928	Description: View looking east of final excavation.

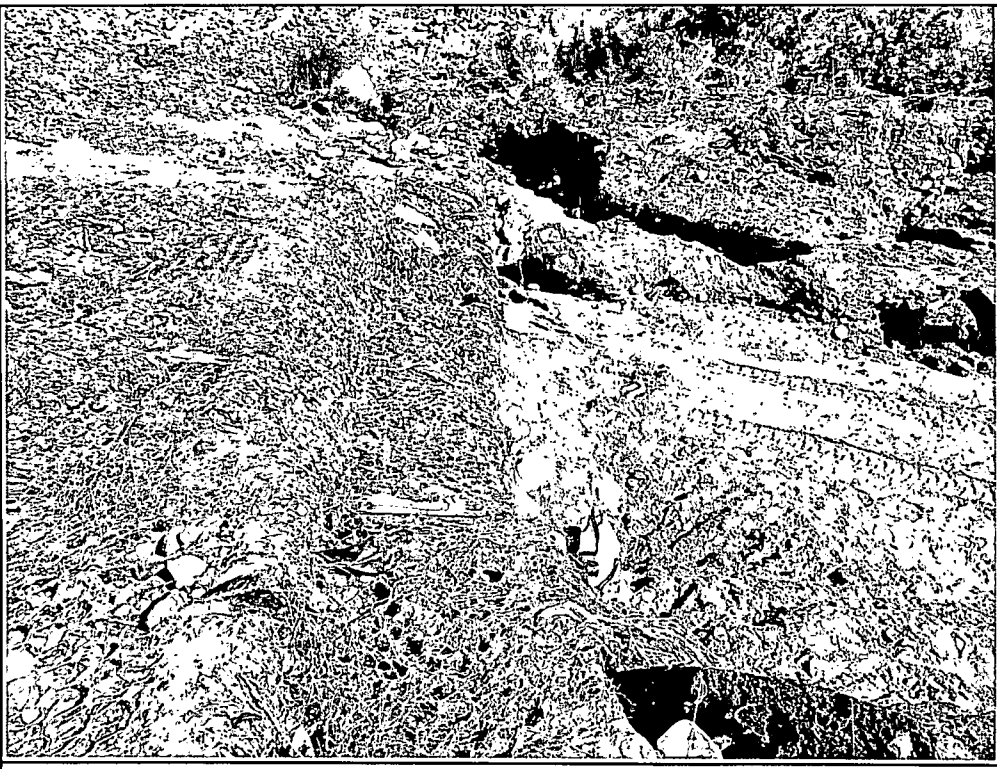
Photo #4

Client: Enterprise Field Services, LLC	
Project: Lateral 5D-2	
Taken by: Heather Woods	
Date: October 8, 2013	
AES Project No. 130928	Description: View looking east of wash where soil borings SB-1 and SB-2 were completed.

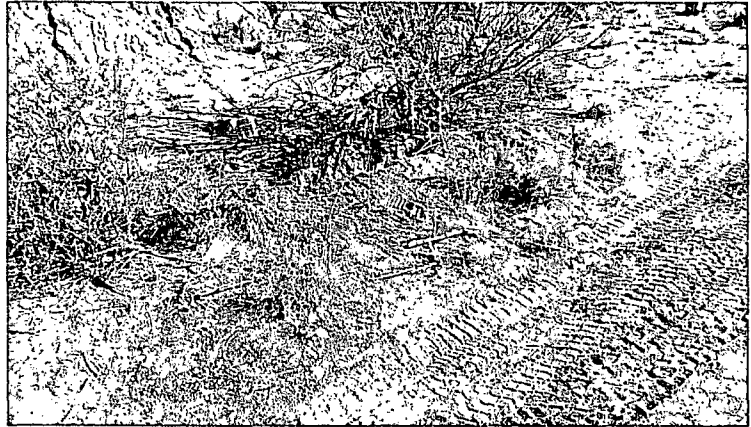
Evidence of pipeline release at ground surface.

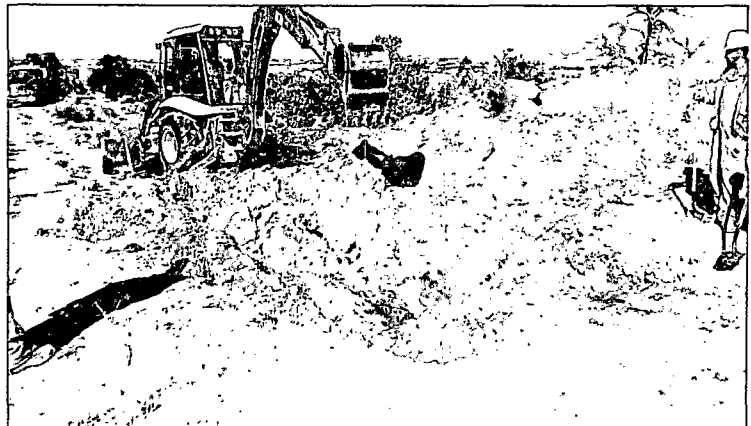
**Photograph 2**

Initial excavation activities.

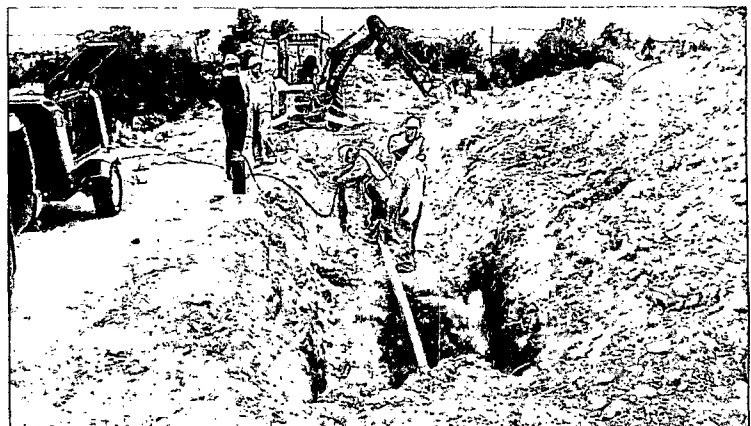
**Photograph 3**

Removal of sandstone along the pipeline using jackhammer subsequent to excavation and repair activities.

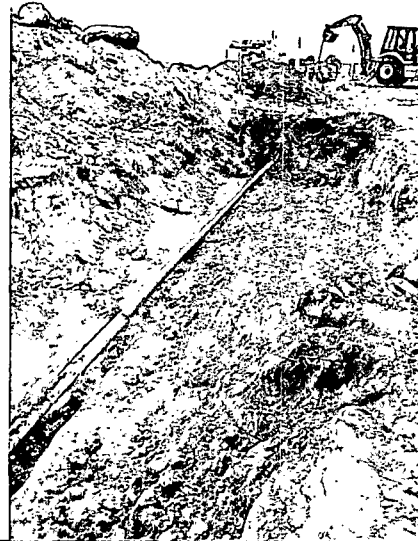
**Photograph 4**

View of pipe chase (facing east) after final excavation and repair activities.

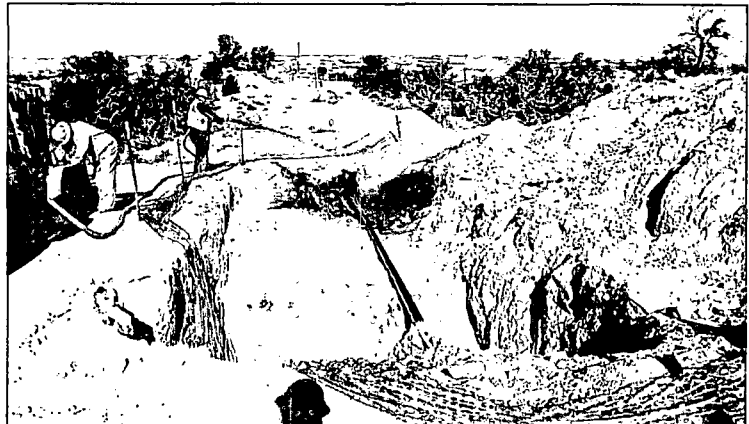
**Photograph 5**

Application of potassium permanganate by Envirotech.

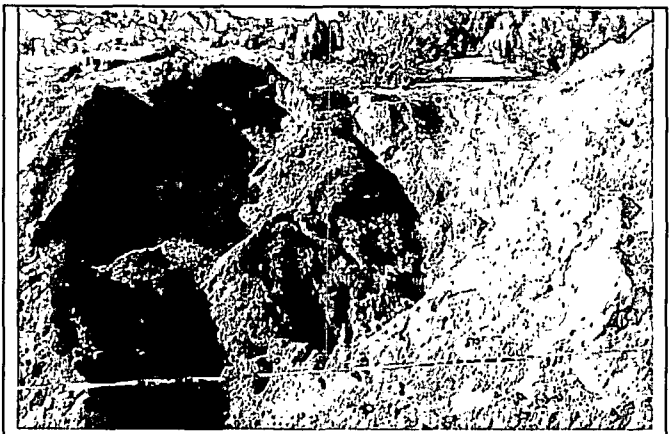
2.) View of excavation of apparent historic release at northeast portion of excavation (note apparent staining).

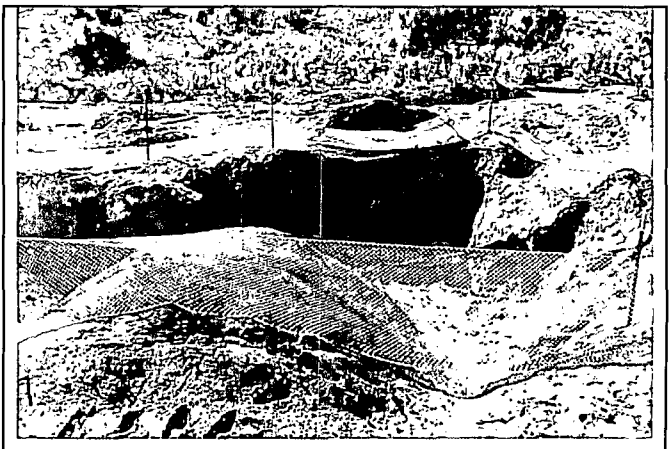
4.) View of fencing being removed prior to resumption of excavation activities in March 2013.

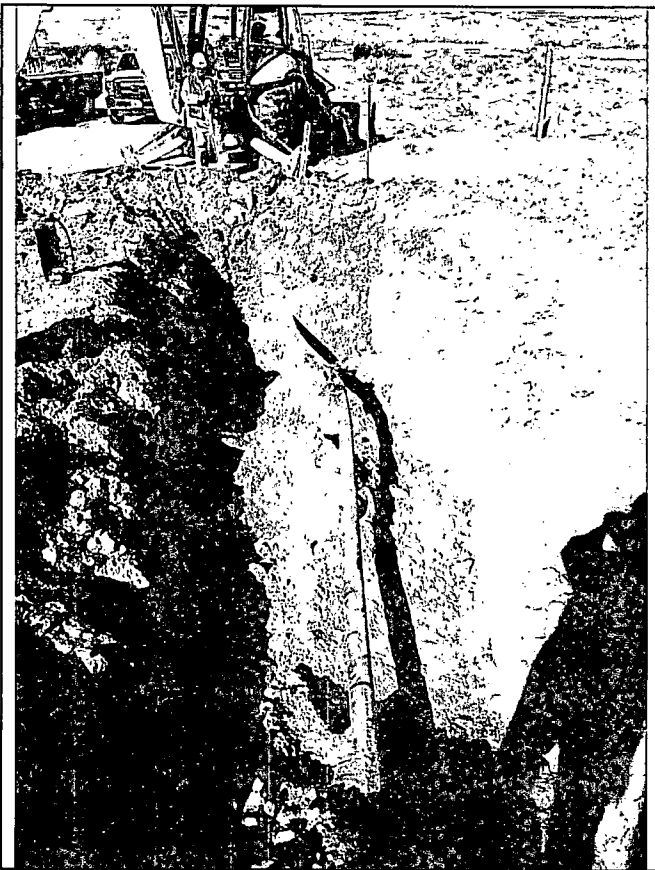
1.) Early stages of excavation facing to the west. Showing where the pipeline had been struck by something in the past (source of leak).

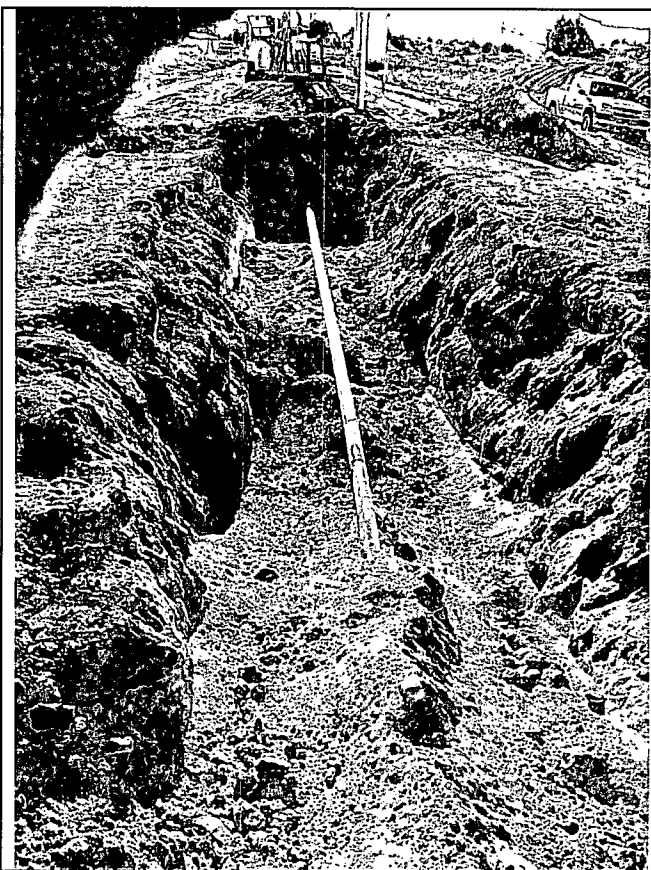
2.) View of excavation facing the east after repairs were completed and new coating applied to the pipeline.

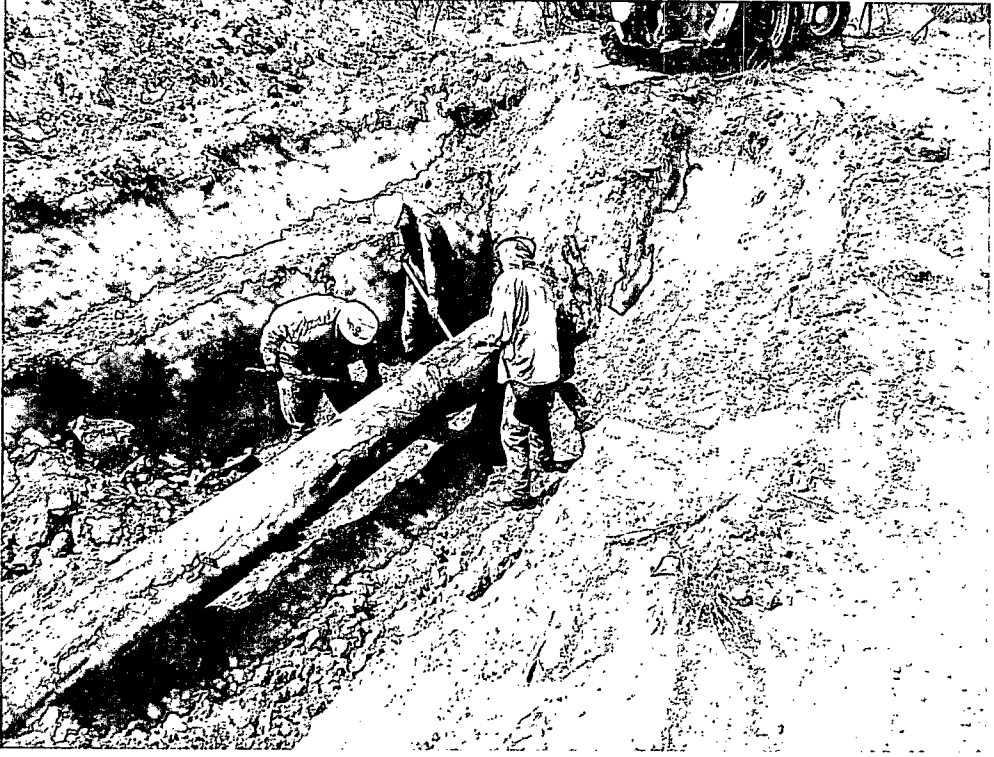
Photo #1

Client: Enterprise Field Services, LLC	
Project: Trunk K Pipeline Release	
Taken by: Heather Woods	
Date: September 9, 2013	
AES Project No. 130908	<b>Description:</b> View looking west of initial excavation prior to pipeline repair.

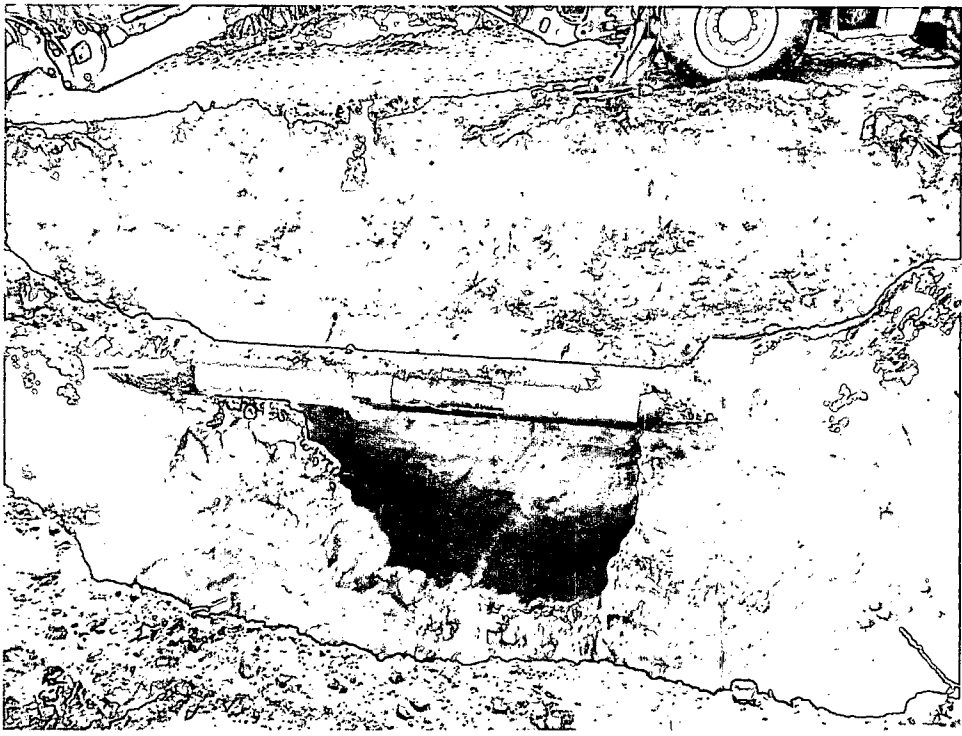
Photo #2

Client: Enterprise Field Services, LLC	
Project: Trunk K Pipeline Release	
Taken by: Heather Woods	
Date: September 9, 2013	
AES Project No. 130908	<b>Description:</b> View looking southwest of final excavation extents following pipeline repair.

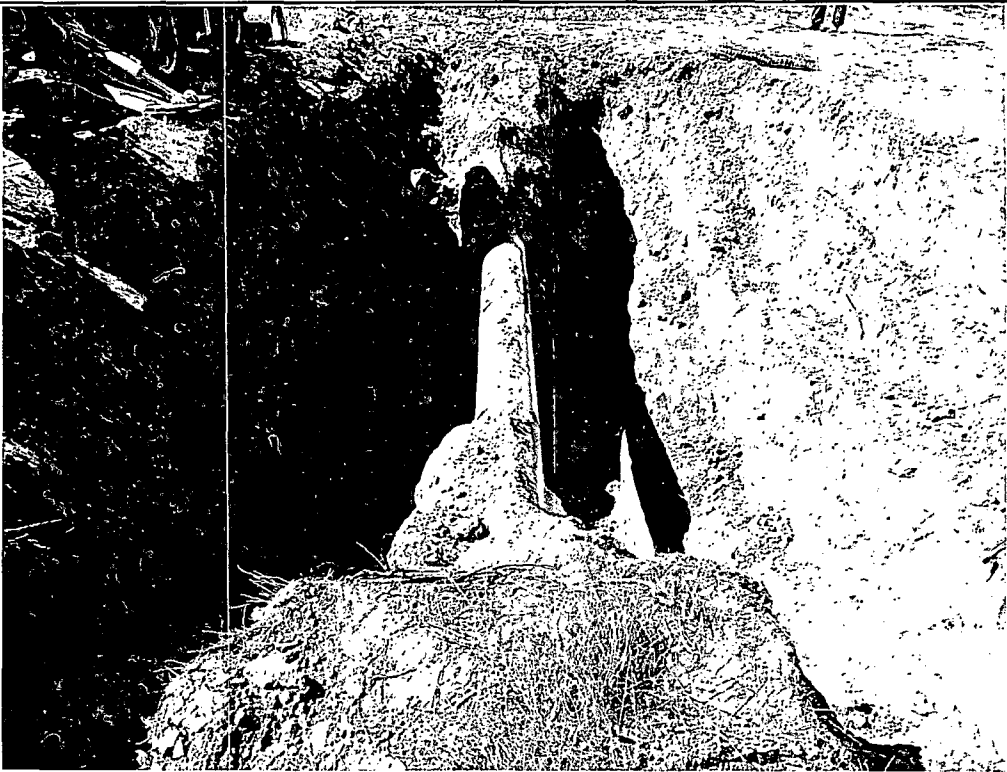
Photo #3

Client: Enterprise Field Services, LLC	
Project: Trunk K Pipeline Release	
Taken by: Heather Woods	
Date: September 11, 2013	
AES Project No. 130908	Description: View looking northwest of final excavation extents following pipeline repair.

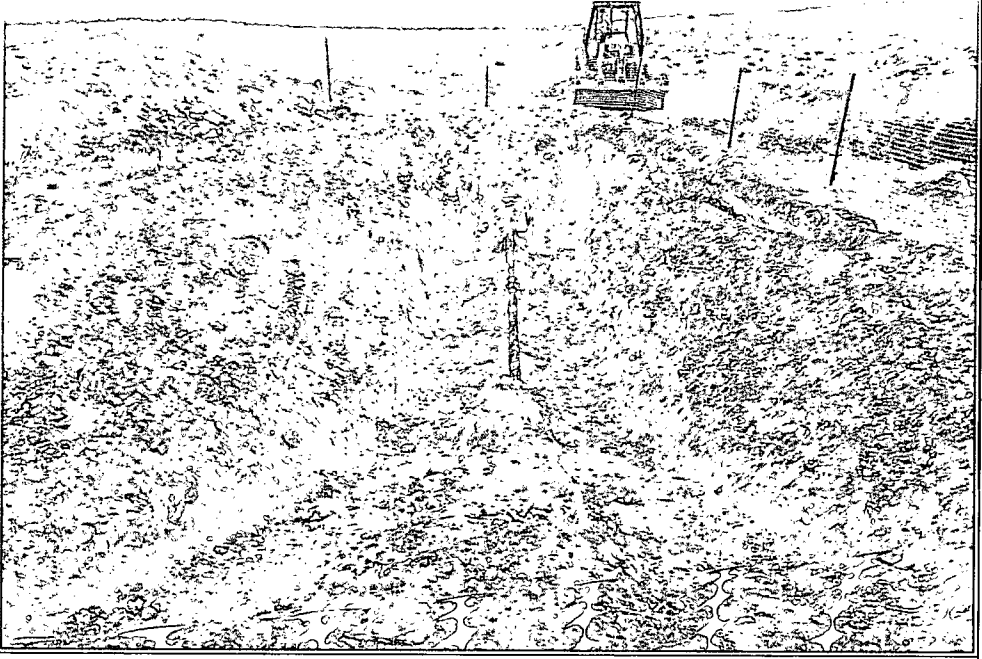
Photo #1

Client: Enterprise Field Services, LLC	
Project: Trunk 10A Pipeline Release	
Taken by: Heather Woods	
Date: February 27, 2014	
AES Project No. 140224	Description: View of final excavation looking southeast.
