**3R-1012**

**Release Report/ General  
Correspondence**

**Release Notification and Corrective Action**

**Enterprise Products**  
**Lateral 2C-6 Pipeline Release**  
**Latitude North 36.414134°, Longitude West -107.639709°**  
**NW/SW (Unit L) Section 12 T25N R8W**  
**San Juan County, New Mexico**  
**October 14, 2014**

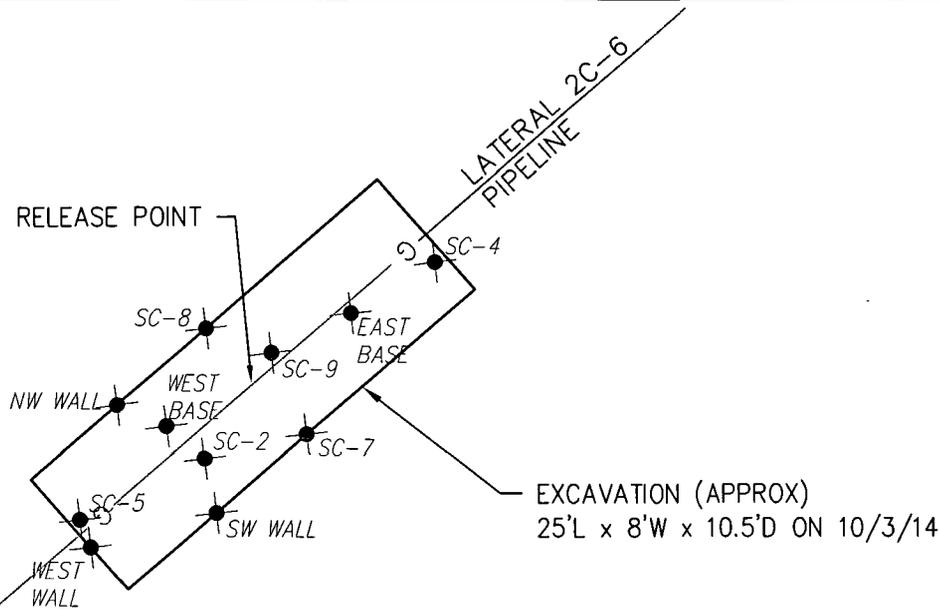
**SOIL CONTAMINANT CONCENTRATION MAP**  
**LATERAL 2C-6**  
**SECTION 12, T25N, R8W**

Laboratory analytical results for samples collected during the final excavation on October 3, 2014 were below NMOCD Guidelines for benzene (10 ppm), BTEX (50 ppm) and combined GRO/DRO (1,000 ppm).

Soil contaminant concentrations are illustrated in Figure 3. A summary of laboratory analysis is included in Table 3. Laboratory reports are included in Appendix B.

● SOIL SAMPLE LOCATION  
RESULTS IN mg/kg REPORTED 10-7-14

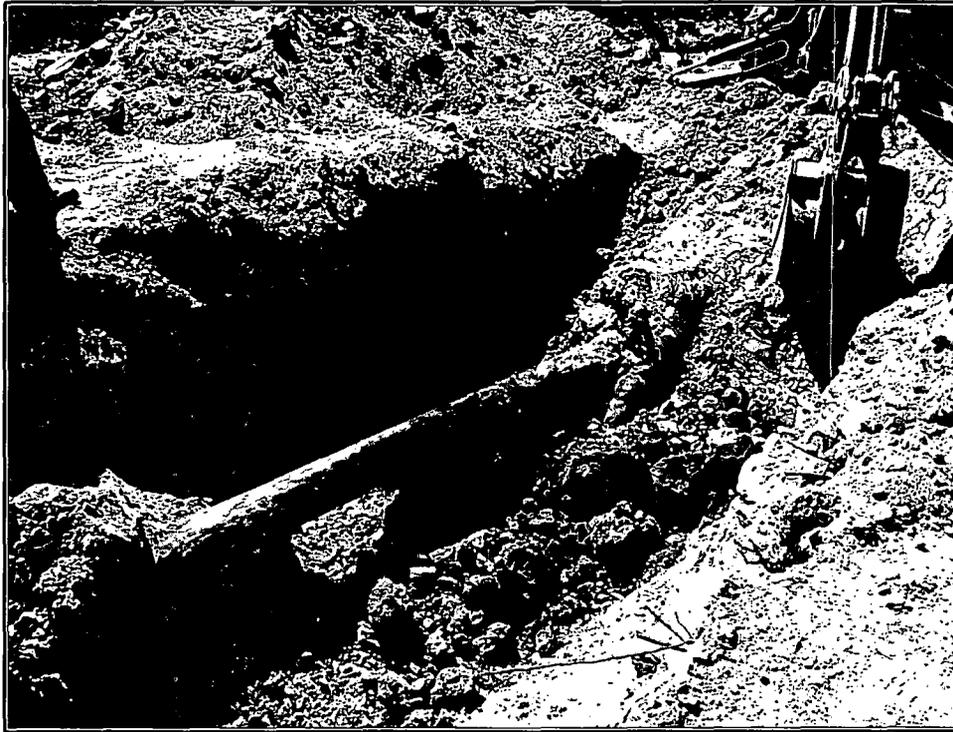
Photo 1: Beginning of excavation at the Lateral 2C-6 pipeline release at a depth of approximately 4.5' bgs.

On September 18 and 22, SMA mobilized to the release site to oversee excavation activities during the repair of the pipeline and guide remediation activities. SMA guided the excavation activities by collecting soil samples for field screening with a calibrated photo-ionization detector (PID). Representatives from Enterprise were present to oversee site health and safety and direct repair activities.

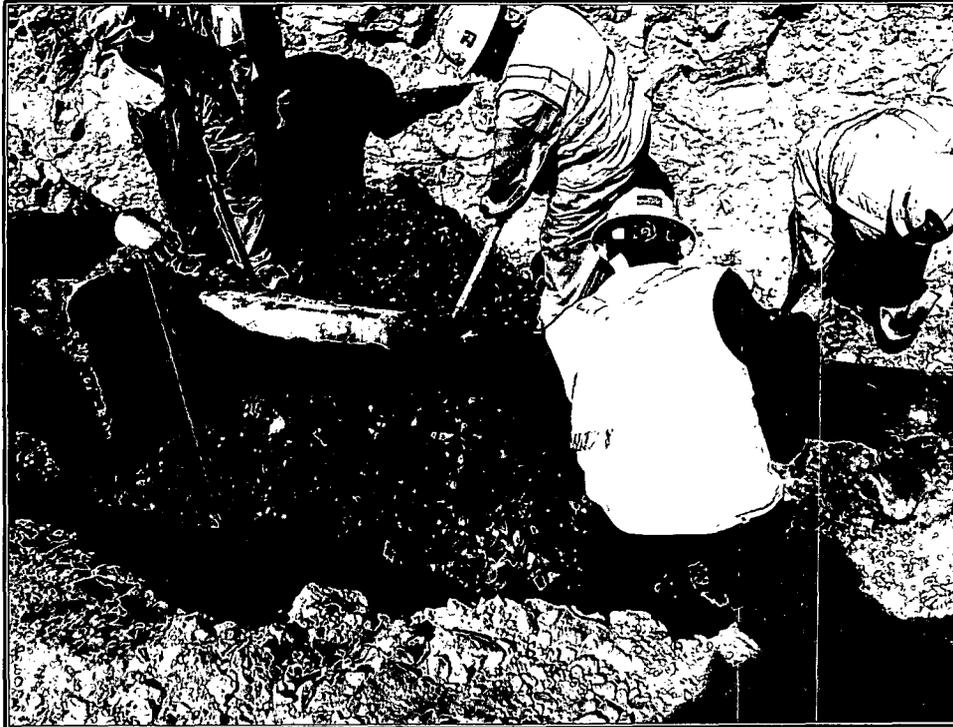
Photo 2: Removal of heavily stained soils from the Lateral 2C-6 release.

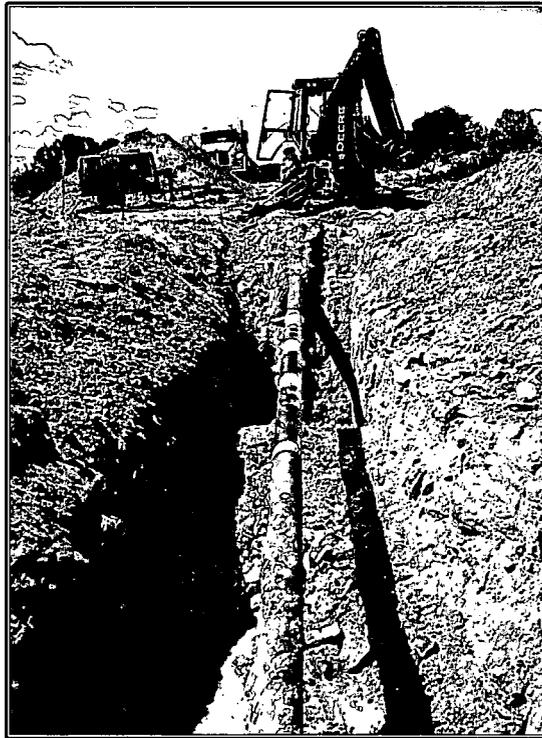
Photo 3: View of rubber tired backhoe equipped with rock teeth used during the excavation.

On September 26, 2014, OFT Construction advanced the base of the excavation to a depth of 6 feet on the western base and 7 feet on the eastern base using a rubber tire backhoe equipped with rock teeth. Samples were collected by SMA for laboratory analysis from the east and west base. Laboratory results indicated that the east base was below regulatory standards; however, the west base remained above the regulatory standard with a combined GRO/DRO concentration of 4,130 mg/kg.

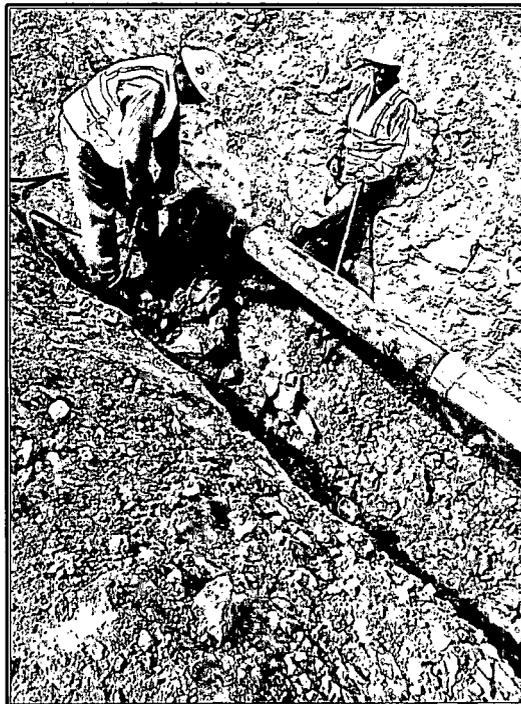
Photo 4: View of Lateral 2C-6 pipeline excavation continuing through the bedrock base using an air powered jackhammer.

On October 1, 2014, OFT Construction, under the direction of Enterprise and guided by SMA field screening, employed an air-powered jackhammer to break up and excavated the sandstone bedrock base to a maximum achievable depth of approximately 10.5 feet below ground surface. A sample was collected from the west base at a depth of 10.5 and laboratory results indicated the base was below regulatory standards; however, the sidewalls were not sampled in the advanced excavation from 5 to 10.5 feet below ground surface. On October 3, 2014, SMA returned to the site to collect samples for laboratory analysis from the sidewalls in question. Final laboratory results determined that the sidewalls were below regulatory standards.

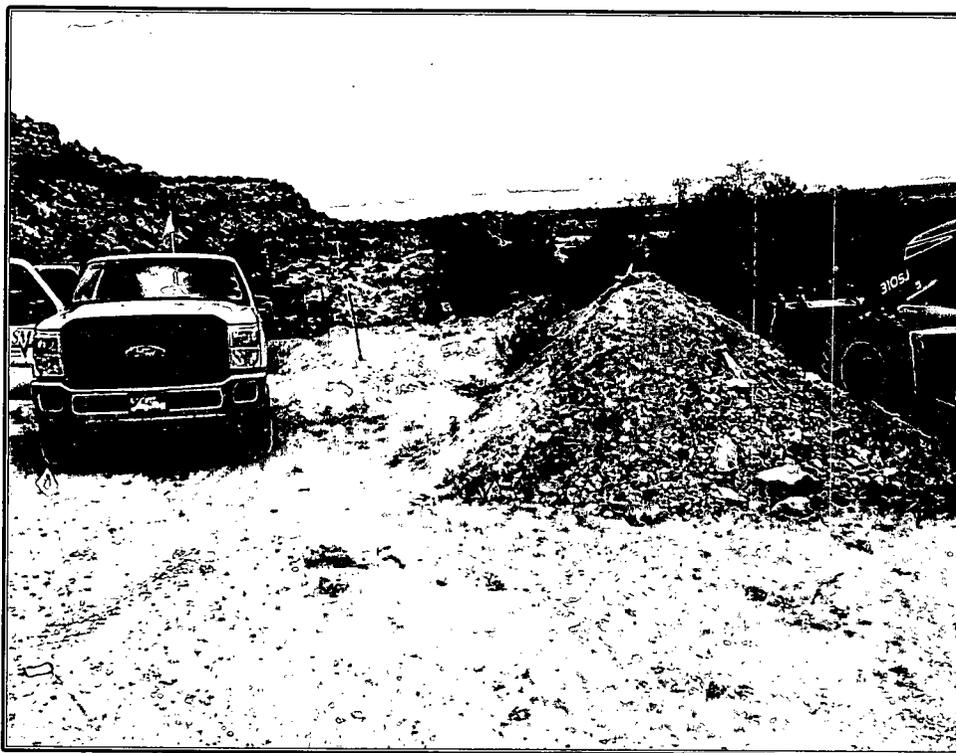
Photo 5: View of stockpiled soil that is to be transported for offsite disposal.

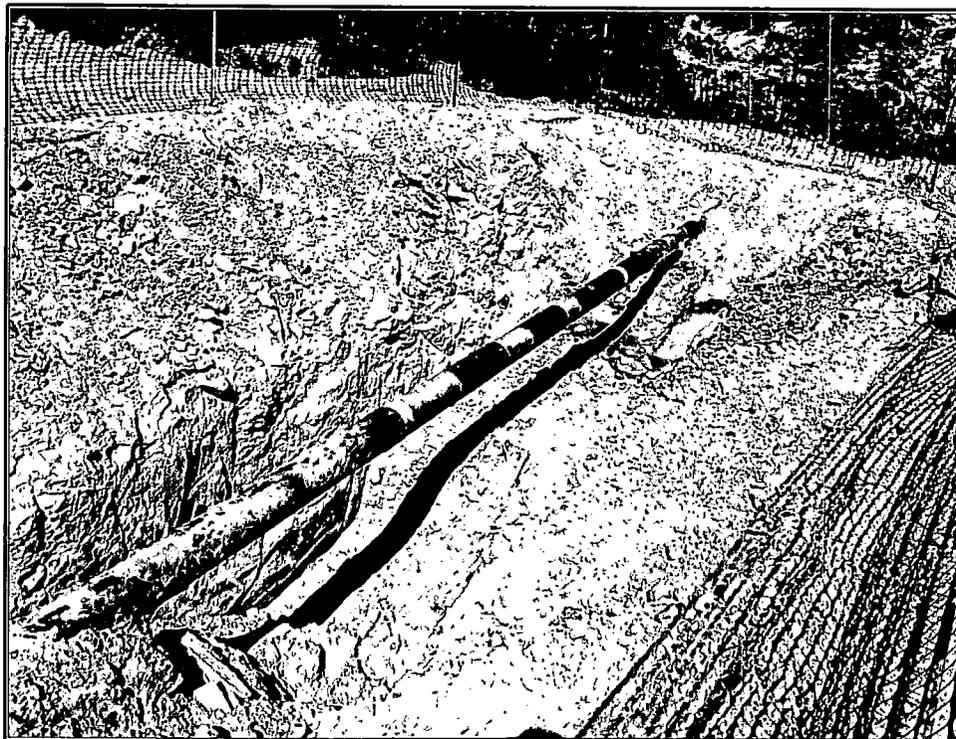
Photo 6: View of the final excavation with a maximum depth of 10.5 feet on the western base.

The final excavation dimensions were approximately 25 feet long by a maximum of 8 feet wide and a maximum of 10.5 feet deep, covering an area of approximately 200 square feet. In total, approximately 90 cubic yards of material were excavated and hauled to Envirotech Landfarm near Bloomfield, New Mexico for proper disposal and replaced with clean backfill material. Soil disposal documentation is included in Appendix B.
