## **REMEDIATION SUMMARY AND SITE CLOSURE REQUEST**

**BOPCO, LP  
POKER LAKE UNIT #68  
Eddy County, New Mexico  
Unit Letter "A" (NE/NE), Section 20, Township 24 South, Range 31 East  
Latitude 32.207618° North, Longitude 103.797917° West  
NMOCD Reference #2RP-\_\_\_\_\_**

**June 2012**

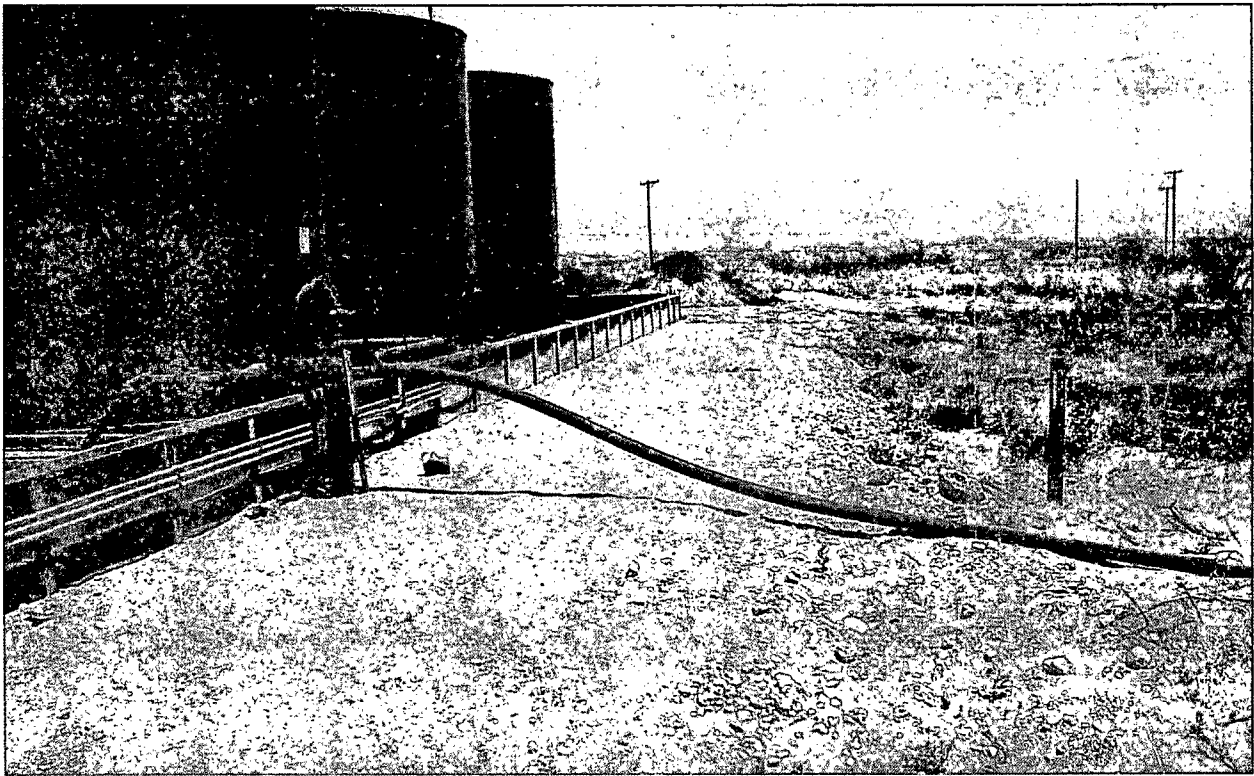
Photograph of the initial release at PLU #68. (Looking East)

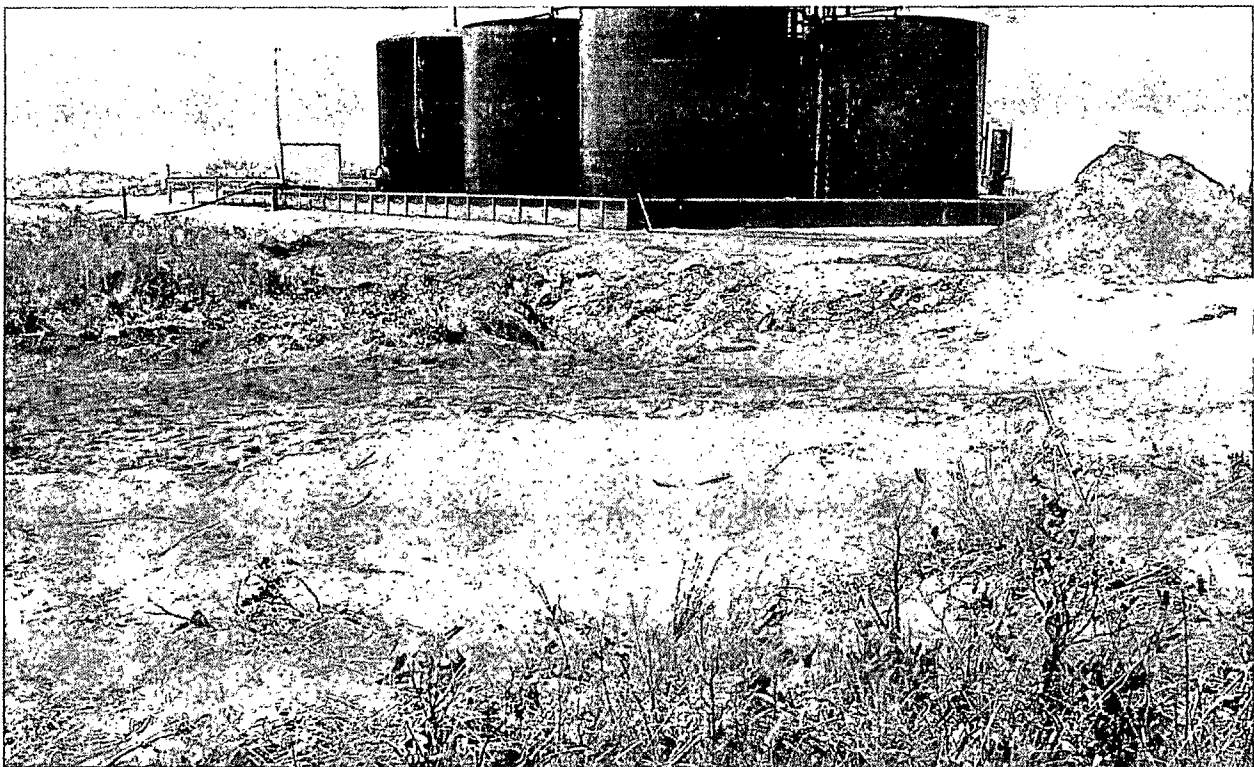
Photograph of initial response activities at PLU #68. (Looking Northwest)

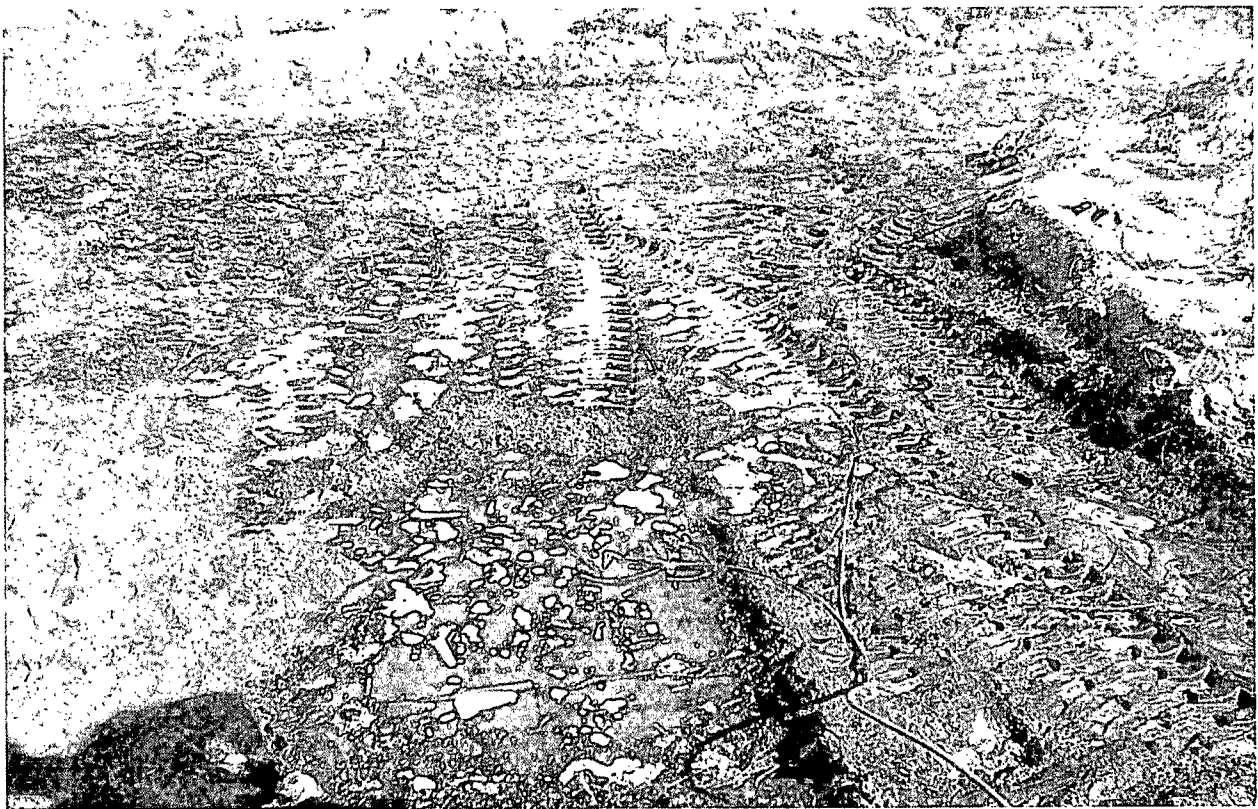
Photograph of May 15, 2012, release at PLU #68.

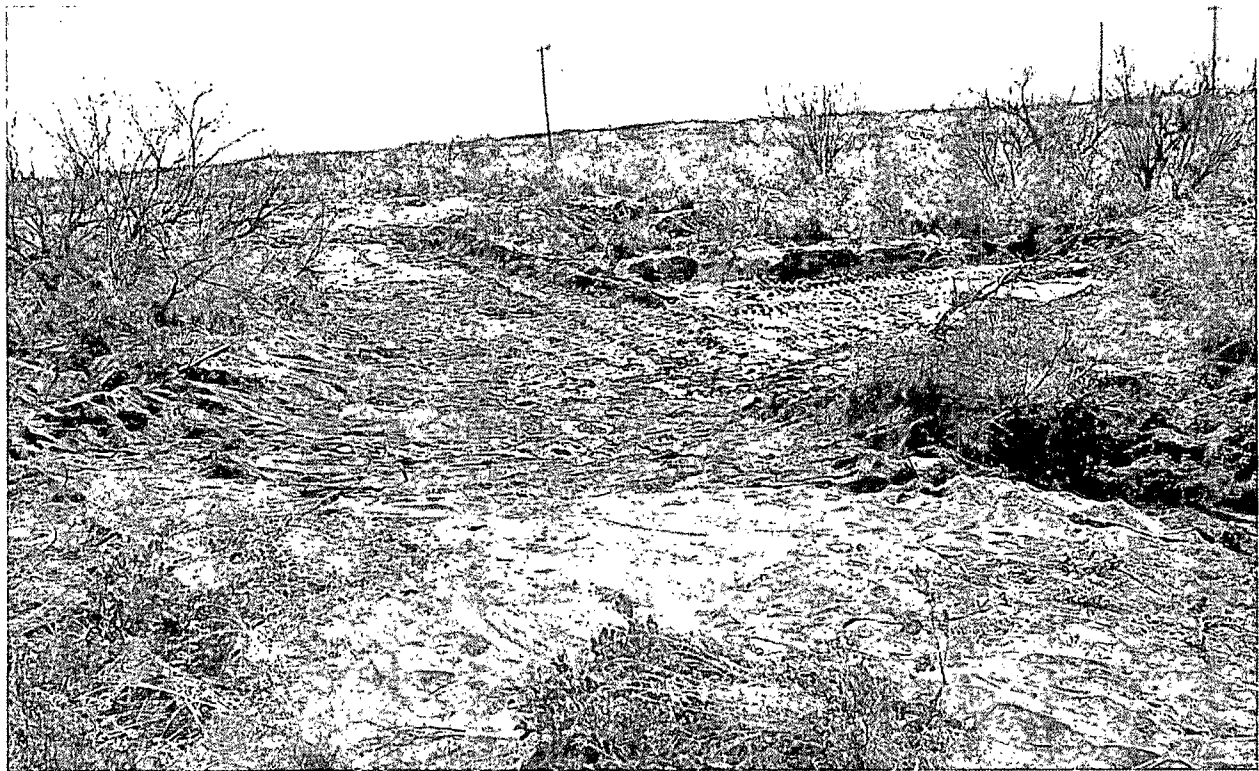
Photograph of May 15, 2011, release at PLU #68.

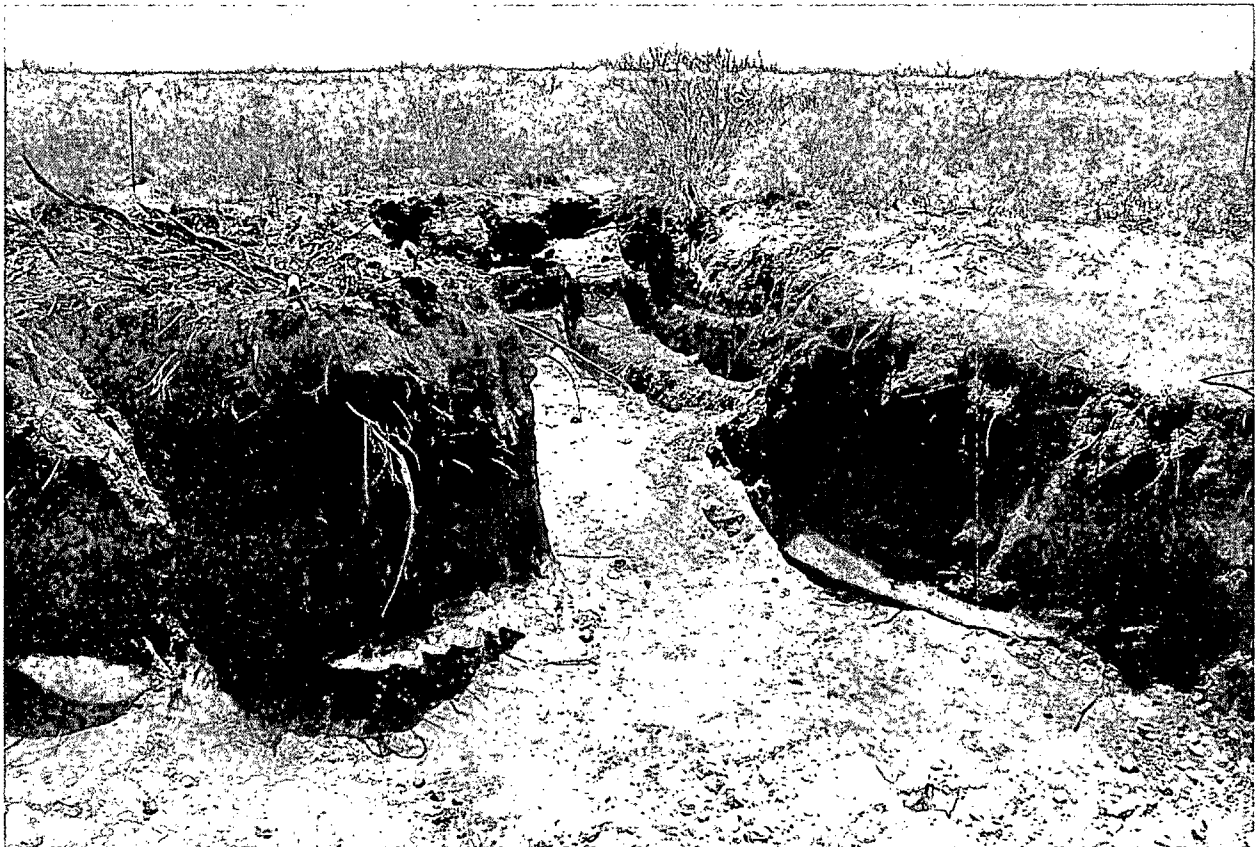
Photograph of Excavation and Sample Locations at PLU #68.

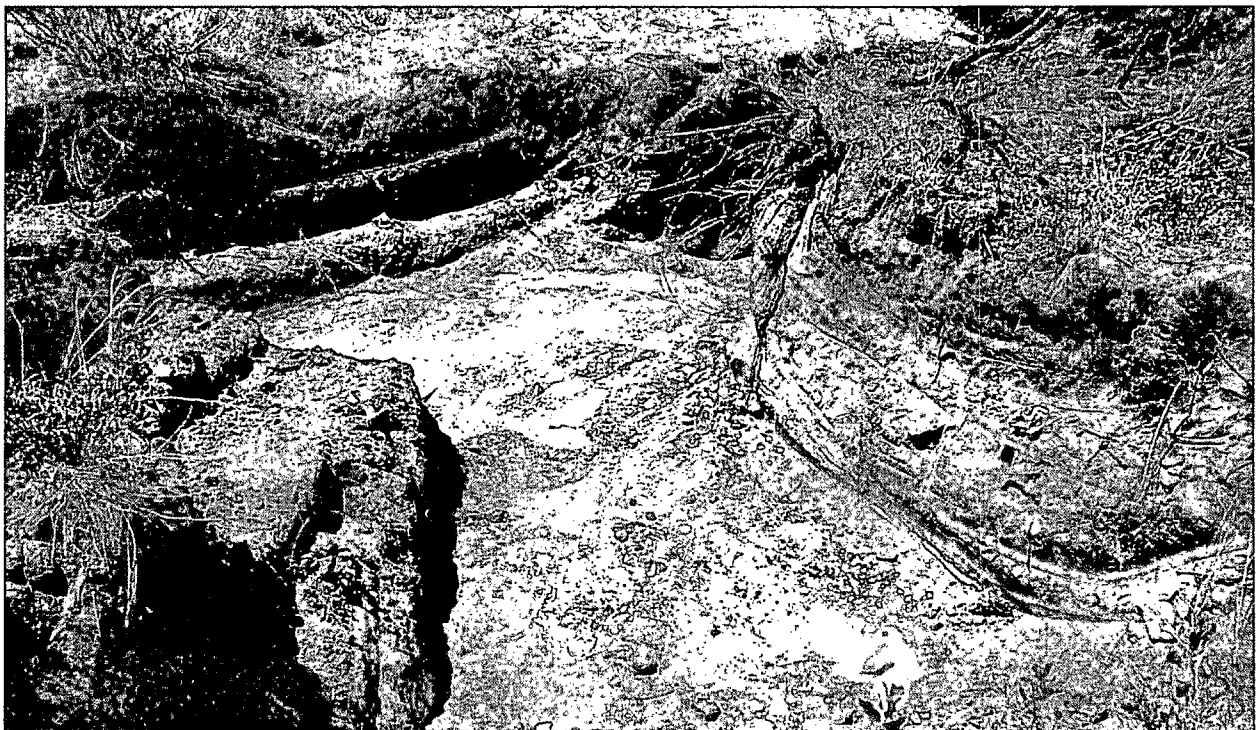
Photograph of Excavation and Sample Locations at PLU #68.

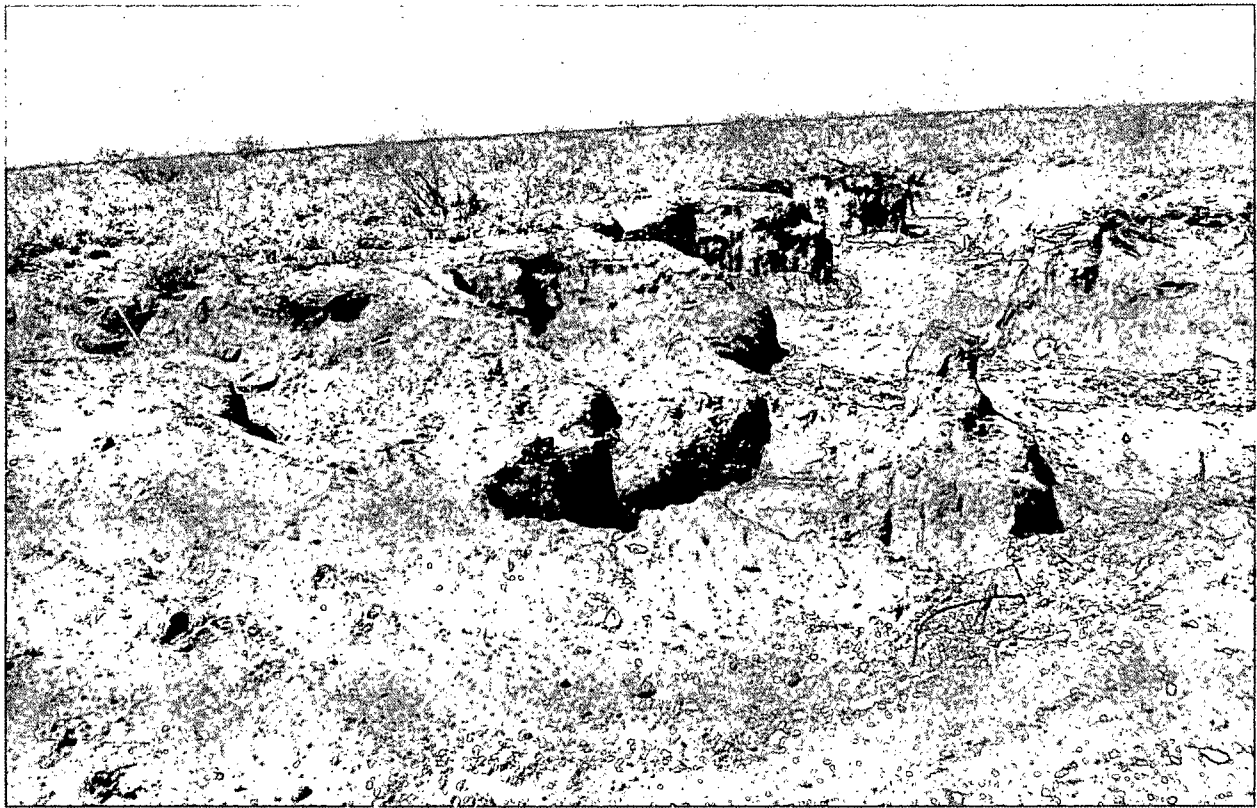
Photograph of Excavation and Sample Locations at PLU #68. (Looking Southwest)

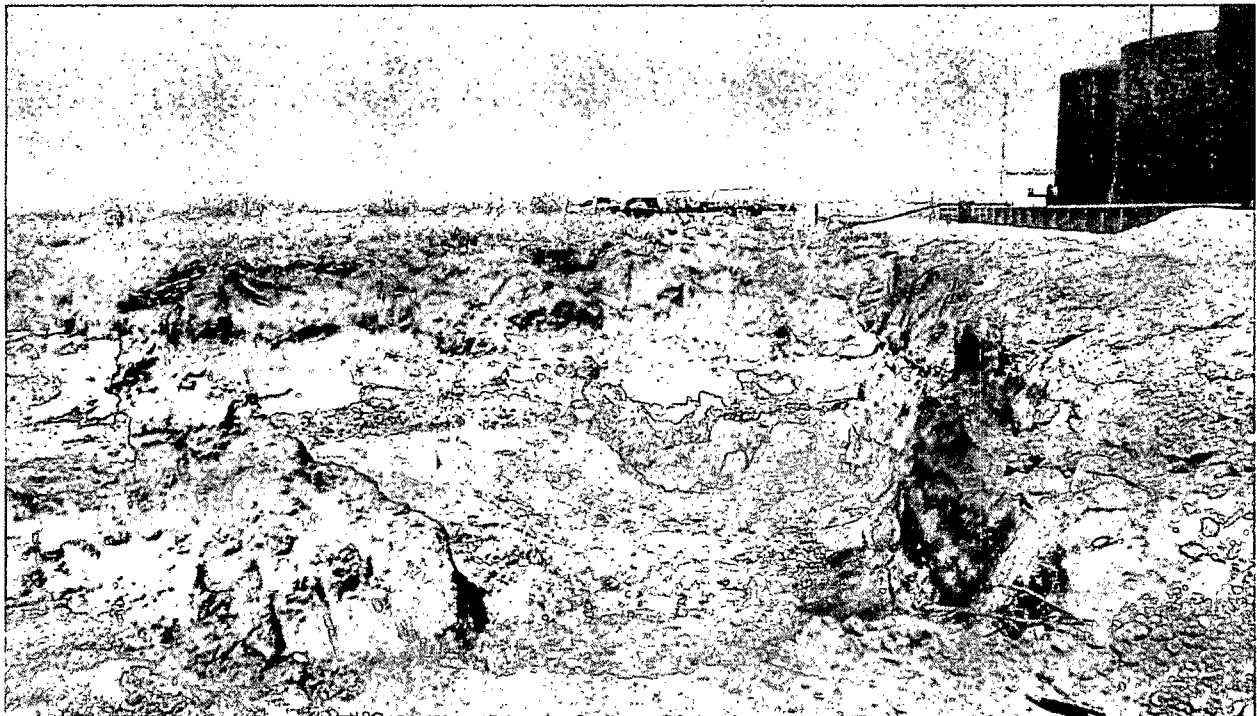
Photograph of Excavation and Sample Locations at PLU #68 release site. (Looking West)
