REMEDIATION SUMMARY & SOIL CLOSURE REQUEST

**BOPCO, LP
G.H. Cobb Federal #1
Eddy County, New Mexico
Unit Letter "M" (SWSW), Section 23, Township 20 South, Range 31 East
Latitude 32° 33' 11.412" North, Longitude 103° 50' 44.304"
NMOCD Reference # 2RP-369**

September 2011

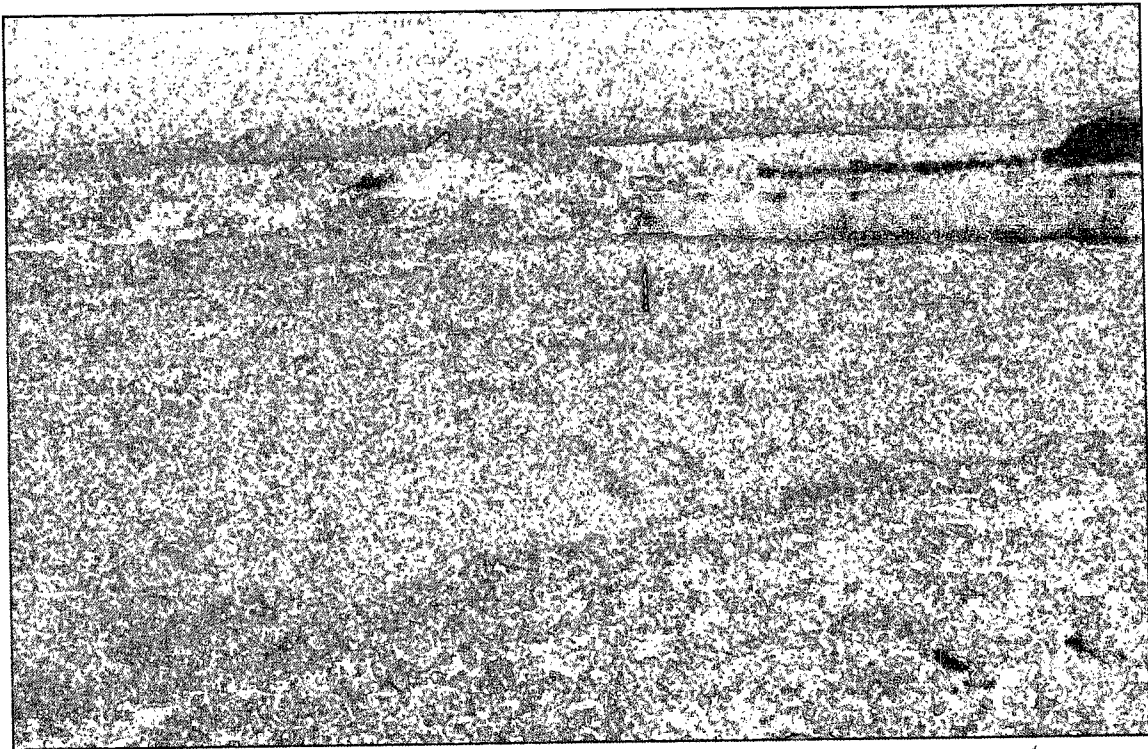
G.H. Cobb Federal #1 - Liner Installation

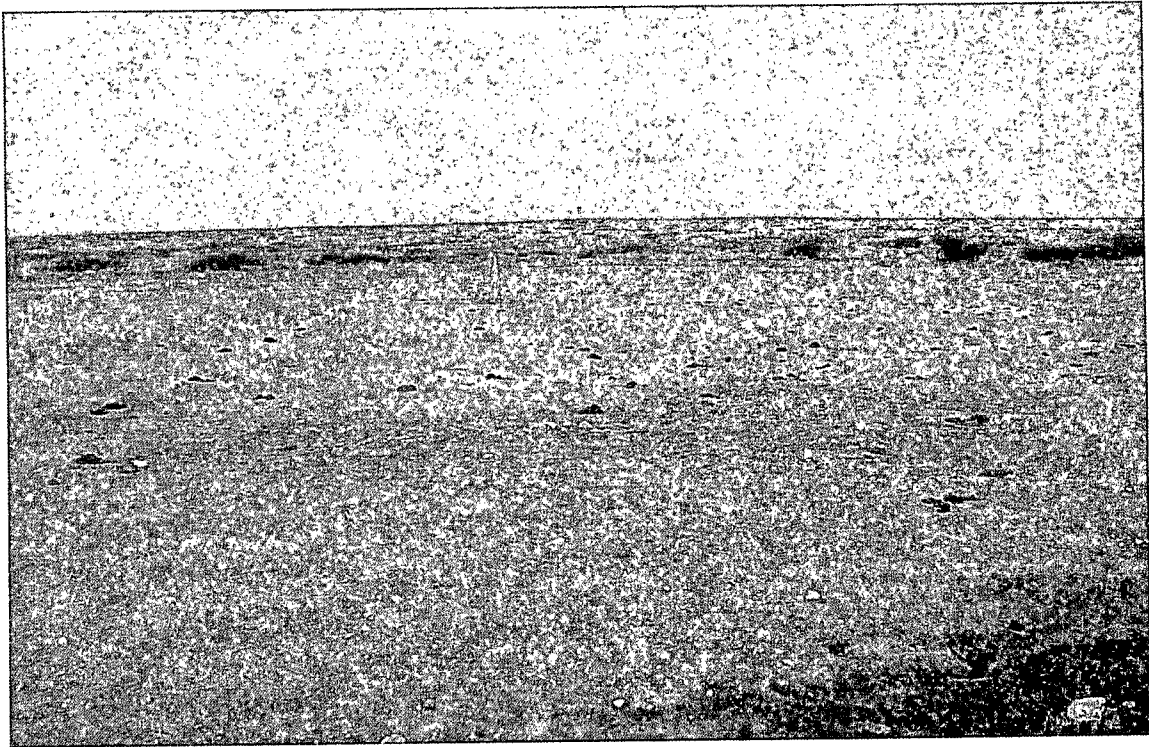
G.H. Cobb Federal #1 - Excavation (prior to seeding; looking North)
