**REMEDIATION SUMMARY  
AND SITE  
CLOSURE REQUEST**

**BOPCO, L.P.  
Poker Lake Unit #227  
Eddy County, New Mexico  
BOPCO Job # CPL-09-02  
UNIT LTR "P" (SE ¼ /SE ¼ ), Section 30, Township 24 South, Range 30 East  
Latitude 32.18191° North, Longitude 103.91429°  
NMOCD Reference # 2RP-348**

**May 2010**

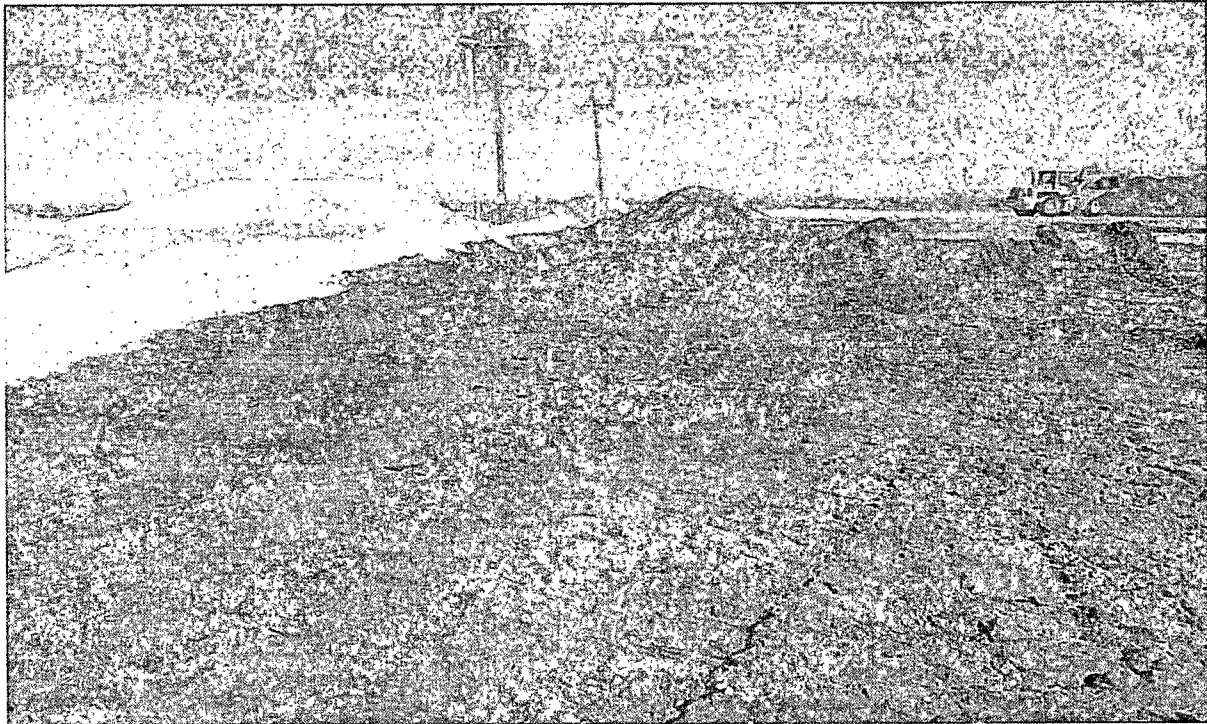
Excavation Activities on the Tank Battery at the Poker Lake 227 Release Site

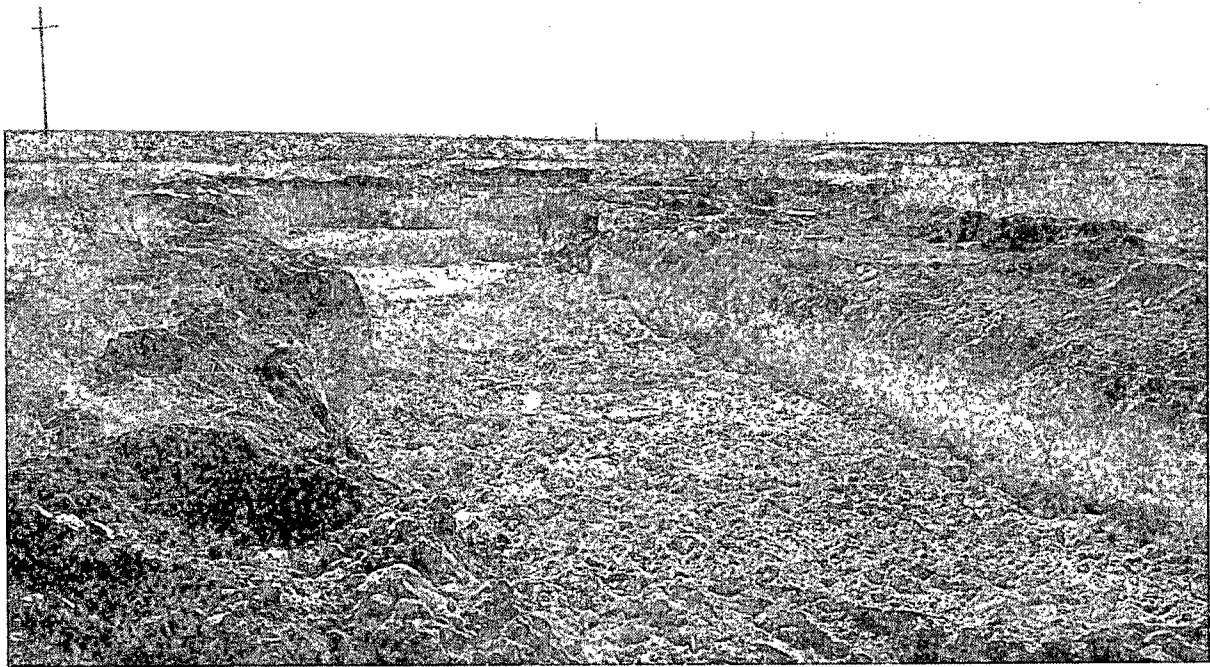
Excavation Activities in the Runoff Area at the Poker Lake 227 Release Site
