REMEDIATION SUMMARY AND SITE CLOSURE REQUEST

**BOPCO, LP
GOLDEN 8 FEDERAL BATTERY #1 FLOWLINE
Eddy County, New Mexico
Unit Letter "K" (NE/SW), Section 8, Township 21 South, Range 29 East
Latitude 32.491352° North, Longitude 103.008223° West
NMOCD Reference #s 2RP-466**

September 2012

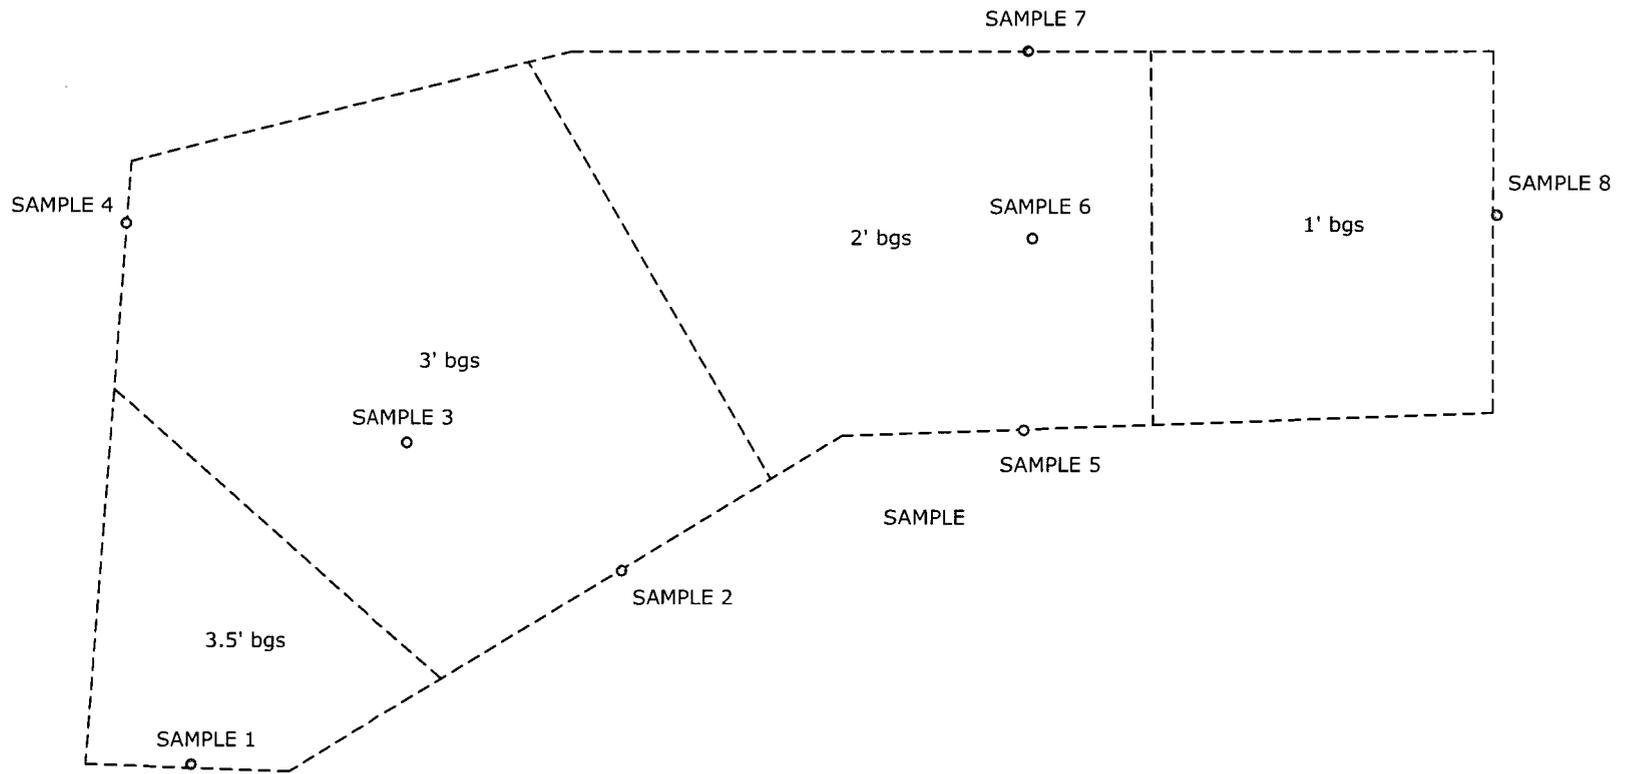
Figure 2
Site Map
BOPCO, L.P.
Golden 8 Federal Battery #1 Flowline
Eddy County, New Mexico

- Excavation Extent
- Pipeline
- Sample Location
- Caliche Road

On April 20, 2012, eight (8) soil samples (Sample 1, Sample 2, Sample 3, Sample 4, Sample 5, Sample 6, Sample 7 and Sample 8) were collected from the excavation floor and sidewalls and submitted to the laboratory for analysis of TPH and chloride concentrations. Laboratory analytical results indicated TPH concentrations were less than the appropriate laboratory method detection limit (MDL) for each of the submitted soil samples with the exception of soil sample "Sample 6", which had a concentrations of 25.6 mg/Kg. Analytical results indicated chloride concentrations ranged from less than the laboratory MDL for soil sample "Sample 1" to 624 mg/Kg for soil sample "Sample 6". Soil sample "Sample 6" was also analyzed for BTEX constituent concentrations, which were determined to be less than the appropriate laboratory MDL for each constituent. Chloride, BTEX and TPH concentrations were less than NMOCD regulatory standards in each of the submitted soil samples.

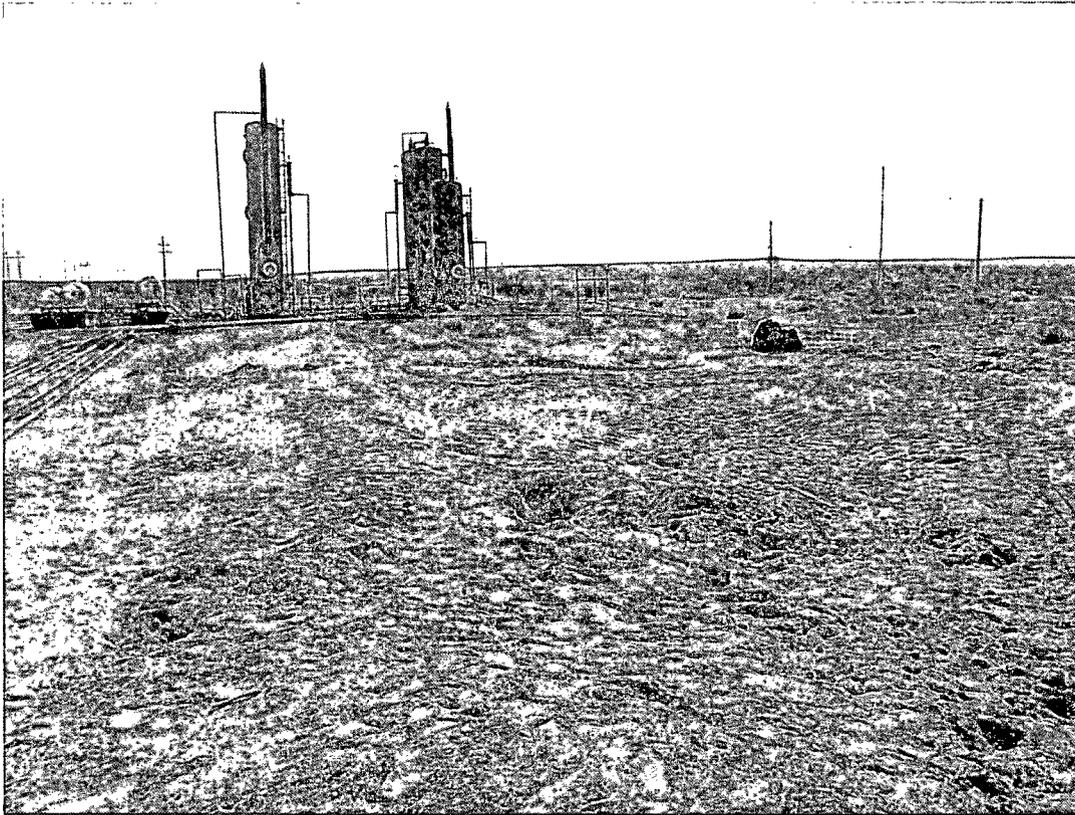
Photograph of the Initial Release at the Golden 8 Federal Battery #1.

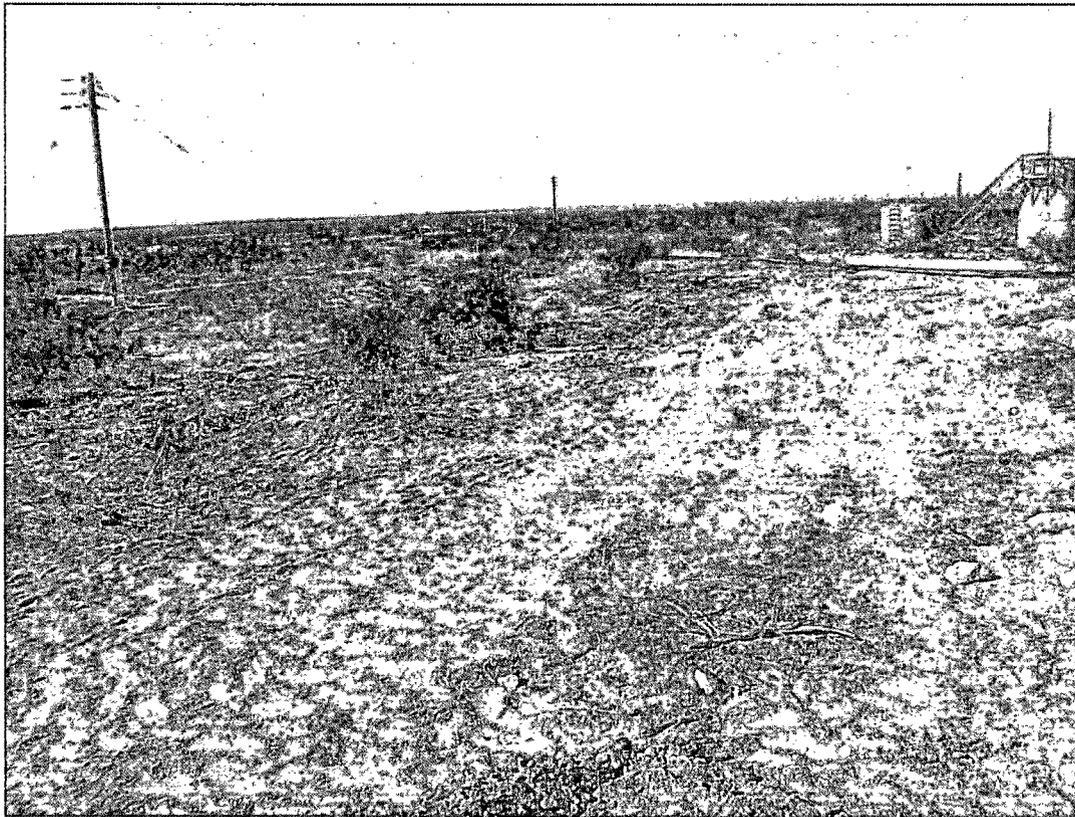
Photograph of the Initial Release at the Golden 8 Federal Battery #1.

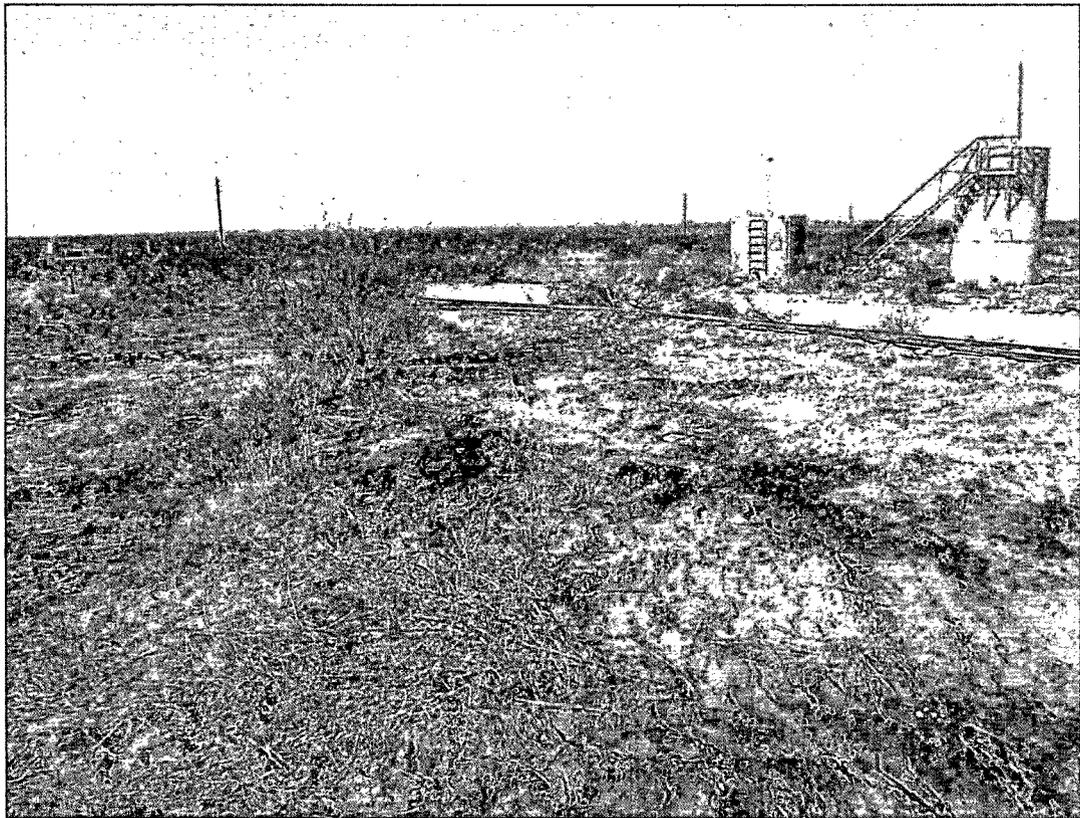
Photograph of the Initial Release at the Golden 8 Federal Battery #1.

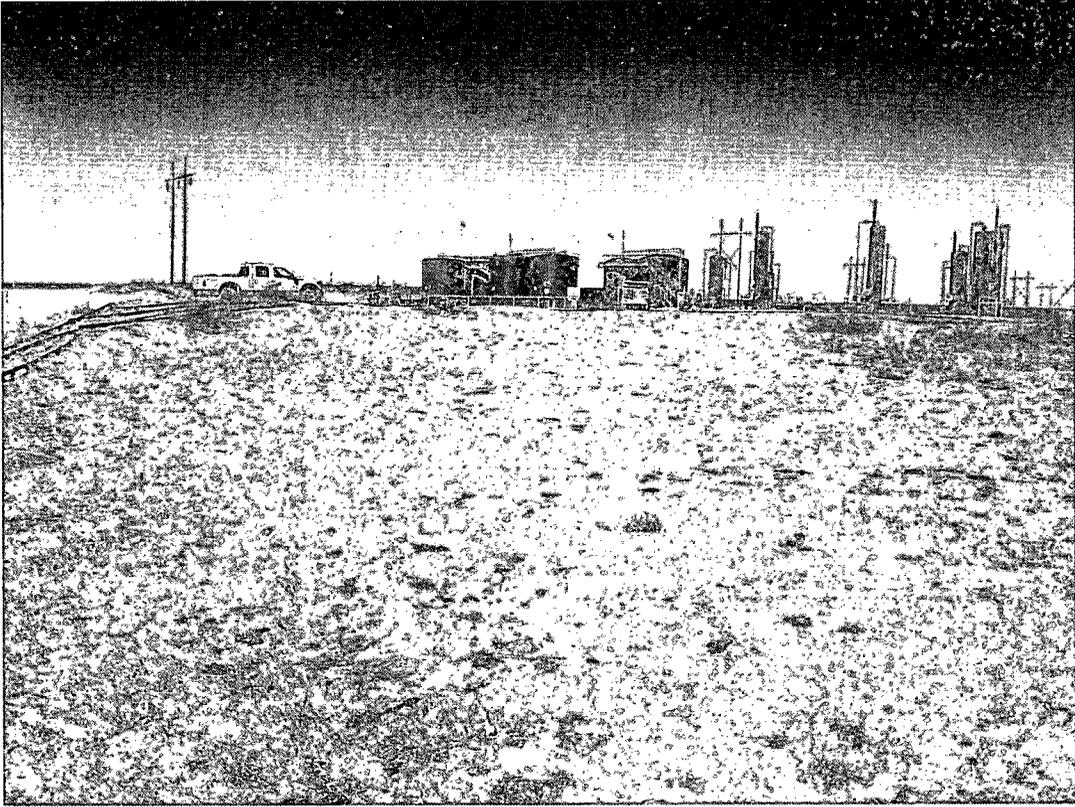
Post-Remediation Picture of Golden 8 Federal Battery #1 Flowline

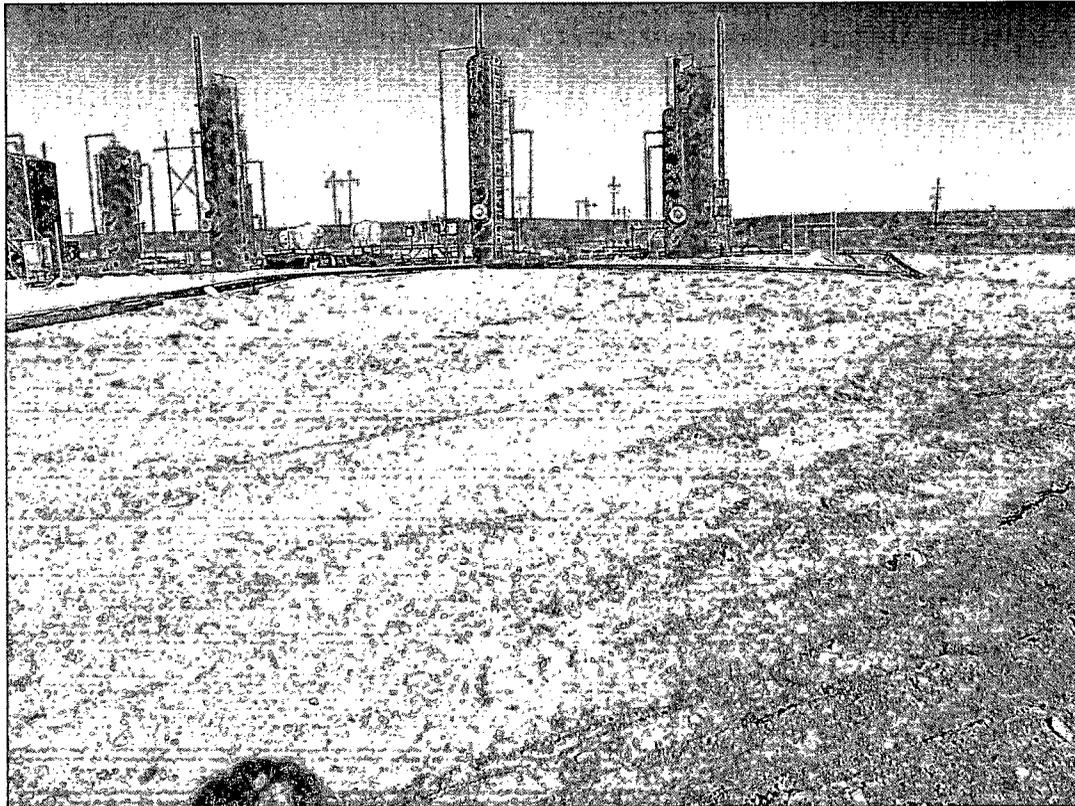
Post-Remediation Picture of Golden 8 Federal Battery #1 Flowline
