REMEDIATION SUMMARY & RISK-BASED SITE CLOSURE REQUEST

**BOPCO, LP
POKER LAKE UNIT #108
Eddy County, New Mexico
UNIT LTR "J" (NW/SE), Section 25, Township 24 South, Range 30 East
Latitude 32.187010° North, Longitude 103.832130° West**

December 2011

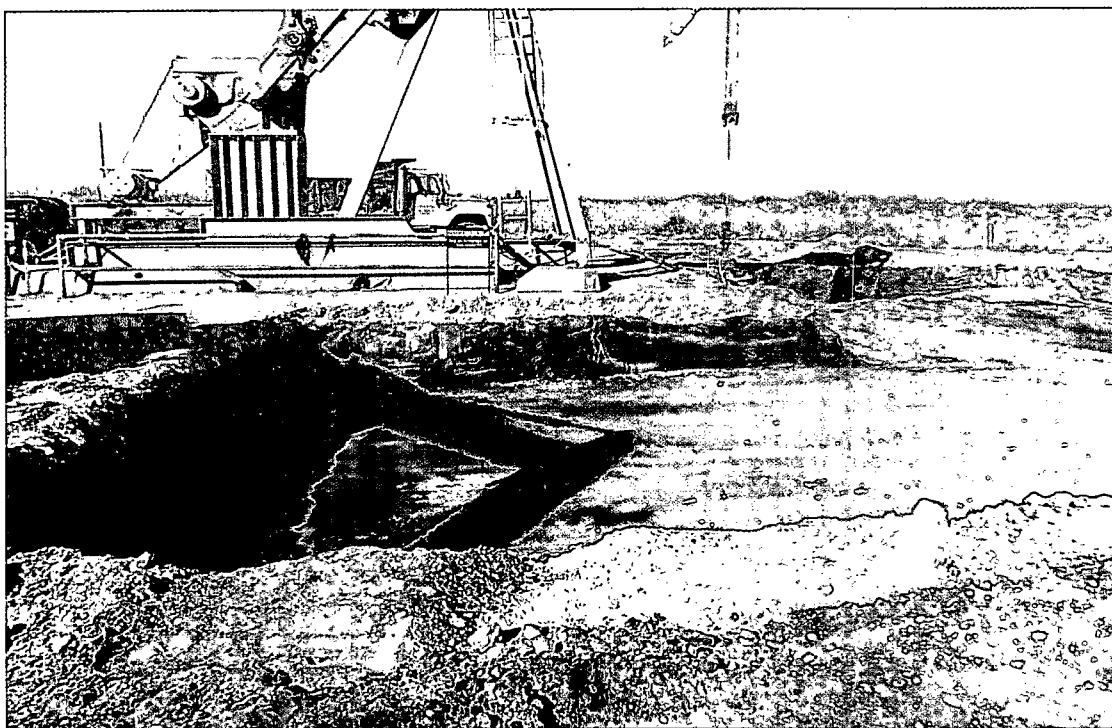
Following initial response activities, on October 31, 2011, excavation of impacted soil commenced at the site. A Photo-Ionization Detector (PID) and Hach Quantab chloride titrators were used to field-screen the horizontal and vertical extent of impacted soil and to guide the excavation.

From October 31 through November 8, 2011, approximately seven hundred and twenty cubic yards (720 cy) of impacted soil was transported to Lea Land, Inc. (NMOCD Permit # WM-01-035) for disposal.

Poker Lake Unit #108 - Excavation

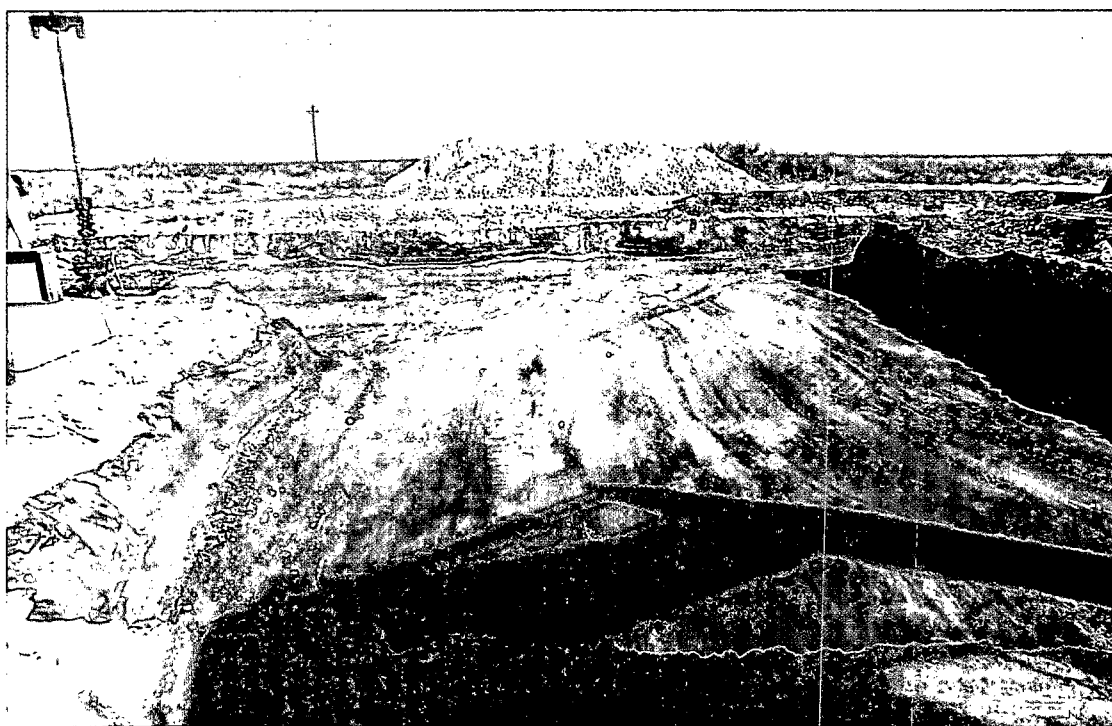
Poker Lake Unit #108 - Excavation
