REMEDICATION SUMMARY & RISK-BASED SITE CLOSURE REQUEST

**BOPCO, LP
POKER LAKE UNIT #108 FLOWLINE
Eddy County, New Mexico
UNIT LTR "J" (NW/SE), Section 25, Township 24 South, Range 30 East
Latitude 32.18713° North, Longitude 103.83280° West**

December 2011

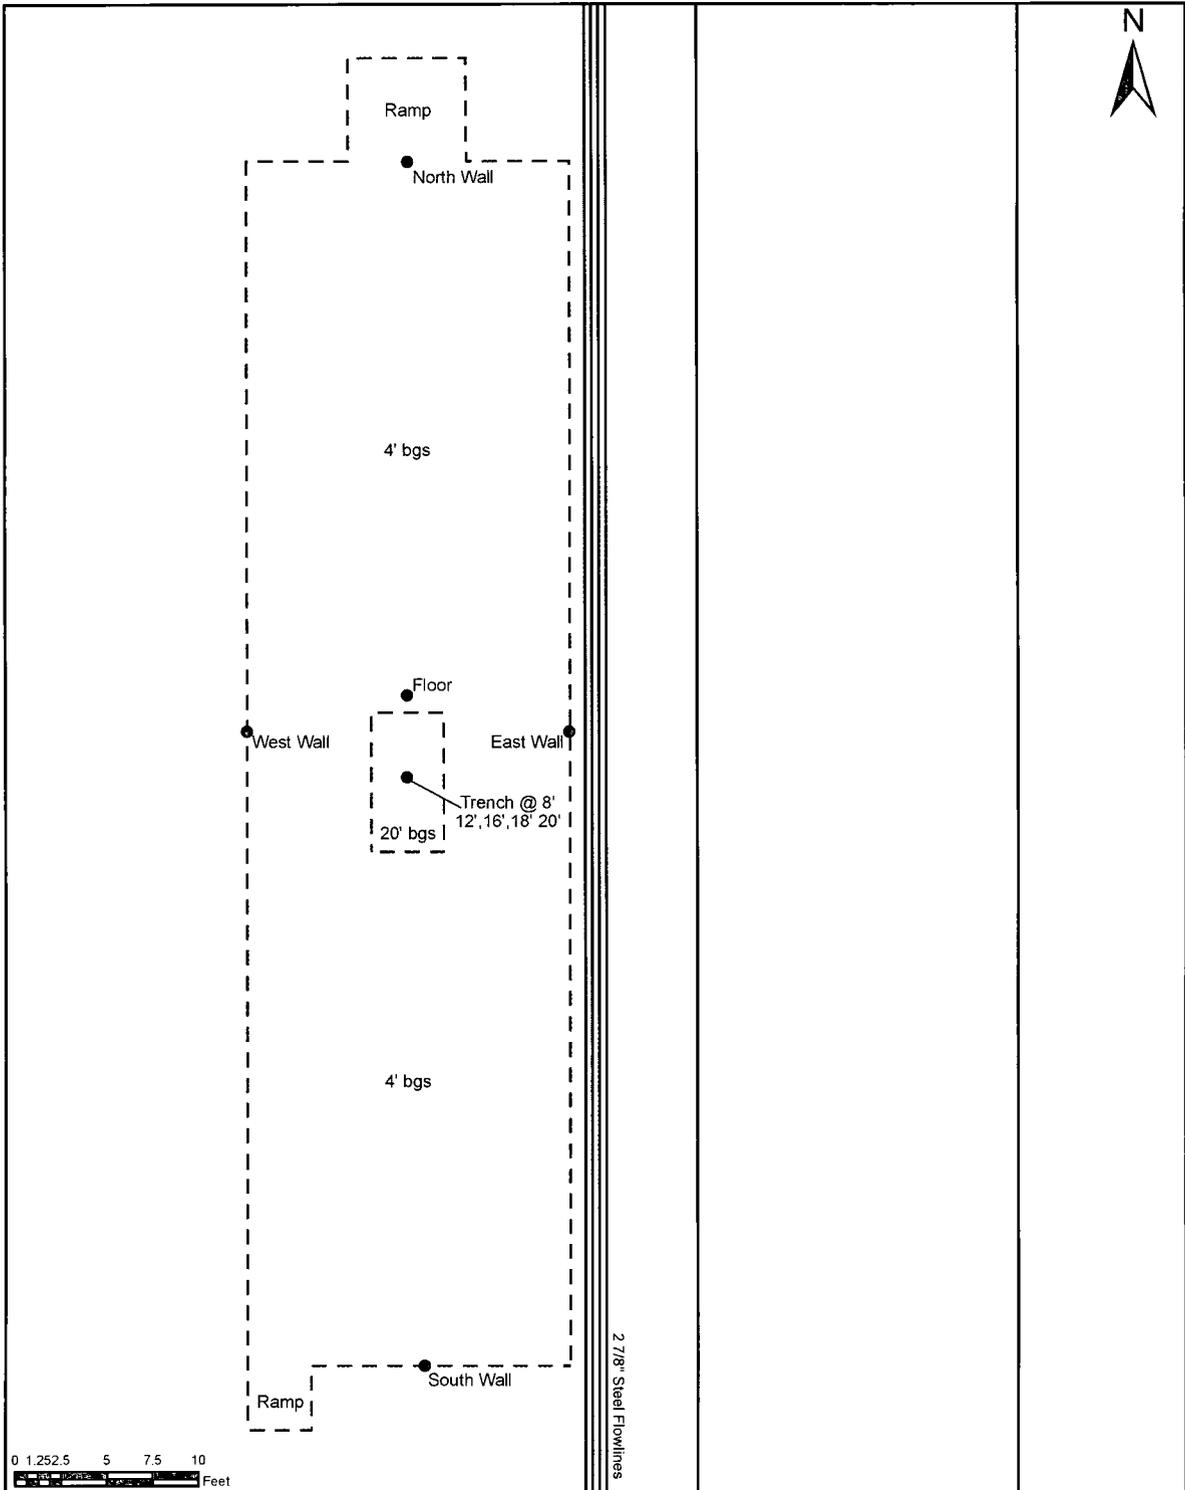
Figure 2
Site & Sample Location Map
BOPCO, LP
Poker Lake Unit #108 Flowline
North Excavation
Eddy County, New Mexico

Five (5) soil samples (North Wall, South Wall, East Wall, West Wall, and Floor) collected from the floor and sidewalls of the North Excavation and five (5) soil samples (Trench @ 8', Trench @ 12', Trench @ 16', Trench @ 18', and Trench @ 20') from delineation trench "Trench" were submitted to the laboratory

for analysis of BTEX, TPH, and/or chloride concentrations. Sample locations are depicted in Figure 2, "Site & Sample Location Map - North Excavation".

Based on laboratory analytical results, on November 22 through November 23, 2011, the North Excavation was backfilled in eighteen-inch (18") lifts, compacted, and contoured to fit the surrounding topography. Prior to backfilling, a 20 mil polyurethane liner was installed in the floor of the North Excavation at approximately three feet (3') bgs. Approximately one foot (1') of non-impacted pad sand was installed both above and below the liner to protect the liner from damage during installation and backfilling activities. Final dimensions of the North Excavation were approximately sixty-six feet (66') in length, approximately fifteen feet (15') in width, and ranging in depth from approximately four feet (4') to approximately twenty feet (20') bgs.

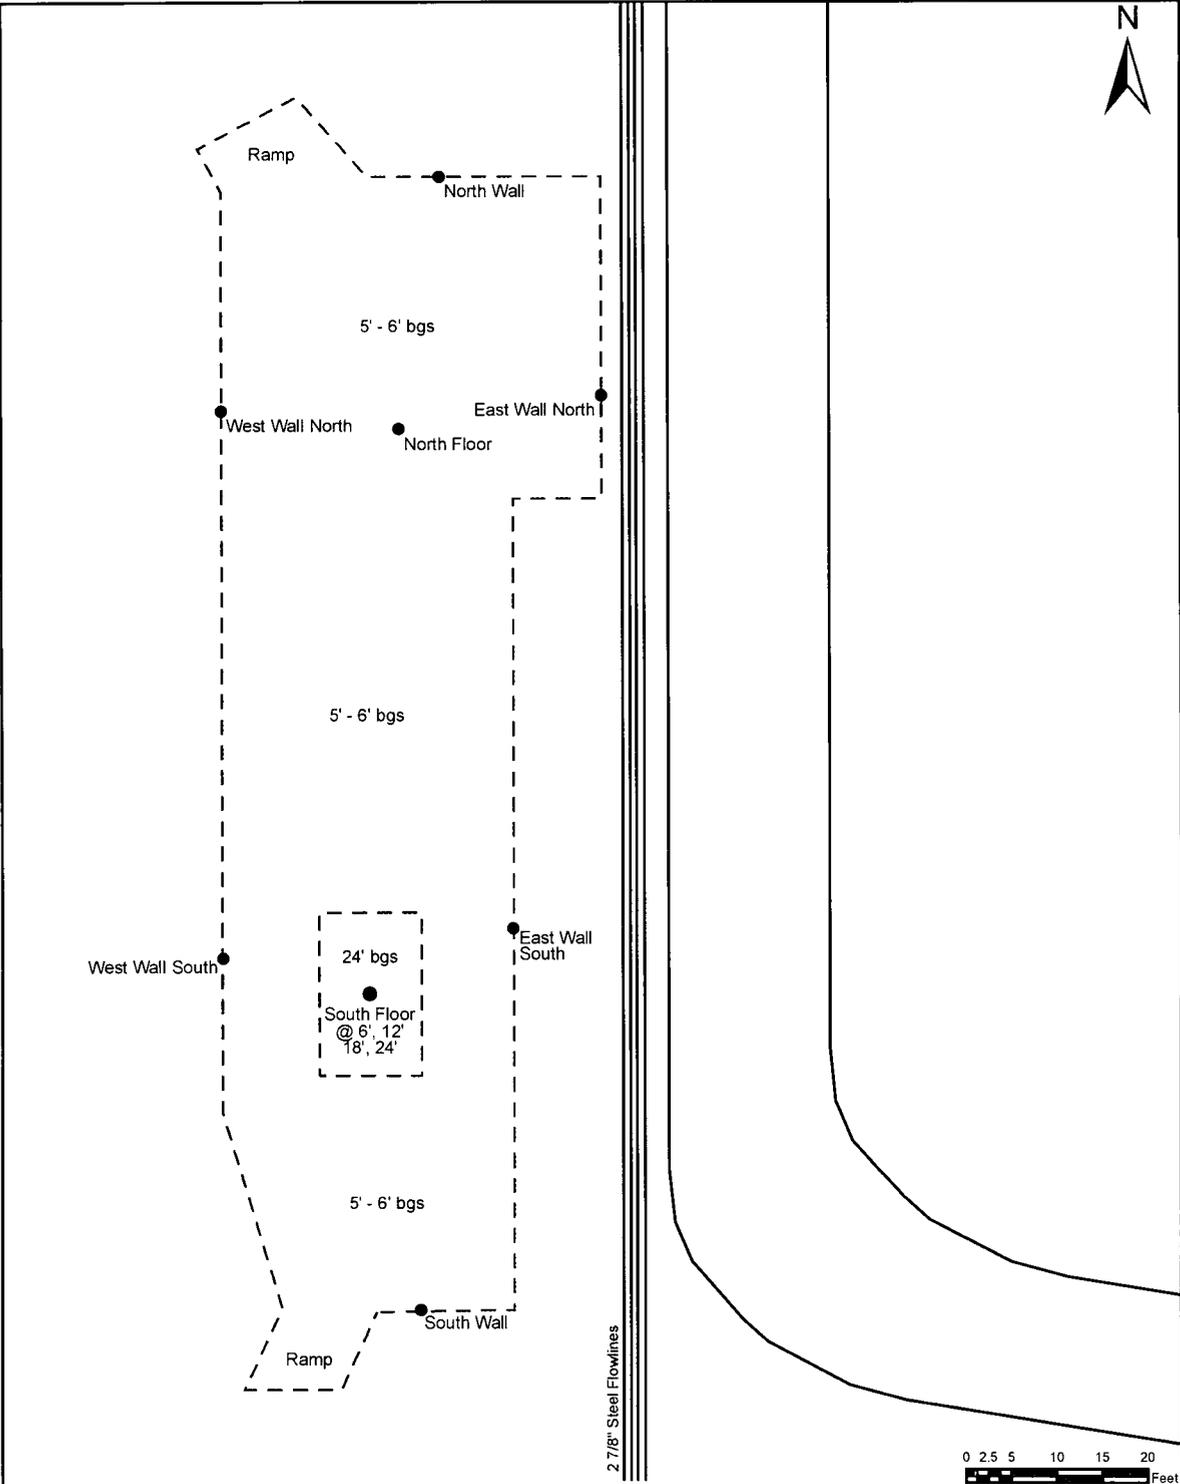
Figure 3
Site & Sample Location Map
BOPCO, LP
Poker Lake Unit #108 Flowline
South Excavation
Eddy County, New Mexico

Seven (7) soil samples (North Wall, South Wall, East Wall North, West Wall North, North Floor, East Wall South, and West Well South) collected from the floor and sidewalls of the South Excavation and four (4) soil samples (South Floor @ 6', South Floor @ 12', South Floor @ 18', and South Floor @ 24') from delineation trench "South Floor" were submitted to Cardinal Laboratories (Hobbs, New Mexico) for analysis of benzene, toluene, ethylbenzene, and xylenes (BTEX), total petroleum hydrocarbons (TPH), and/or chloride concentrations using EPA methods SW-846 8021b, SW-846 8015M, and 4500 Cl-B, respectively. Table 1 summarizes the "Concentrations of Benzene, BTEX, TPH & Chlorides in Soil". Sample locations are depicted in Figure 3, "Site & Sample Location Map - South Excavation". Laboratory analytical reports are provided as Appendix C.

Based on laboratory analytical results and field-screens, from November 17 through November 21, 2011, the South Excavation was backfilled in eighteen-inch (18") lifts, compacted, and contoured to fit the surrounding topography. Prior to backfilling, a 20 mil polyurethane liner was installed in the floor of the South Excavation at approximately four feet (4') bgs. Approximately one foot (1') of non-impacted pad sand was installed both above and below the liner to protect the liner from damage during installation and backfilling activities. Final dimensions of the South Excavation were approximately one hundred and twenty-three feet (123') in length, ranging in width from approximately twenty-seven feet (27') to approximately thirty-five feet (35'), and ranging in depth from approximately five feet (5') to approximately twenty-four feet (24') bgs.

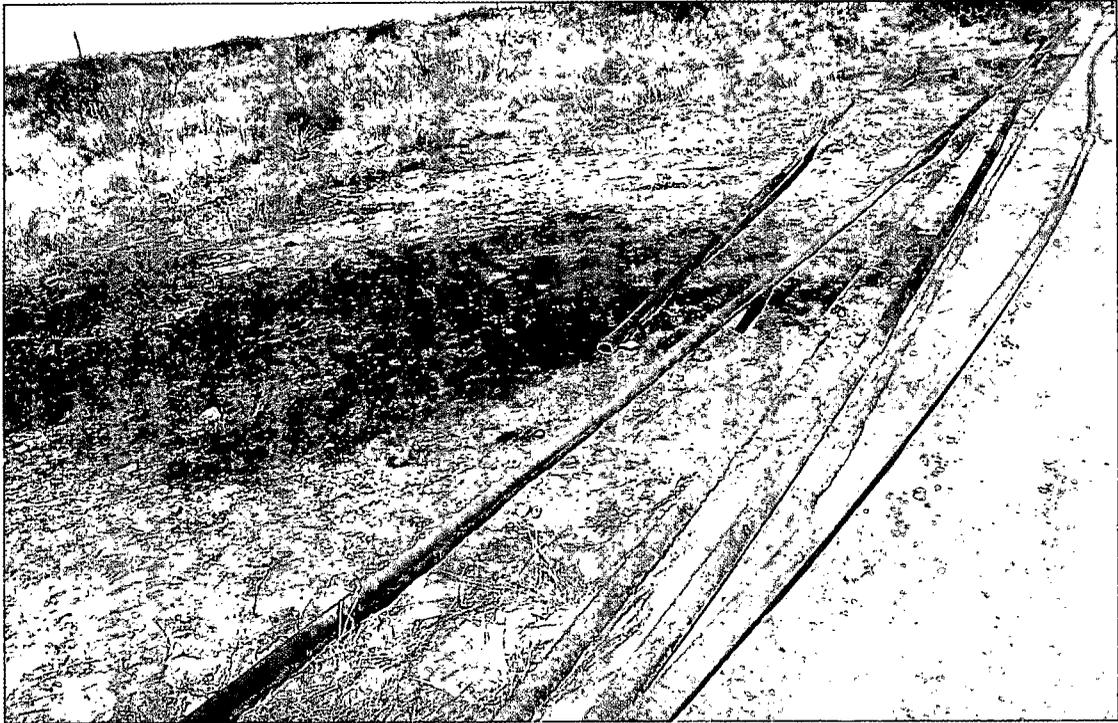
Poker Lake Unit #108 Flowline - Release Site, North Excavation (Looking North-northwest)

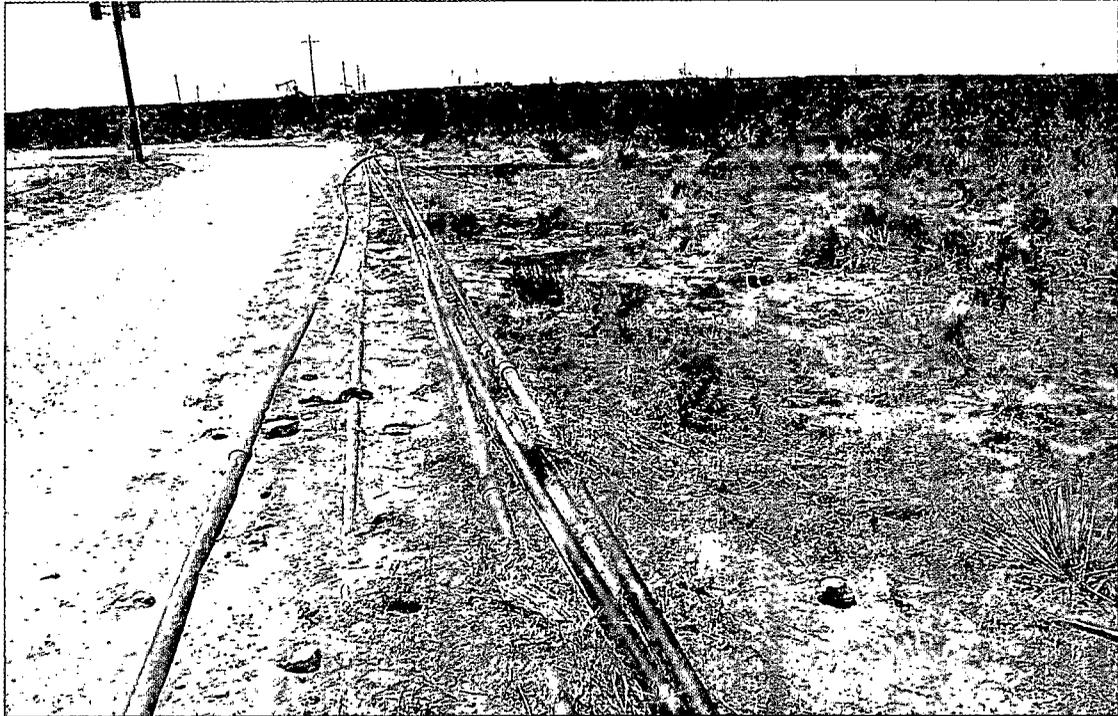
Poker Lake Unit #108 Flowline - Release Site, South Excavation (Looking South)

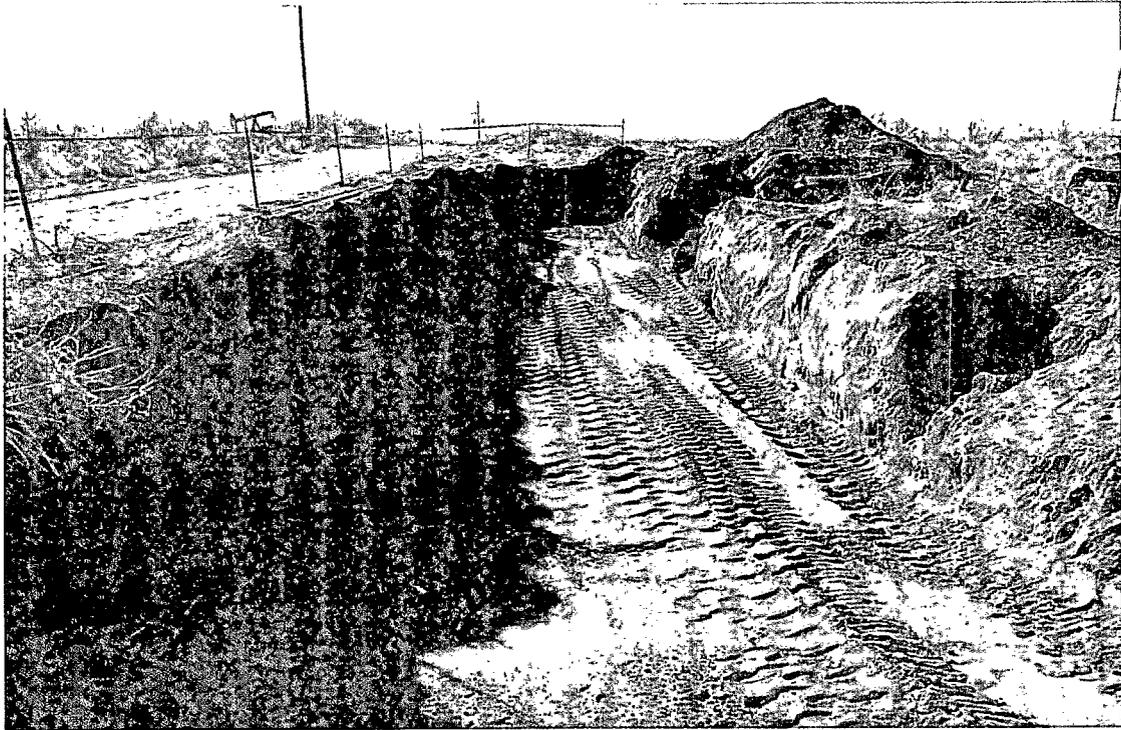
Poker Lake Unit #108 Flowline - North Excavation (Looking South)

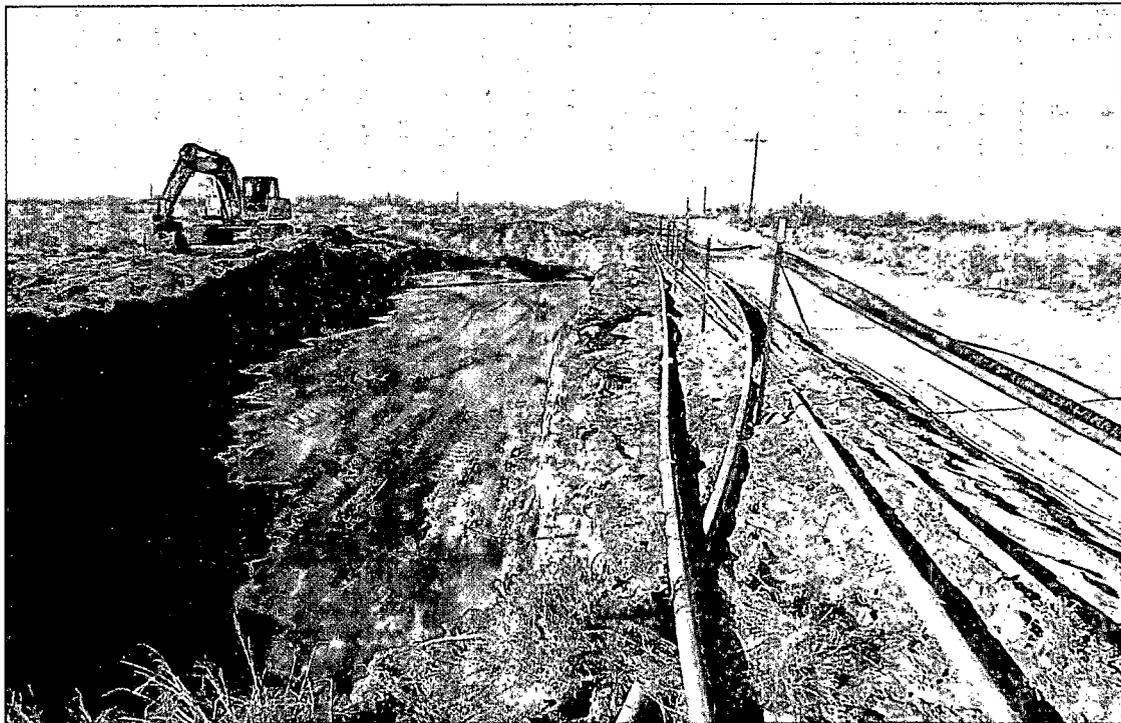
Poker Lake Unit #108 Flowline - South Excavation (Looking North)

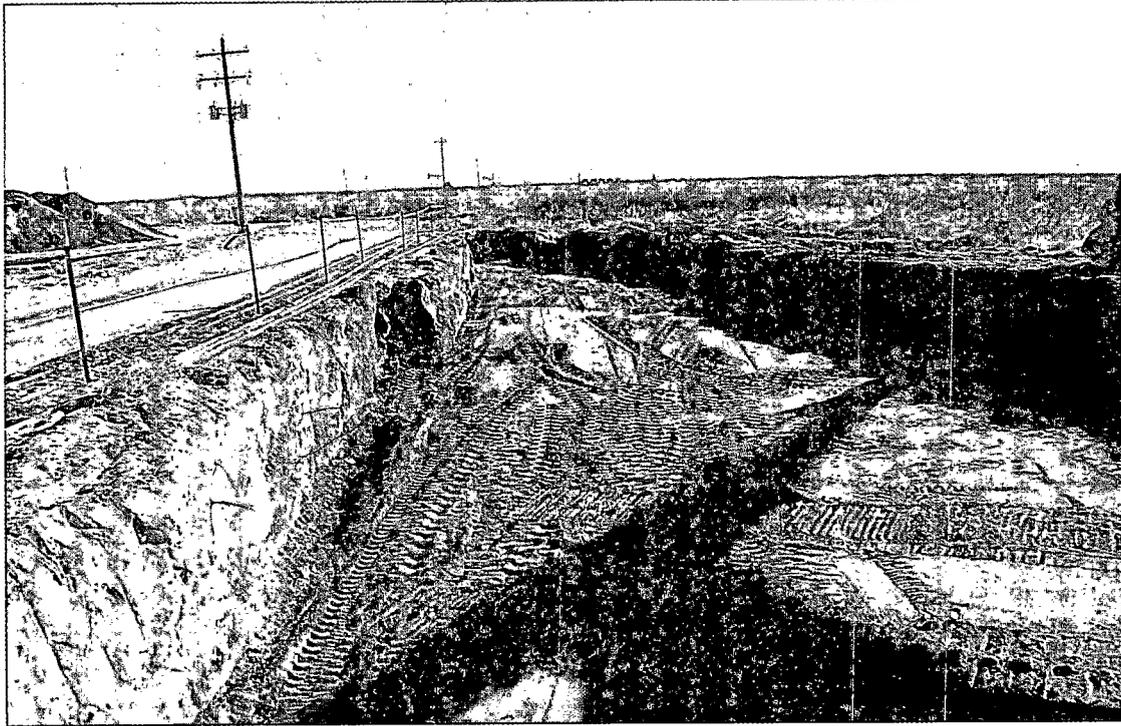
Poker Lake Unit #108 Flowline - South Excavation (Looking South)

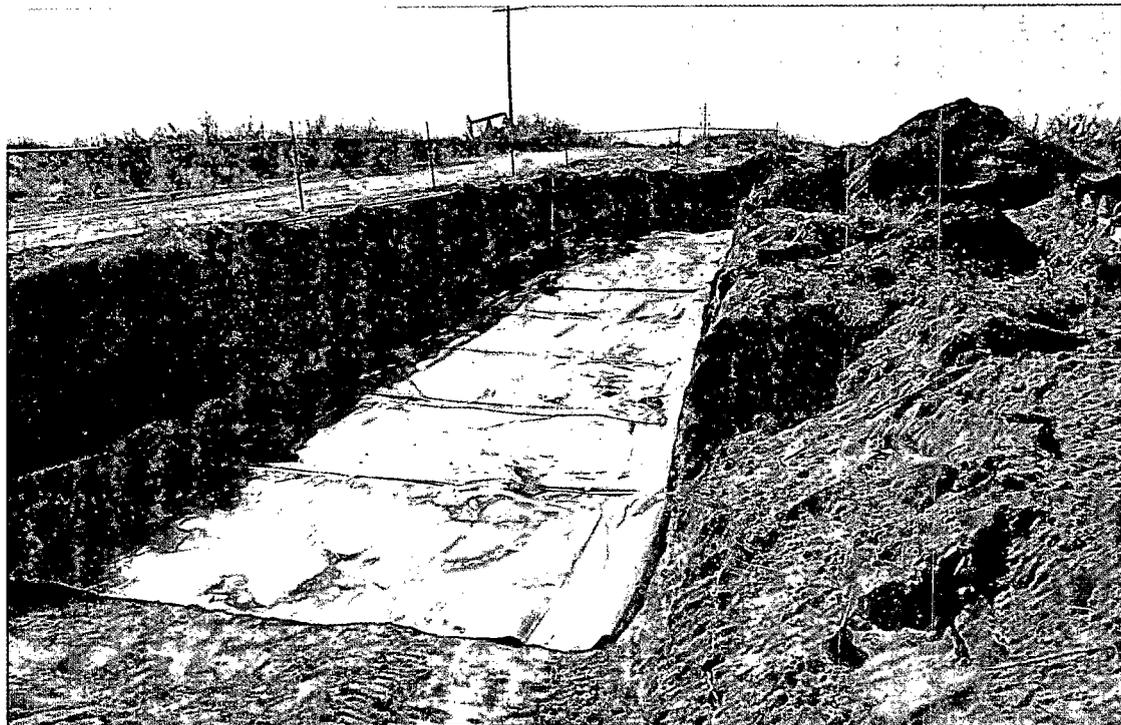
Poker Lake Unit #108 Flowline - Liner Installation, North Excavation

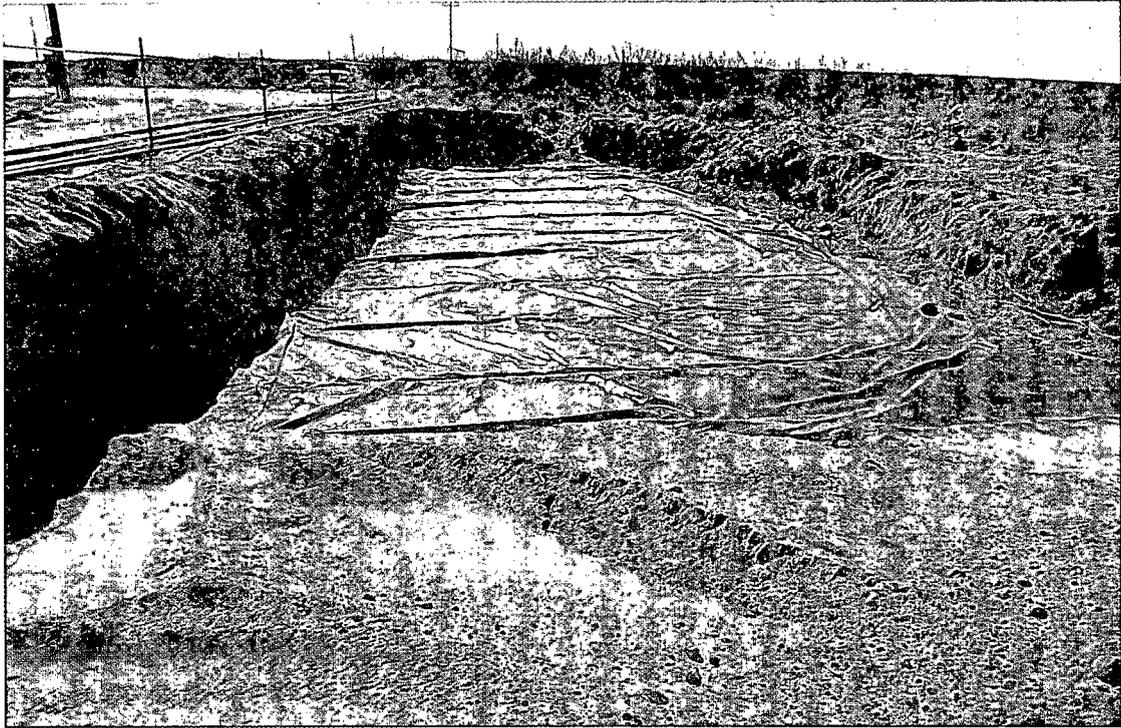
Poker Lake Unit #108 Flowline - Liner Installation, South Excavation

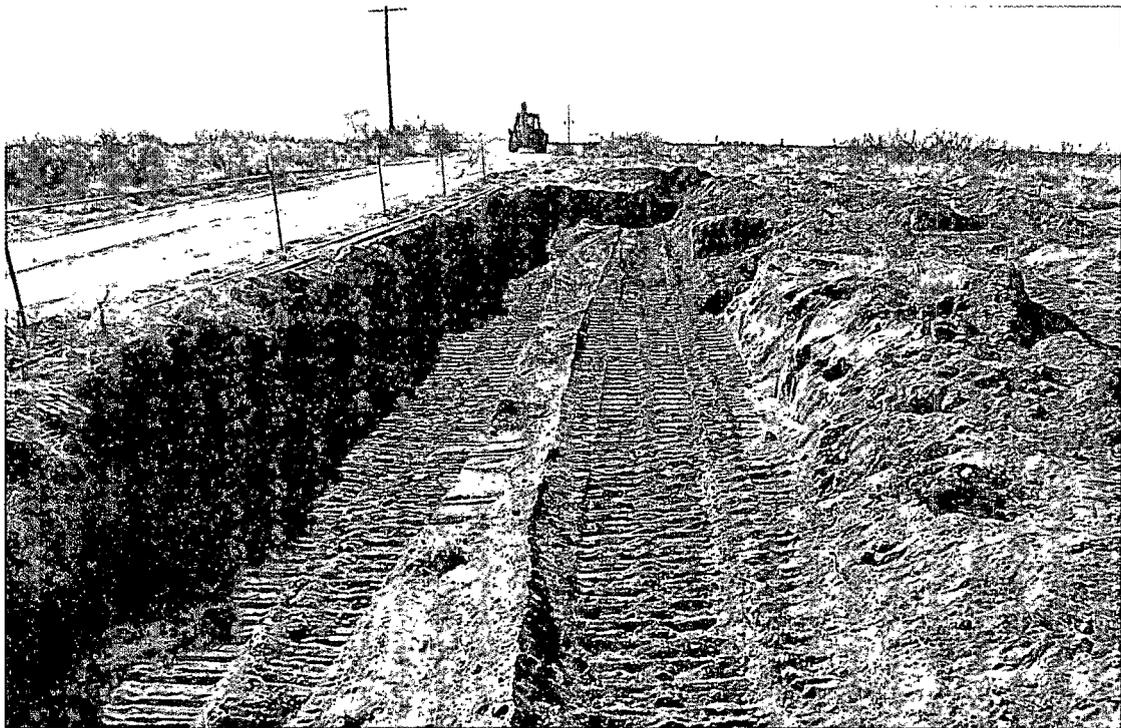
Poker Lake Unit #108 Flowline - North Excavation (Following Installation of Liner & Pad Sand)

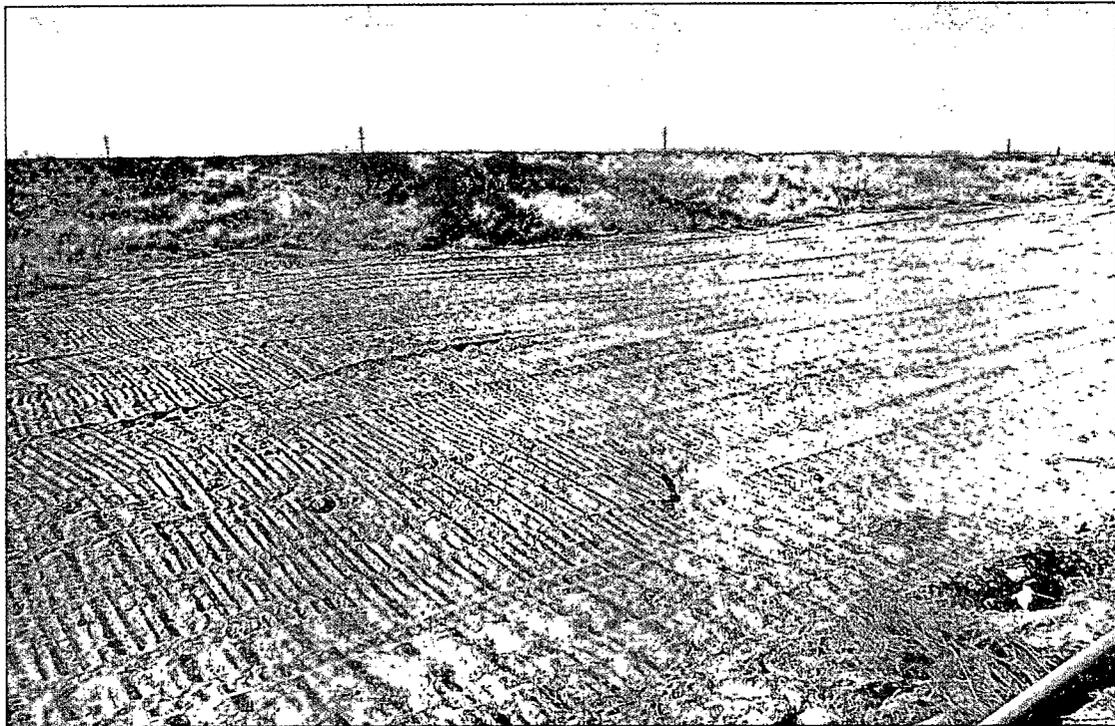
Poker Lake Unit #108 Flowline - North Excavation (Following Backfill, Looking Northwest)

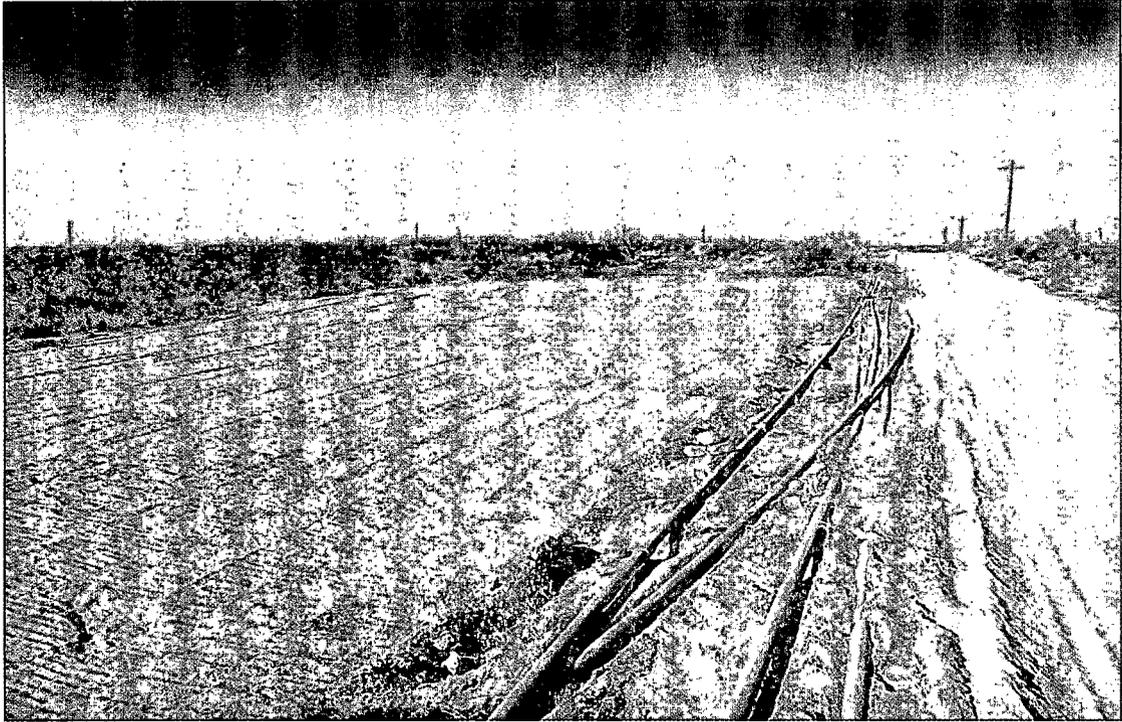
Poker Lake Unit #108 Flowline - South Excavation (Following Backfill, Looking North)
