REMEDIATION SUMMARY & RISK-BASED SITE CLOSURE REQUEST

**BOPCO, LP
POKER LAKE UNIT #79
Eddy County, New Mexico
Unit Letter "M" (SW/SW), Section 2, Township 25 South, Range 30 East
Latitude 32.154414° North, Longitude 103.857821° West**

July 2012

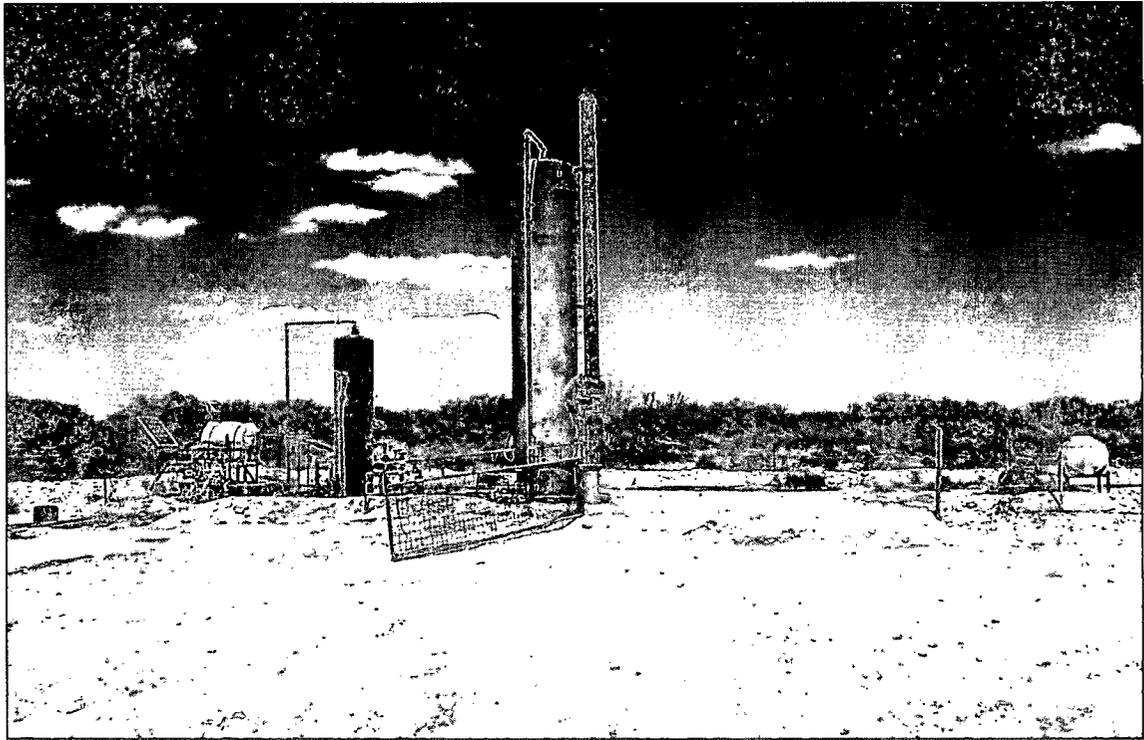
Poker Lake Unit #79 - Release Point

On May 2, 2011, BOPCO discovered a release had occurred at the PLU #79 tank battery. A gasket on a heater treater failed, resulting in the release of a mixture of produced water and crude oil. During initial response activities, the heater treater was isolated, and the gasket was replaced.

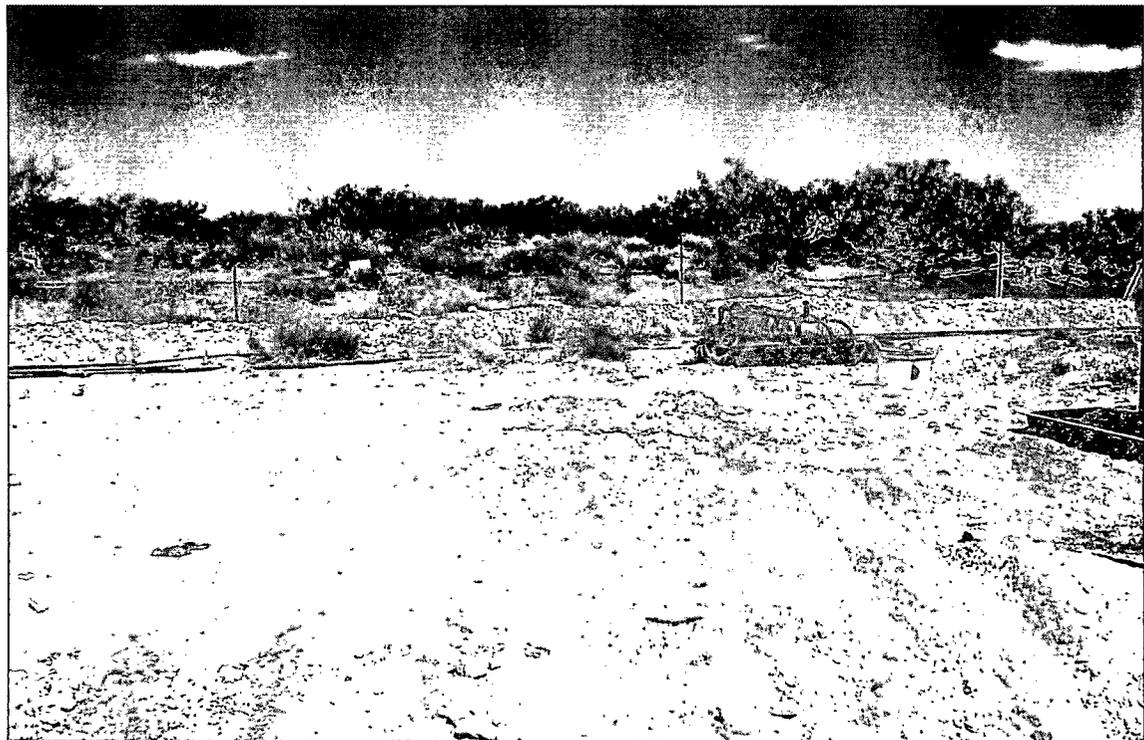
Poker Lake Unit #79 - Soil Boring SB-1

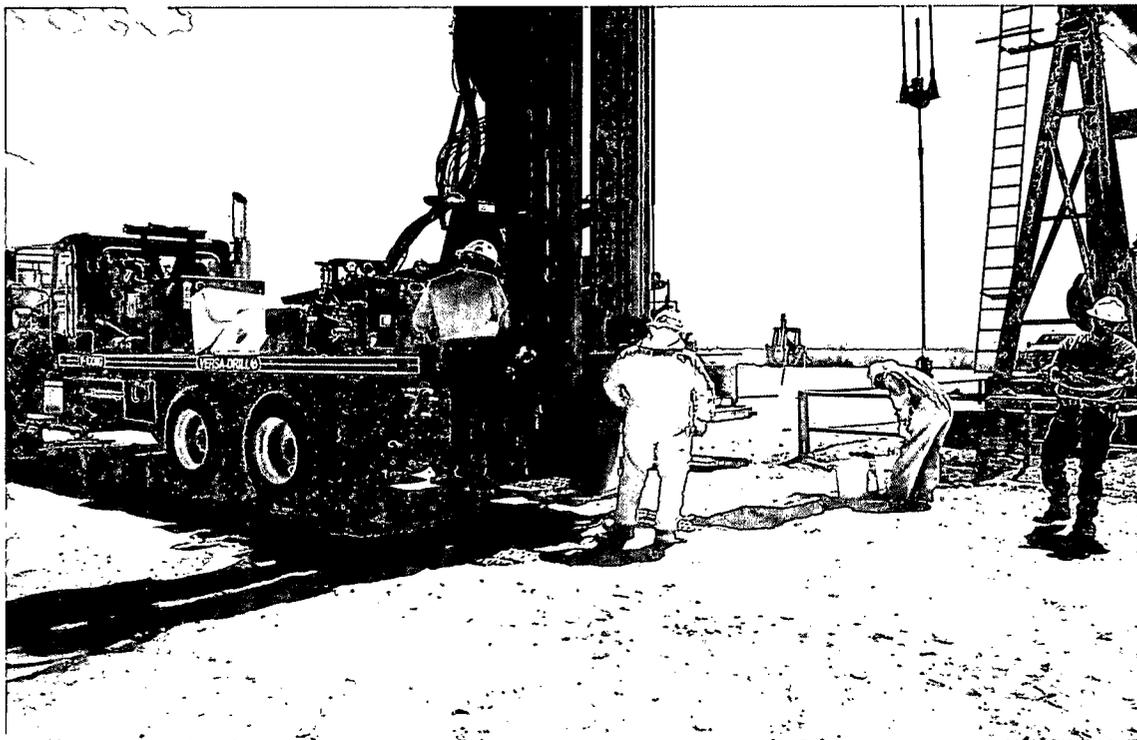
Poker Lake Unit #79 - Advancement of Soil Boring SB-2

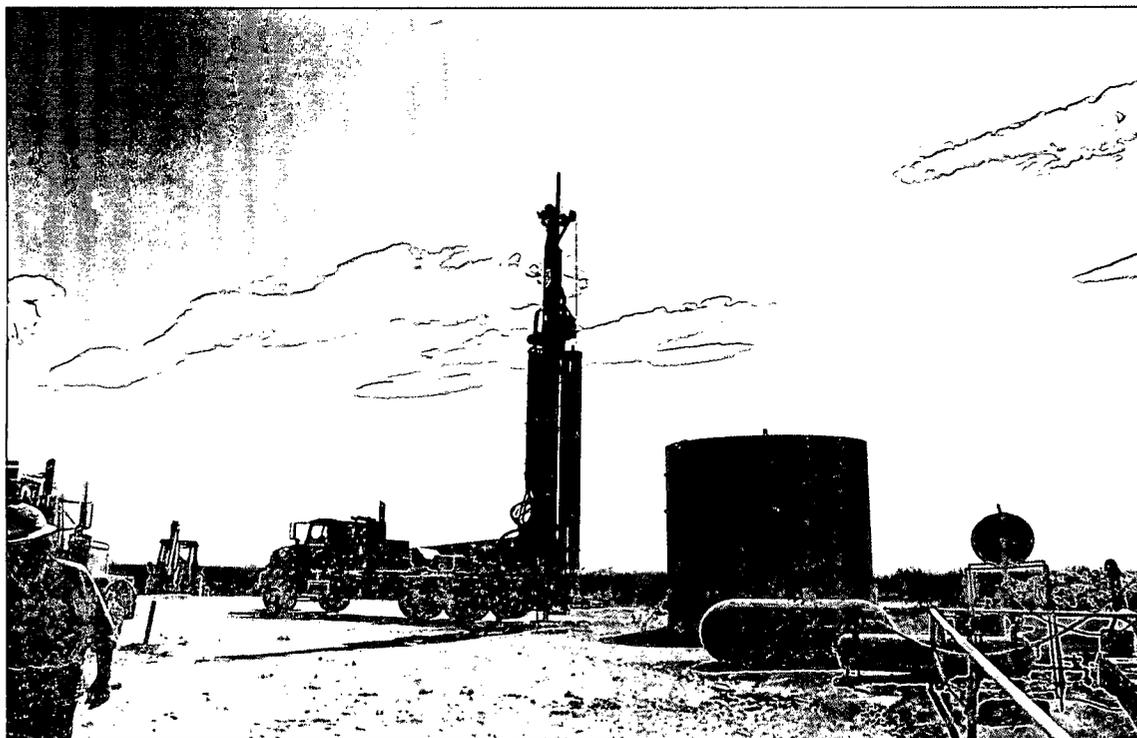
Poker Lake Unit #79 - Advancement of Soil Boring SB-3

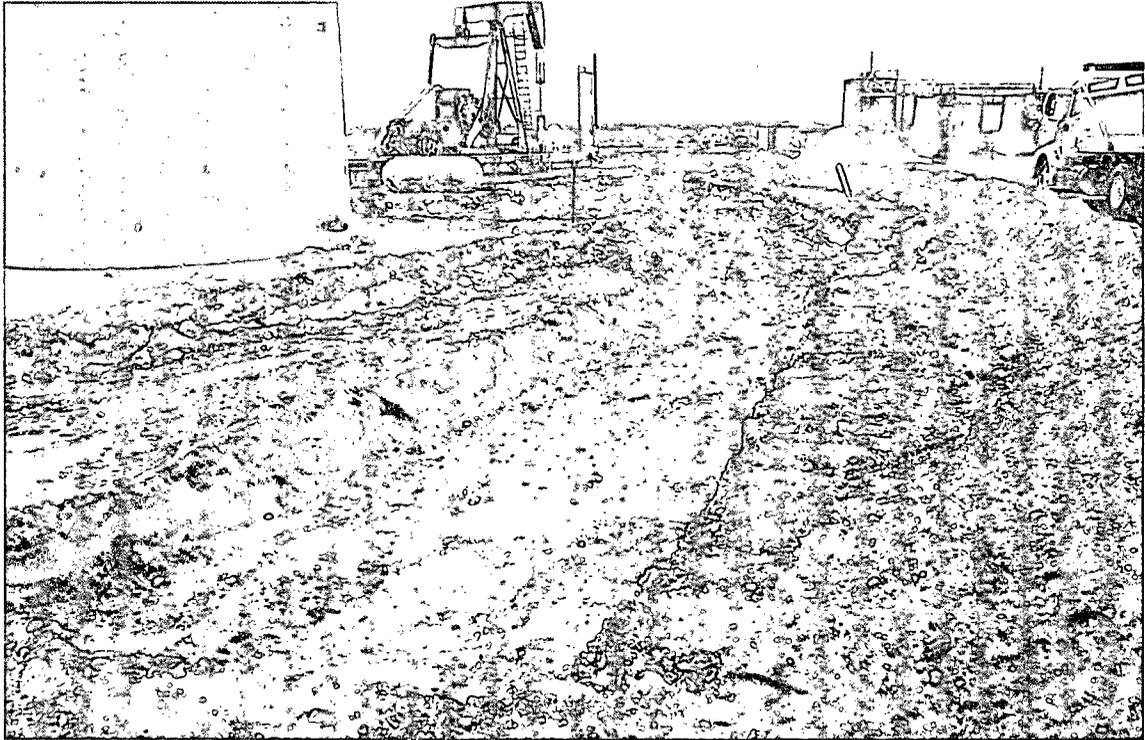
Poker Lake Unit #79 - Excavation 1 (Looking East-northeast)

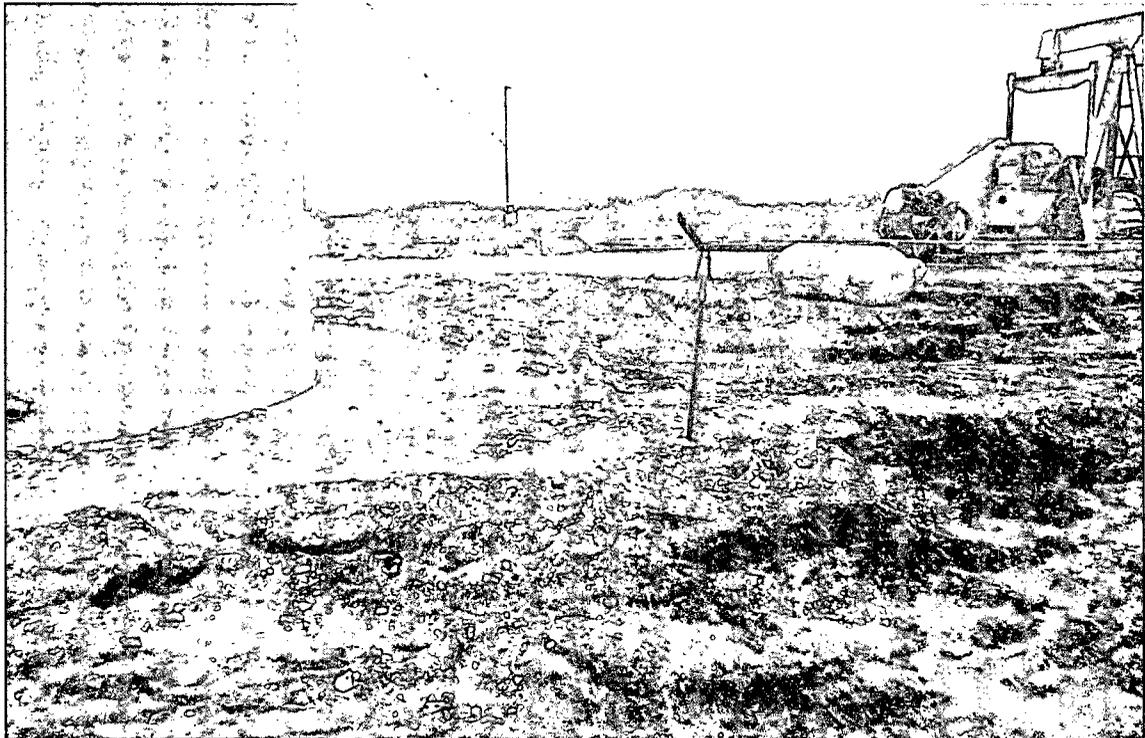
Poker Lake Unit #79 - Excavation 1 (Looking North-northeast)

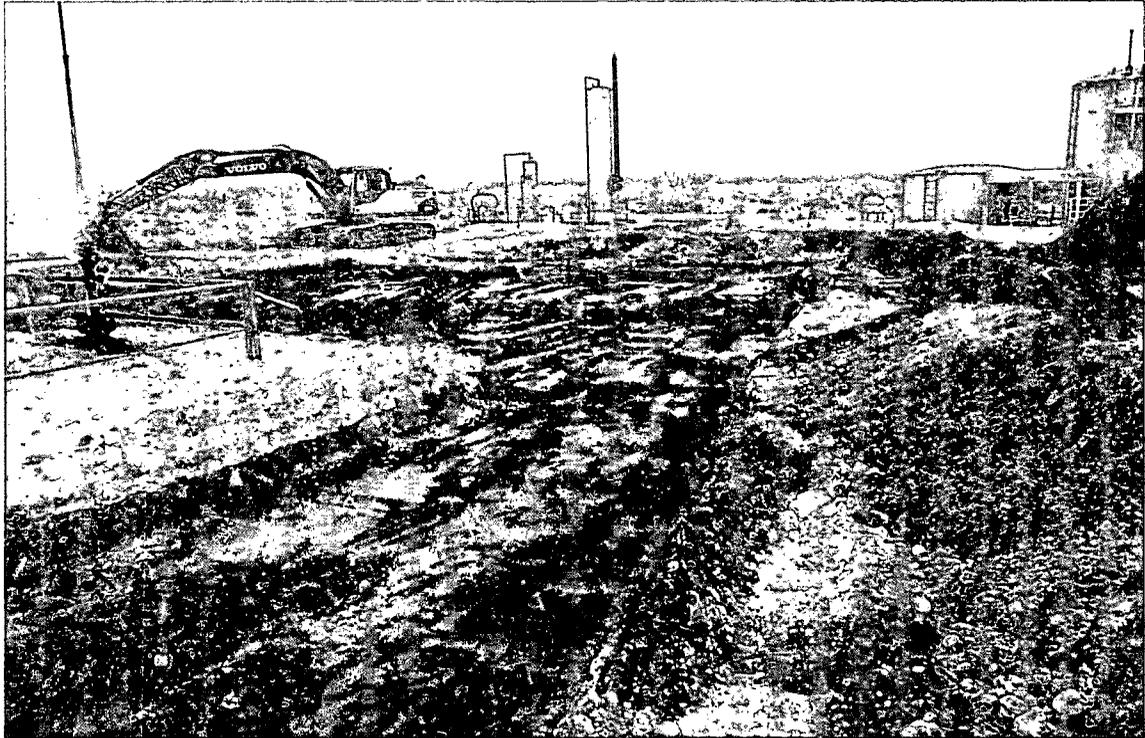
Poker Lake Unit #79 - Excavation 1 (Looking East-northeast)

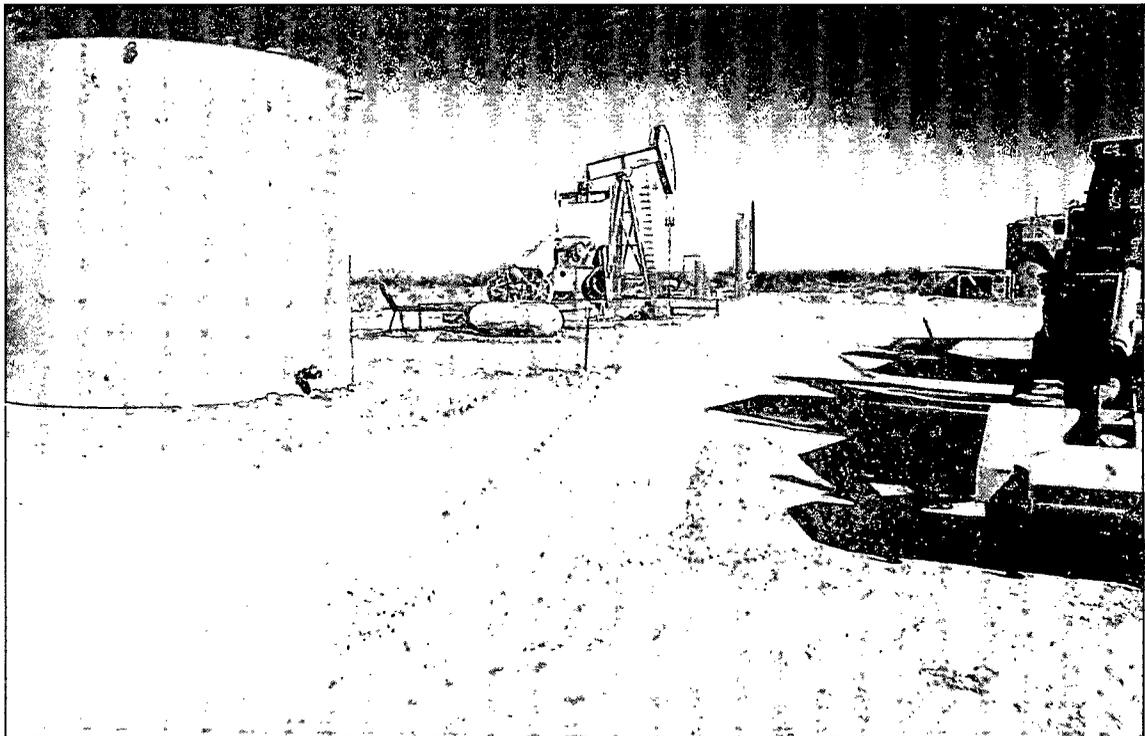
Poker Lake Unit #79 - Excavation 1, Following Backfill (Looking Northeast)

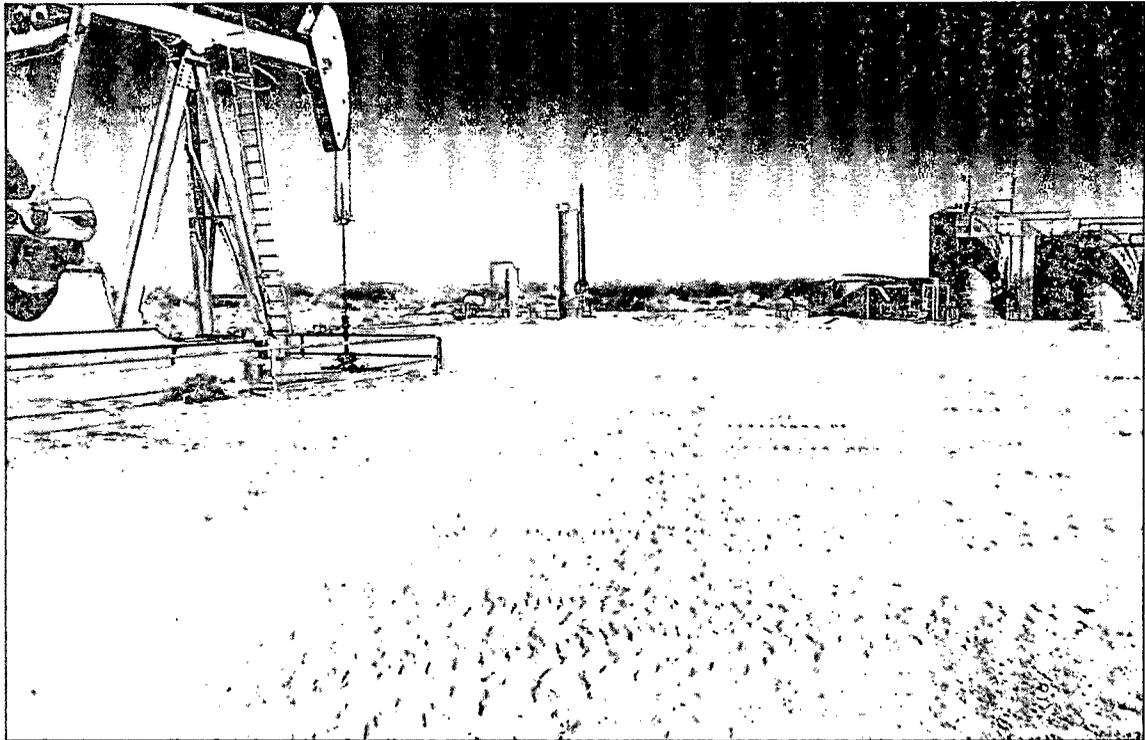
Poker Lake Unit #79 - Excavation 1, Following Backfill (Looking Northeast)

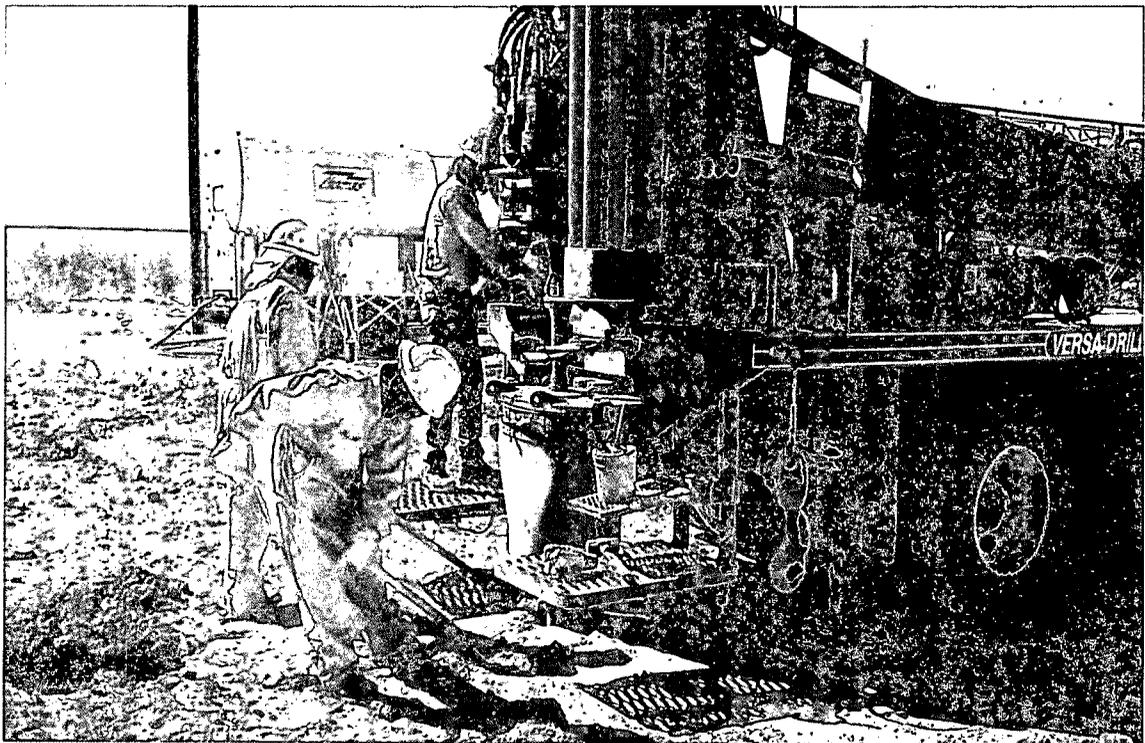
Poker Lake Unit #79 - Advancement of Soil Boring SB-5

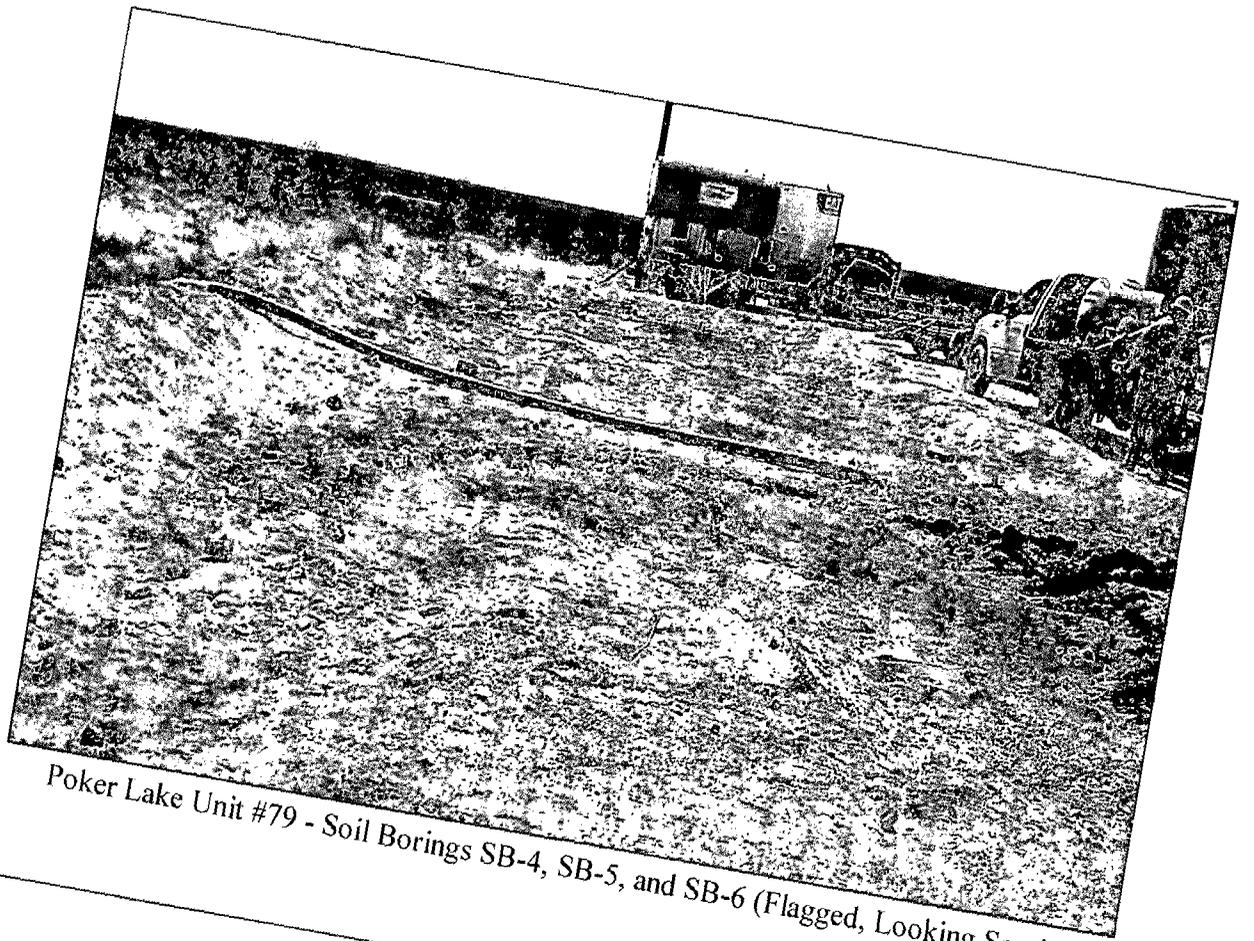
Poker Lake Unit #79 - Soil Borings SB-4, SB-5, and SB-6 (Flagged, Looking South)

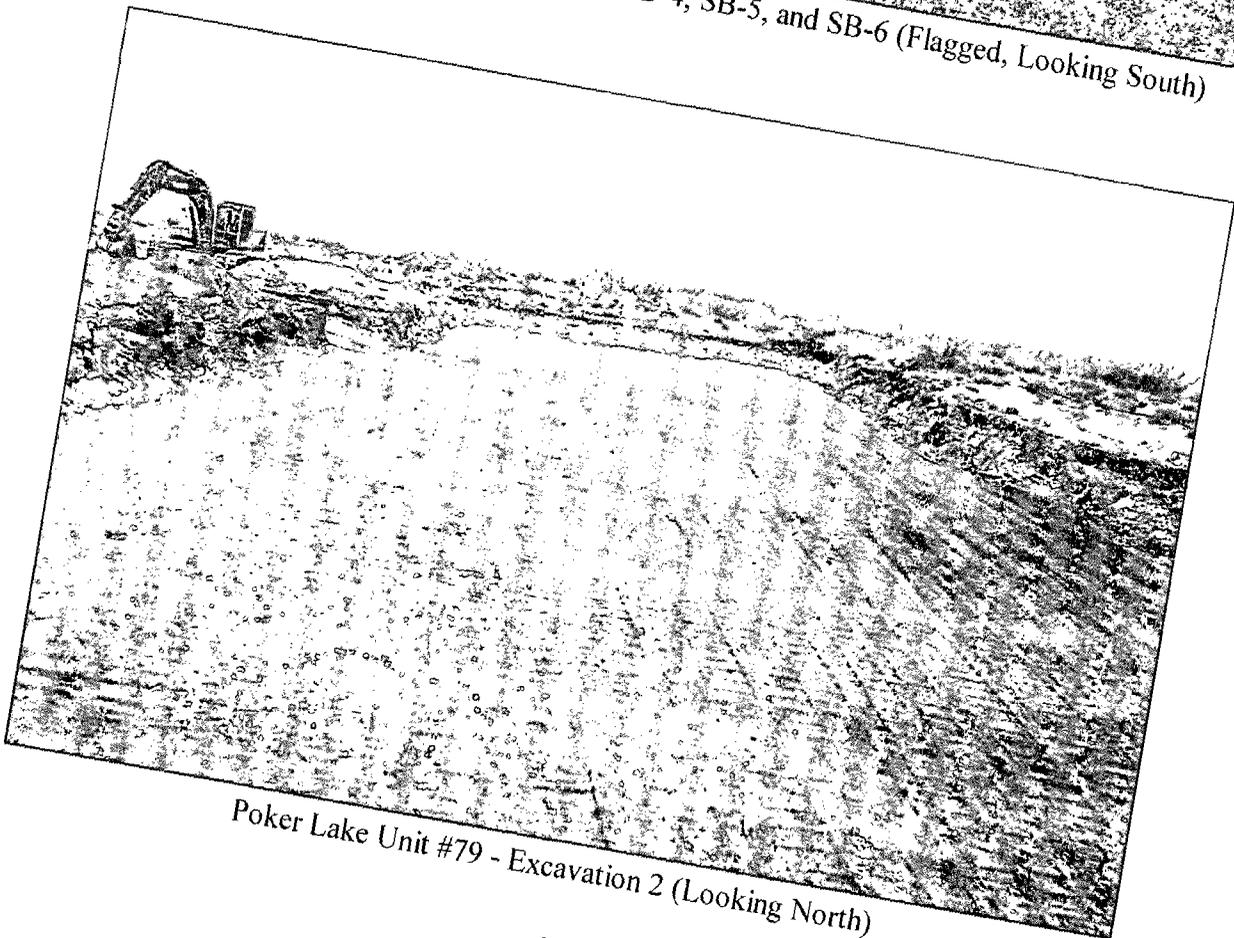
Poker Lake Unit #79 - Excavation 2 (Looking North)

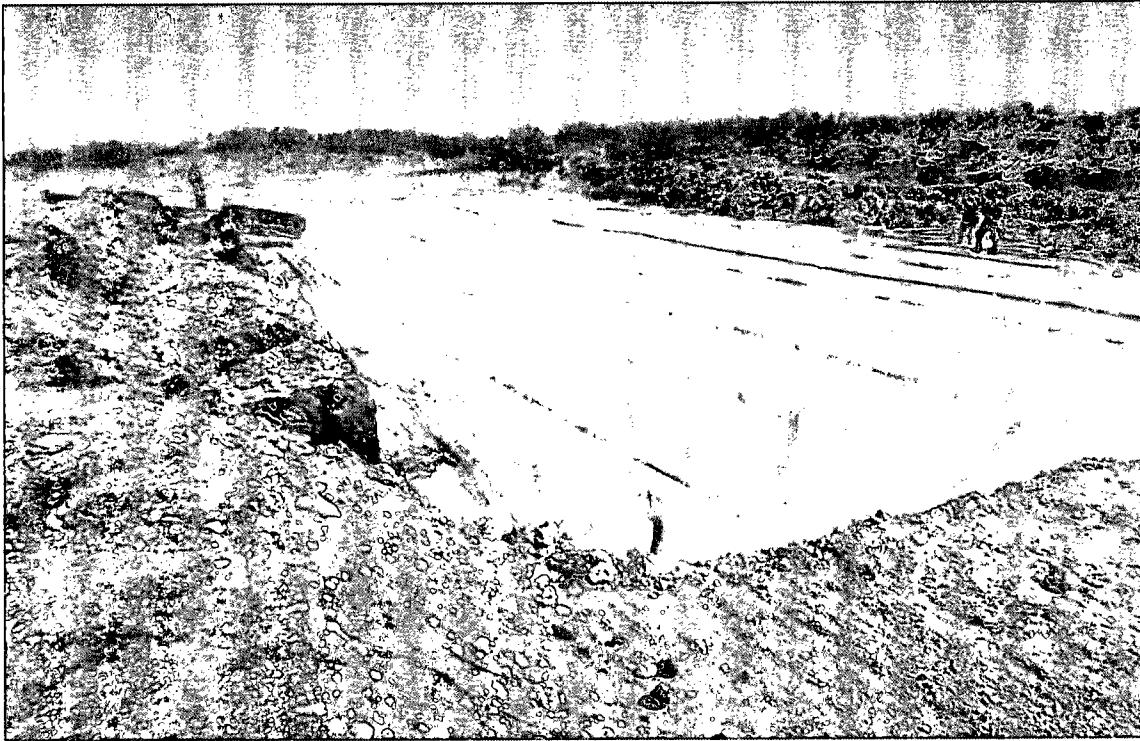
Poker Lake Unit #79 - Excavation 2, Liner Installation (Looking Northeast)

On April 2, 2012, a twenty (20) mil polyurethane liner was installed in the floor of Excavation 2 at approximately five feet (5') bgs. Approximately six inches (6") of non-impacted pad sand was installed both above and below the liner to protect the liner from damage during installation and backfilling activities.

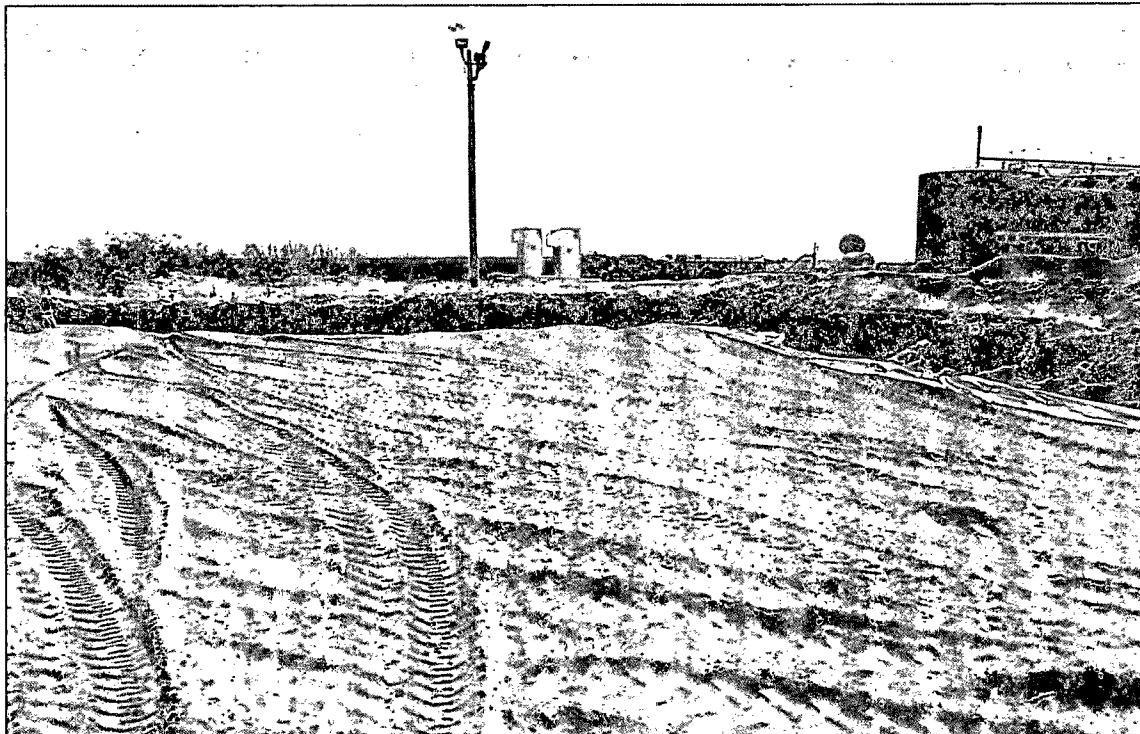
Poker Lake Unit #79 - Excavation 2, Pad Sand Installation (Looking South-southwest)

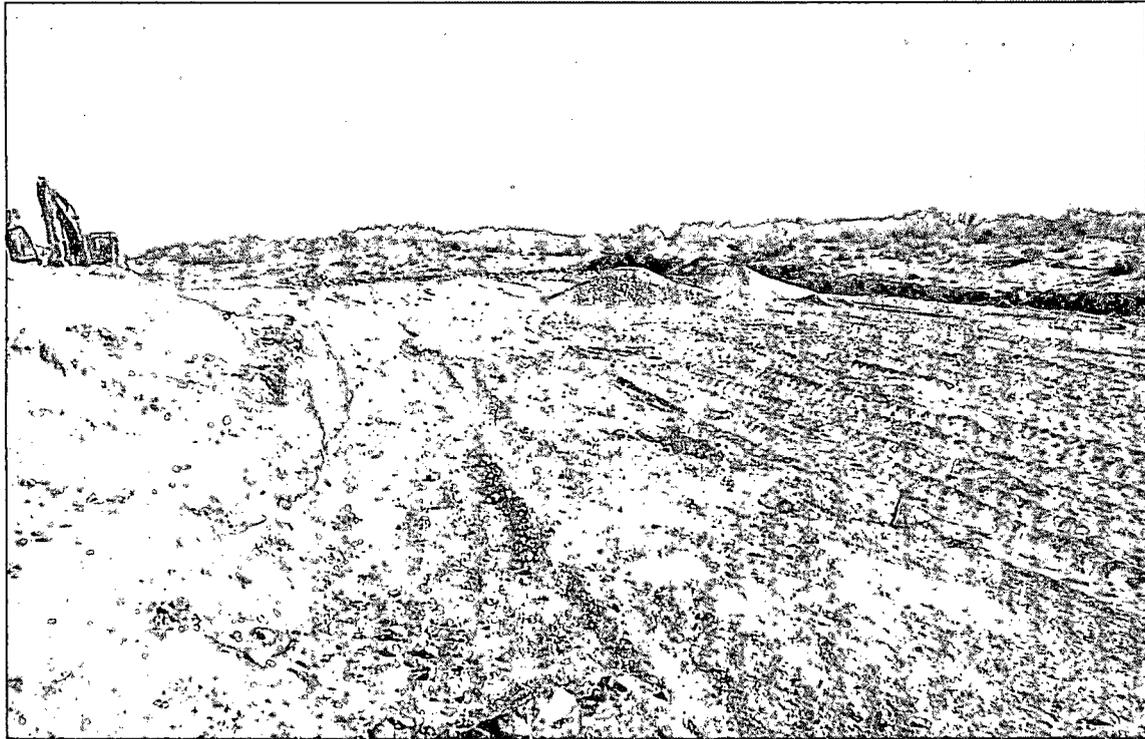
Poker Lake Unit #79 - Excavation 2, Backfilling Activities (Looking North-northeast)

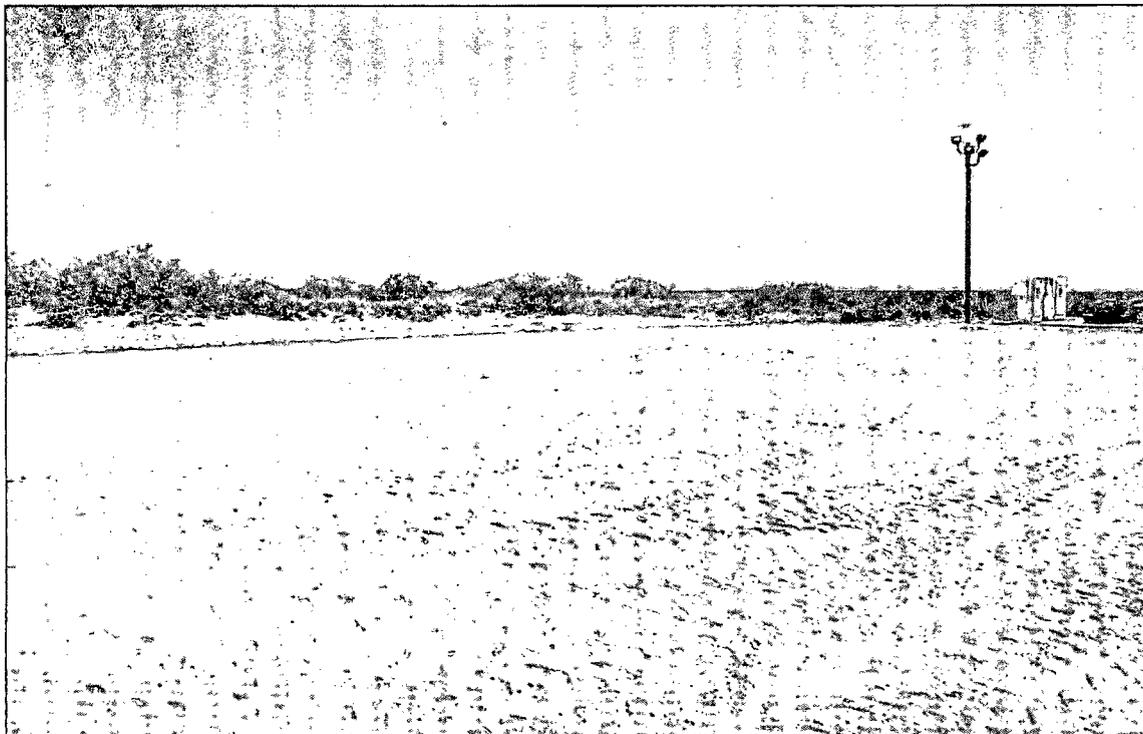
Poker Lake Unit #79 - Excavation 2, Following Backfill (Looking Southeast)
