REMEDIATION SUMMARY AND RISK-BASED SITE CLOSURE REQUEST

BOPCO, LP
POKER LAKE UNIT #183 FLOW LINE
Eddy County, New Mexico
Unit Letter "O" (SW/SE), Section 6, Township 24 South, Range 30 East
Latitude 32.240774° North, Longitude 103.918504° West
NMOCD Reference #2RP-_____

March 2014

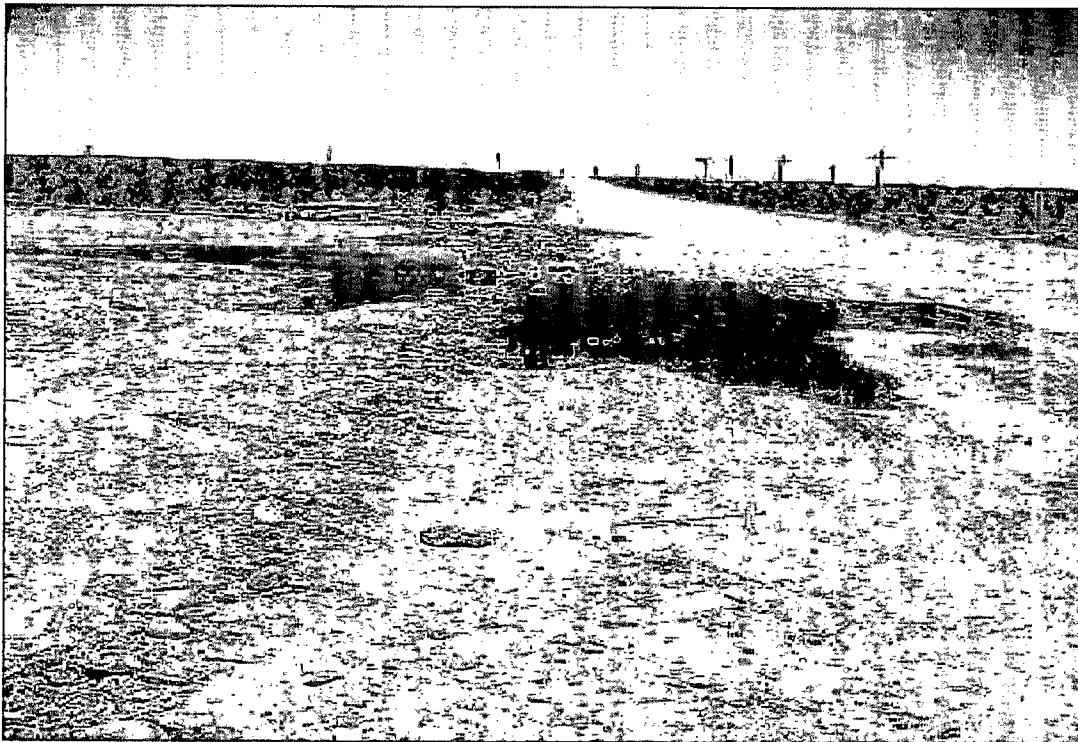
On September 2, 2012, BOPCO discovered a release had occurred on the PLU #183 flow line. The release was attributed to external corrosion. The "Release Notification and Corrective Action" (Form C-141) indicated approximately three barrels (3 bbls) of crude oil and five barrels (5 bbls) of produced water were released, affecting approximately two hundred square feet (200 ft²) of lease road. During initial response activities, approximately three barrels (3 bbls) of fluid was recovered and the saturated soil was removed from the road way and placed on a nearby well pad before being transported to an NMOCD-approved disposal facility. The affected section of pipeline has since been replaced. The Form C-141 is provided as Appendix A. General photographs of the release site are provided as Appendix B.

Photograph of the initial release at the PLU #183 Flow Line Release Site.

The 2 7/8 inch flow developed a leak due to external corrosion. A temporary leak clamp was installed on the pipe.

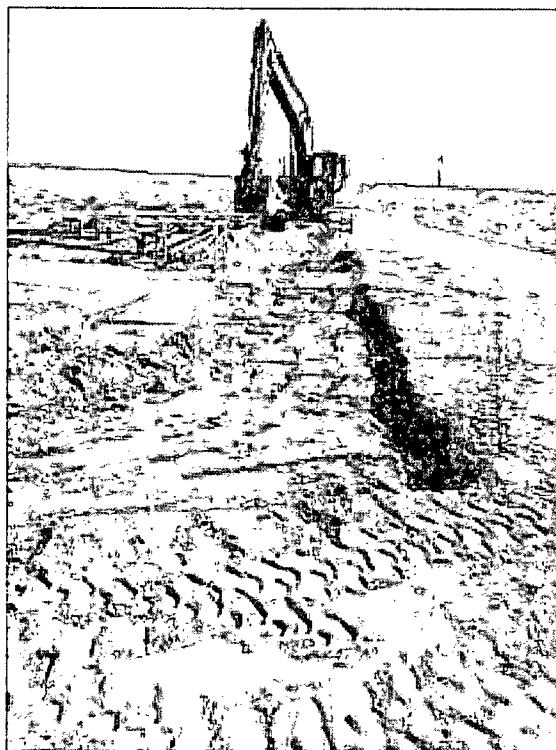
Photograph of excavation activities at the PLU #183 Flow Line Release Site.

On February 20, 2014, Basin began excavating impacted soil at the release site. The floor and sidewalls of the excavation were advanced until field tests suggested concentrations of benzene, toluene, ethylbenzene and xylene (BTEX), total petroleum hydrocarbons (TPH) and chloride were less than NMOCD Regulatory Standards. Excavated material was stockpiled on-site, pending final disposition.
