3R-1011

**Release Report/ General
Correspondence**

Enterprise SJ

Enterprise Products
Katherine Pierce #1 Well Tie Pipeline Release
Latitude North 36.78854°, Longitude West -108.06425°
Unit B Section 26 T30N R12W
San Juan County, New Mexico
July 16, 2014

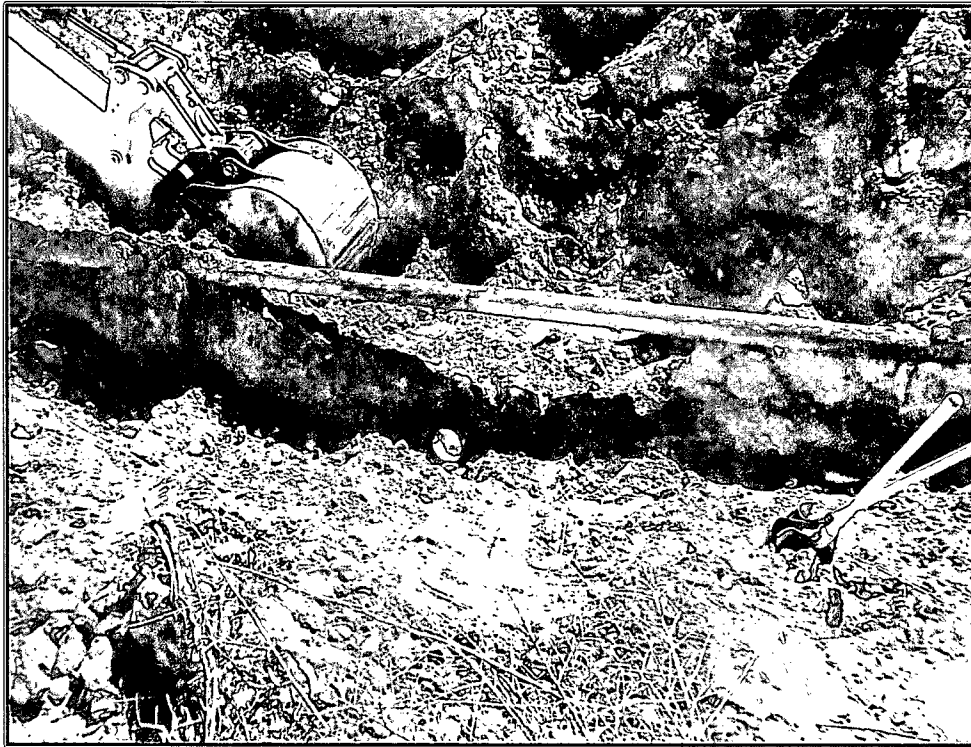
Photo 1: Excavation below the Katherine Pierce #1 well tie pipeline; note the staining of the soils.

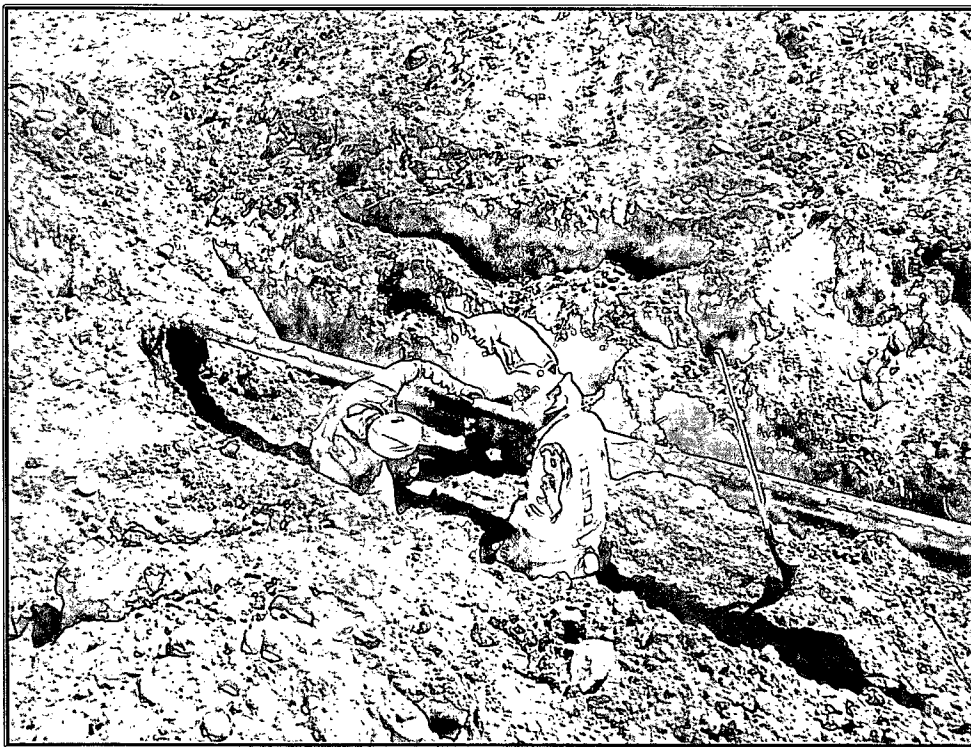
Photo 2: Inspection and repair activities of the Katherine Pierce #1 well tie pipeline.

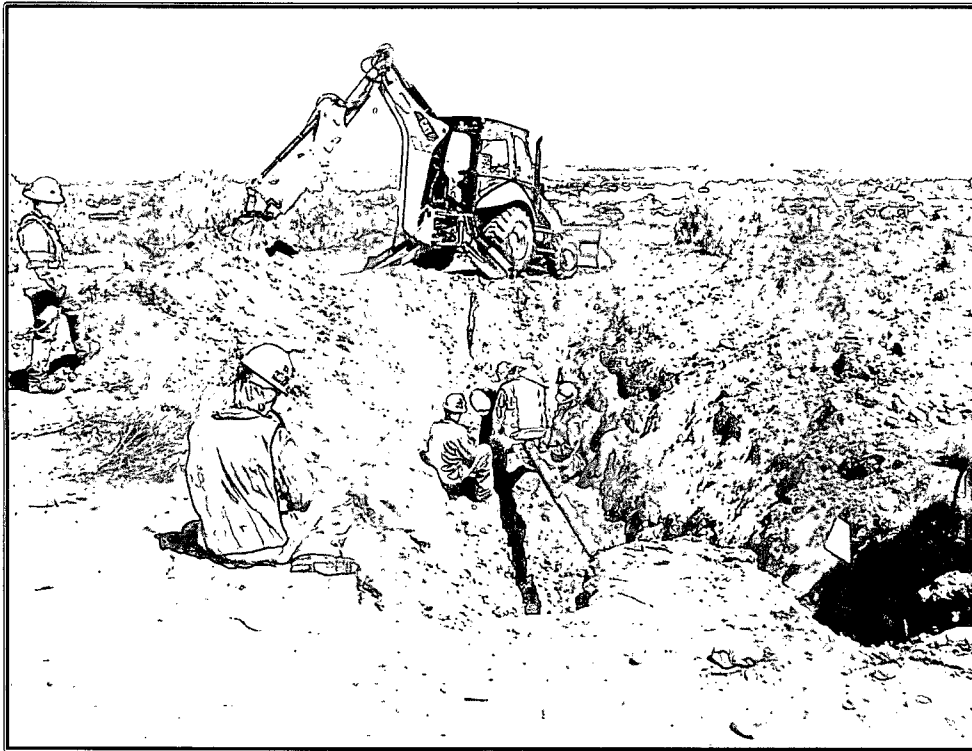
Photo 3: The actual location of the release point being determined by the pipeline contractor.

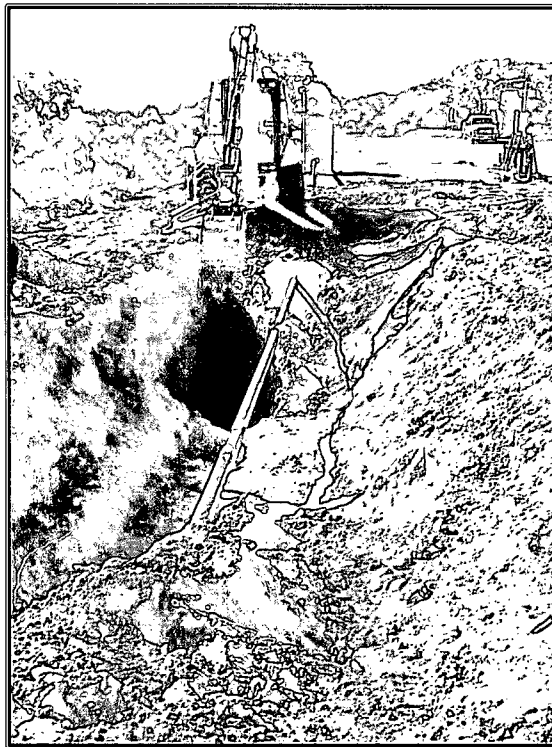
Photo 4: The final excavation of the well tie release after pipeline repair was complete.

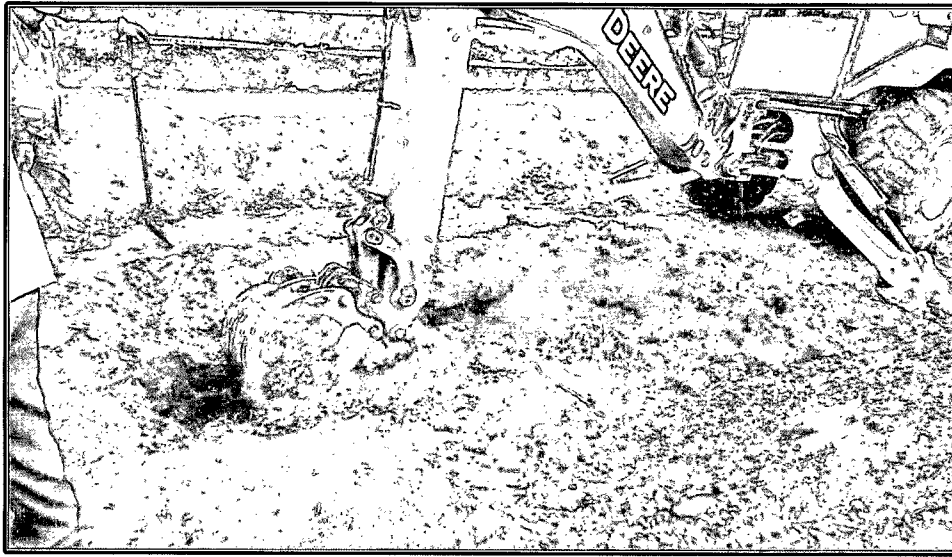
Photo 1: Beginning of excavation at the Lateral O-17 pipeline release.

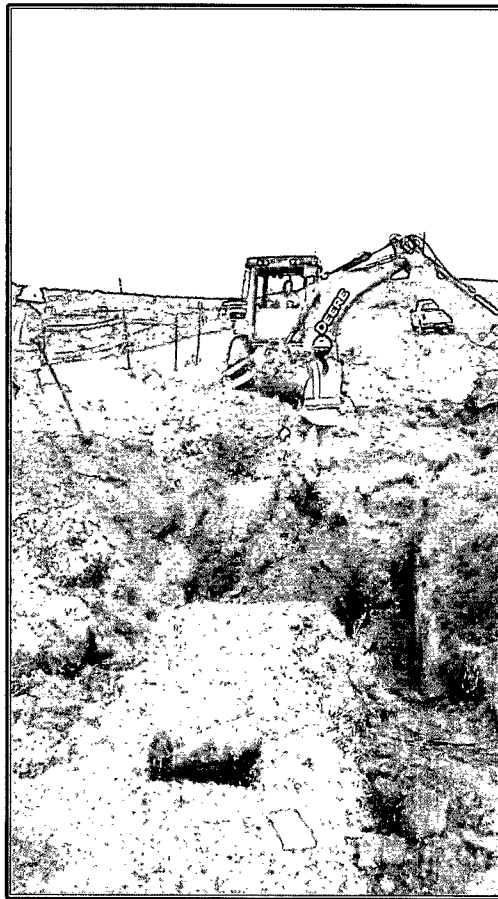
Photo 2: Exposing pipe nearing the release point at the Lateral O-17 release. Pothole visible in foreground.

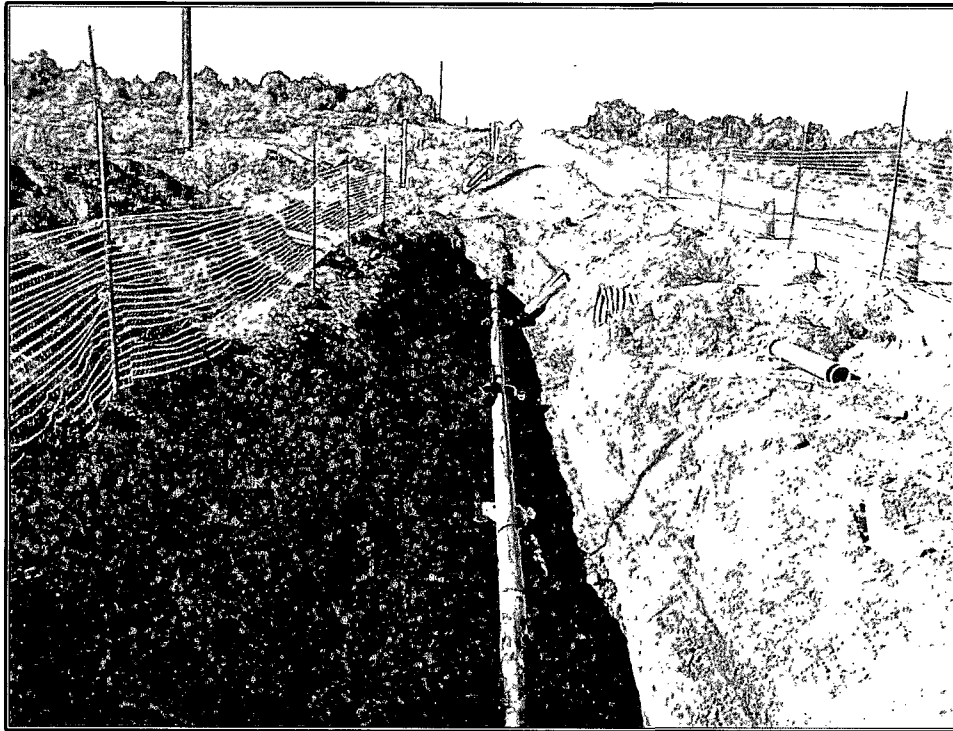
Photo 5: View of repairs completed, new segment in place.

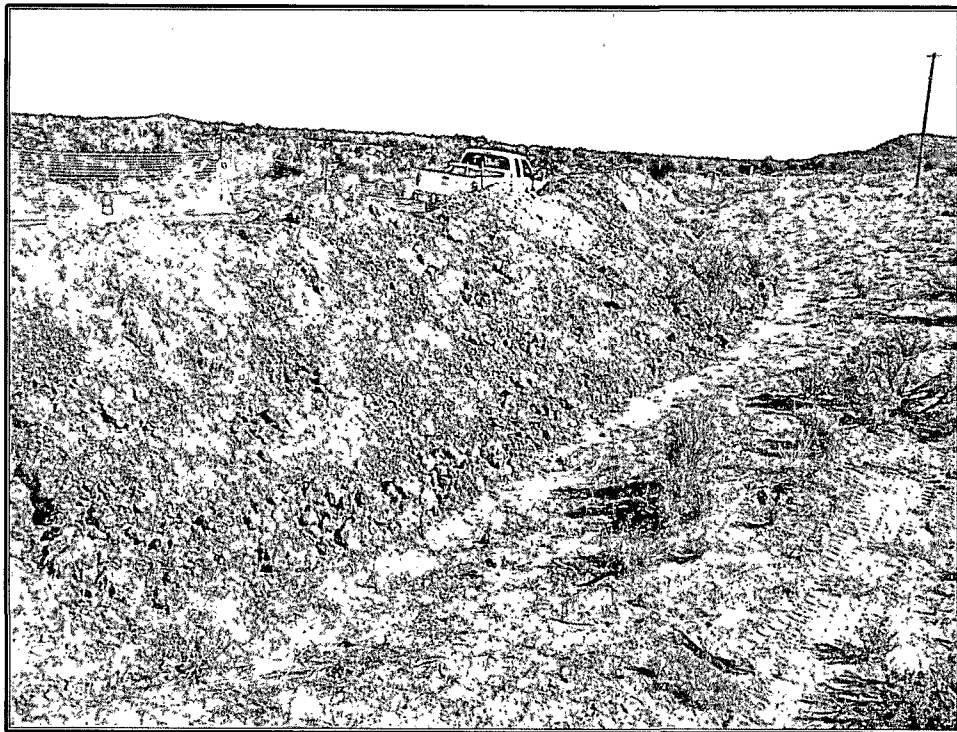
Photo 6: View of stockpiled soil, purple paint marks segments between sample locations.

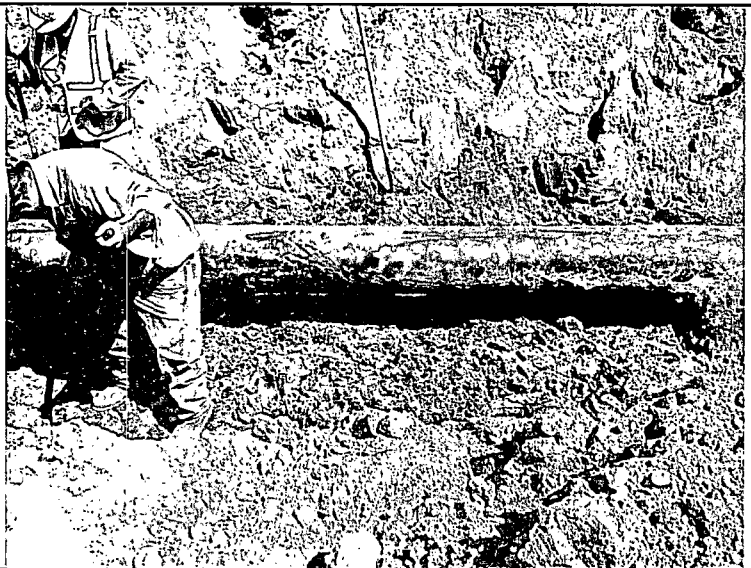
Photograph 3

View of the release point and initial excavation during corrective action activities, facing southeast.

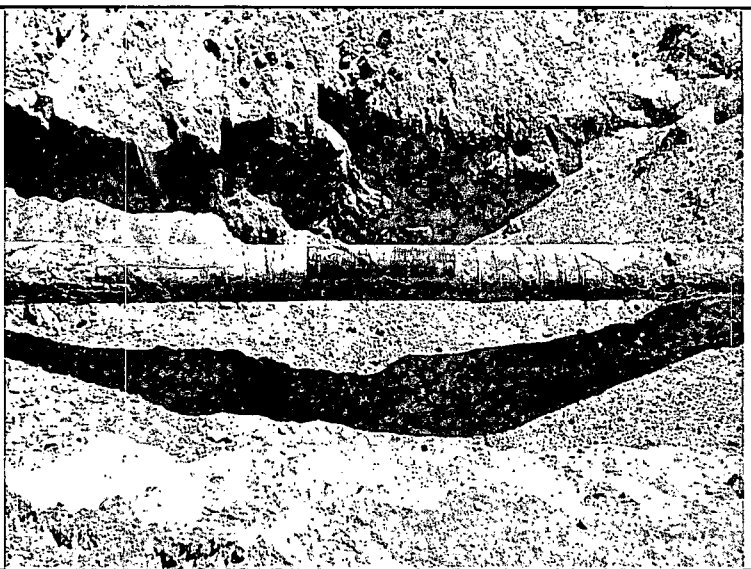
Photograph 4

View of over-excavation activities at the southwest wall subsequent to backfilling of initial excavation, facing northwest.

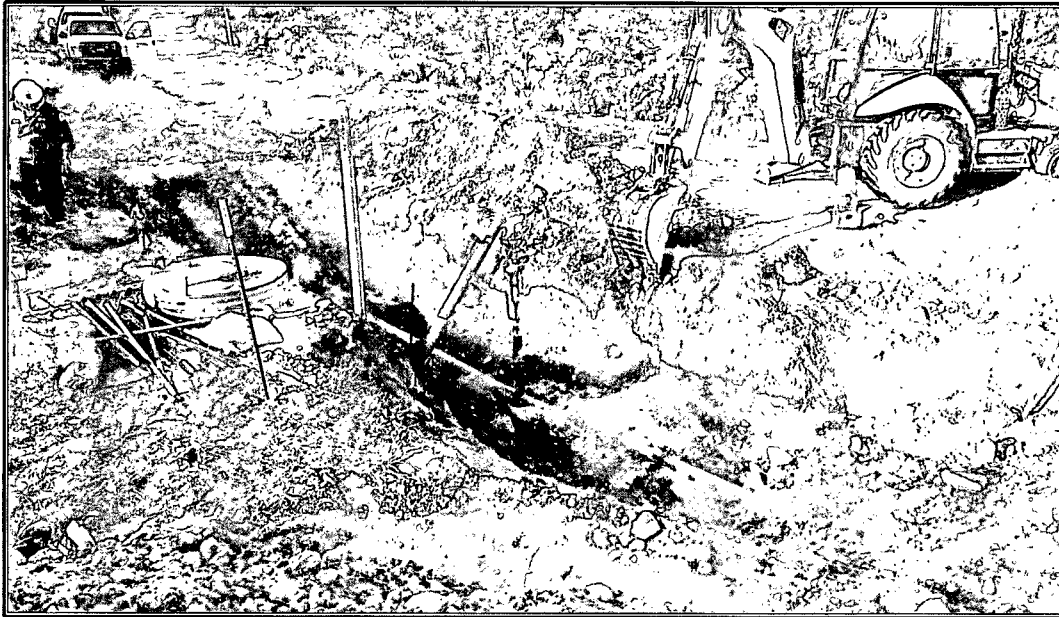
Photo 1: Beginning of excavation at the Lateral L-14A pipeline release at a depth of approximately 4' bgs. Strong odor present

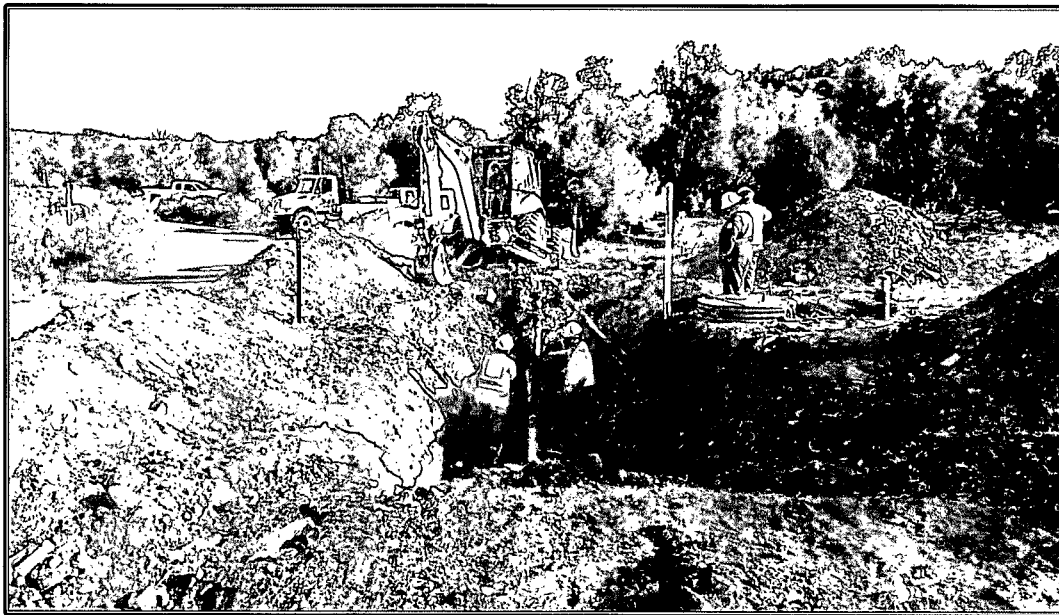
Photo 2: Monitoring air quality in excavation, Benzene levels stayed below PELs.

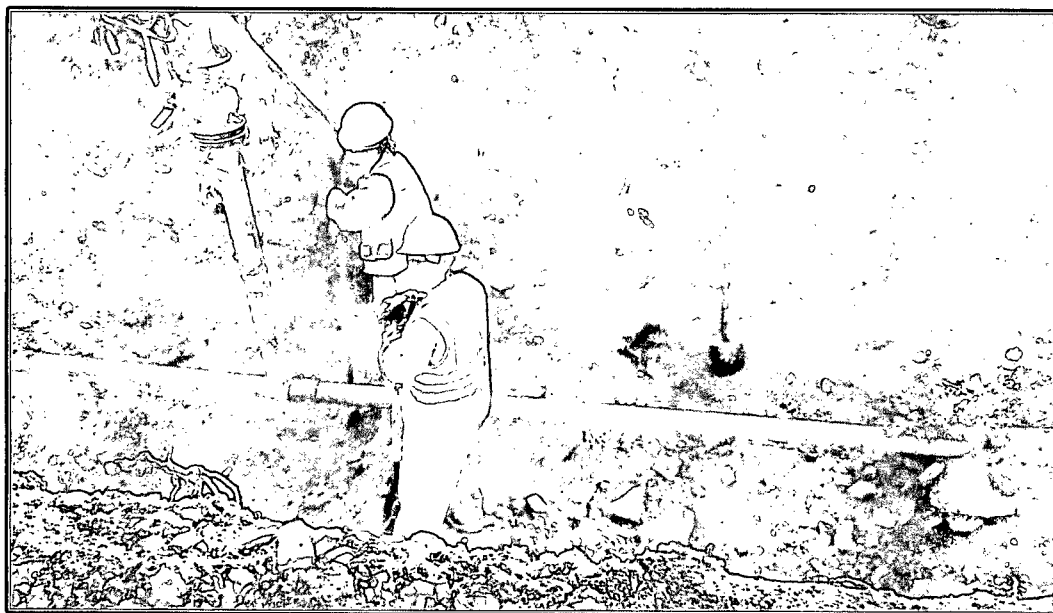
Photo 3: View of Conoco Phillips water line crossing under the pipeline.

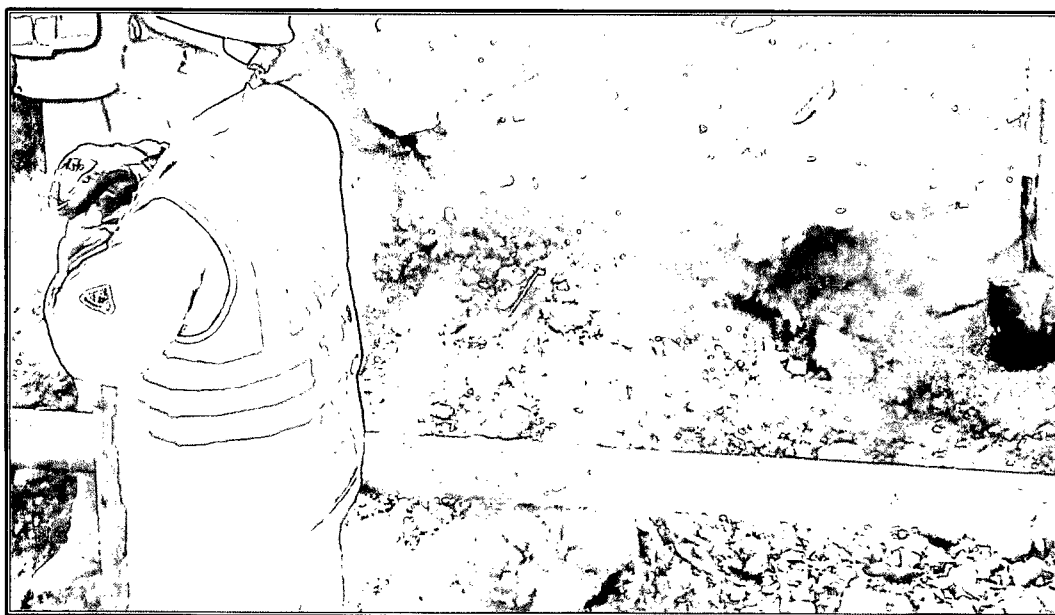
Photo 4: Close up of waterline, exposed in center of photograph.

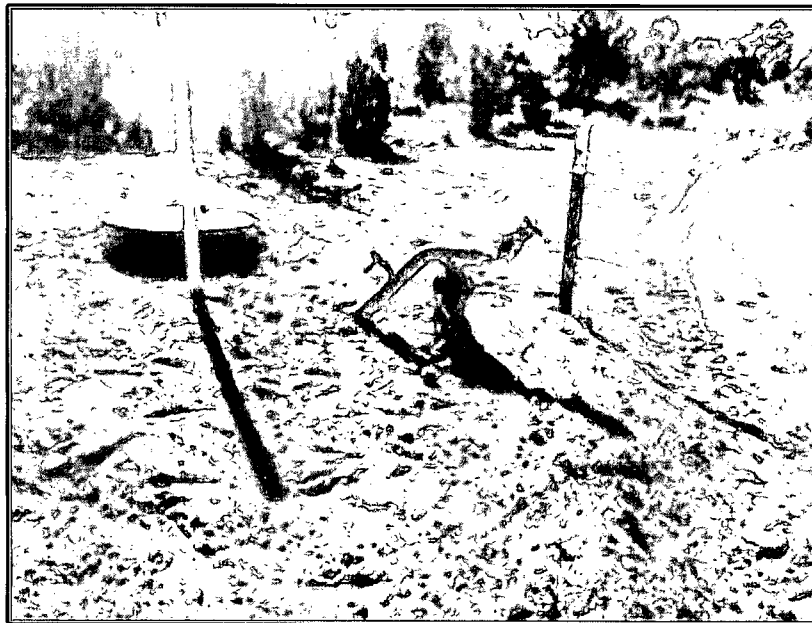
Photo 6: backfill complete.

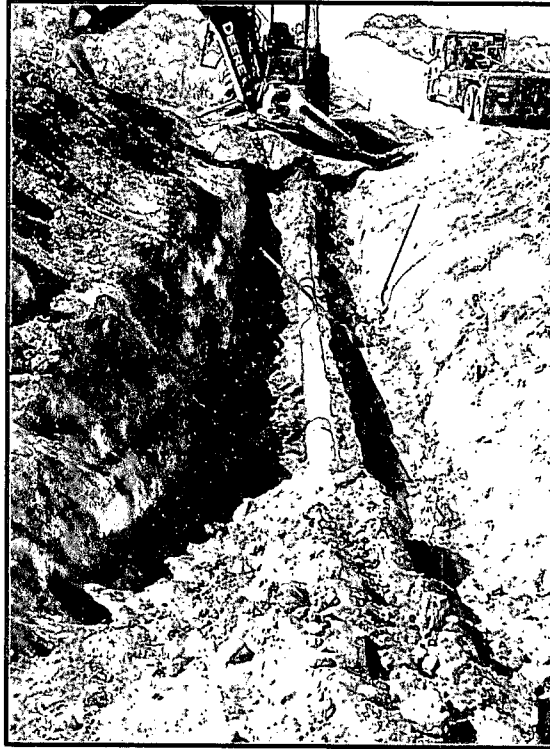
Photo 1: Lateral C-27 pipeline prior to repairs.

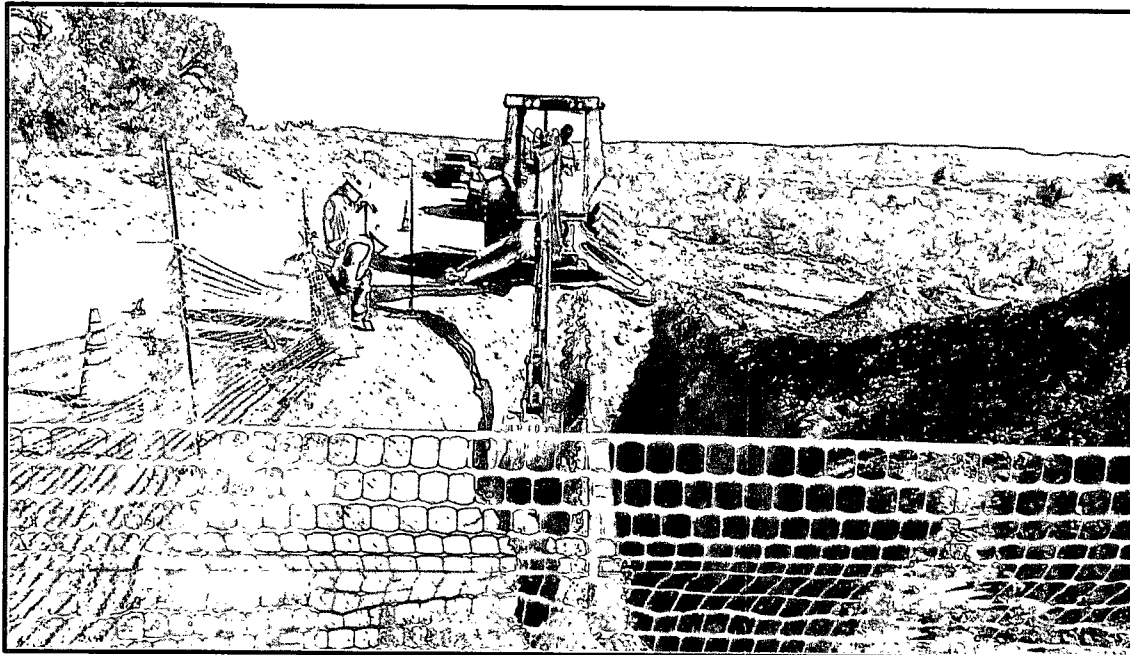
Photo 2: Lateral C-27 pipeline after repairs.

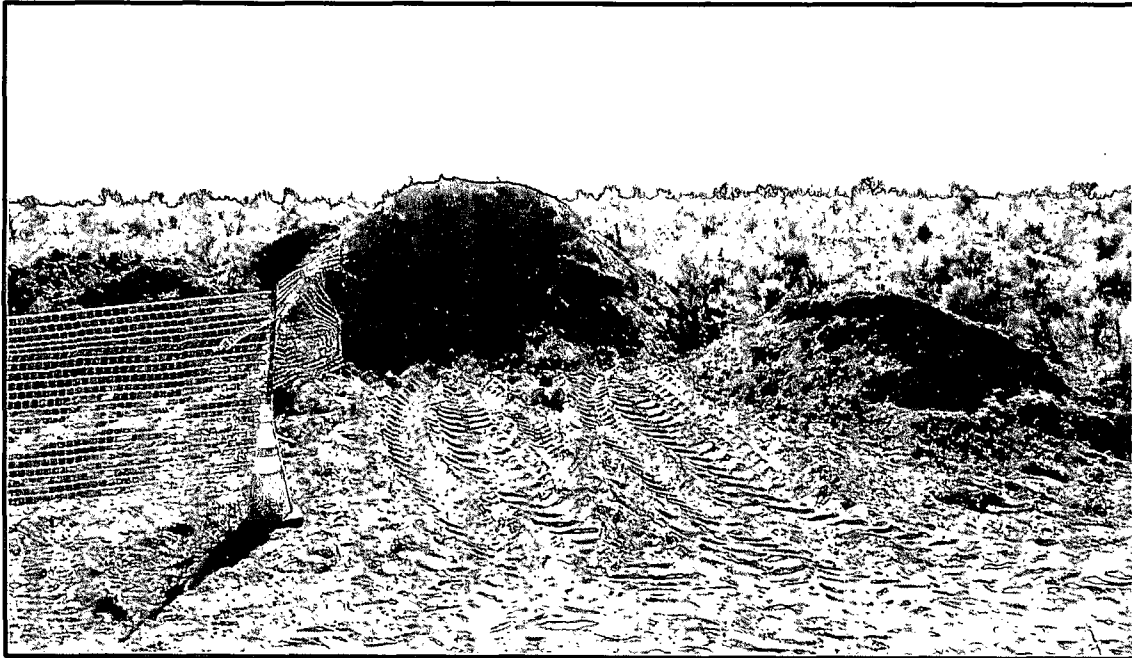
Photo 3: View of stockpiled soil at the Lateral C-27 pipeline release site.

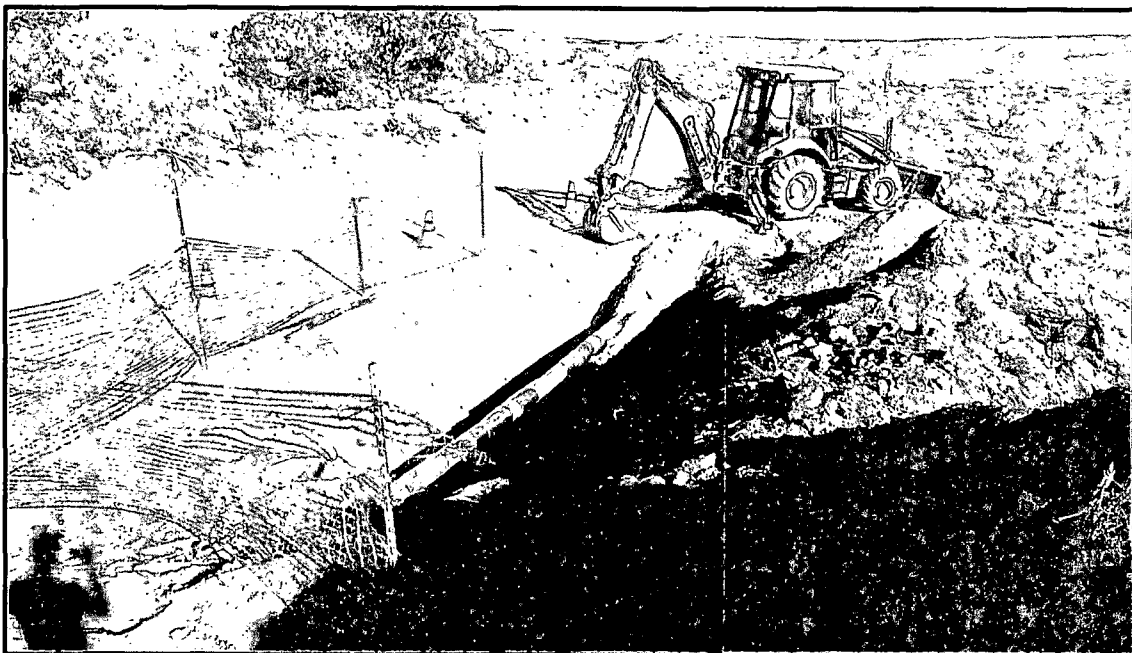
Photo 4: View of Lateral C-27 pipeline excavation at its fullest extent.

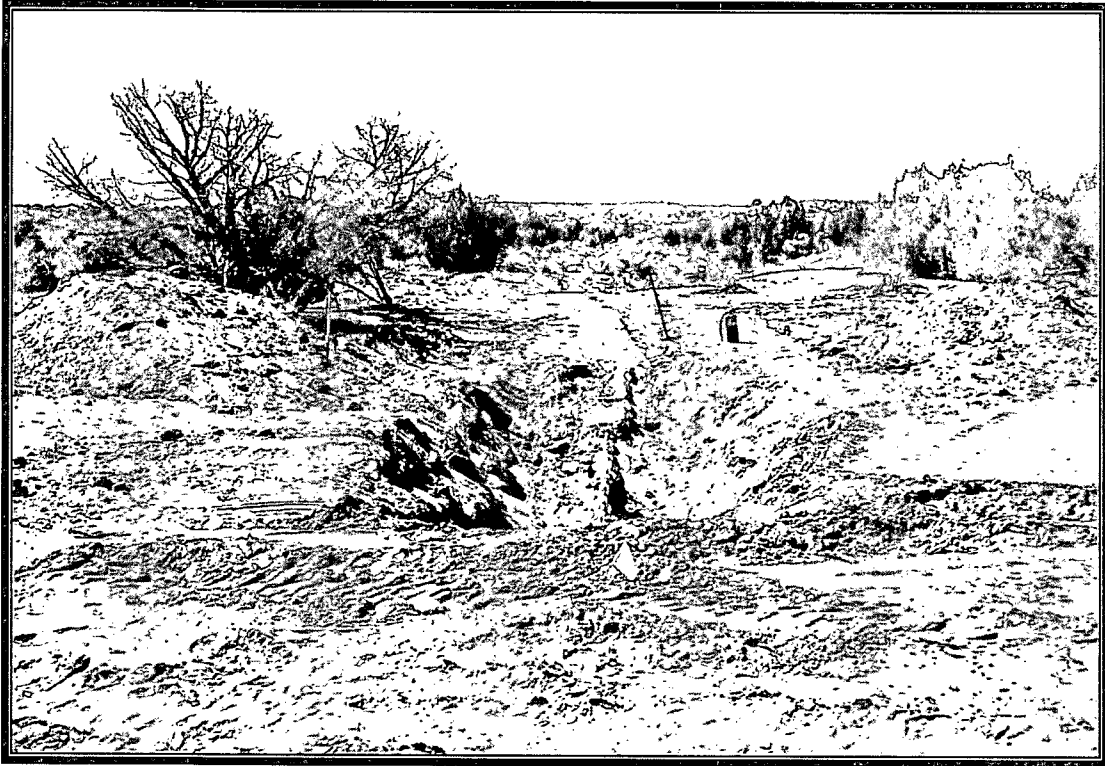
Photo 1: View of the pipeline and excavation for the northern release.

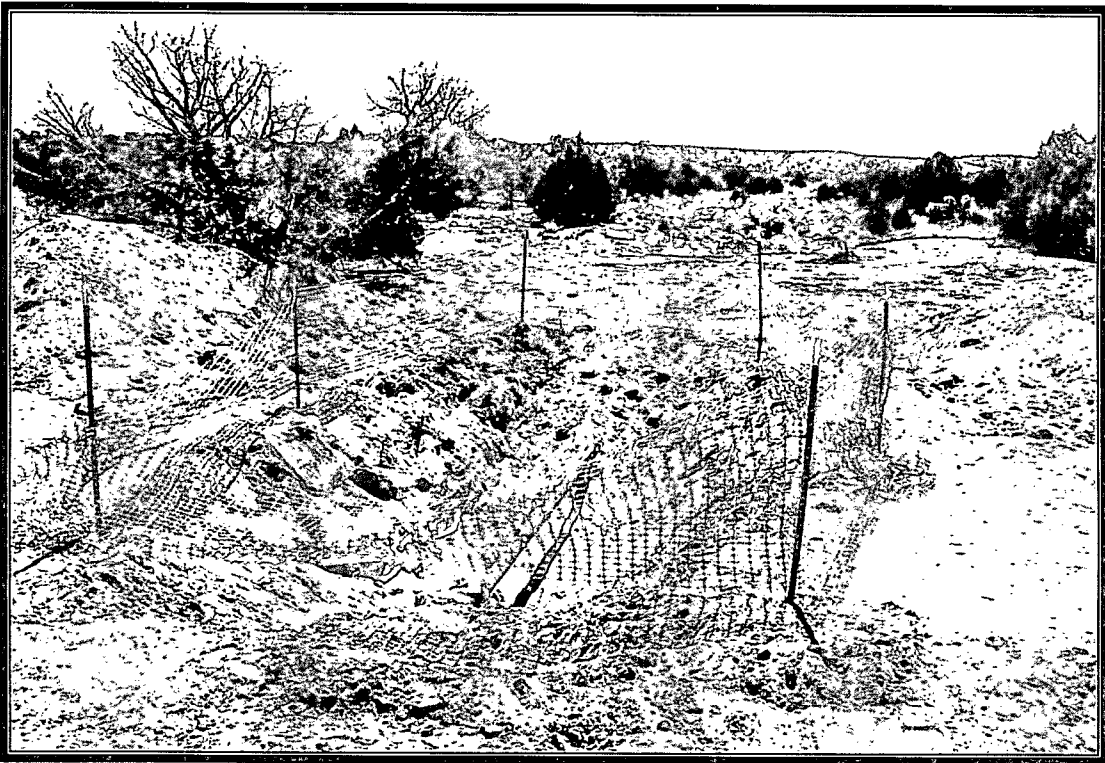
Photo 2: View of the excavation for the northern release.

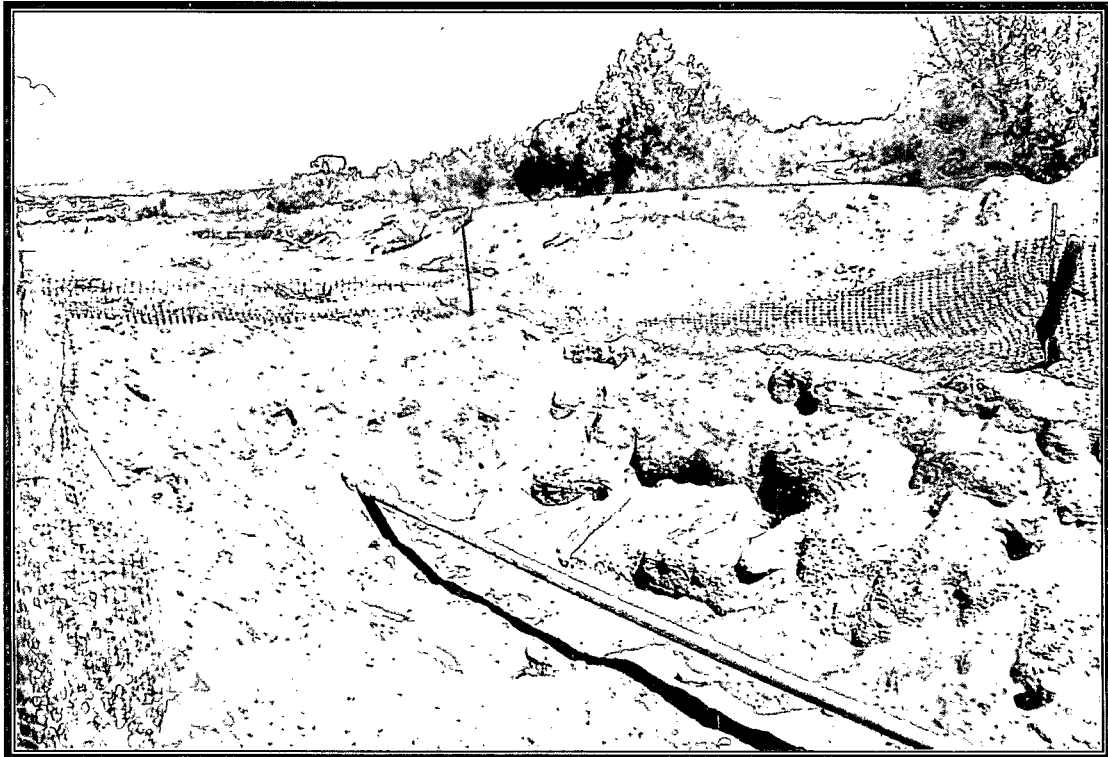
Photo 4: View of the excavation for the southern release.

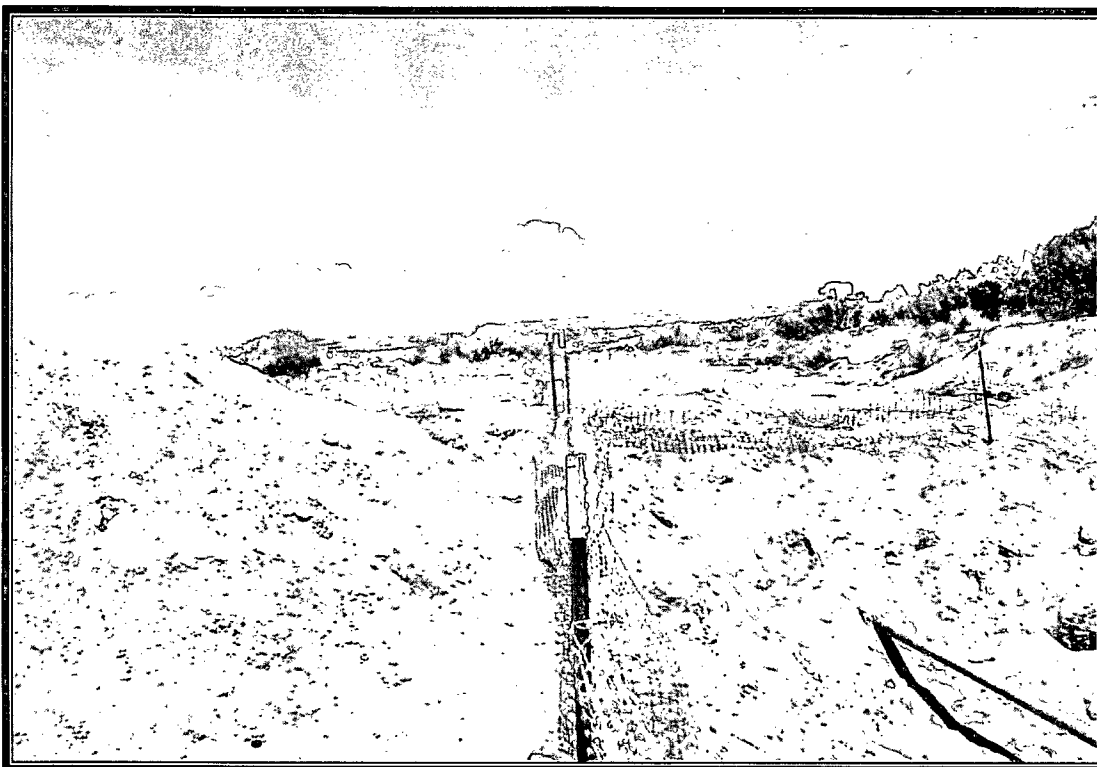
Photo 5: View of the excavation for the northern release.

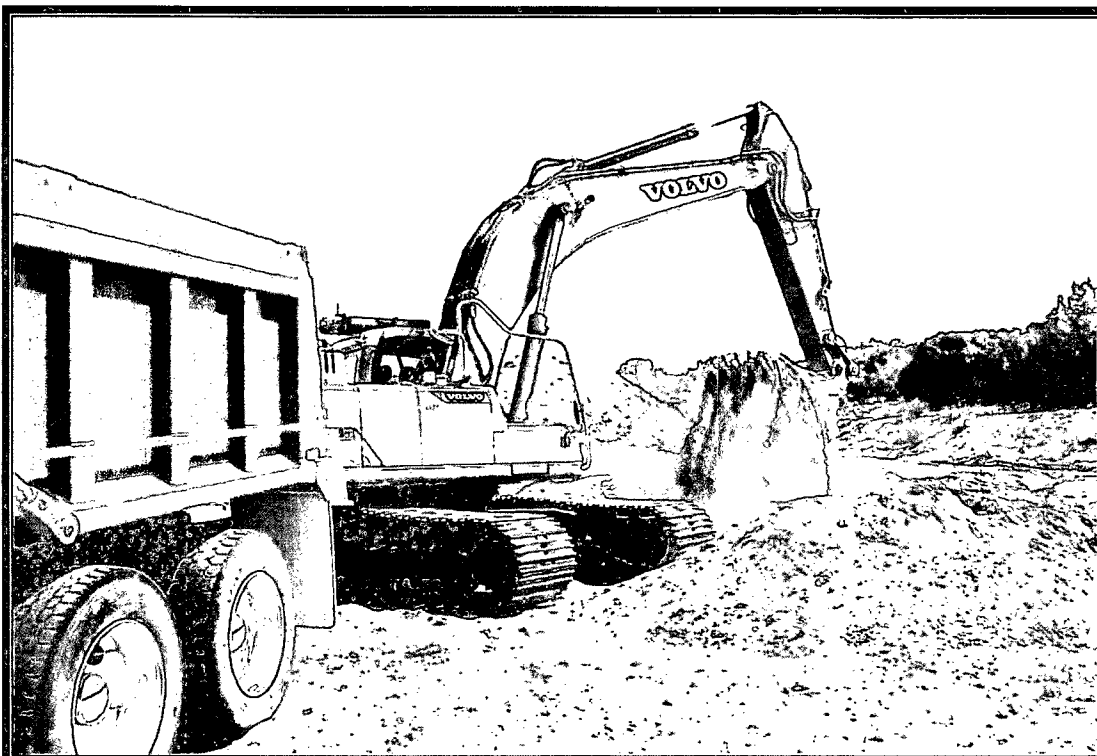
Photo 6: View of the excavation and loading of hydrocarbon impacted soils at the southern release.
