Remediation Summary Report Form

Client: LINN Energy

Site Name: JL Keel B 30

Remediation Activity Summary

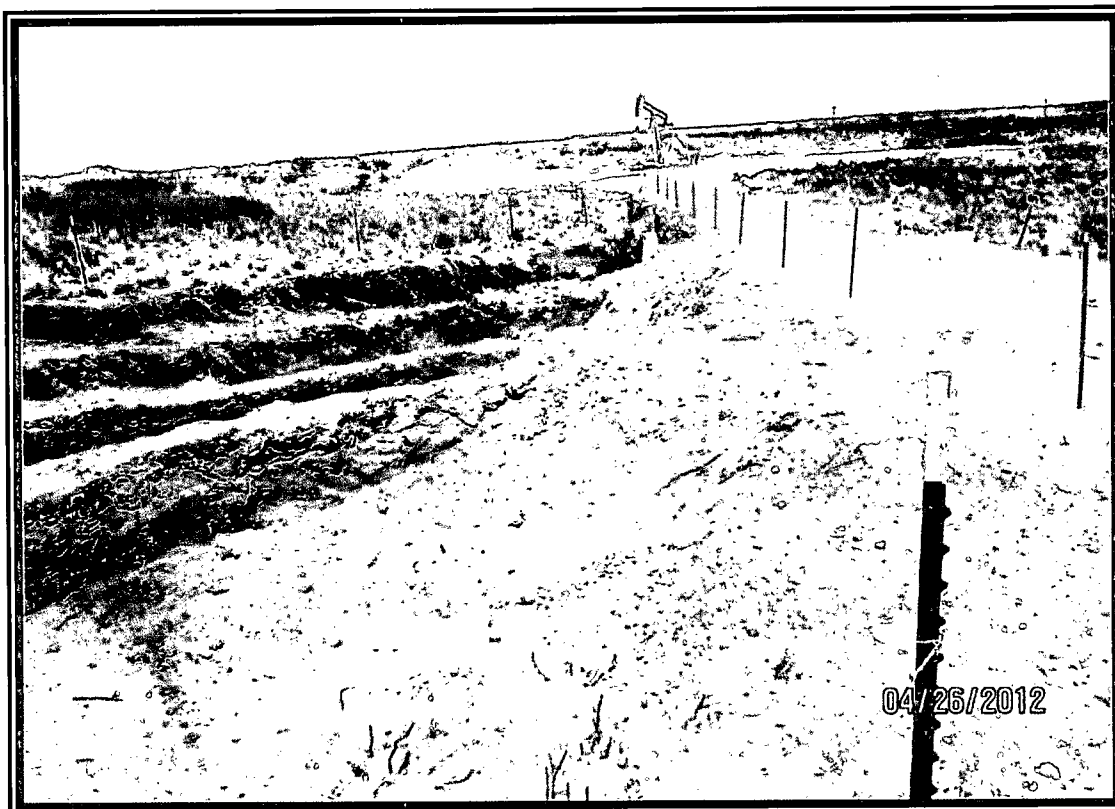
View of excavation looking North.

Impacted soils above regulatory threshold levels were manually and mechanically excavated from the spill area. In the bottom of the excavation a calcium amendment (gypsum) was added where the excavation had 2 points of elevated chloride levels ranging from 2760 mg/kg to 3000 mg/kg to ensure that any residual chlorides will not migrate and cause any adverse impact to the reclamation of the site.

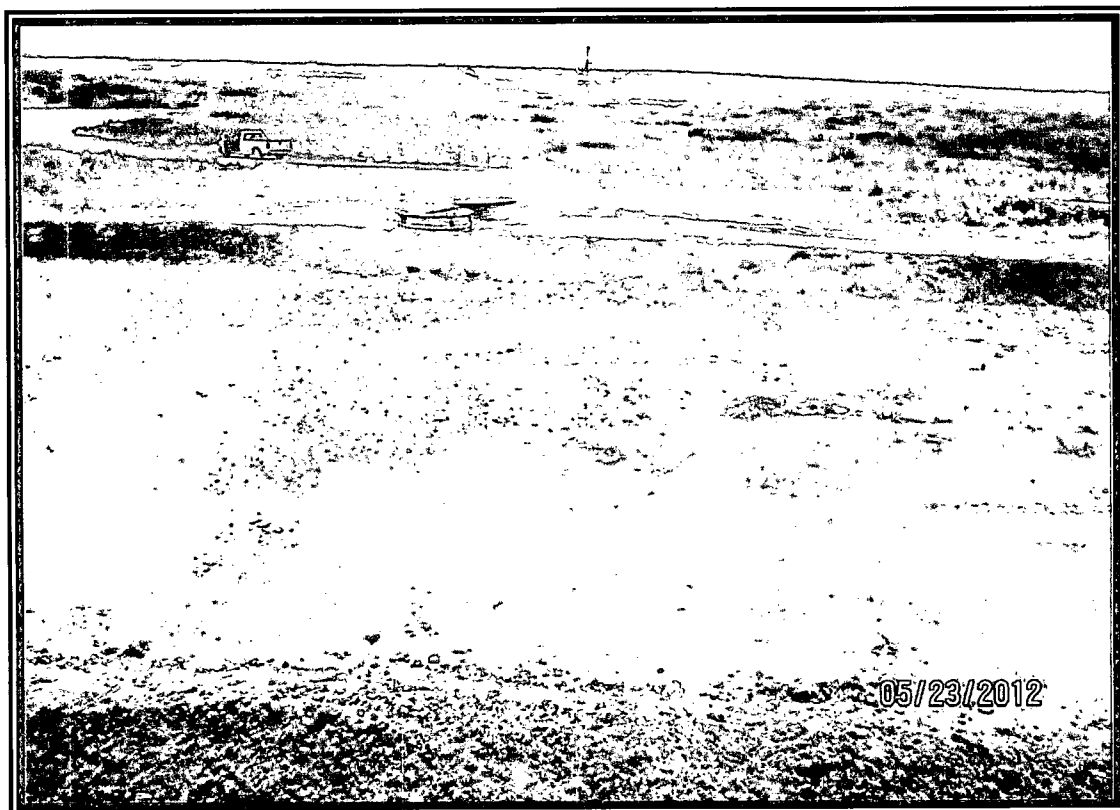
View of backfilled excavation and water bars looking East.

Impacted soils were transported off-site for disposal at Lea Land Landfill. Once the impacted soils were removed to acceptable levels, the pasture and the road areas were backfilled with like materials and smoothed to grade. The pasture area was seeded with a BLM #2 & #4 mix. Water bars were installed to prevent wind and water erosion.

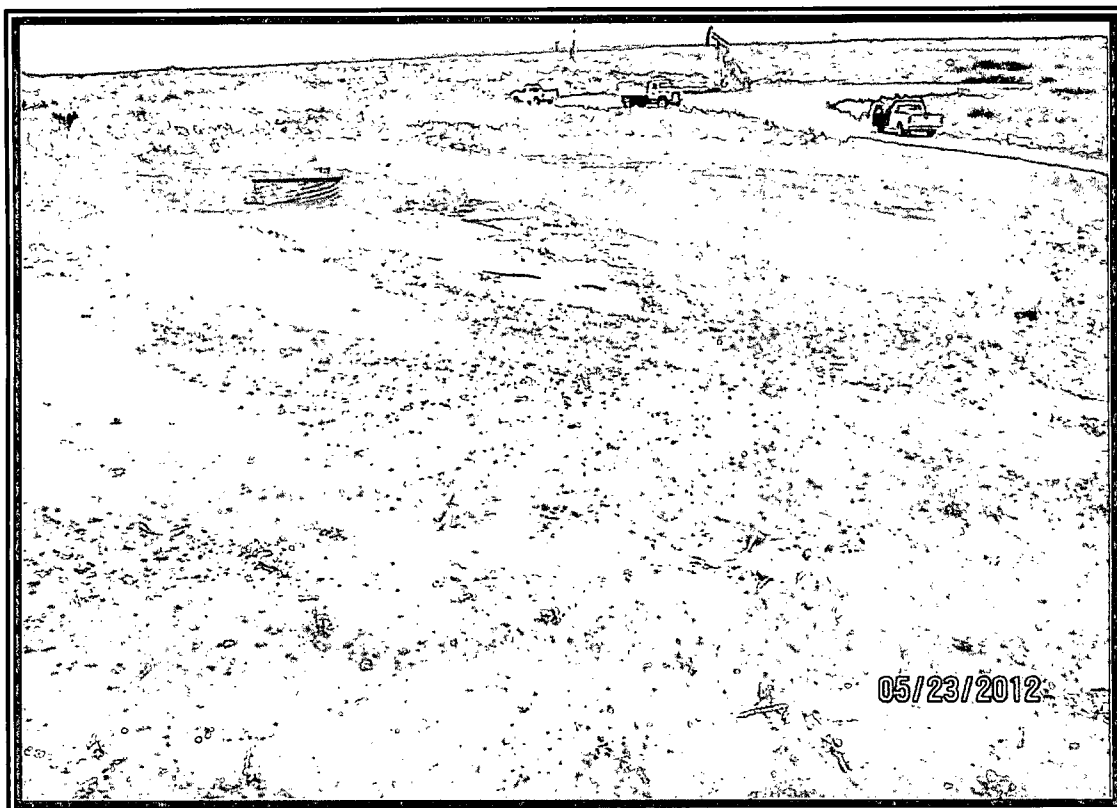
Backfilled excavation and water bars looking North East.
