Report Type: Closure Report

Site:	Antelope SWD 8" Lateral Line	
Company:	COG Operating LLC	
Section, Township and Range	Unit K - Sec 36 - T17S - R31E	
Lease Number:	B-3627	
County:	Eddy County	
GPS:	32.79151	103.82351
Surface Owner:	State	
Mineral Owner:		
Directions:	From mile marker 4 on Hwy 529, travel south on lease road 800', right 400', left 0.6 mile, at four way turn right 0.6 mile, right 0.2 mile to two track road, right 750' to location

Re: Closure Activities and Closure Request for the COG Operating LLC., Antelope State SWD 8", Unit K, Section 36, Township 17 South, Range 31 East, Eddy County, New Mexico.

COG Operating LLC
Antelope SWD 8" Lateral Line
Eddy County, New Mexico
Excavation

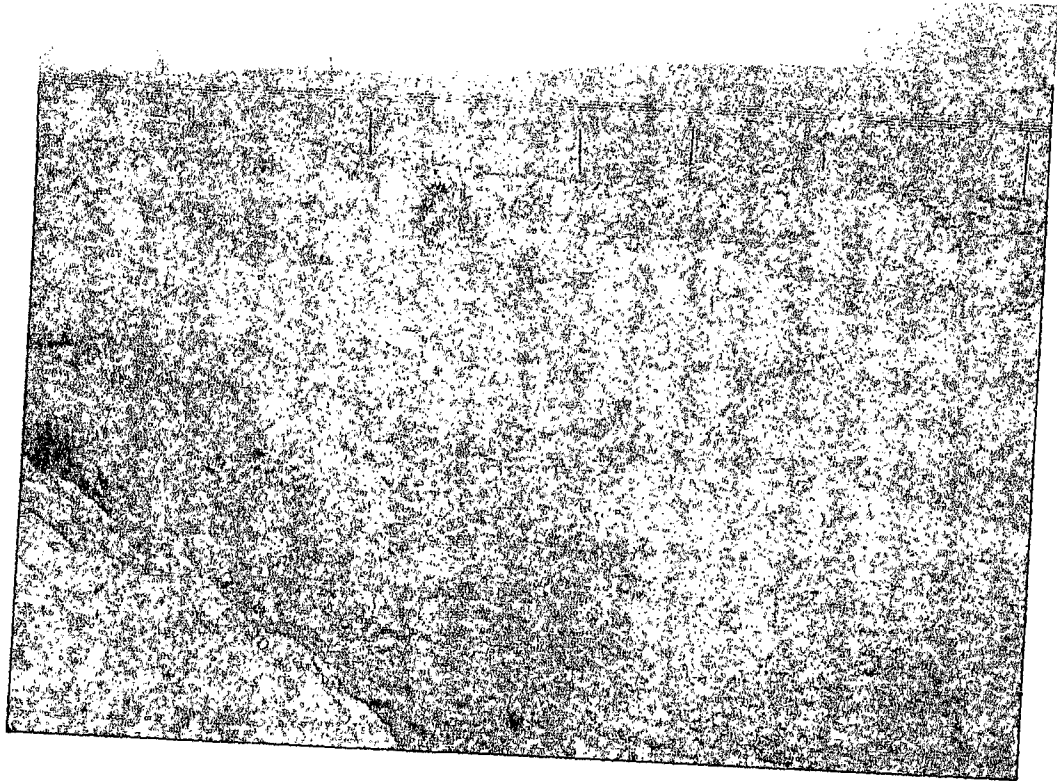
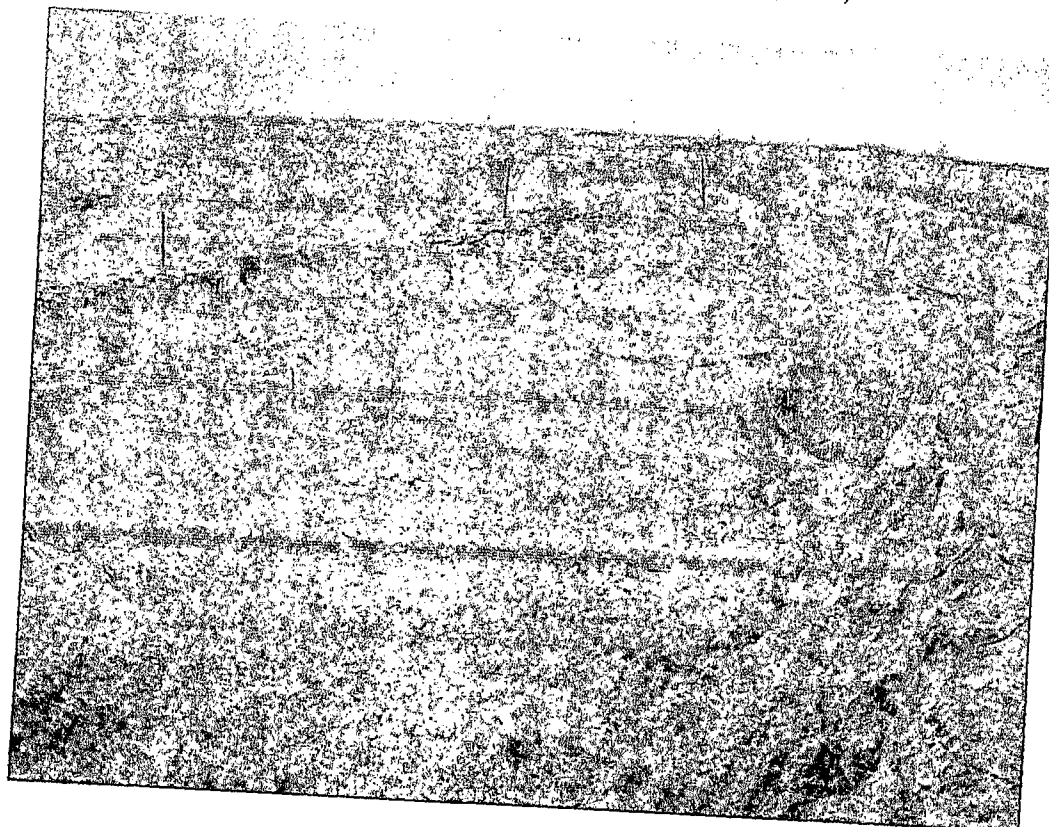
View of excavation in the area of AH-6 (SB-4)

Based on the approved work plan, Tetra Tech personnel supervised the excavation of the site. The excavated areas and depths are highlighted in Table 1 and shown on Figure 4. As shown in Table 1, the excavation depths ranged from 4.0' to 15.0' below surface. The final excavation depths of the soil remediation were met as stated in the approved work plan, except for the area of AH-4 (SB-3). Due to proximity of the active lines, the area was excavated to a depth of 4.0' to 5.0' below surface and lined with a 40 mil liner. Approximately 1,900 cubic yards of impacted soil were excavated and transported to proper disposal. Once completed, the excavations were backfilled with clean soil to grade.

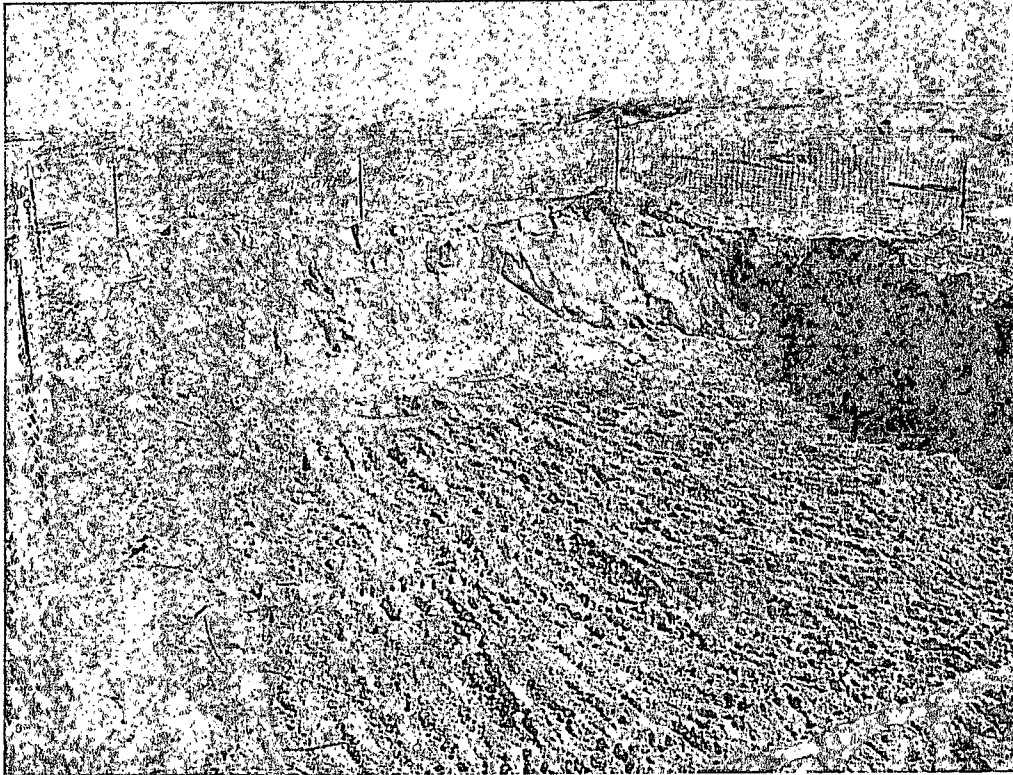
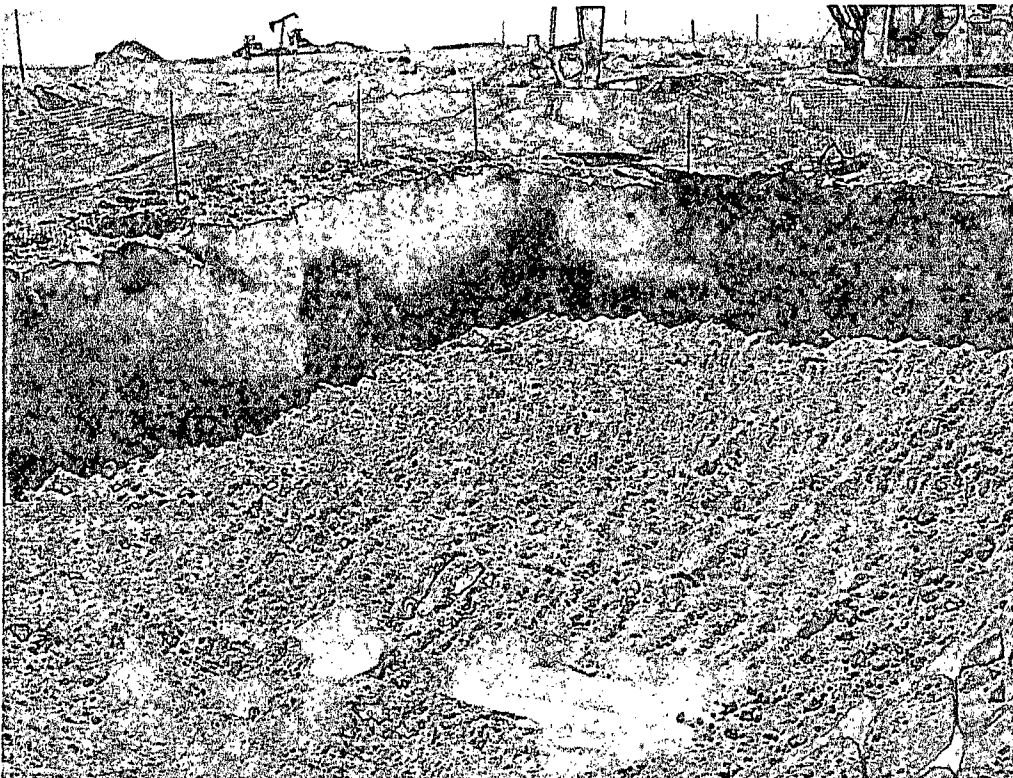
View of excavation in the area of AH-4 (SB-3)

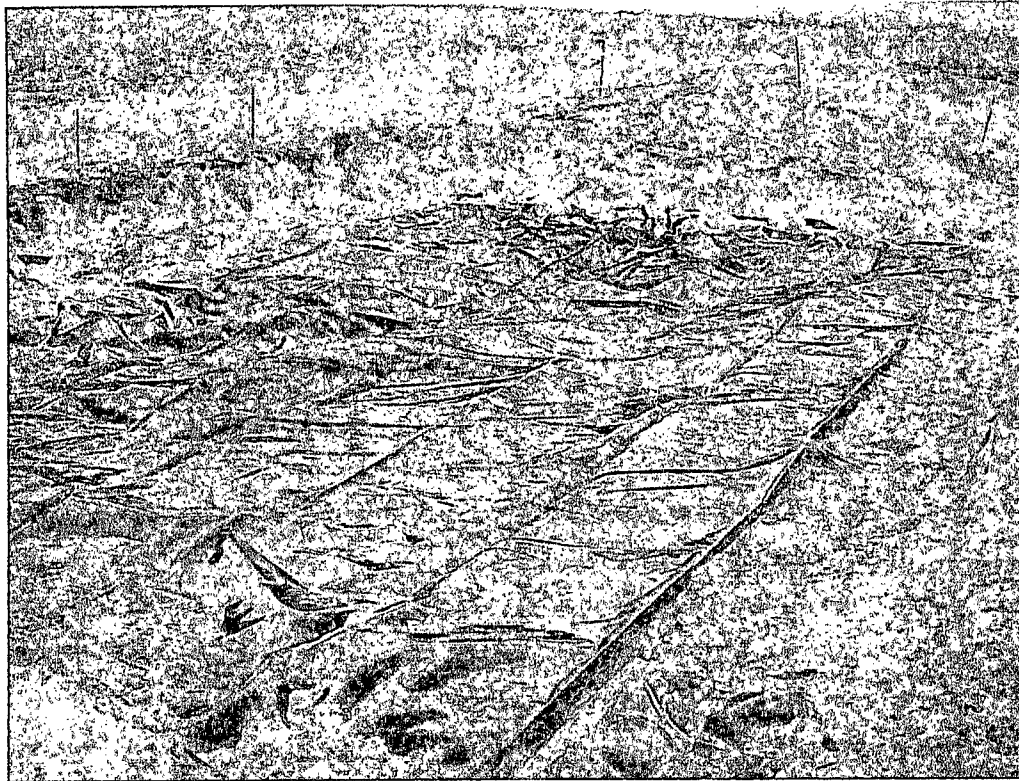
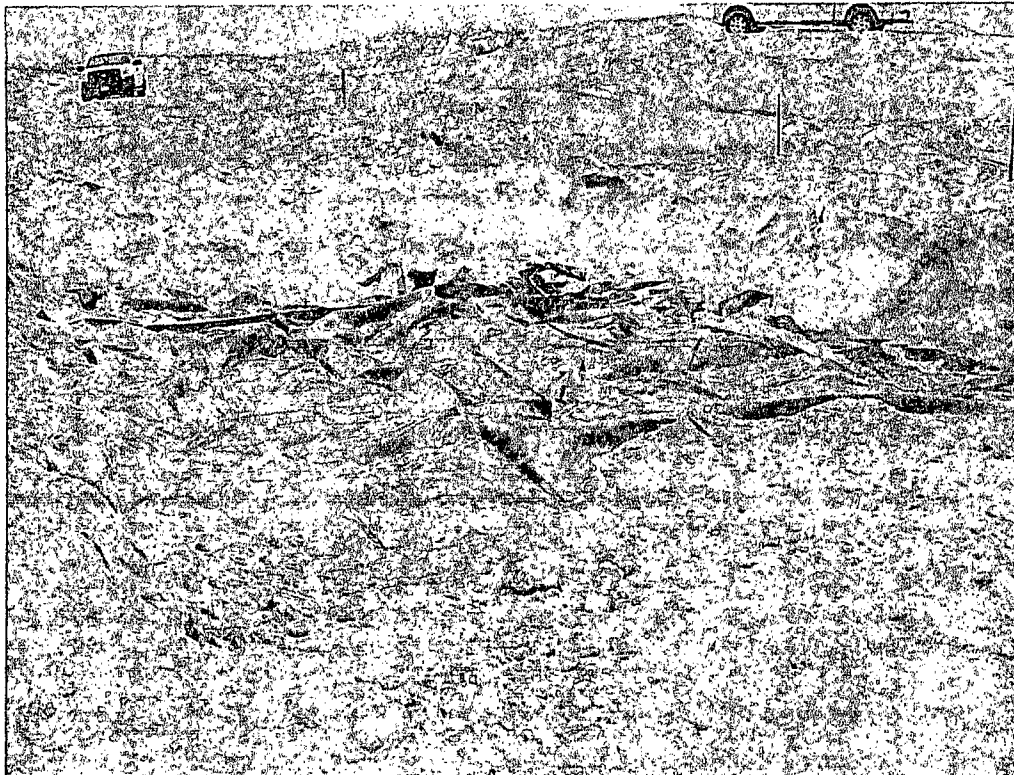
View of excavation in the area of AH-4 (SB-3) and liner installation
