LINN ENERGY

Max Friess & Fren Supply Line

2RP-2033

CAP Report & Termination Request

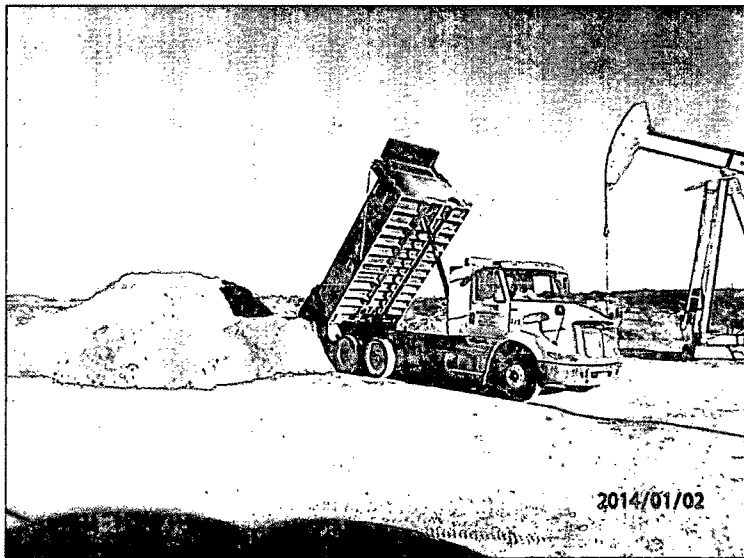
Importing soil, facing east

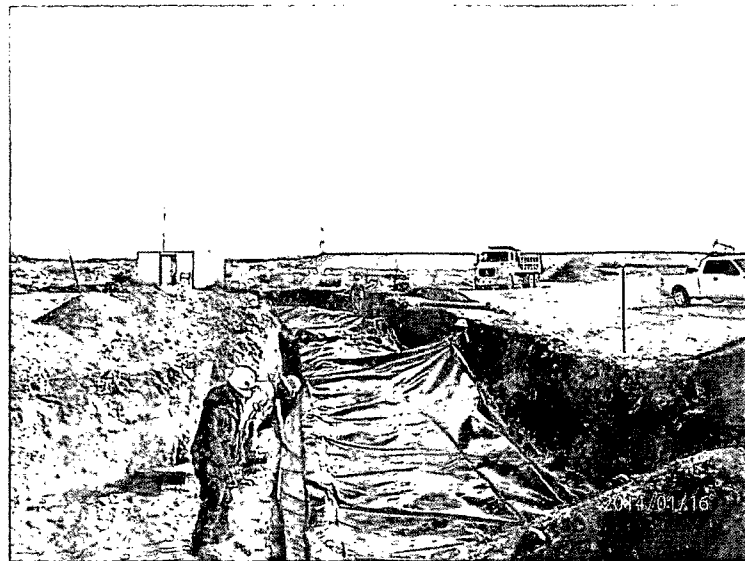
Installing 20-mil poly liner, facing east

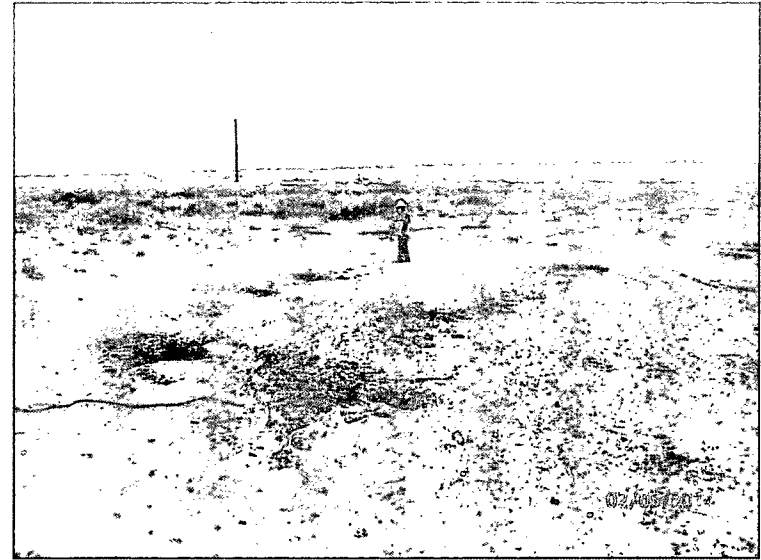
Spreading soil amendments, facing northwest
