# Skelly Unit 22

## Closure Report

2RP-1400

**RE: Termination Request**

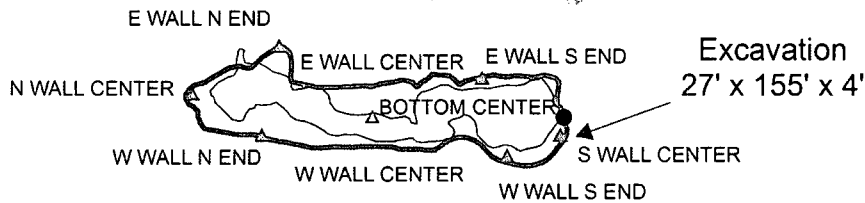
Figure 2

The site was excavated to 4 ft bgs and the excavated soil was disposed of at a NMOCD approved facility. The walls and bottom of the excavation were field tested for chlorides

and hydrocarbons and then sent to a commercial laboratory for analysis (Figure 2). The wall samples returned low chloride, TPH and BTEX results. The bottom sample returned low TPH and BTEX results but returned a chloride value of 6,400 mg/kg (Appendix B). Due to the high chloride reading at the bottom of the excavation, NMOCD District 2 requested that a vertical be installed to determine the vertical extent of contamination.

# Excavation Sampling Data

CI-	GRO	DRO	B	T	E	X	BTEX
N Wall Center	<16	<10	<10	<0.05	<0.05	<0.05	<0.15	<0.3
E Wall S End	48	<10	<10	<0.05	<0.05	<0.05	<0.15	<0.3
E Wall N End	224	<10	<10	<0.05	<0.05	<0.05	<0.15	<0.3
S Wall Center	112	<50	106	<0.05	0.05	<0.05	<0.15	<0.3
W Wall N End	<16	<10	<10	<0.05	<0.05	<0.05	<0.15	<0.3
W Wall S End	32	<10	<10	<0.05	<0.05	<0.05	<0.15	<0.3
Bottom Center @ 4'	6400	<10	<10	<0.05	<0.05	<0.05	<0.15	<0.3

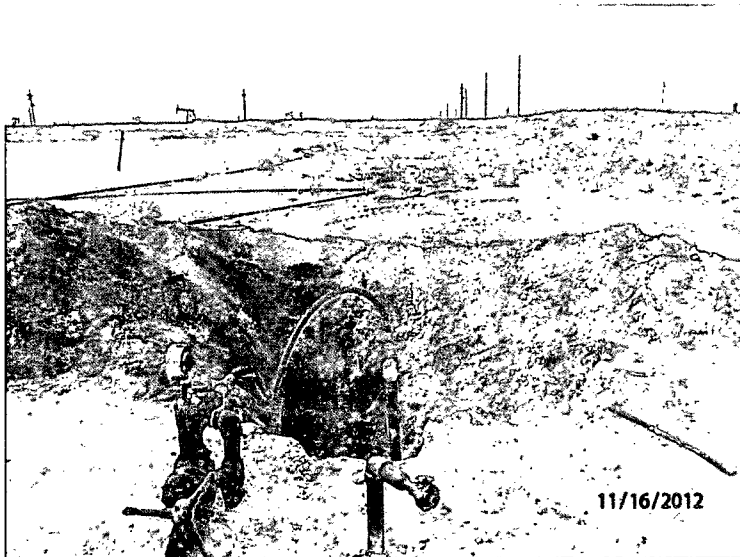
Initial release area, facing west

11/16/12

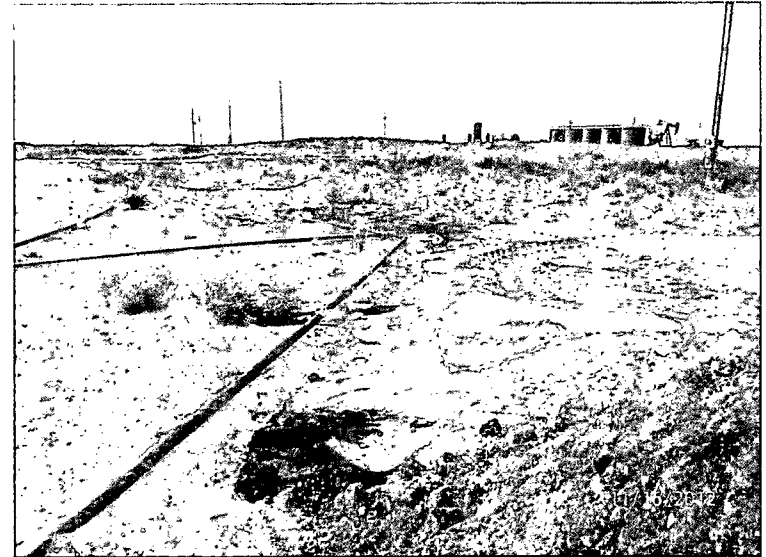
Initial release area, facing west

11/16/12

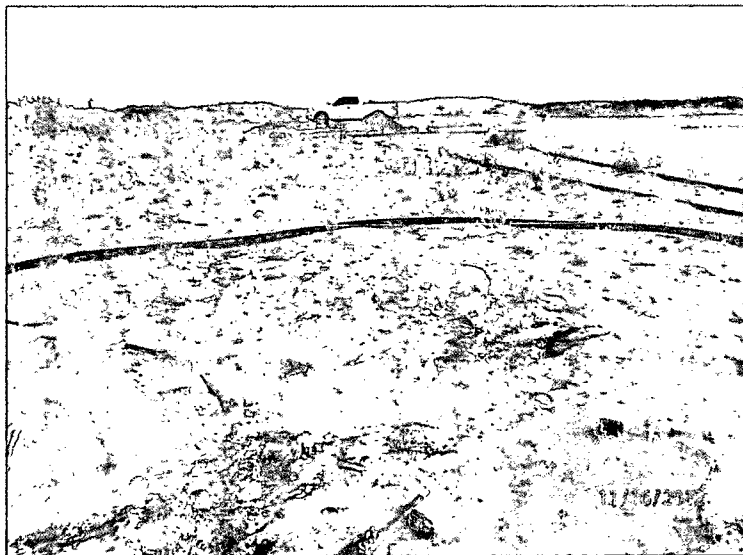
Initial release area, facing east

11/16/12

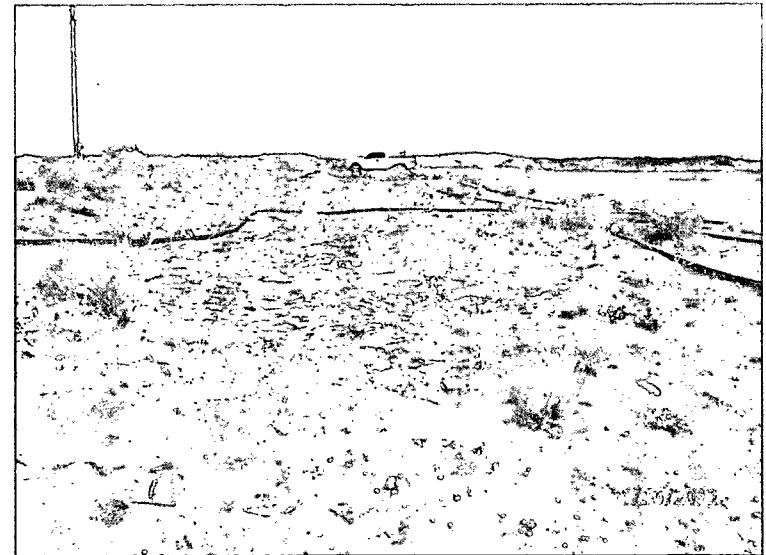
Initial release area, facing east

11/16/12

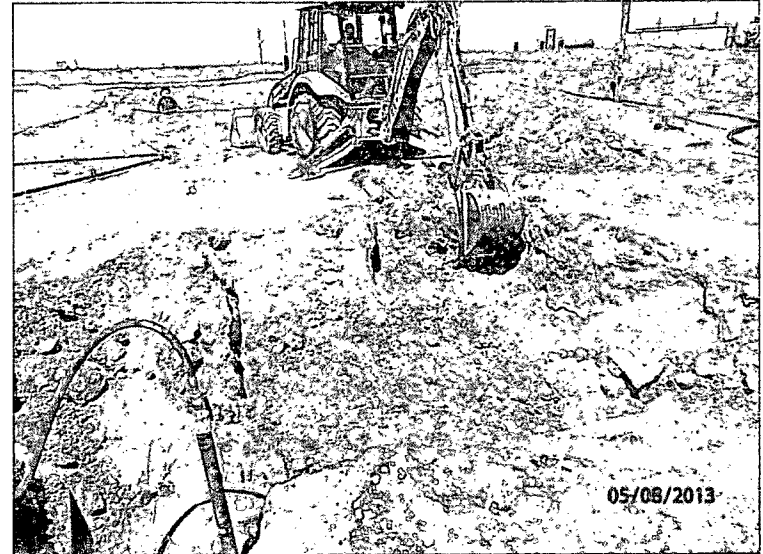
Excavating site, facing north

5/8/13

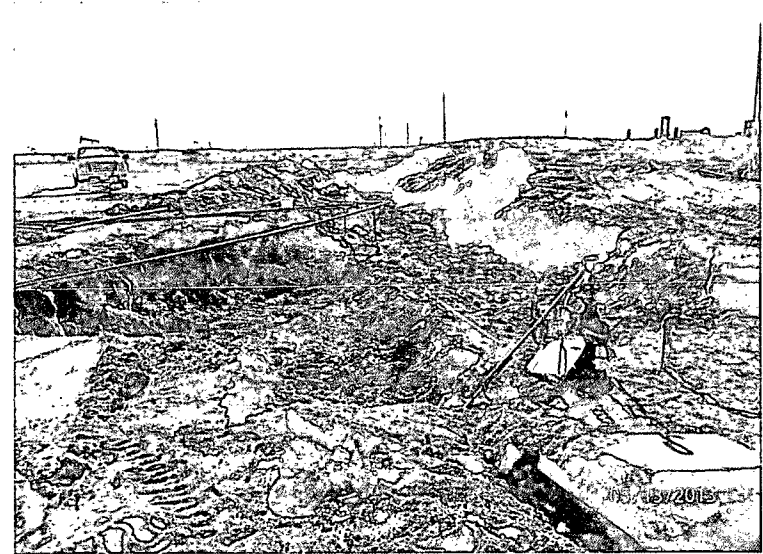
Final excavation, facing north

5/13/13

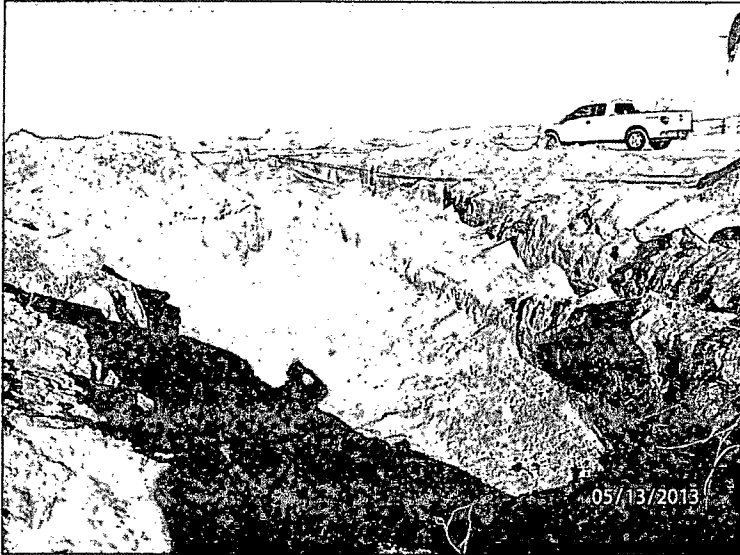
Final excavation, facing south

5/13/13

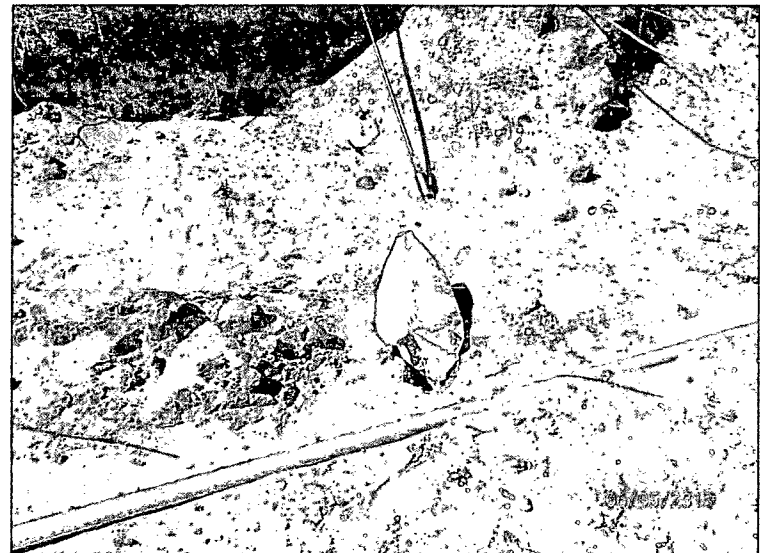
Vertical delineation, facing north

6/5/13

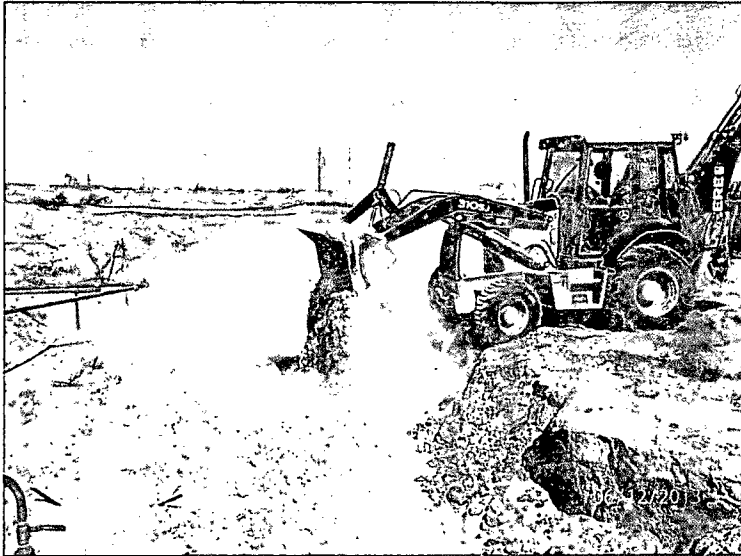
Backfilling with caliche, facing west

6/12/13

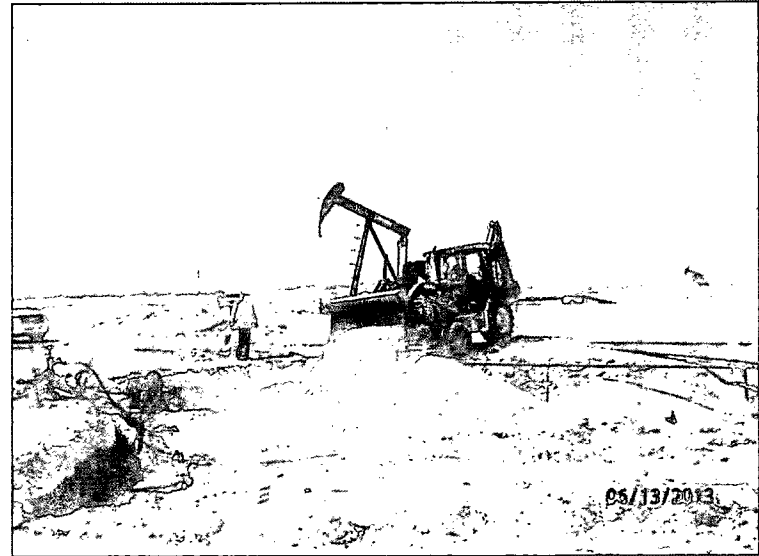
Backfilling with sand, facing south

6/13/13

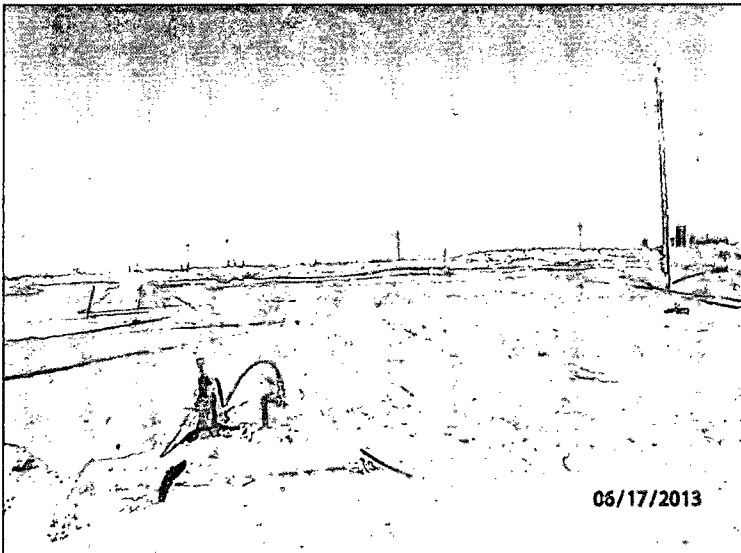
Site backfilled, facing west

6/17/13

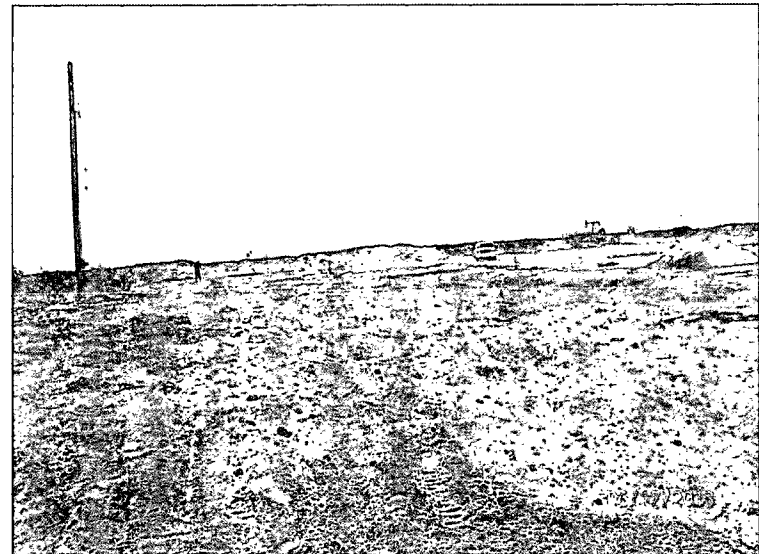
Site backfilled, facing southeast

6/17/13
