**3R-1011**

**Release Report/ General  
Correspondence**

**Enterprise SJ**

### Release Notification and Corrective Action

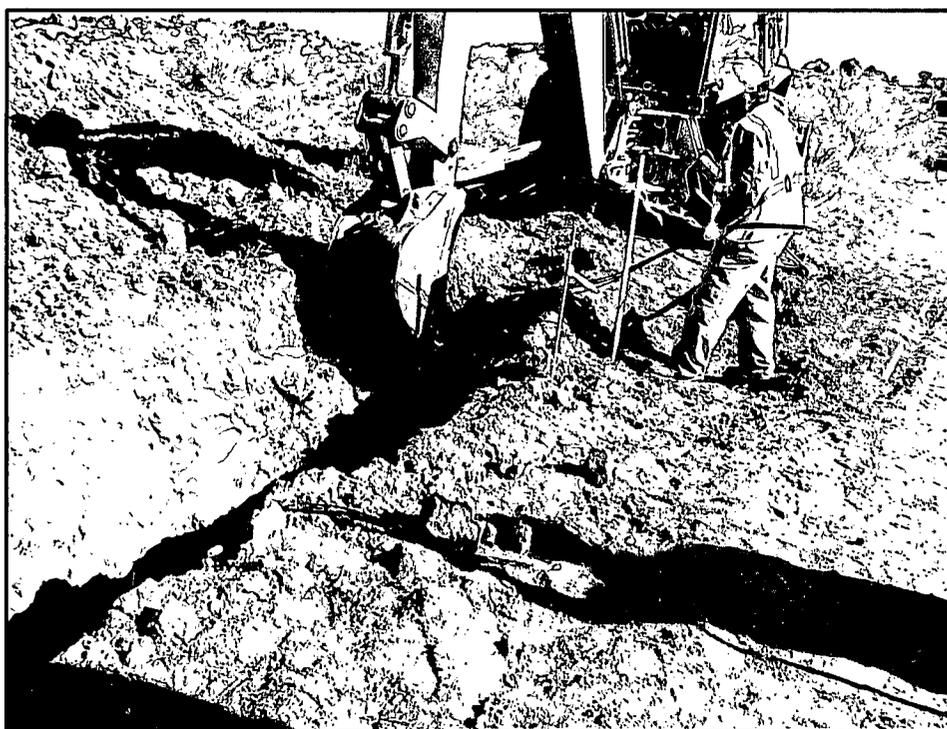
Photo 2: Beginning of the Ludwick LS #18 pipeline excavation for repairs.

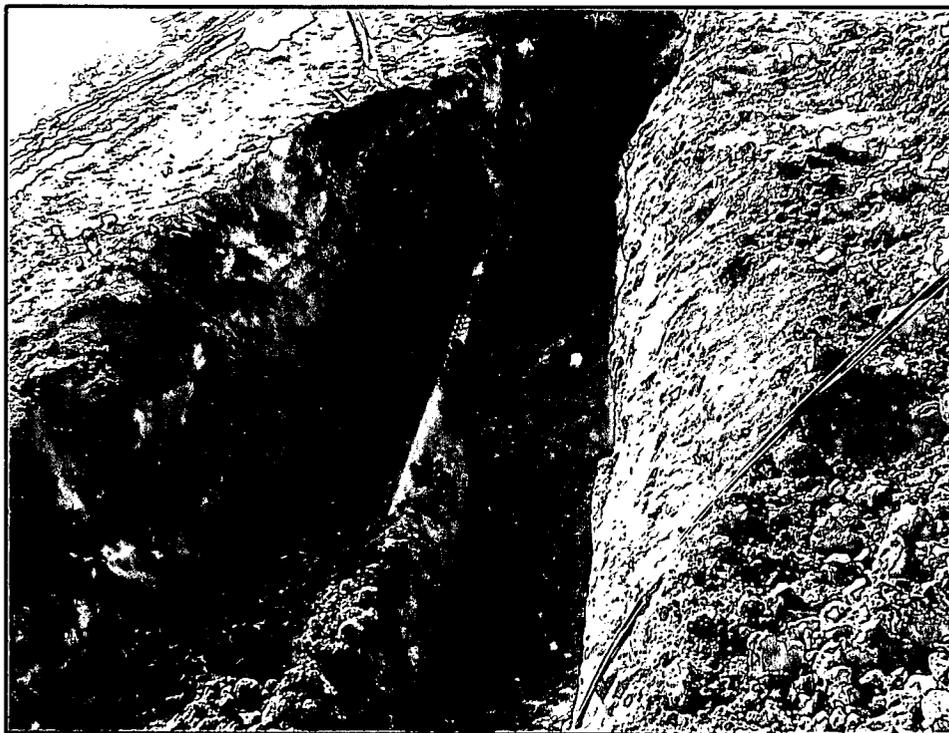
Photo 3: View of releas point found on the Ludwick LS #18 pipline.

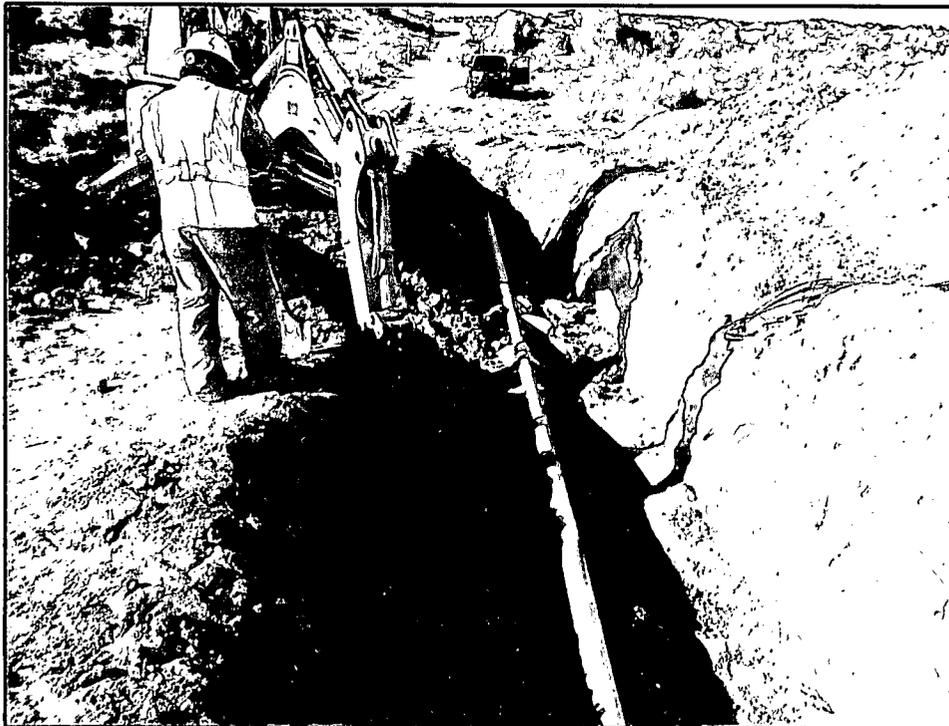
Photo 4: Preliminary remediation excavation following completion of the repairs to the Ludwick LS #18 pipeline.

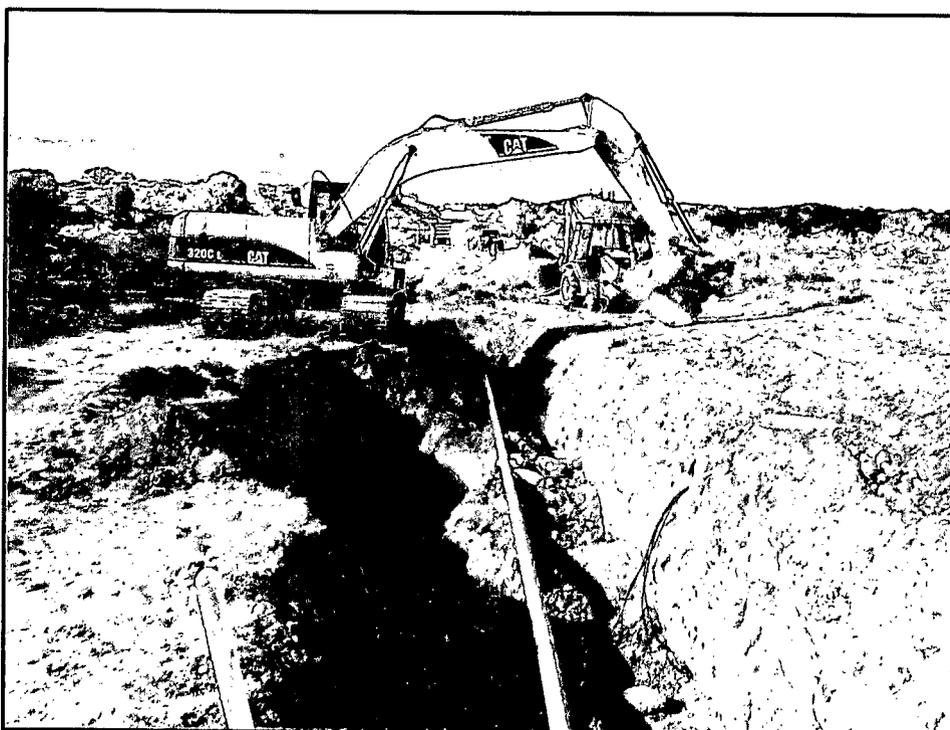
Photo 5: Continued excavation of the Ludwick LS #18 pipeline beyond the reach of 12 feet by a rubber-tired backhoe.

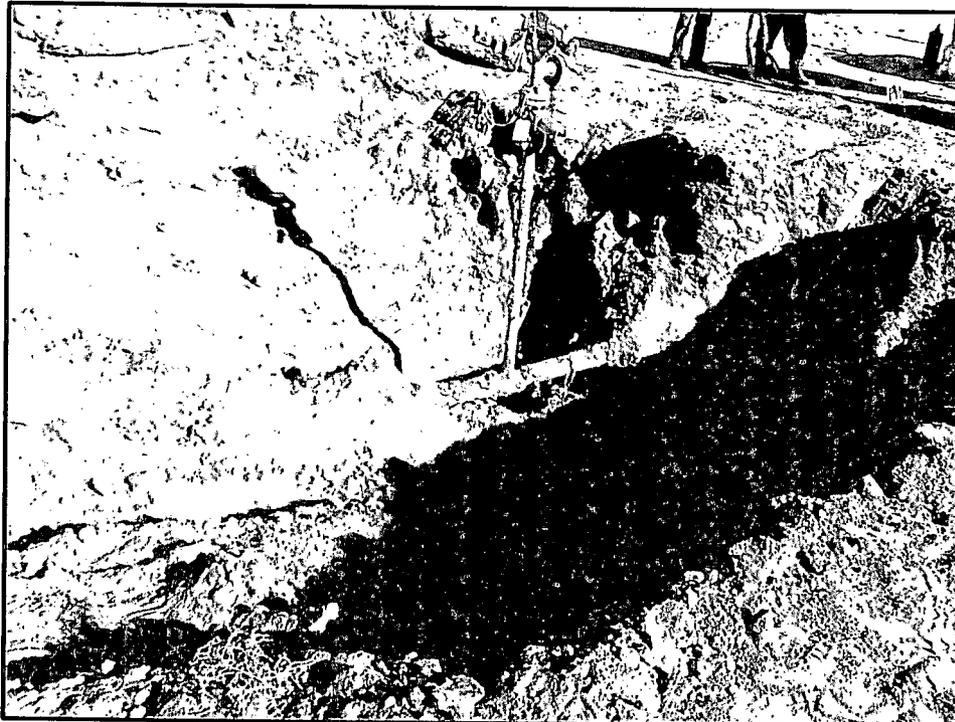
Photo 2: The release point of the Santa rosa 8 #2 pipeline release was a broken weld associated with internal corrosion and likely failed due to freezing.

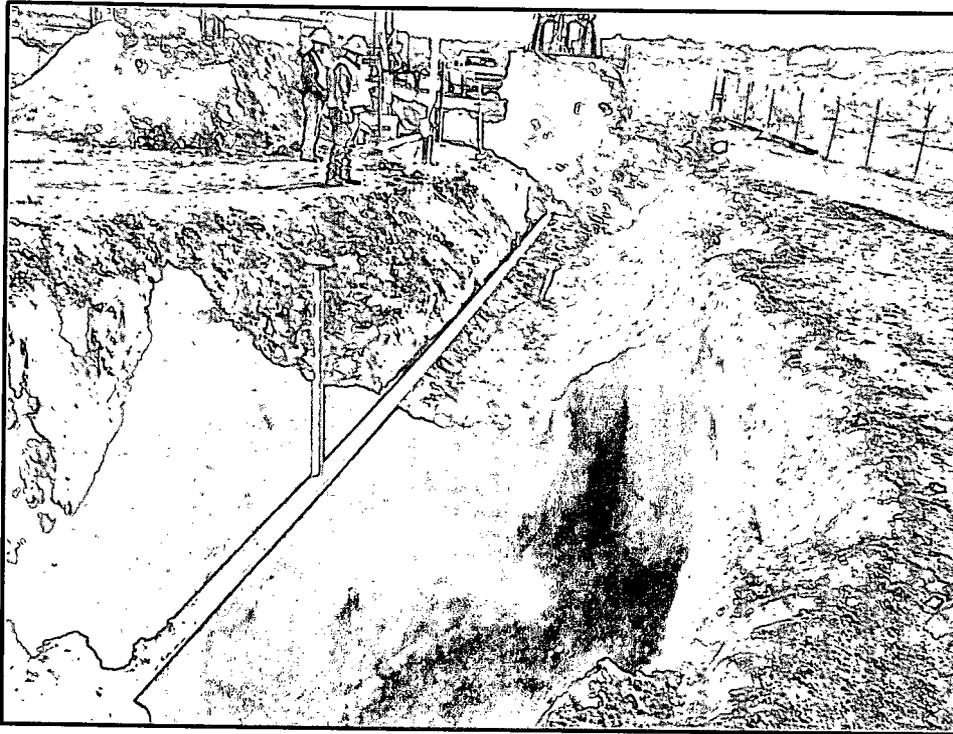
Photo 3: View of the additional excavation advanced solely for pipeline repairs. A 45' section of pipeline was replaced.

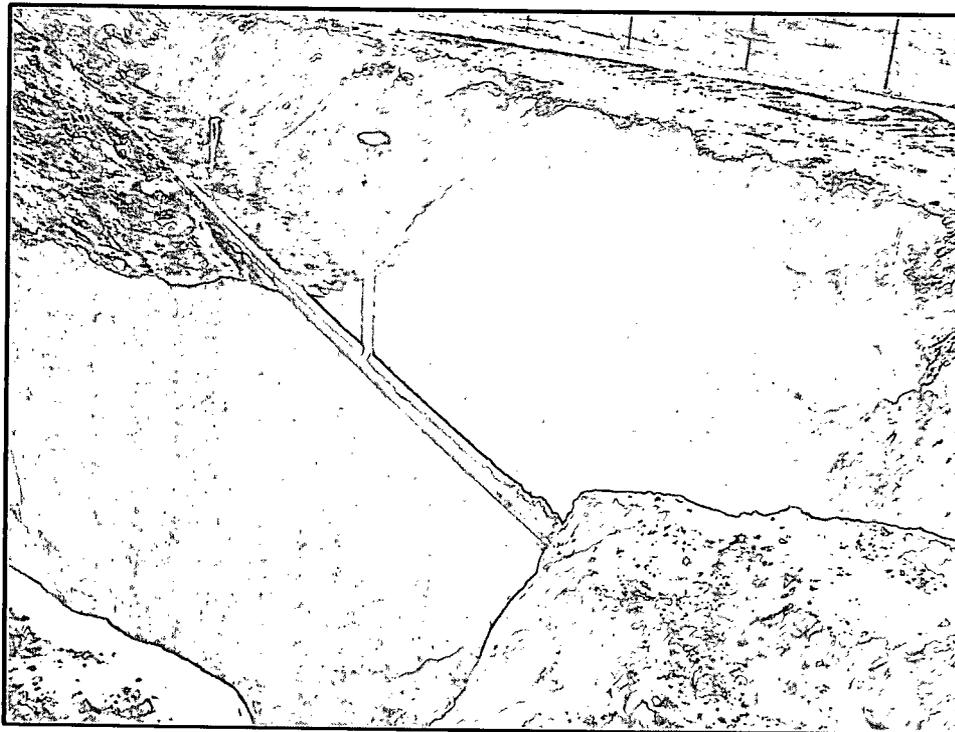
Photo 4: The vertical extent of the Santa Rosa 8 #2 main excavation.

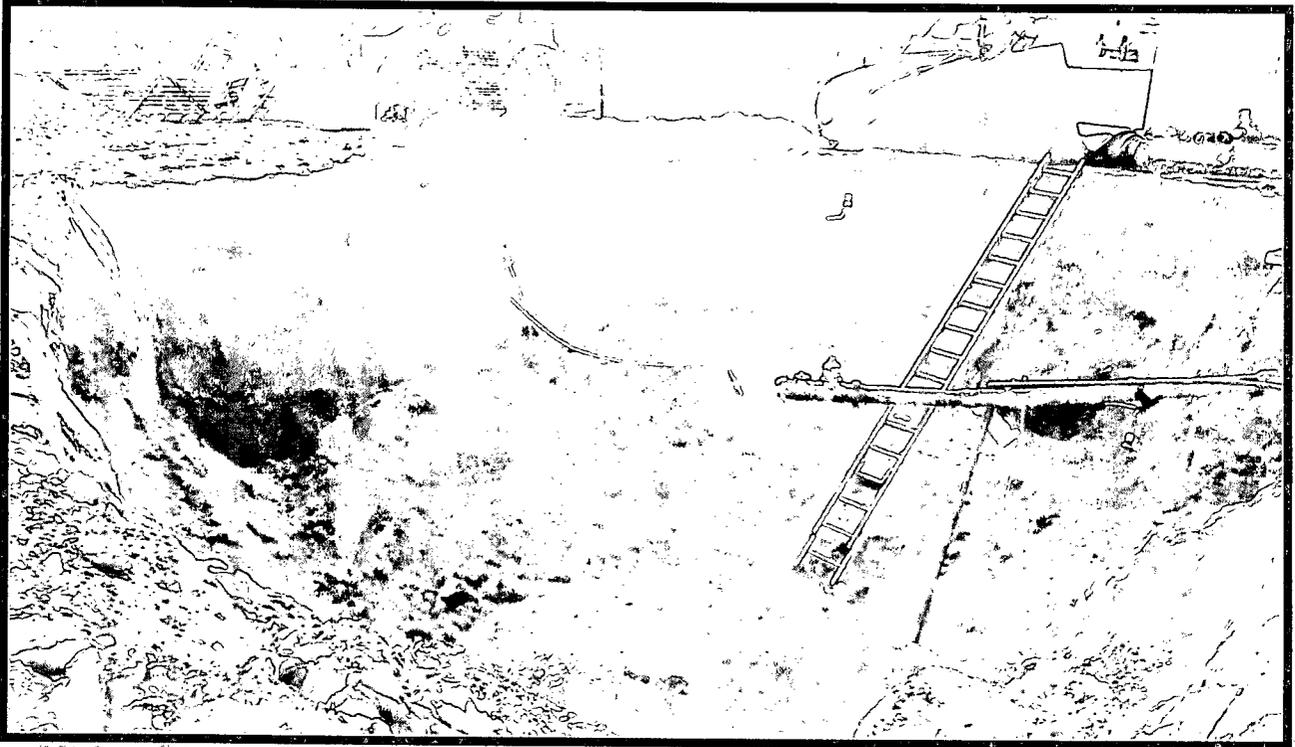
**Photo 7:** Excavation extents after BGT removal. Hammer union on pipe in right of image was found to be leaking.

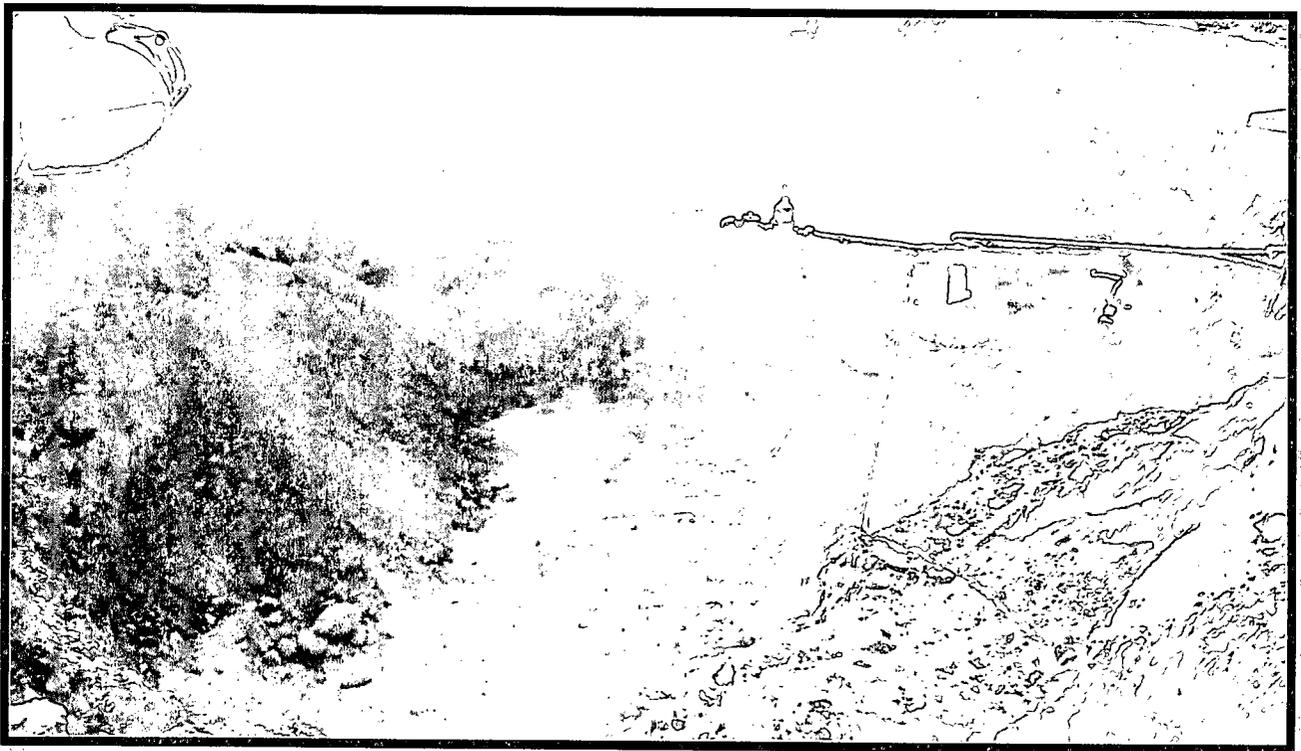
**Photo 8:** Base of excavation on competent sandstone. View is to the south-southwest.

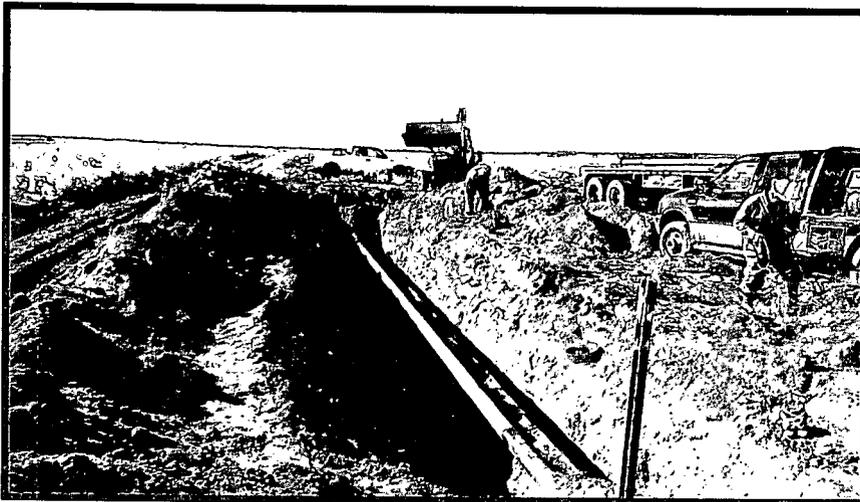
**Photo 4:** The entire excavation extents sampled on February 3, 2015. view is to the south.

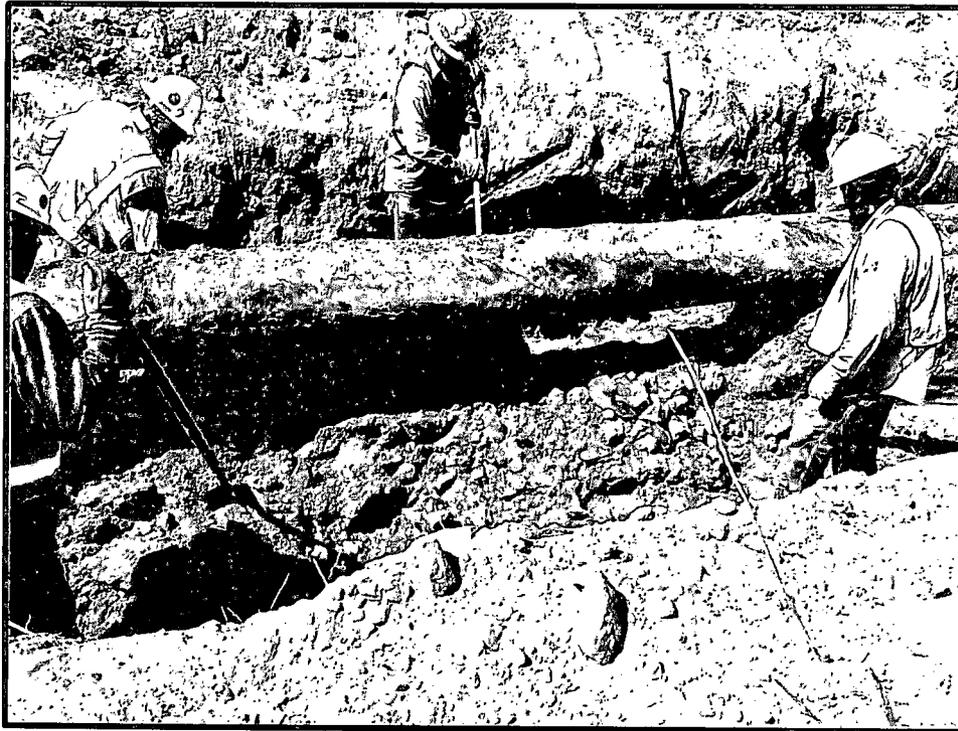
Photo 3: First stage of the Trunk K #2 pipeline excavation. Note extensive staining.

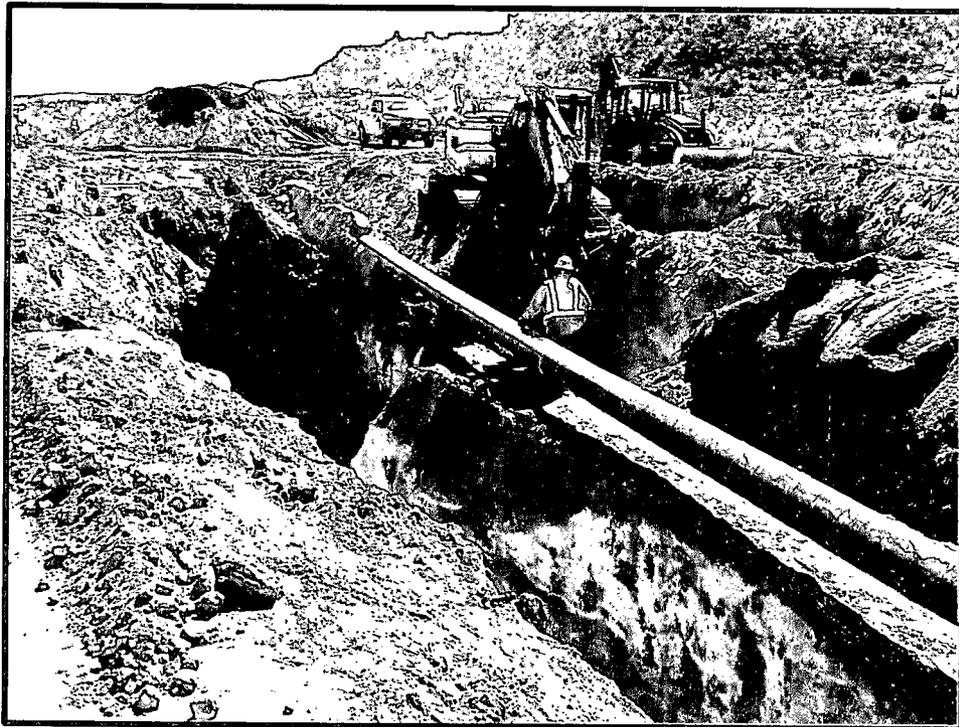
Photo 4: Phase 2 of the overall excavation of the Trunk K #2 pipeline release.

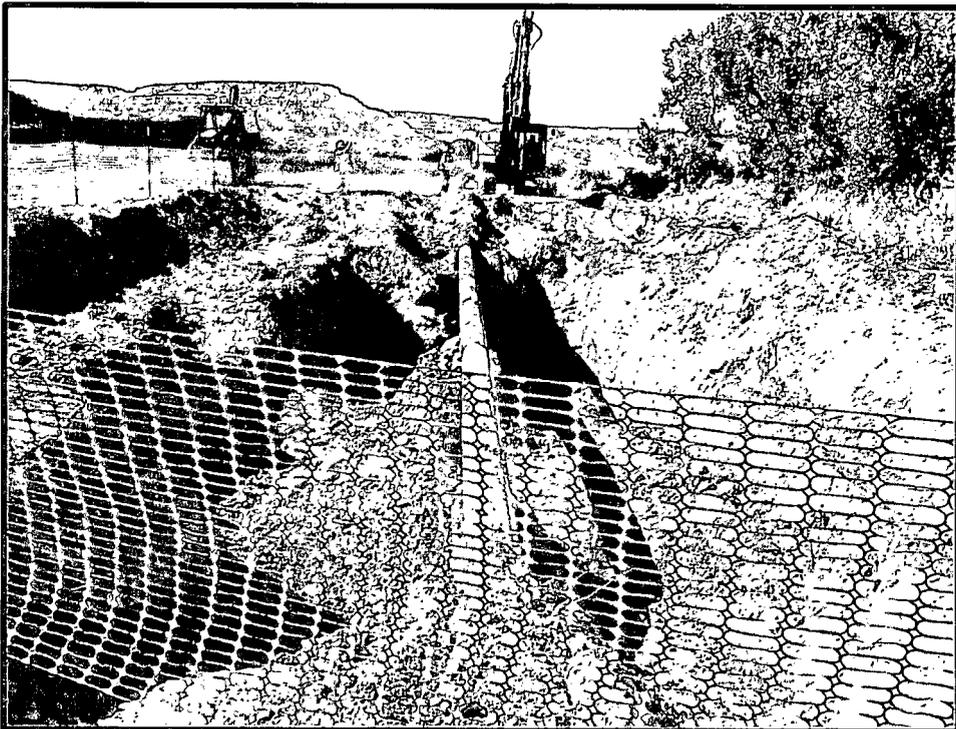
Photo 6: Complete excavation of the Trunk K #3 pipeline release.

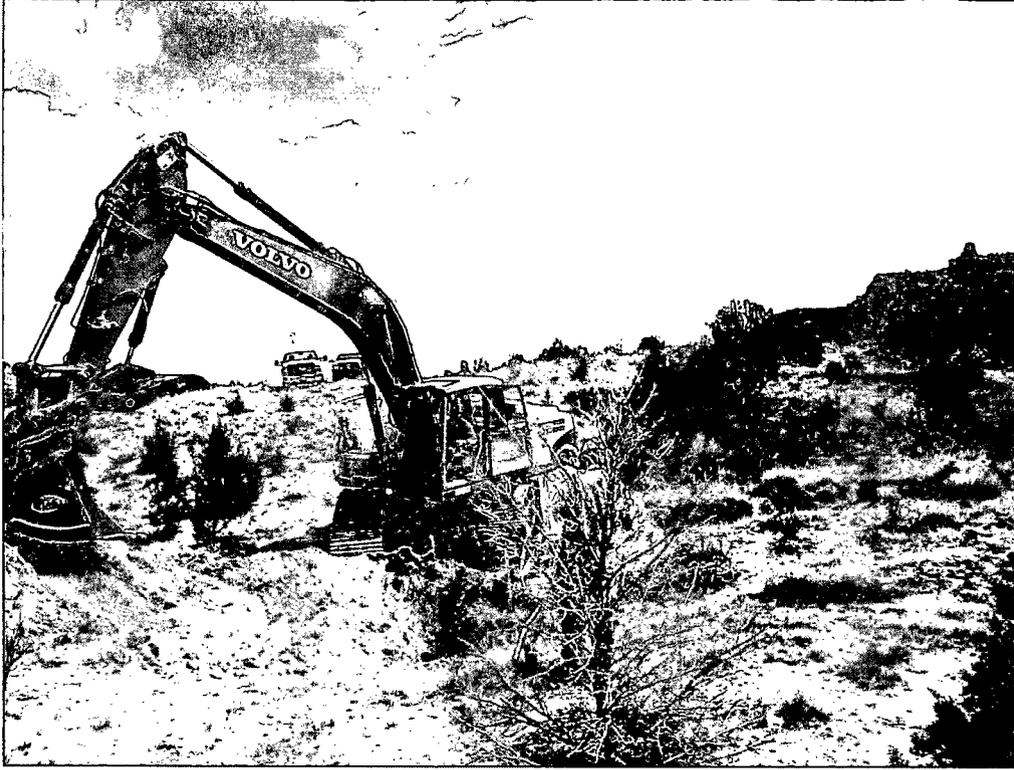
The excavation of repair Location No. 6, looking south towards Site LA 180207.

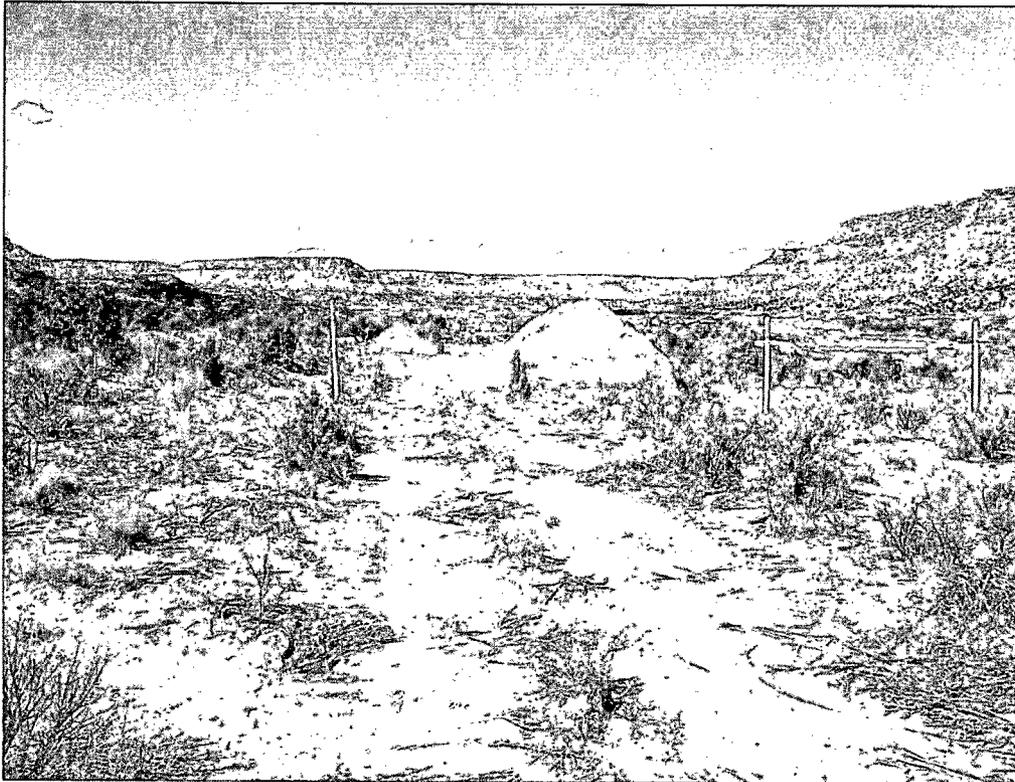
View of access road looking towards Location No. 6 from the northern edge of site LA 180207. Note the red pile of clean soil on the left of the road and the tan pile of contaminated soil on the right.
