Holly Energy Partners Mimosa Gathering Line Closure Report

Eddy County, New Mexico

July 24, 2013

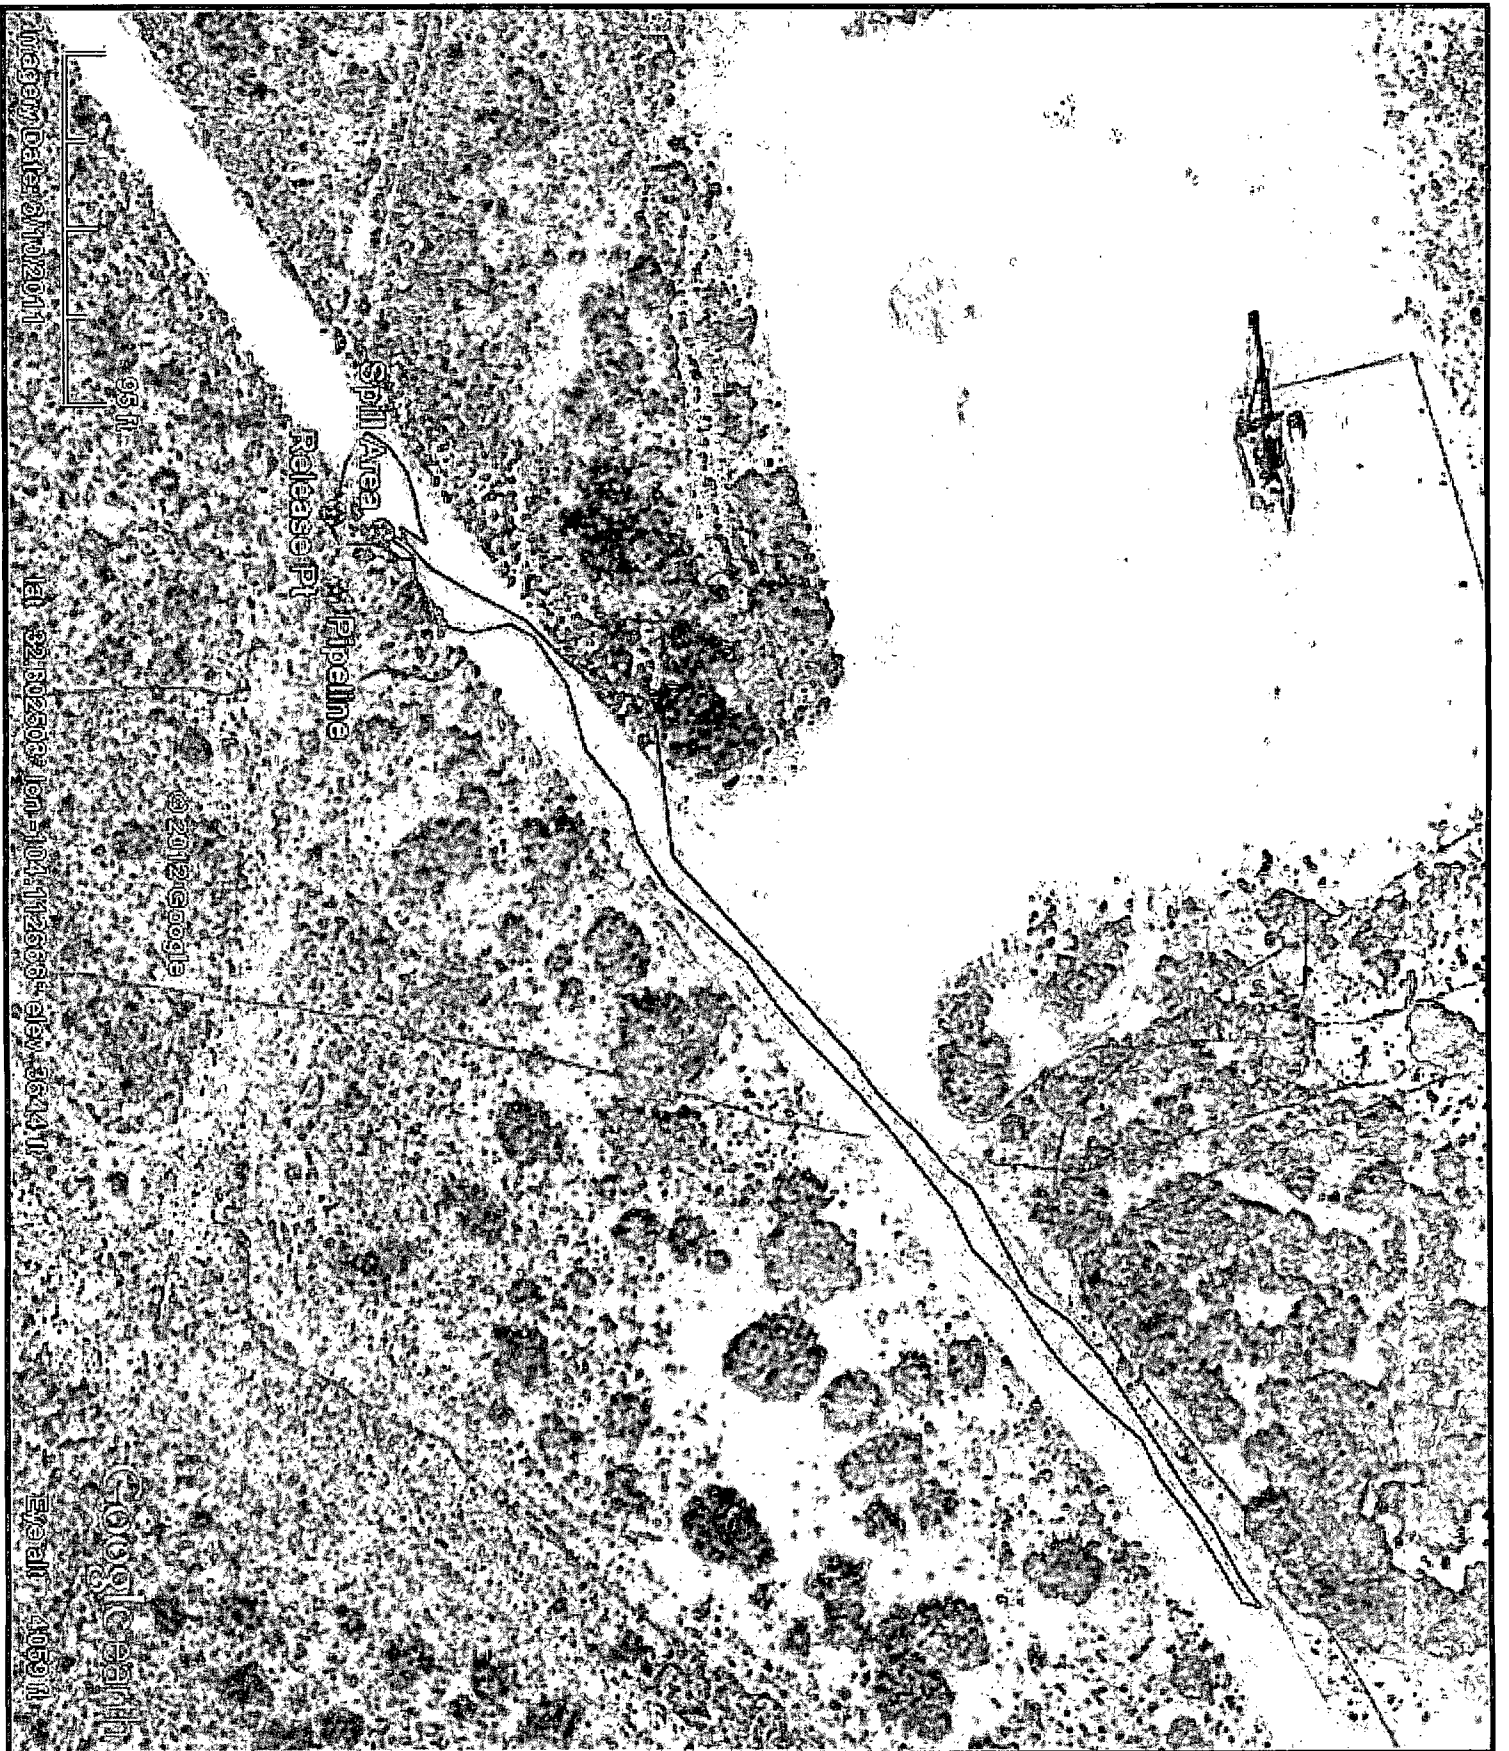
Figure 2
Site Plan

Spill Area
Pipeline
Release Pt

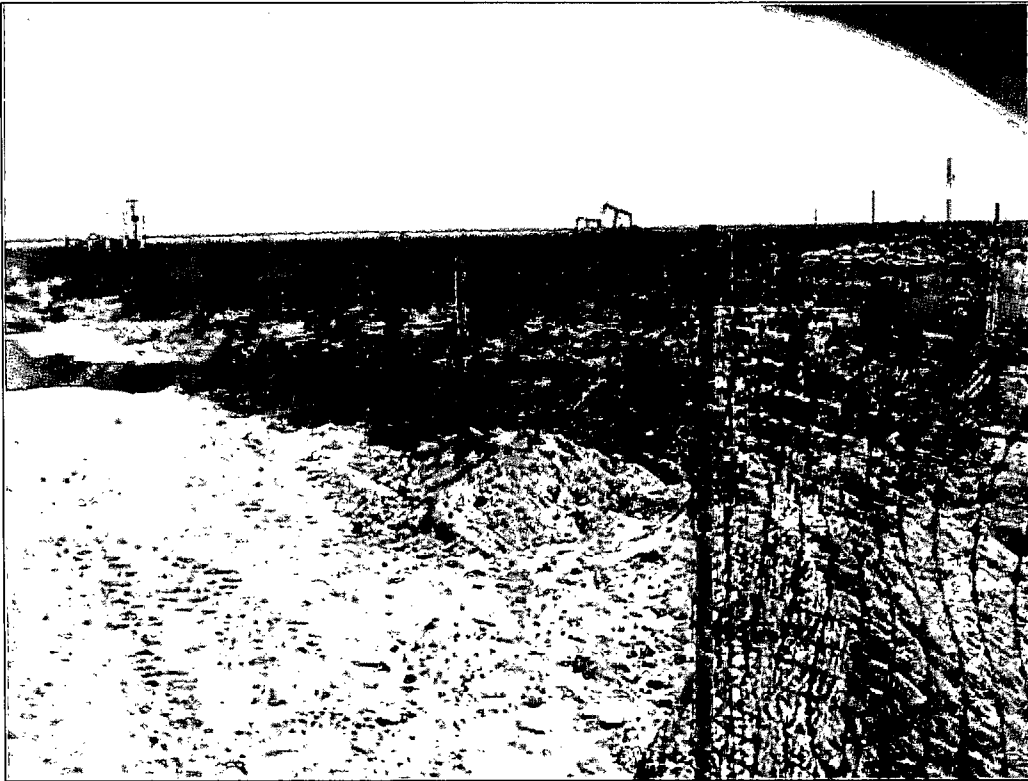
Impacted area around excavation

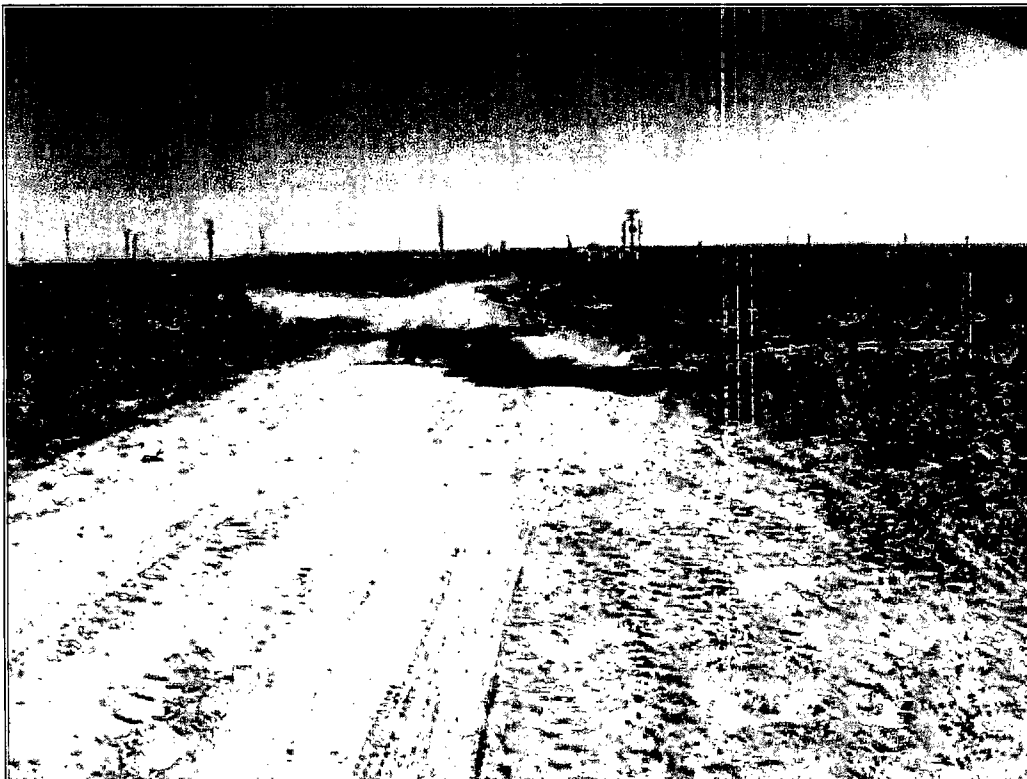
Impacted area in roadway

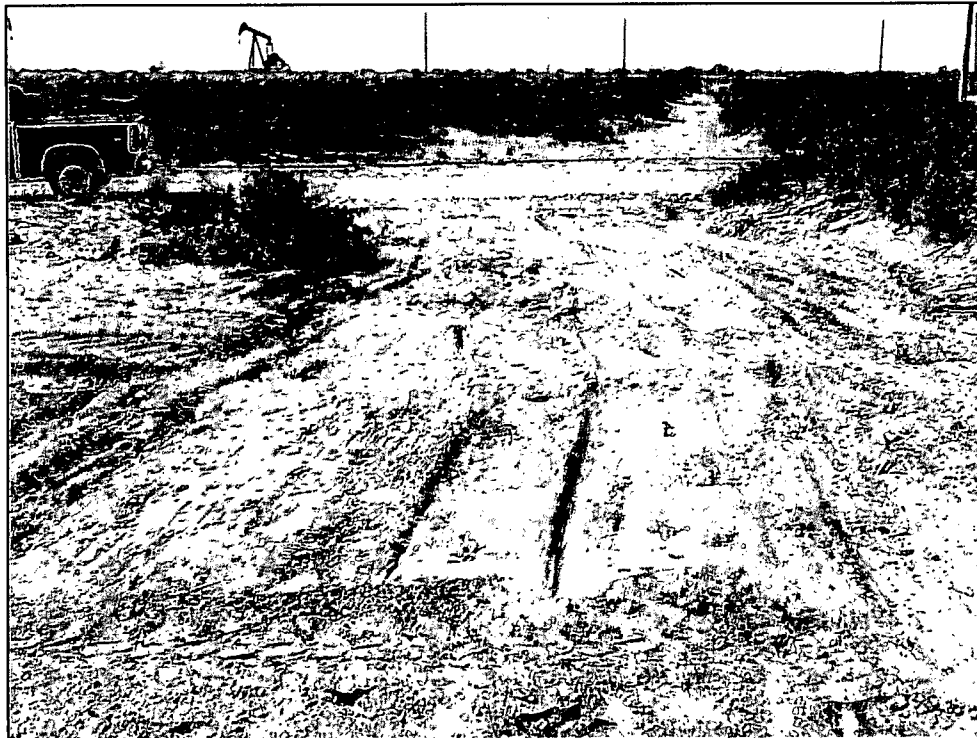
Photo #2 – Facing North showing dirt pile removal from location

Excavated soils were disposed at R360 Landfill, an NMOCD approved facility on July 8 and 9, 2013. (Appendix A)

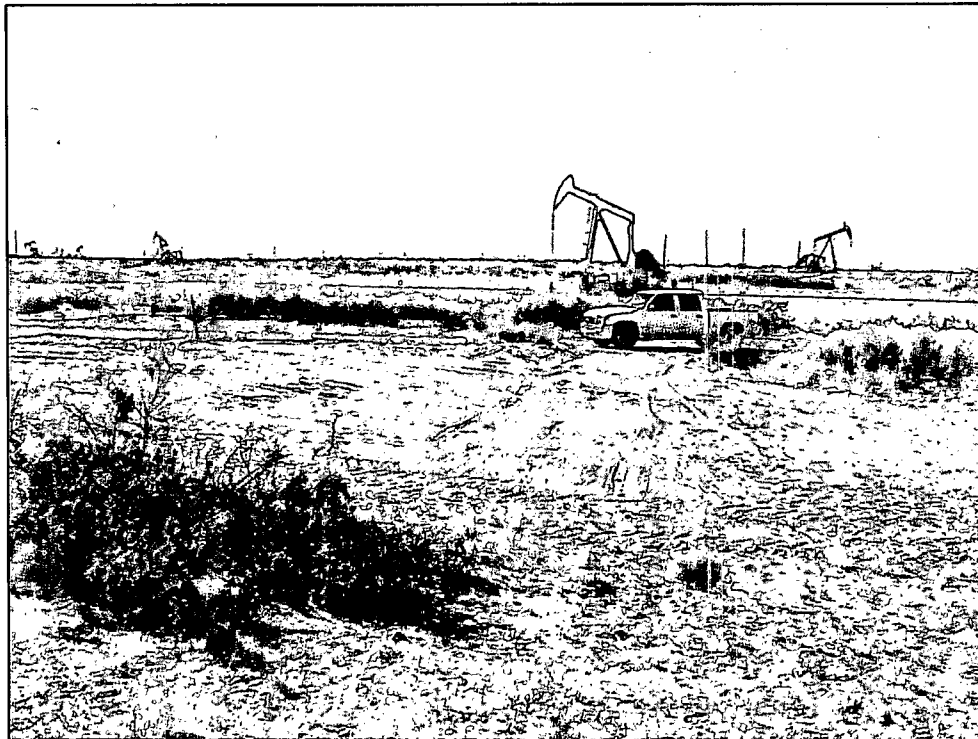
Photo #4 – Picture showing dirt pile removal from location
