**Removal of Wash
Bay Effluent
Holding Tank
Date:
5/2011**

**Key Energy Services
U.S. Highway 64 Truck Yard**

**Removal of Wash Bay Effluent Holding Tank
Remediation of Discovered Hydrocarbon Impacted Area
Decommissioning and Closure of Four Wash Bay Sumps**

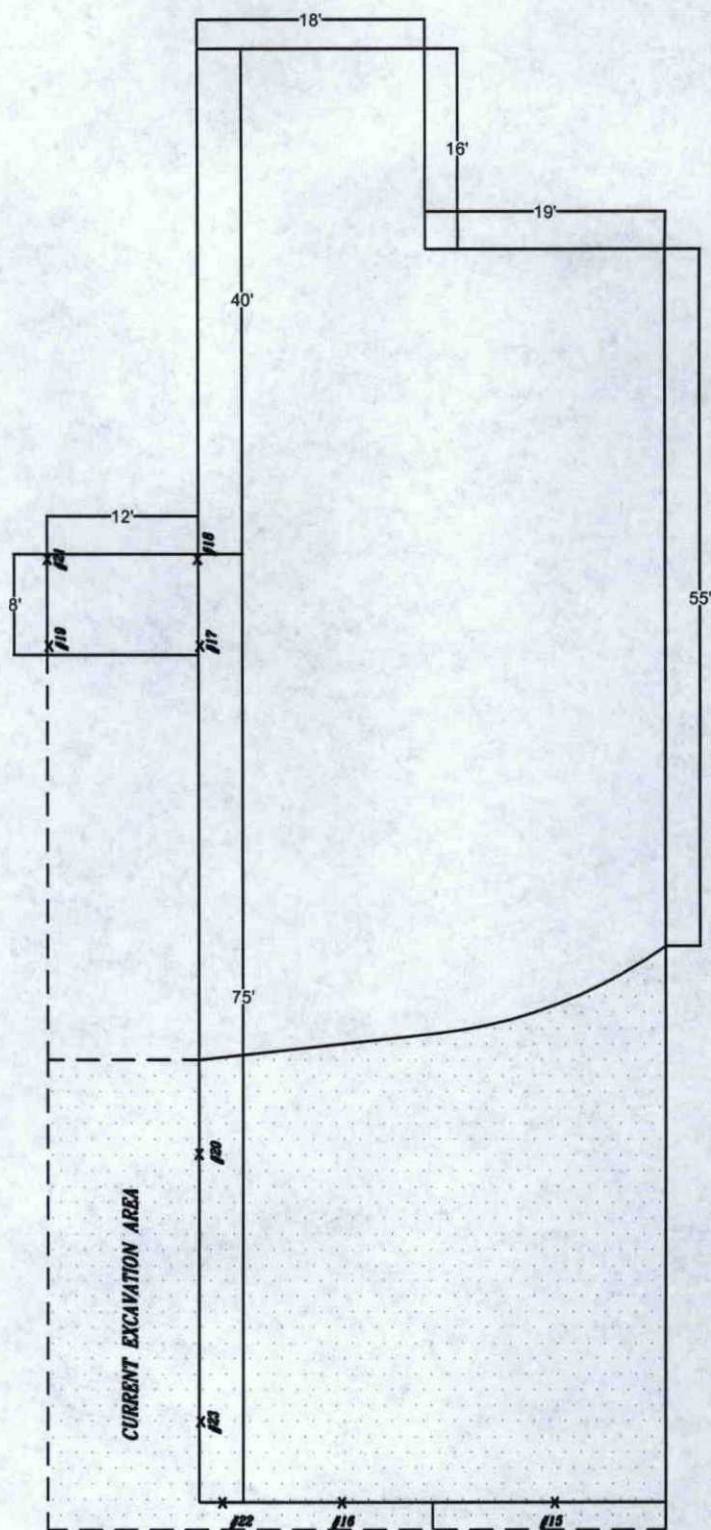
FIGURE 3

for field screening for TPH by Petroflag® to guide the direction and depth of excavation. Figure 3, Key Energy Yard, Excavation Diagram, dated 7/1/11-7/5/11 illustrates the locations where soil samples for field screening were collected. As all field screening results to the south and west continued to be over closure levels, no soil samples were collected for laboratory analysis. SWFS also loaded and transported 252 cubic yards of contaminated soil to IEI for proper disposal and returned with 252 cubic yards of clean backfill material. Disposal documents are included in Appendix C.

KEY ENERGY SERVICES U.S. HIGHWAY 64 YARD
7/1/2011 TO 7/5/2011 SAN JUAN COUNTY, NM

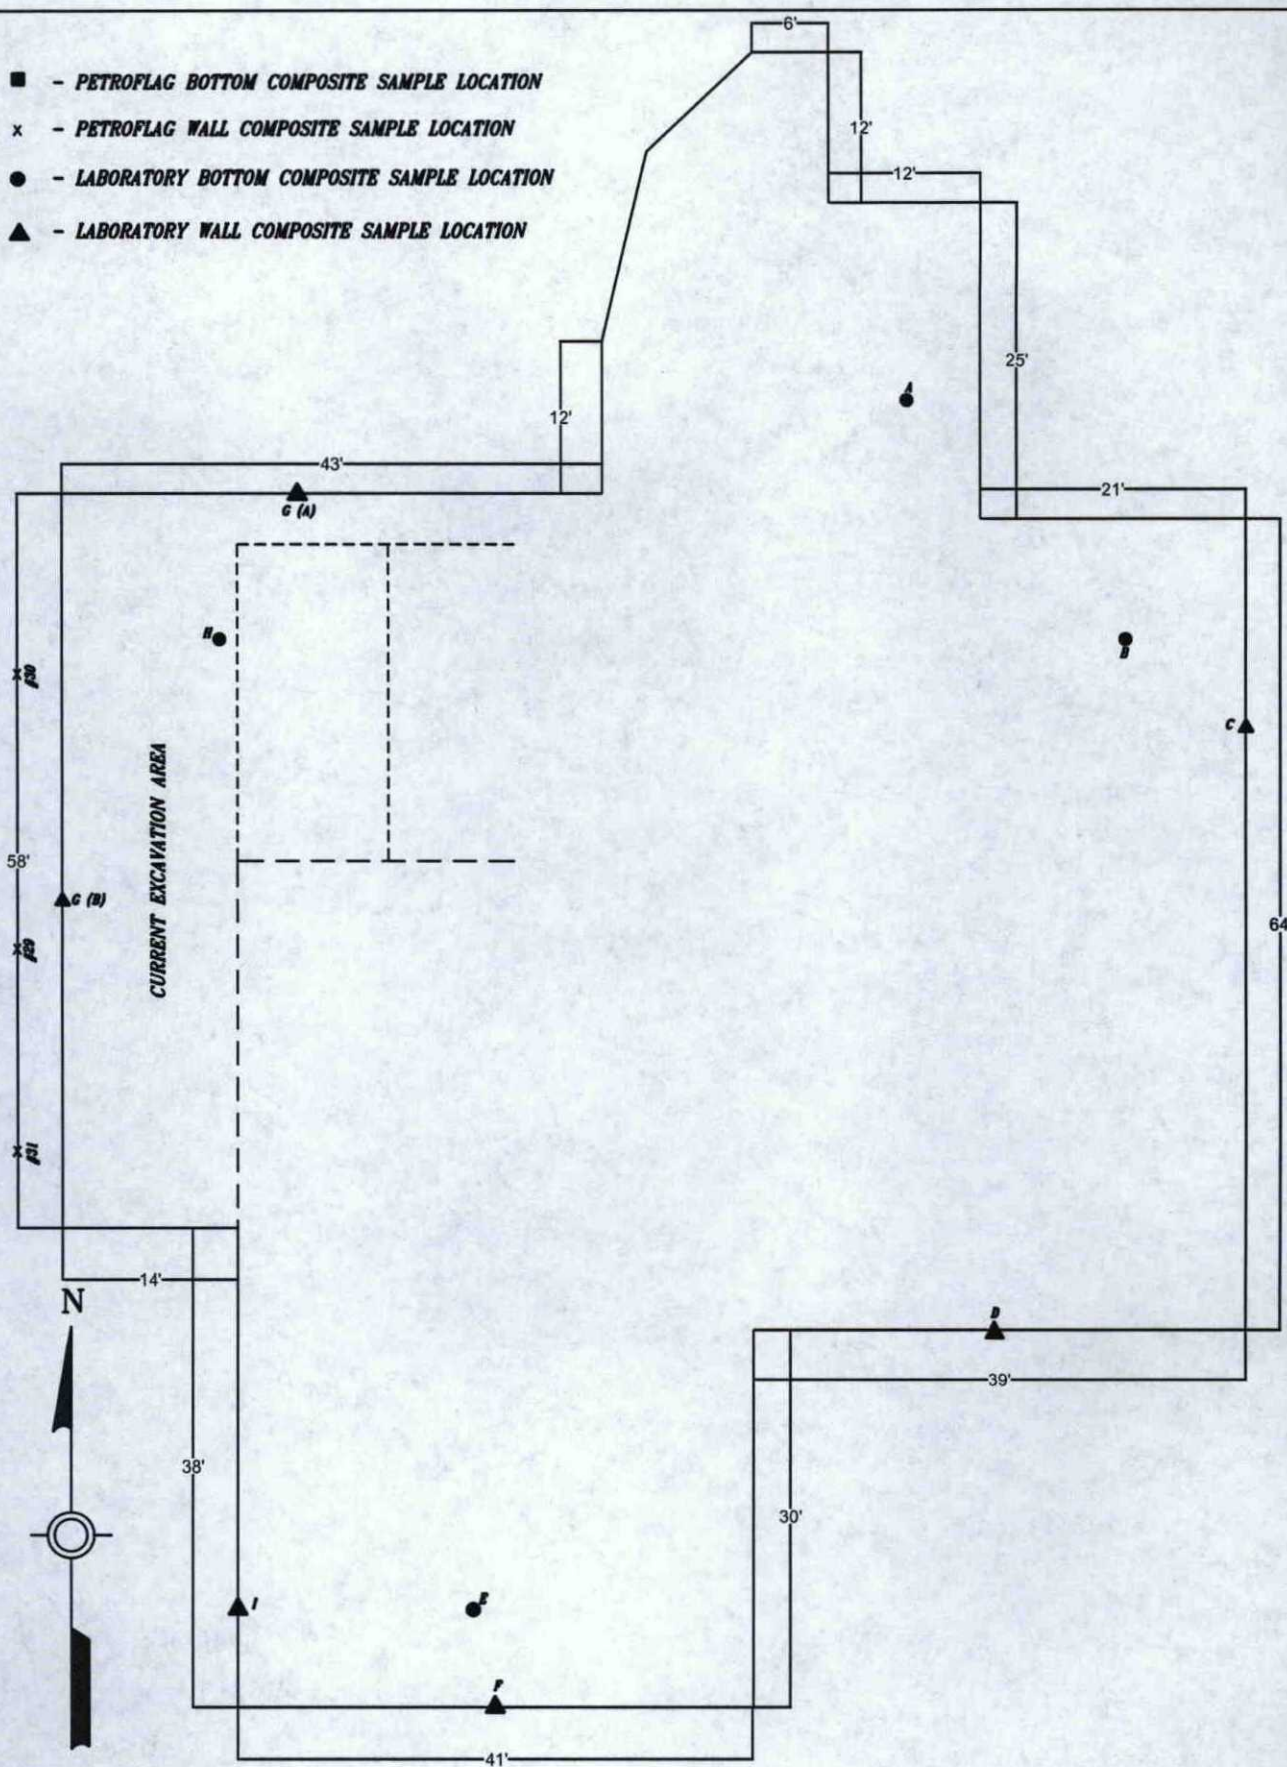
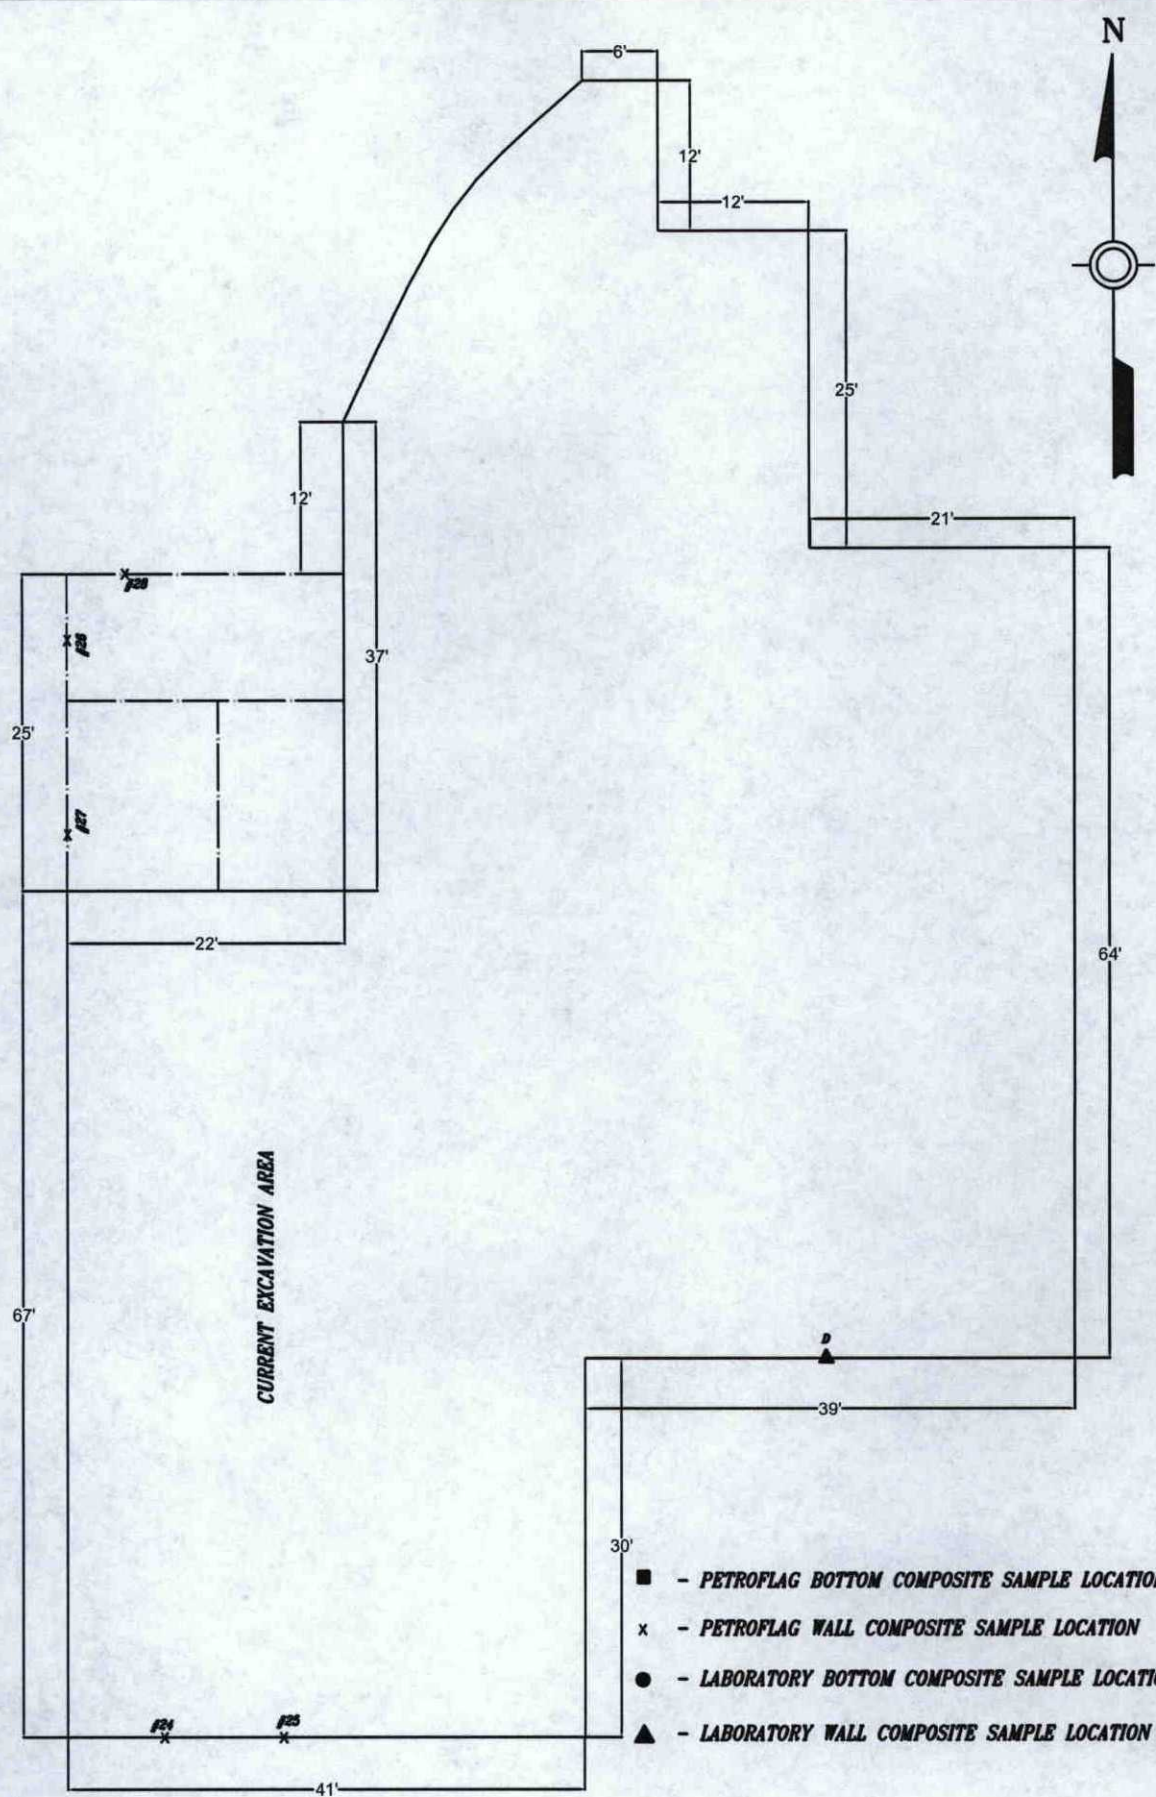
FIGURE 5

Figure 5, Key Energy Yard, Excavation Diagram, dated 7/8/11, illustrates the final dimensions of the excavation and where all composite closure soil samples were collected for laboratory analysis and closure confirmation. July 11, 2011 to July 14, 2011, under the supervision of SMA, SWFS loaded and transported 222 cubic yards of contaminated soil to IEI for proper disposal and returned with clean backfill material. As the impacted soil was being loaded and disposed, SWFS also began to backfill the excavation. Prior to placing backfill on top to the

KEY ENERGY SERVICES U.S. HIGHWAY 64 YARD
7/8/2011 SAN JUAN COUNTY, NM

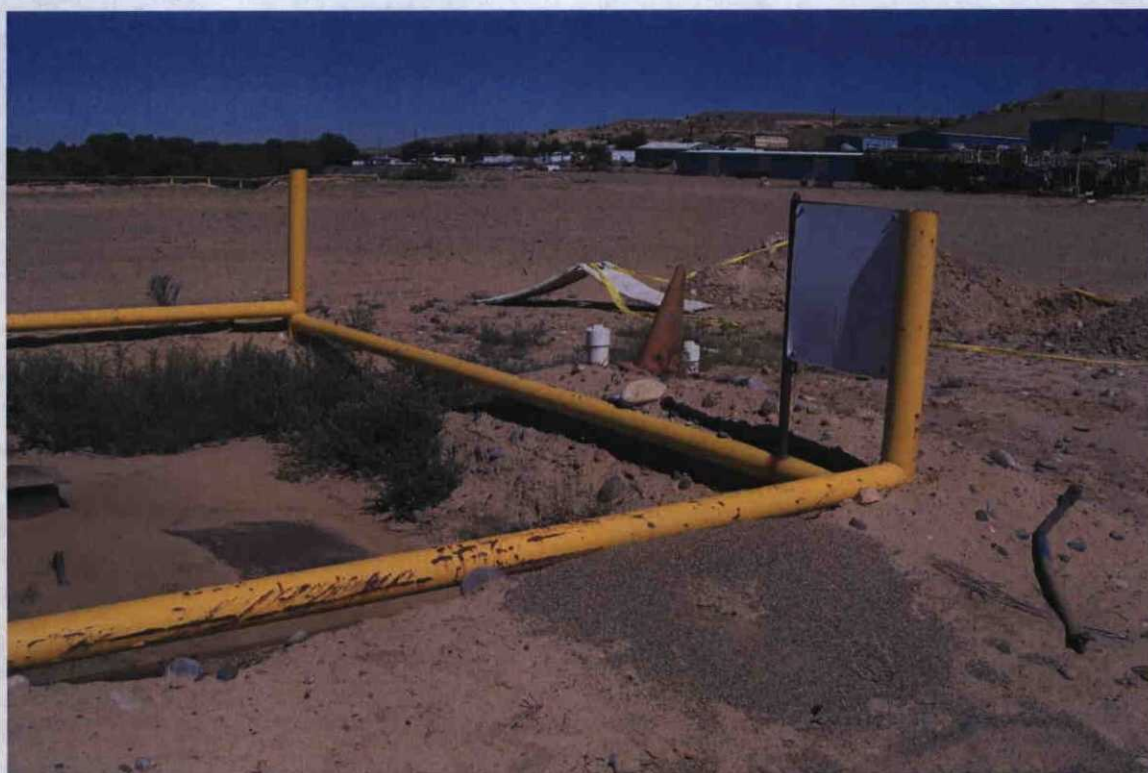
Photo 1: View of the wash tank and bollards.

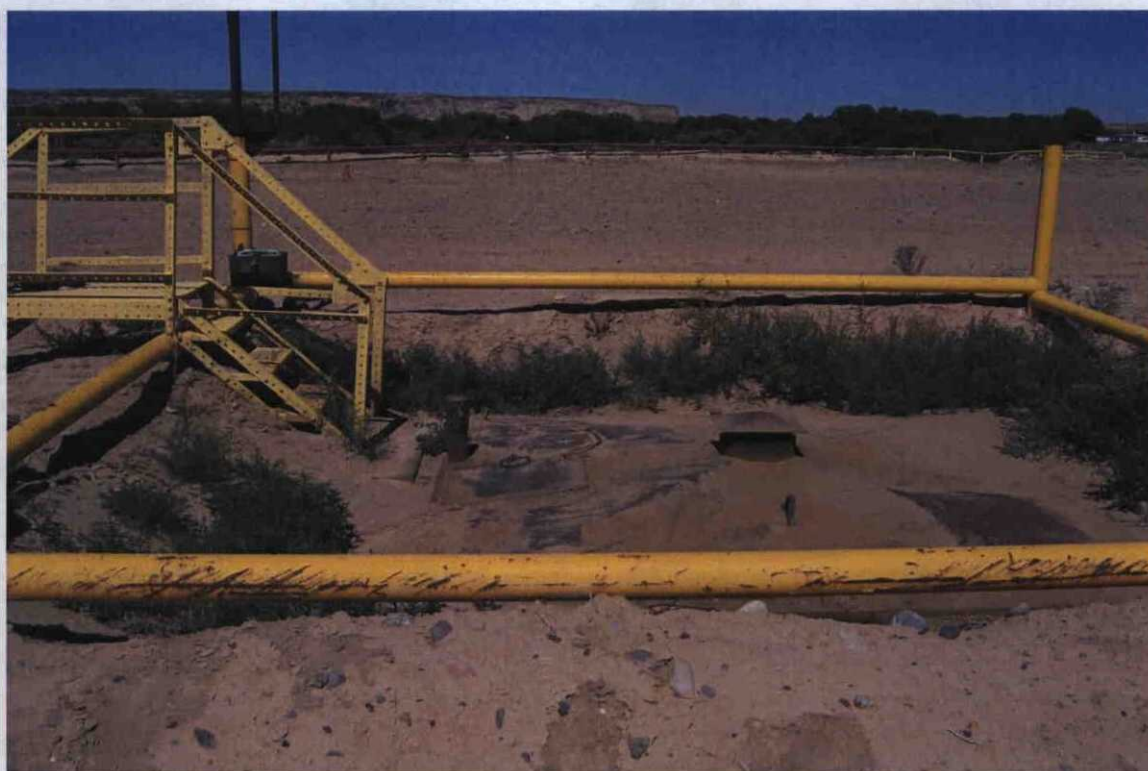
Photo 2: View of the wash tank and bollards.

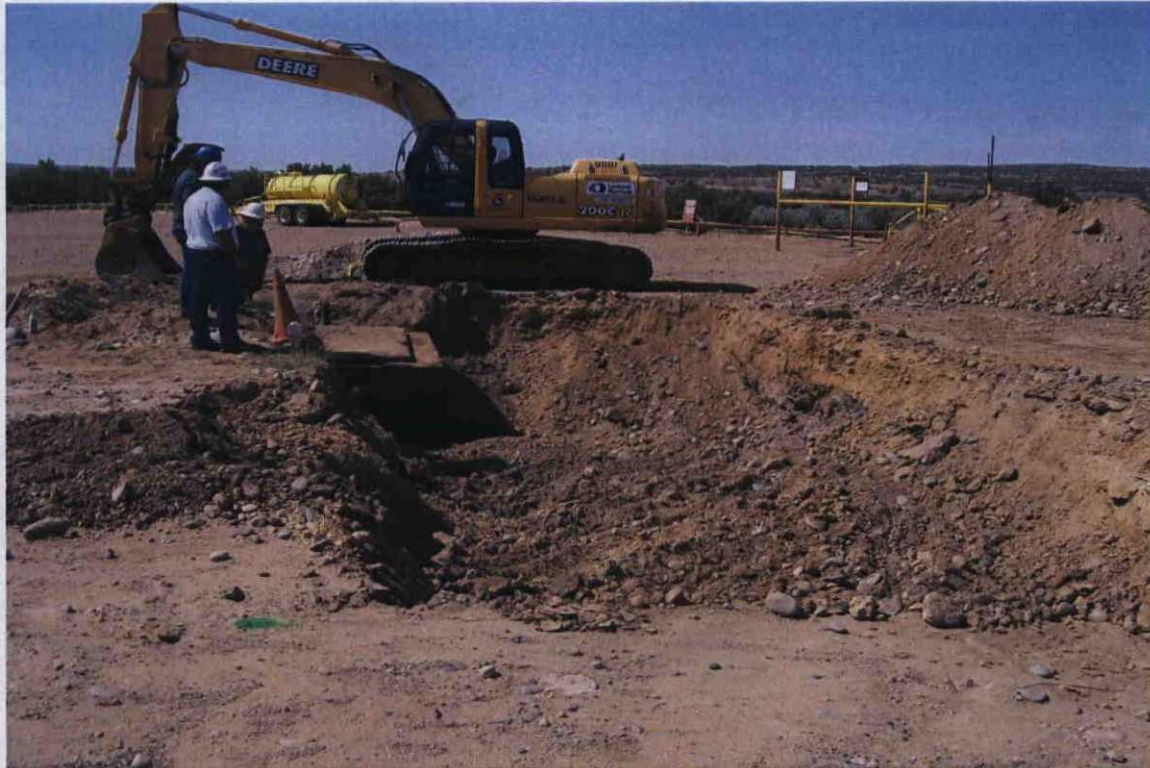
Photo 3: View of the excavation around the wash tank.

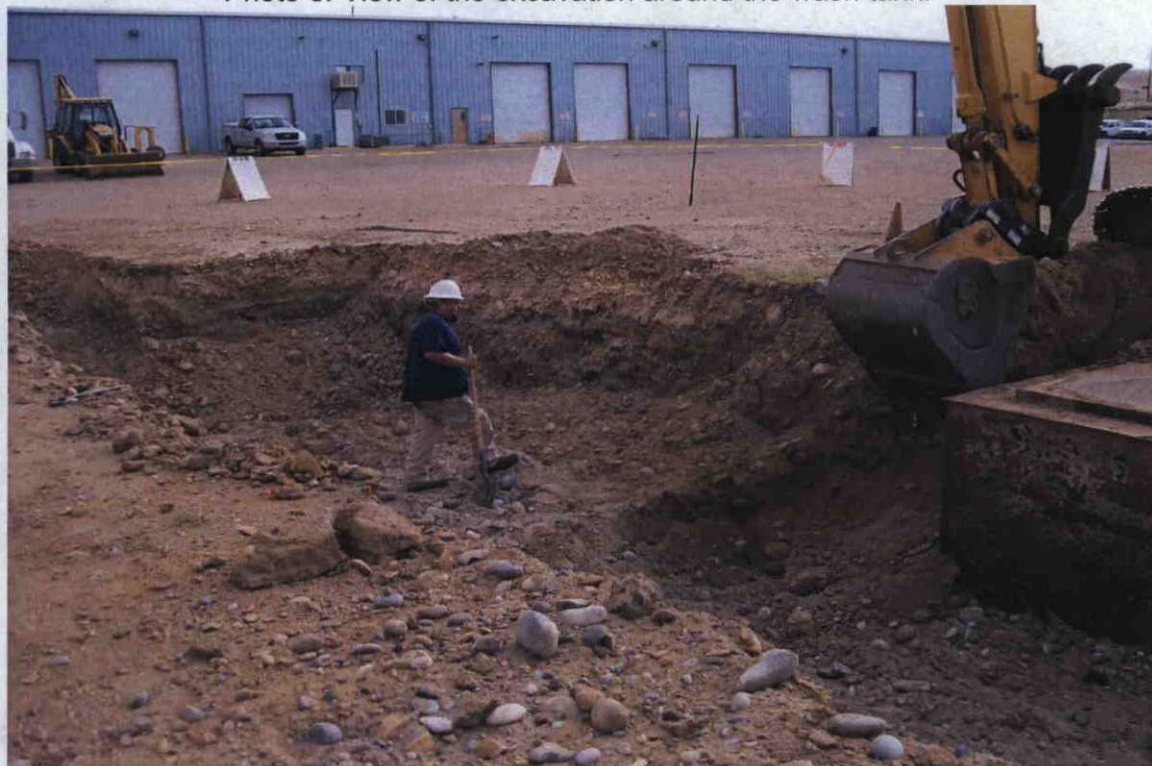
Photo 4: View of the excavation around the wash tank.

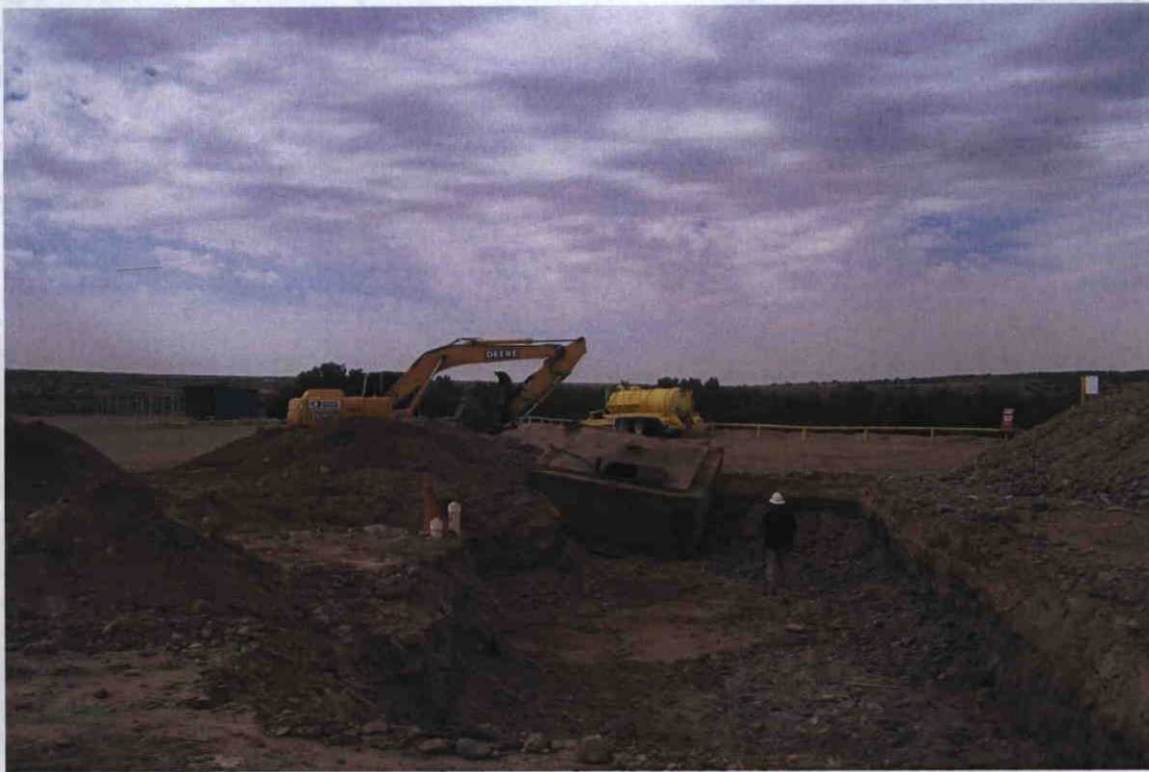
Photo 5: View of the removal of the wash tank.

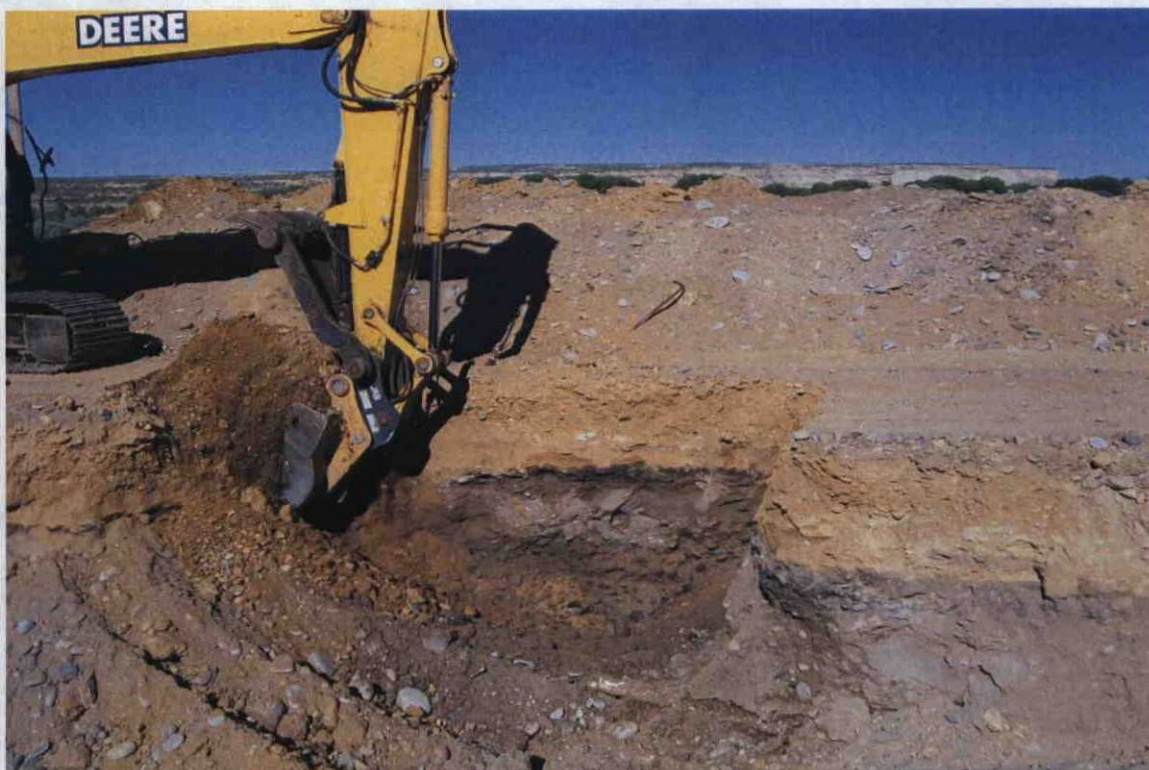
Photo 6: View of excavation activities along the southwest wall.

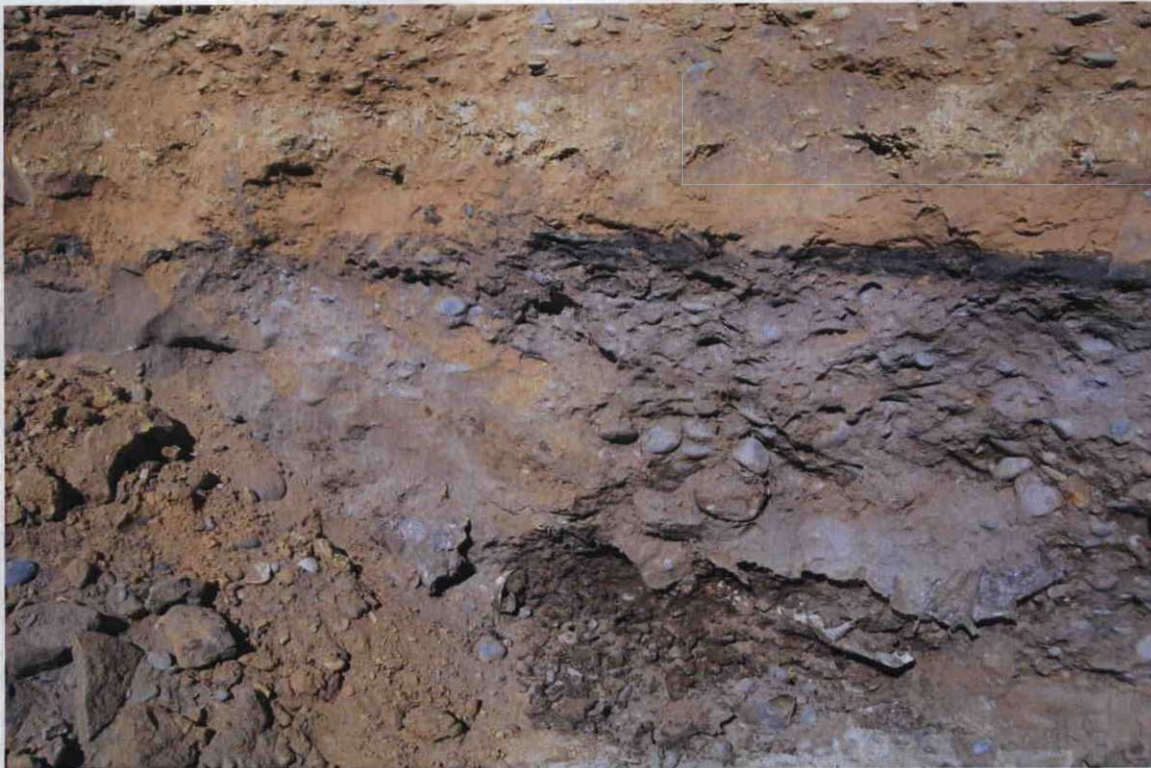
Photo 7: View of contaminated soil on the west side before excavating.

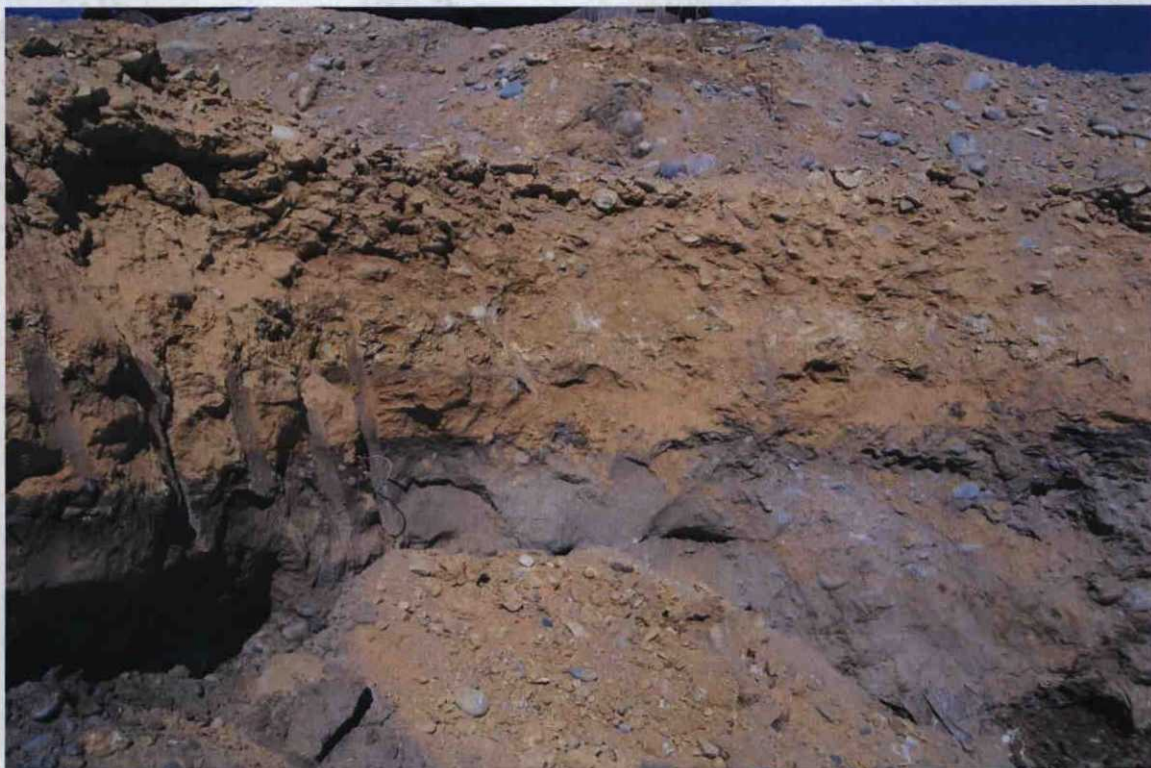
Photo 8: View of the contaminated soil on the west side before excavating.

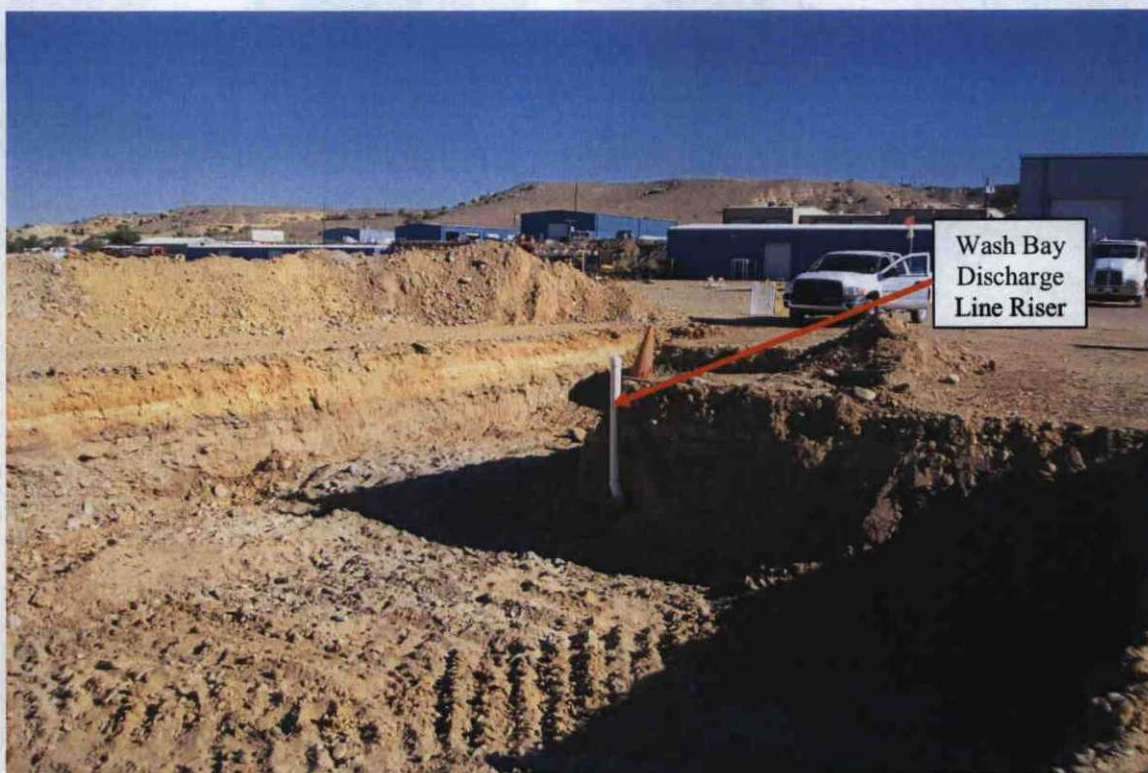
Photo 9: View of the northwest side of the excavation.

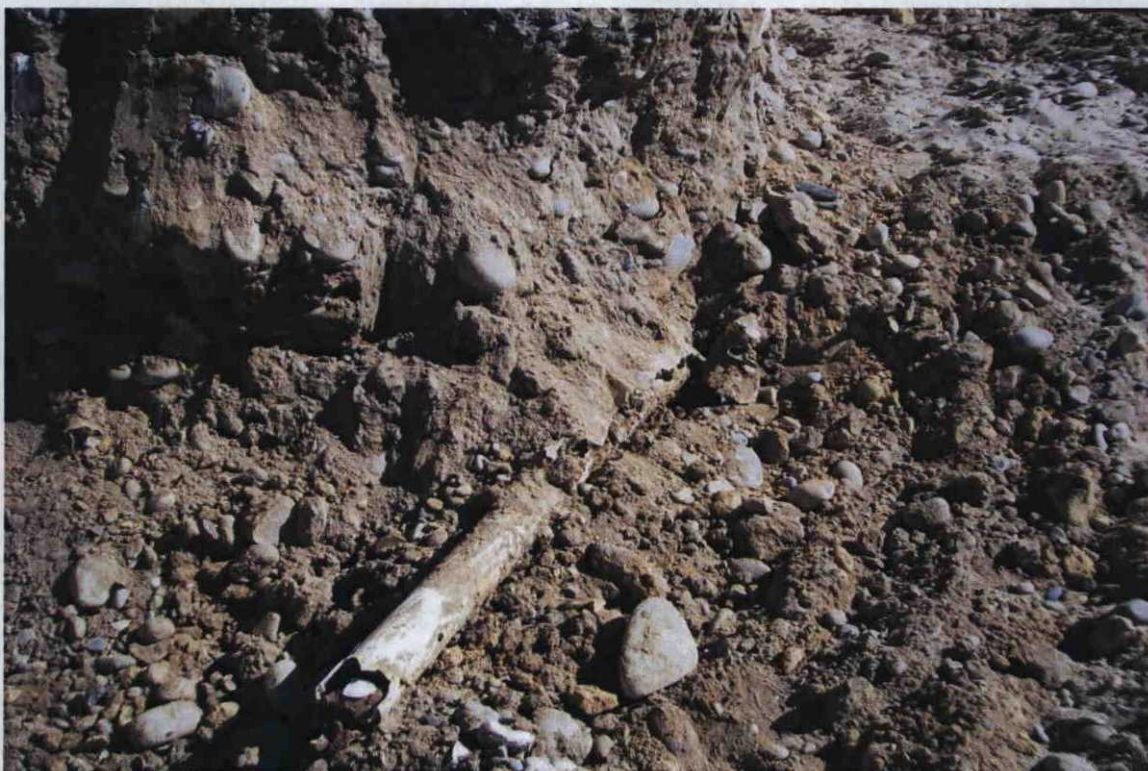
Photo 10: View of a leach line discovered during excavation activities on the northwest side.

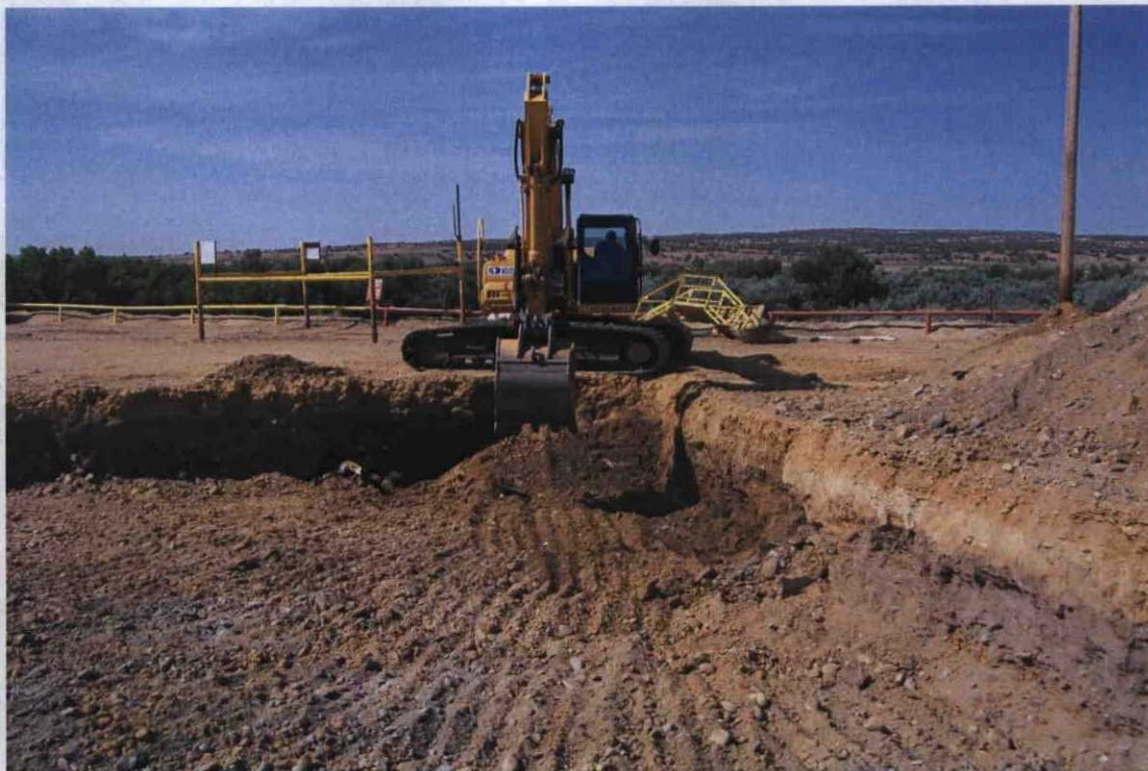
Photo 11: View excavation activities on the southwest corner.

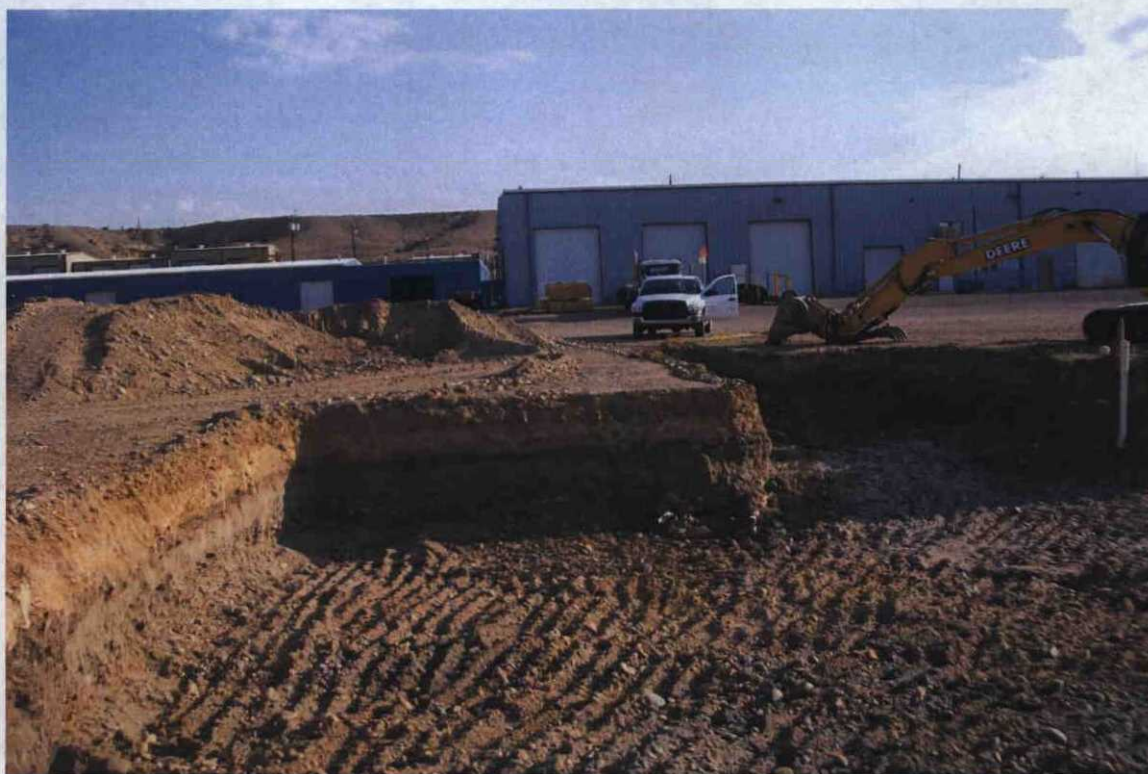
Photo 12: View of the excavation, view from the south.

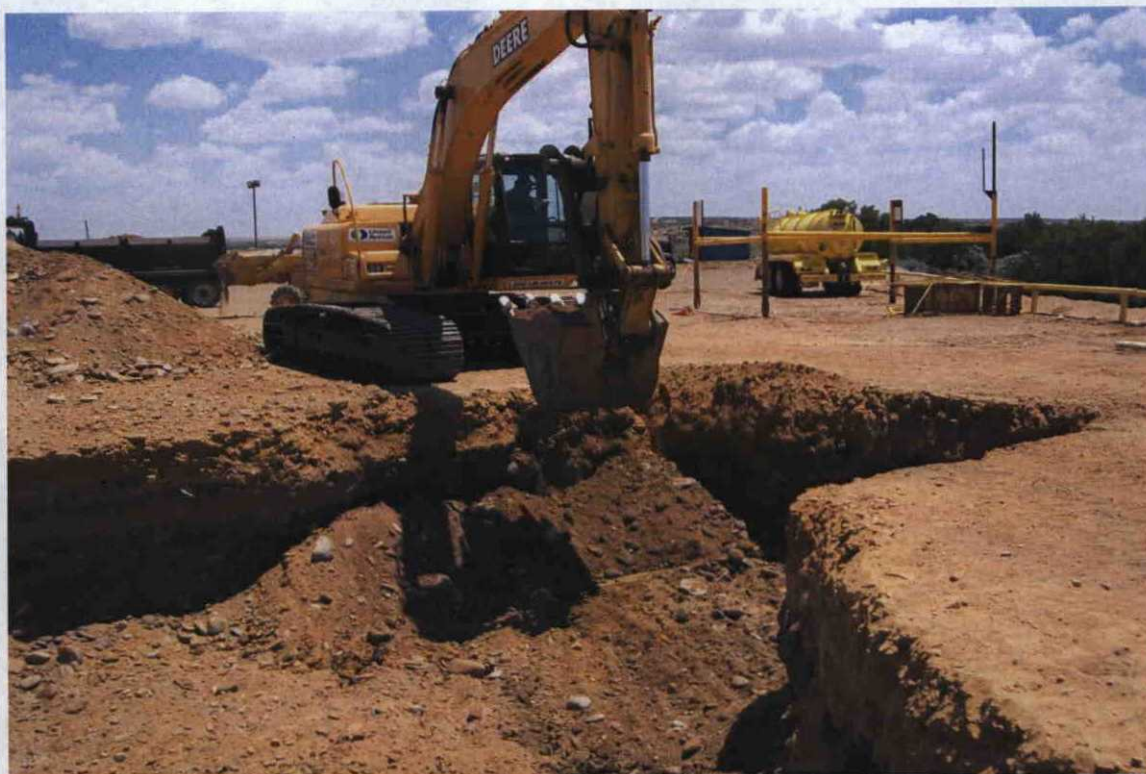
Photo 13: View of excavating activities on the south side.

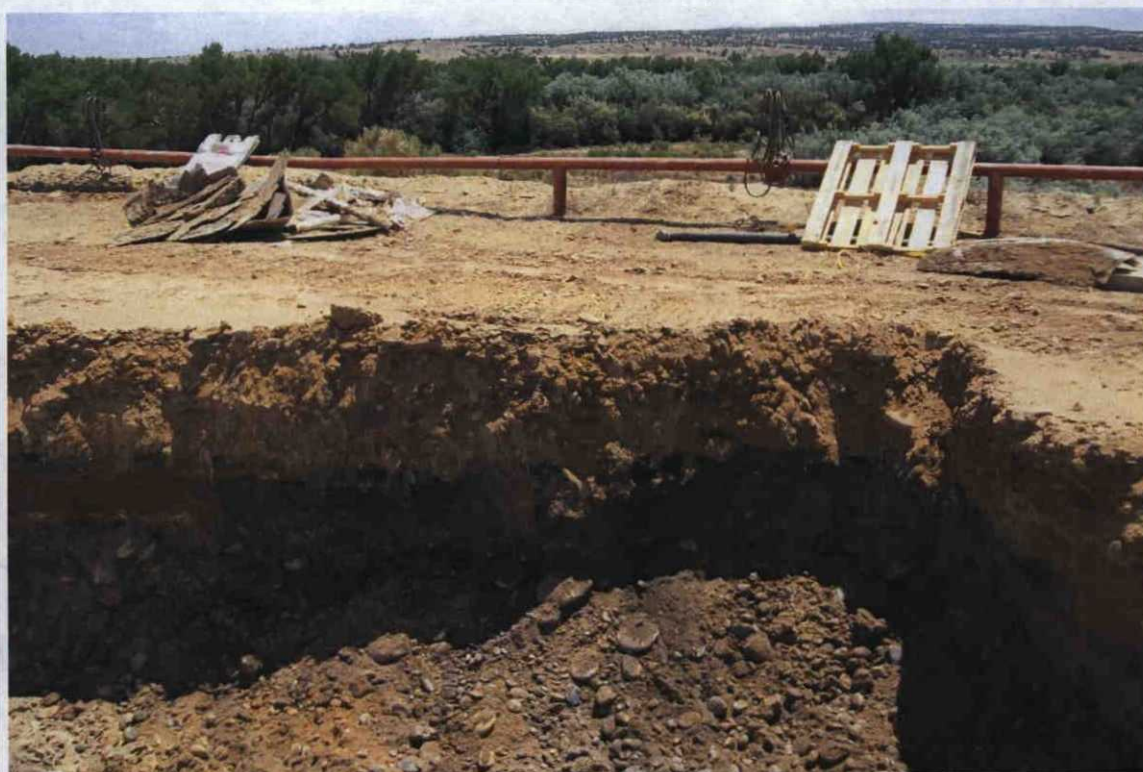
Photo 14: View of the terminated excavation on the southwest corner.

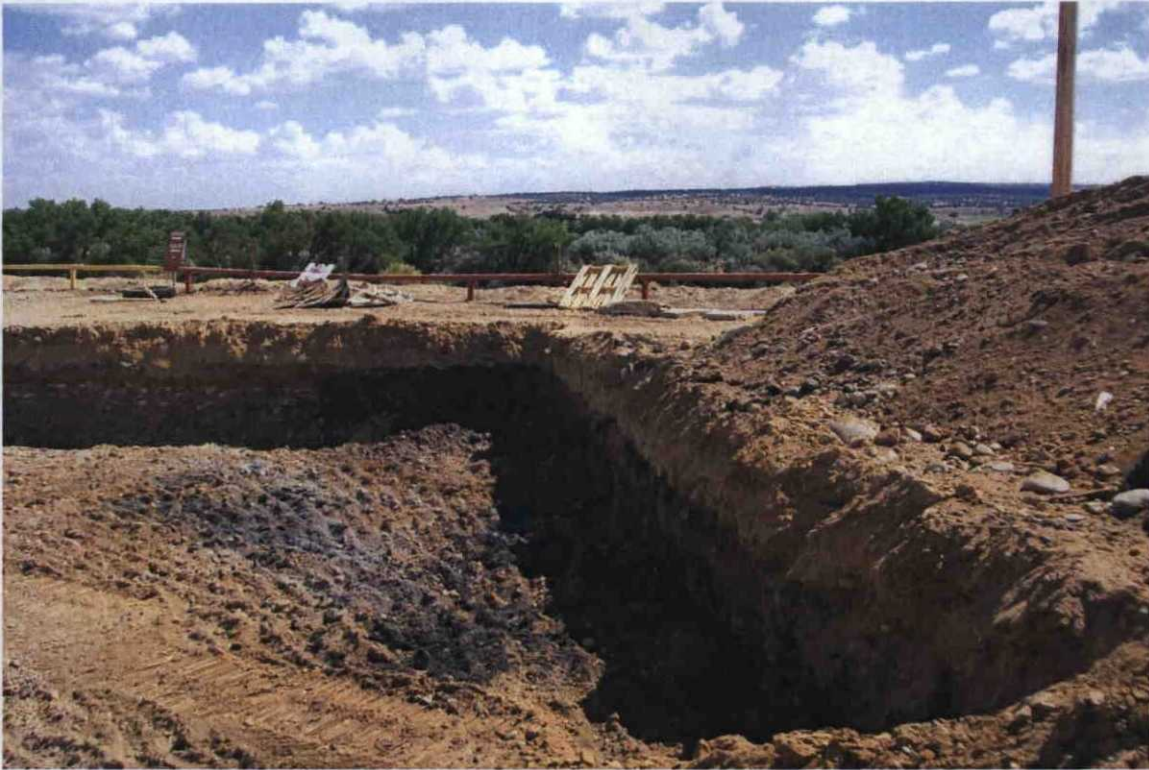
Photo 15: View of the southwest corner of the excavation.

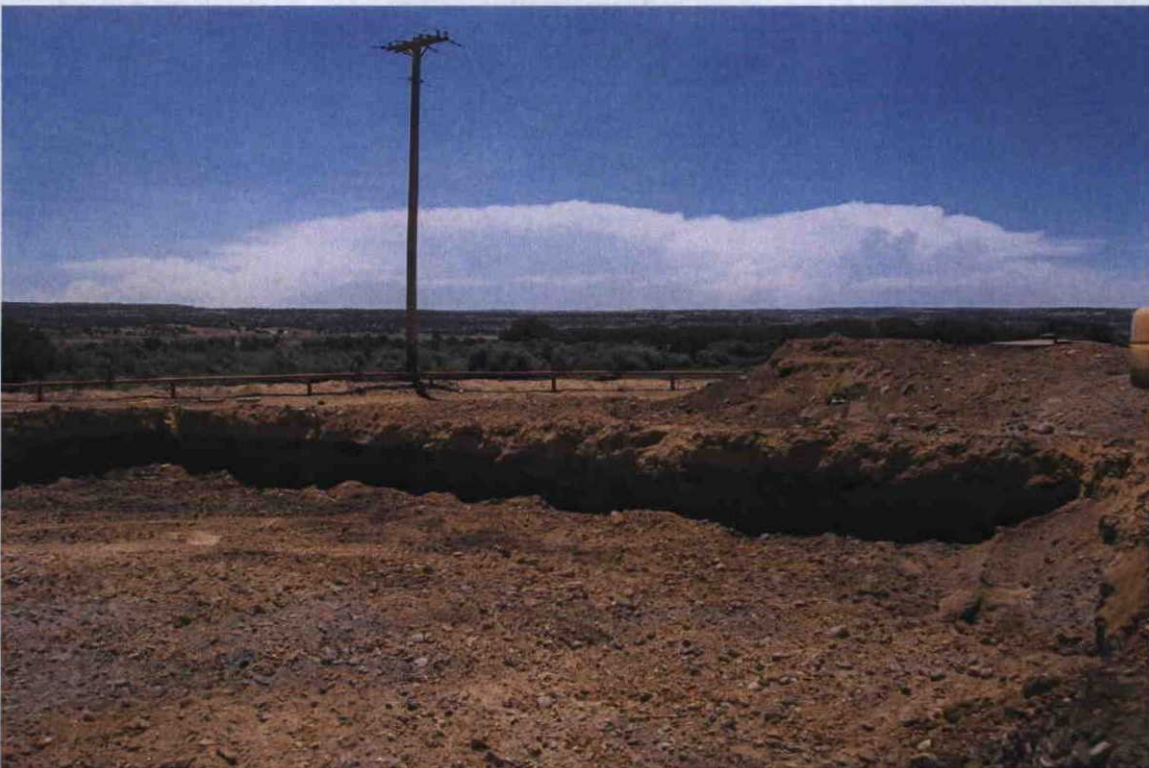
Photo 16: View of the west side of the excavation.

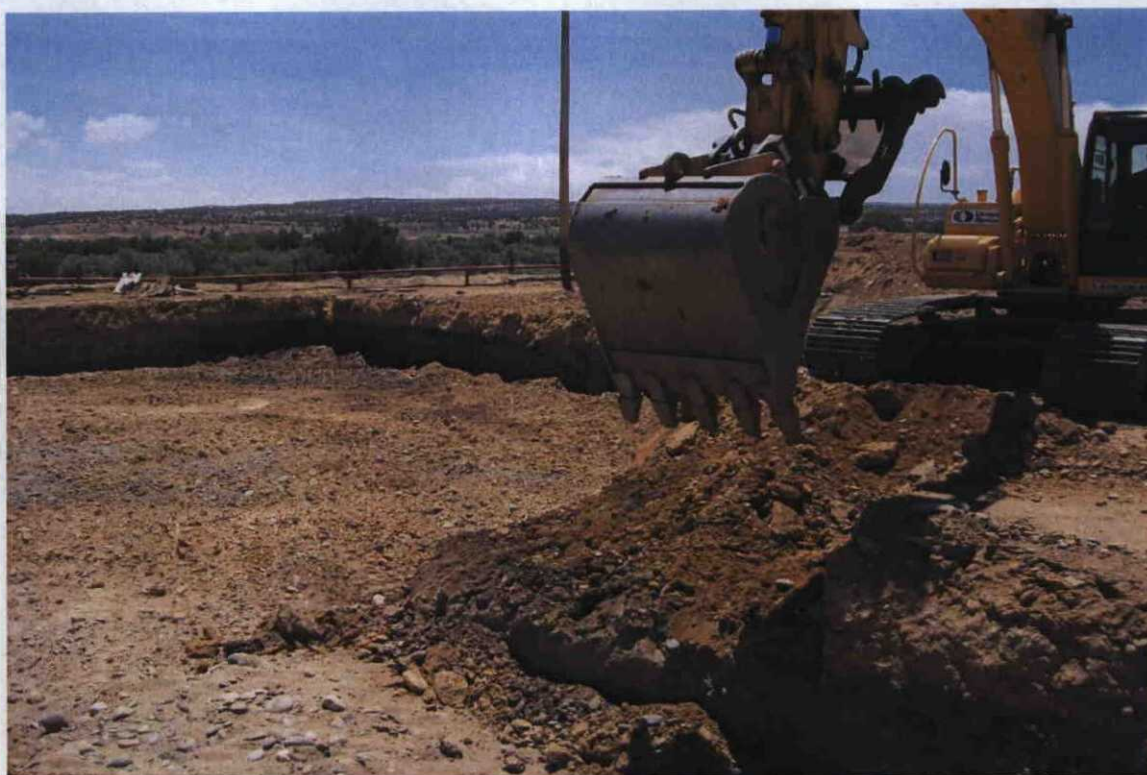
Photo 17: View of excavating activities on the northwest side.

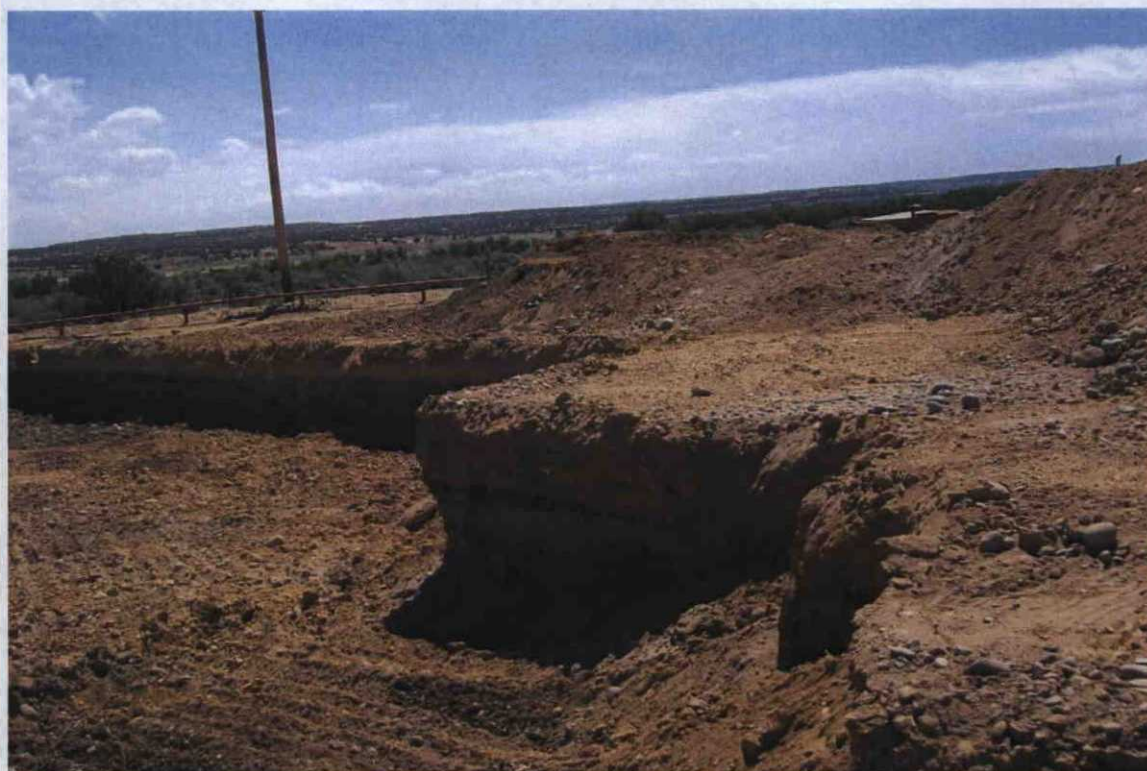
Photo 18: View of the northwest side of the excavation.

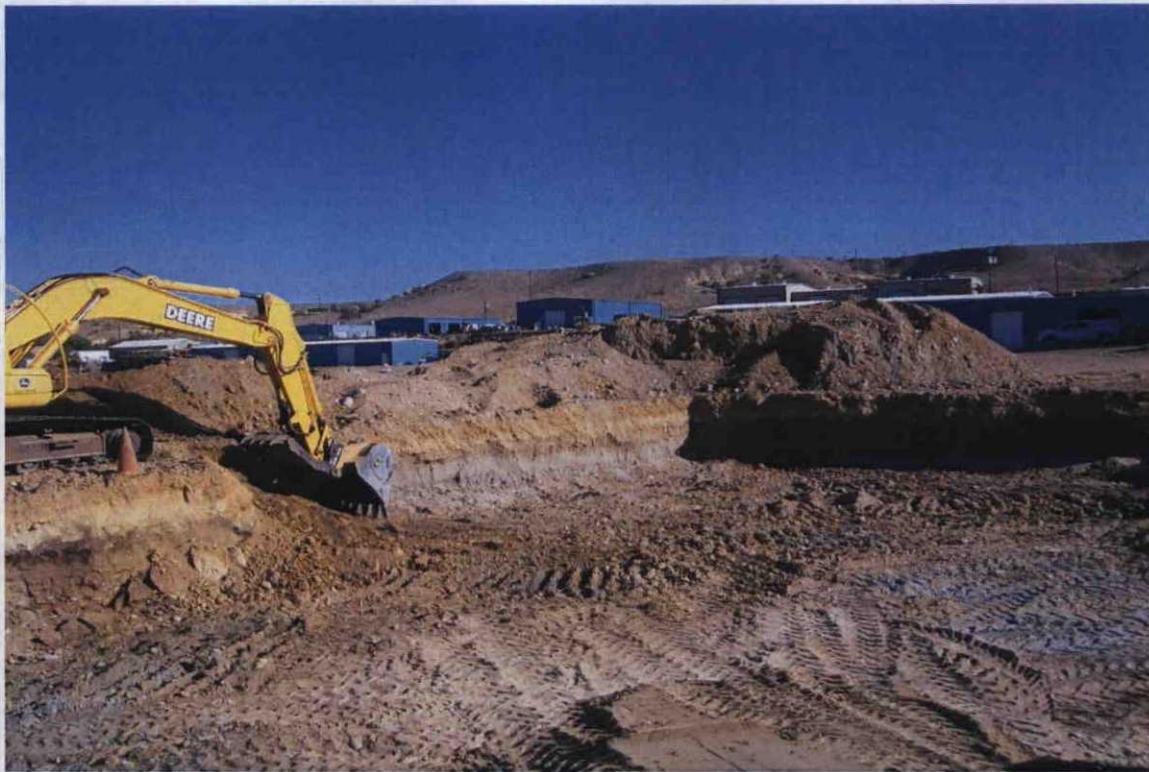
Photo 19: View of the west side of the completed excavation.
