**Removal of Wash
Bay Effluent
Holding Tank
Date:
5/2011**

**Key Energy Services
U.S. Highway 64 Truck Yard**

**Removal of Wash Bay Effluent Holding Tank
Remediation of Discovered Hydrocarbon Impacted Area
Decommissioning and Closure of Four Wash Bay Sumps**

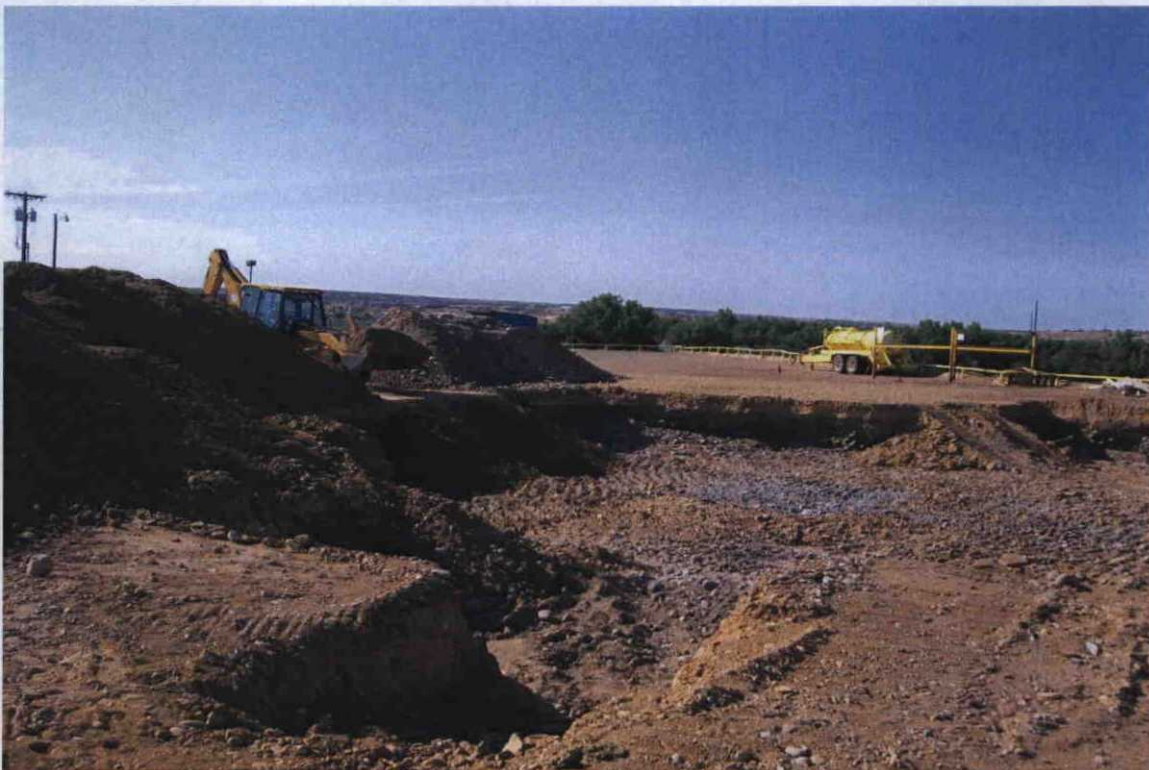
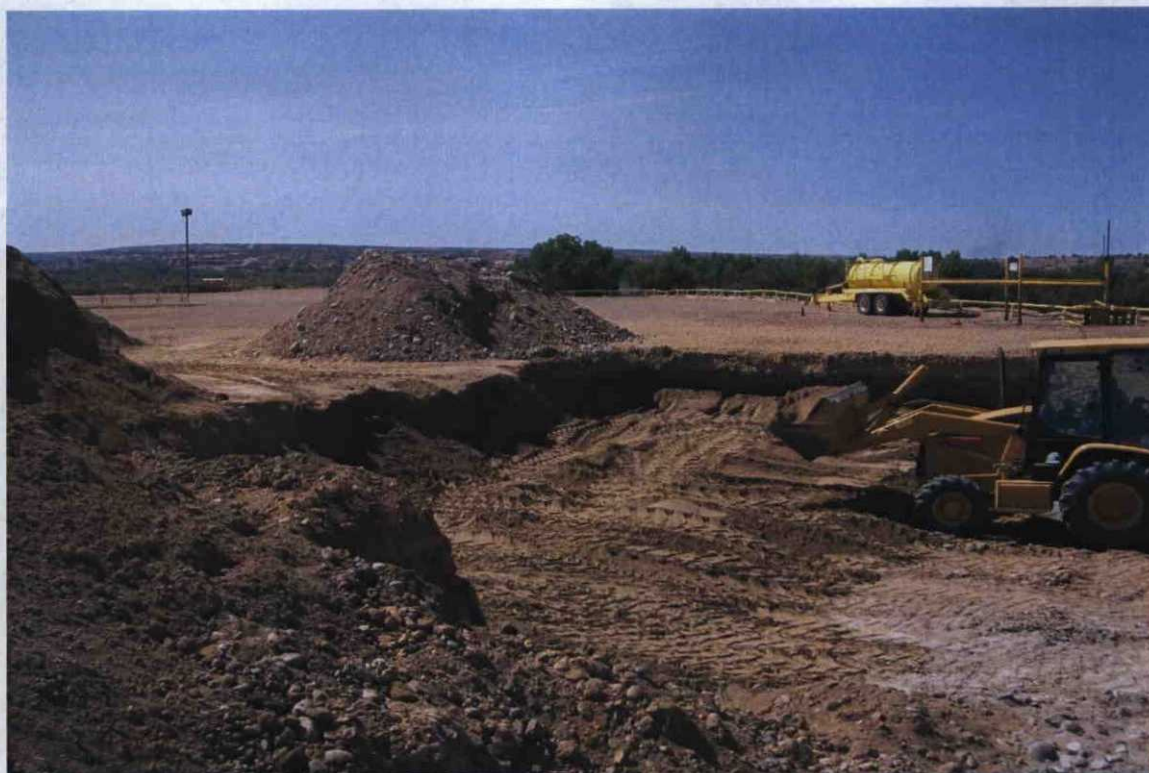
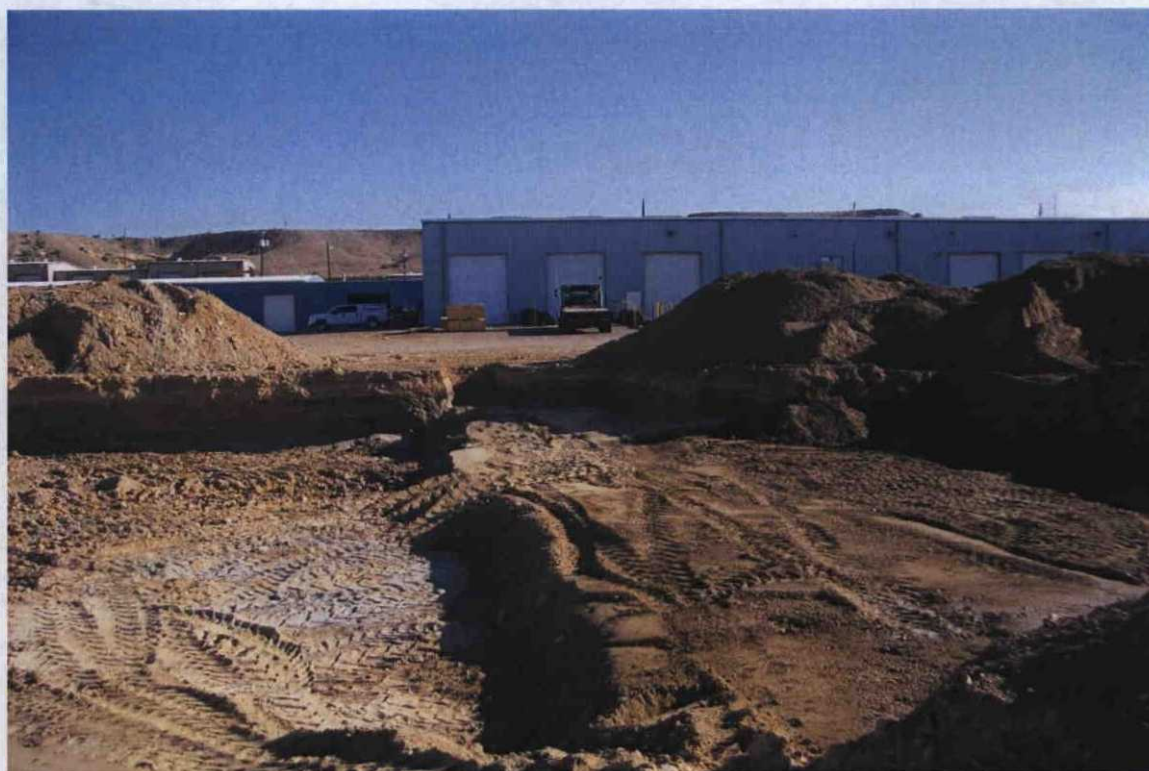
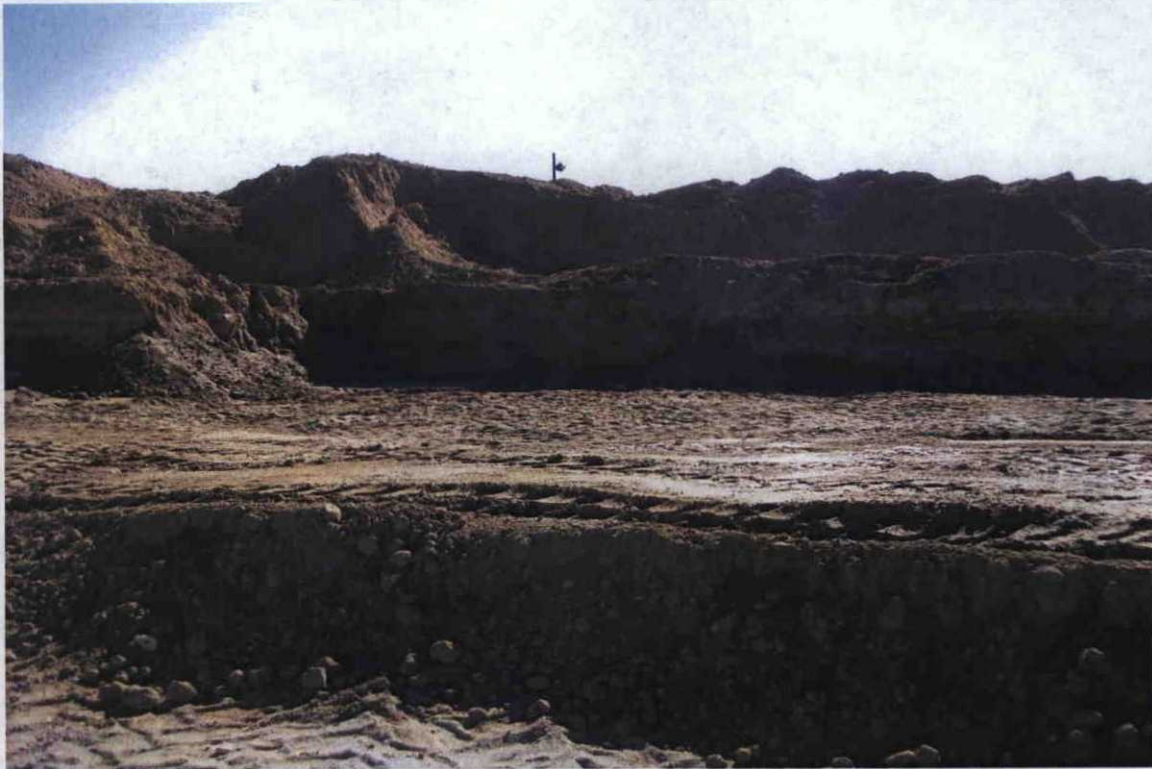
Photo 20: View of backfilling activities on the east side of the excavation.

Photo 21: View of backfilling activities on the east side of the excavation.

Photo 22: View of backfilling activities on the east side of the excavation.

Photo 23: View of backfilling activities on the east side of the excavation.

To backfill the excavation and prevent creation of a soft area subject to subsidence, for each lift, SWFS placed a 1.5 foot lift composed of imported clean fine grained material and then compacted the lift using the back hoe and track hoe. The lift was dampened with water and road base materials composed of larger rocks and gravel was placed onto the lift and then compacted again. This method was continued lift by lift until the entire excavation was backfilled to a depth of approximately six inches bsg. SWFS then placed and compacted a final finish grade lift of one-inch minus road base across the excavation. Photographs of the backfilling and compacting activities are included in Appendix A.

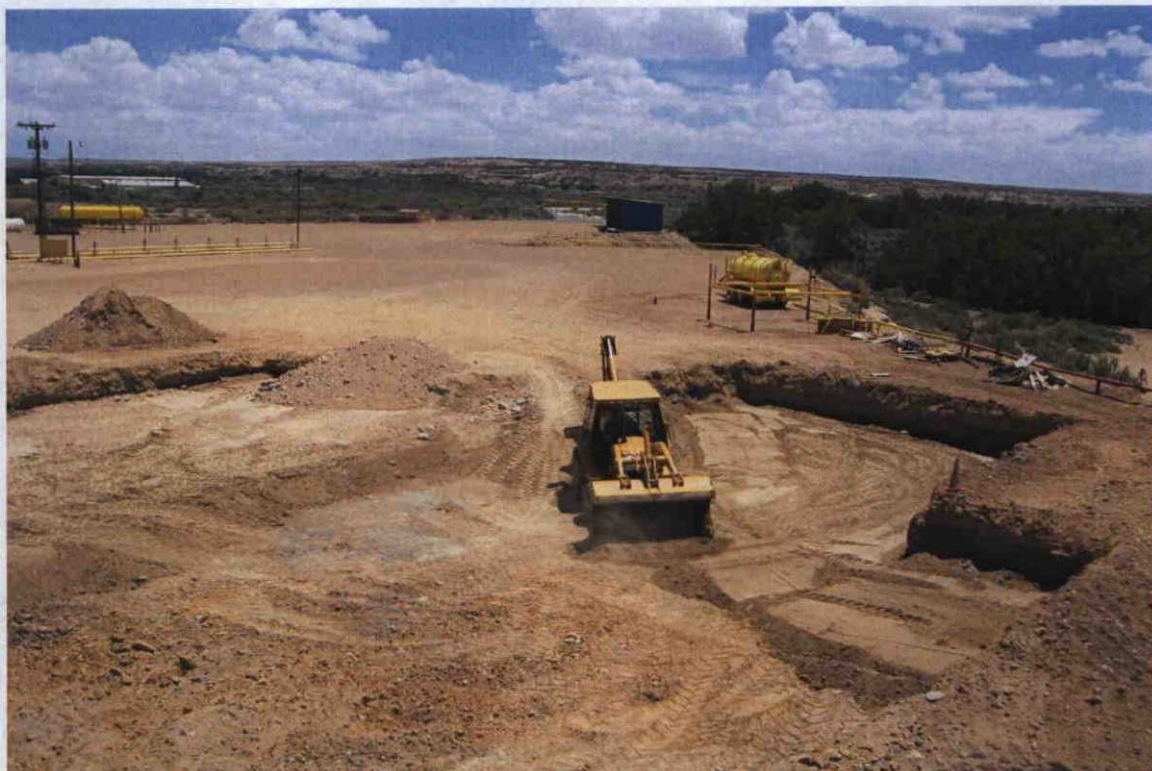
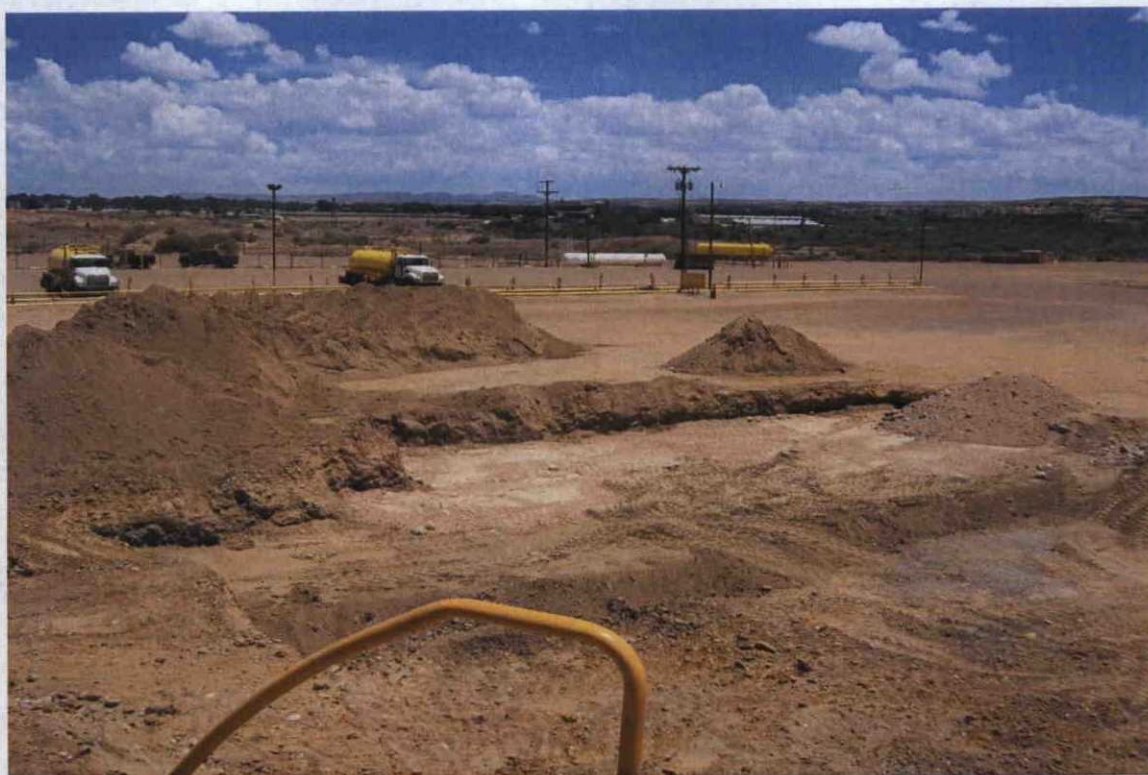
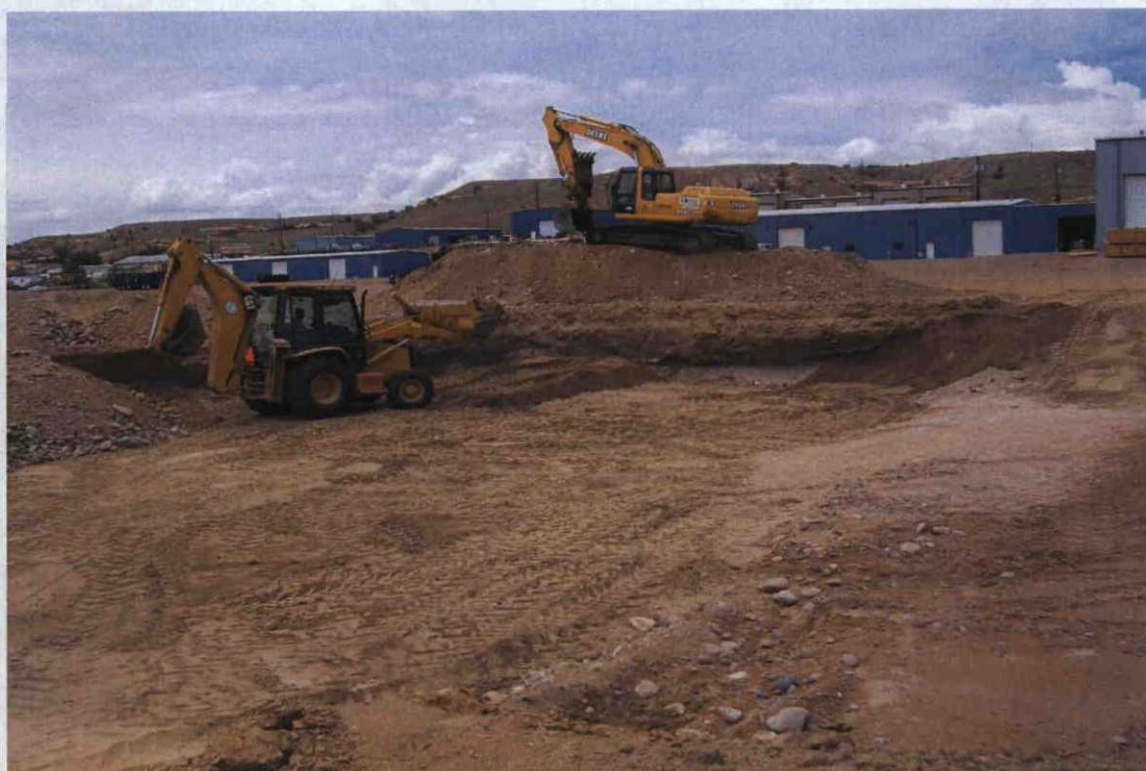
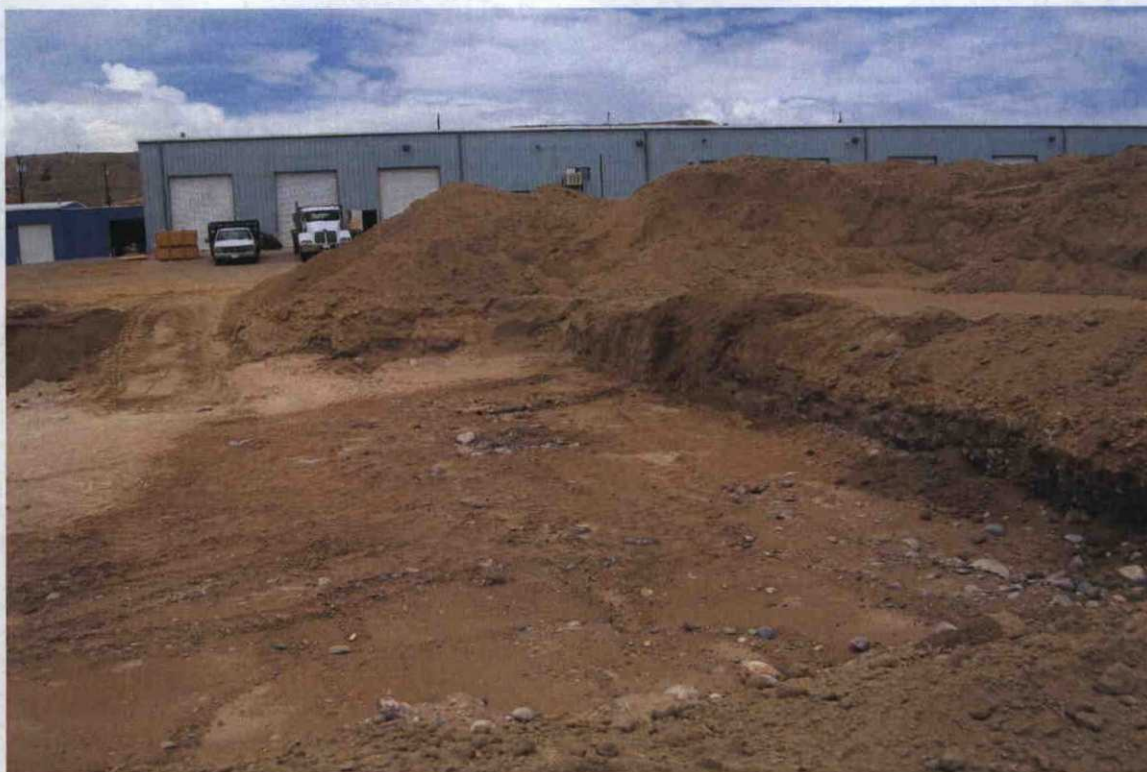
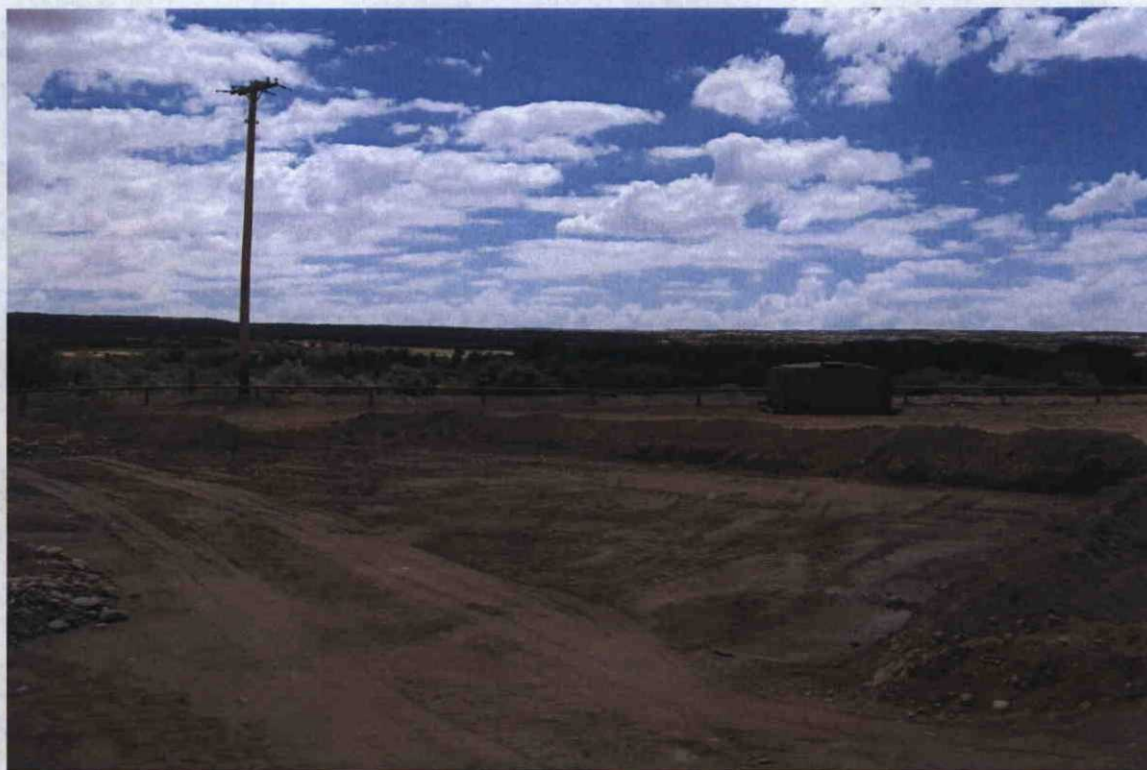
Photo 24: View of backfilling activities of the excavation.

Photo 25: View of backfilling activities of the excavation.

Photo 26: View of backfilling activities of the excavation.

Photo 27: View of backfilling activities of the excavation.

Photo 28: View of backfilling activities of the excavation.

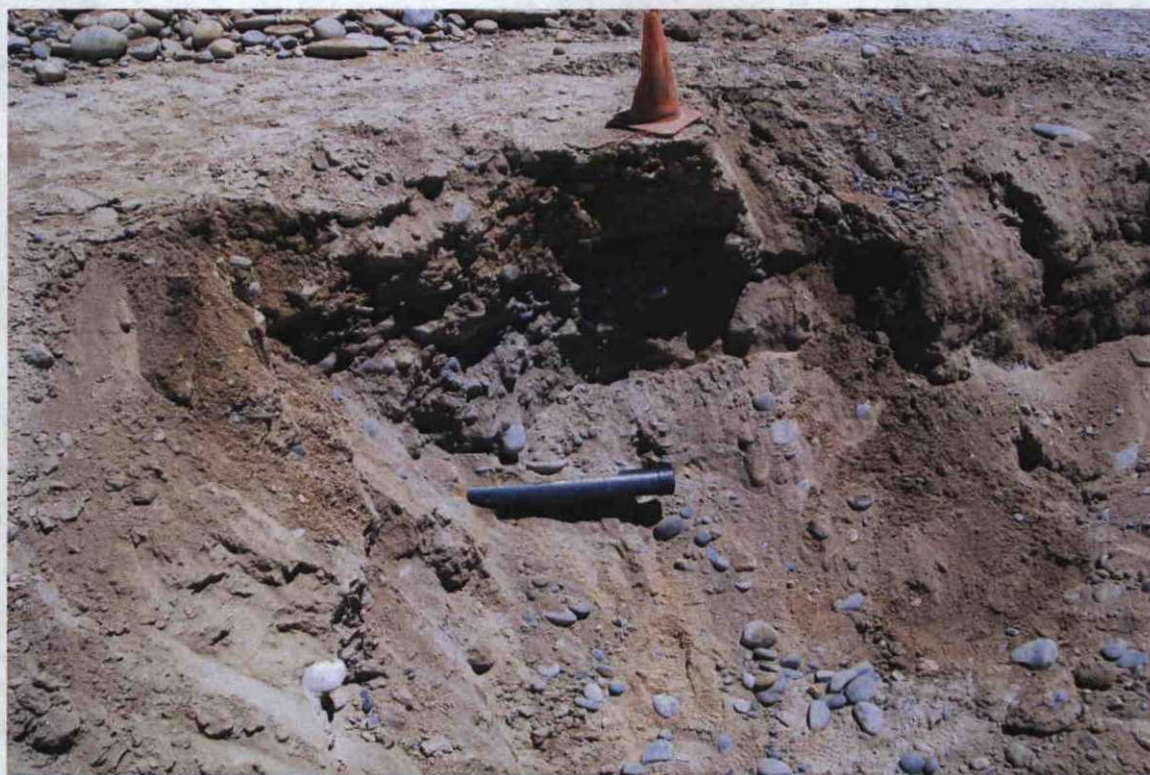
Photo 29: View of capped discharge line from the wash bays.

relict flow line associated with the wash bays, SWFS sealed it by square cutting the end and gluing on a PVC end cap.

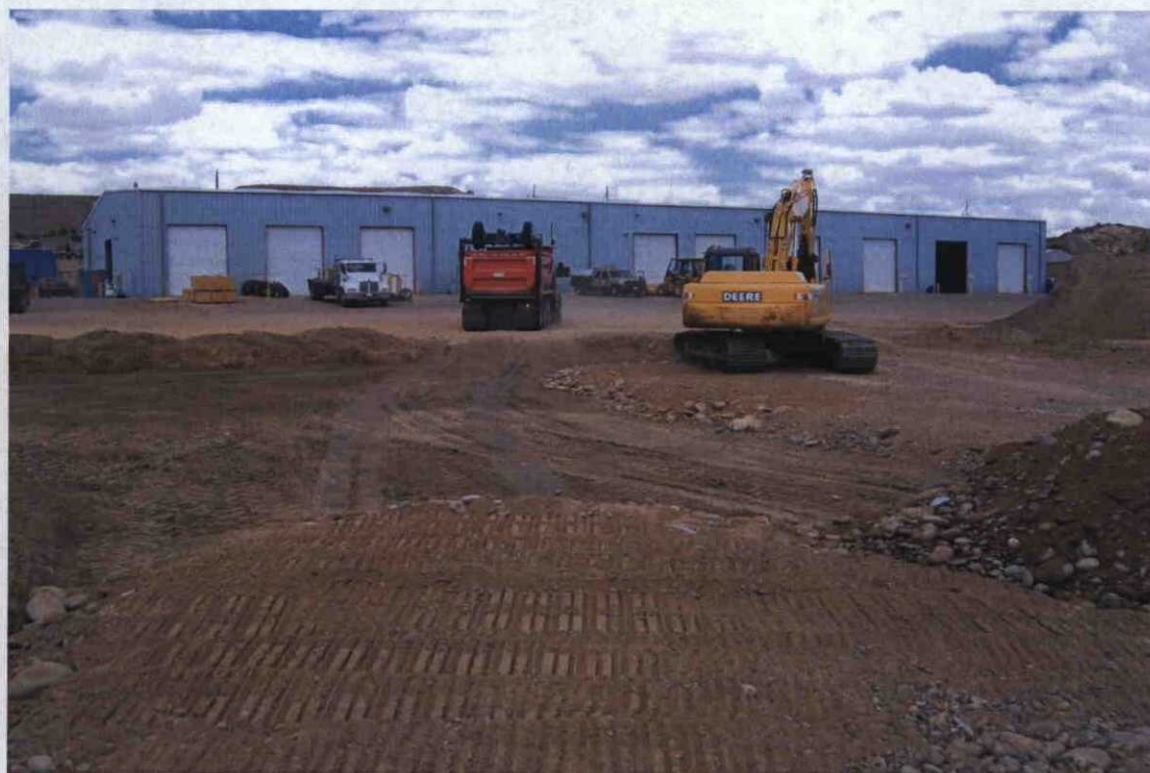
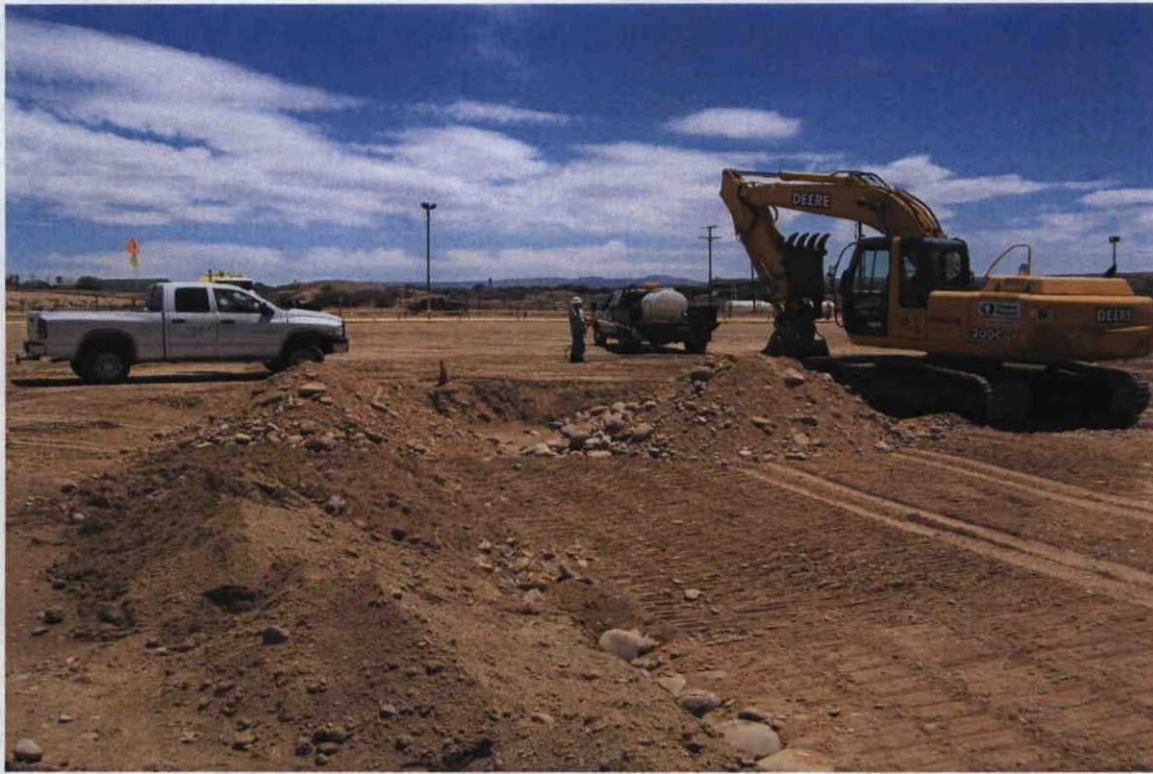
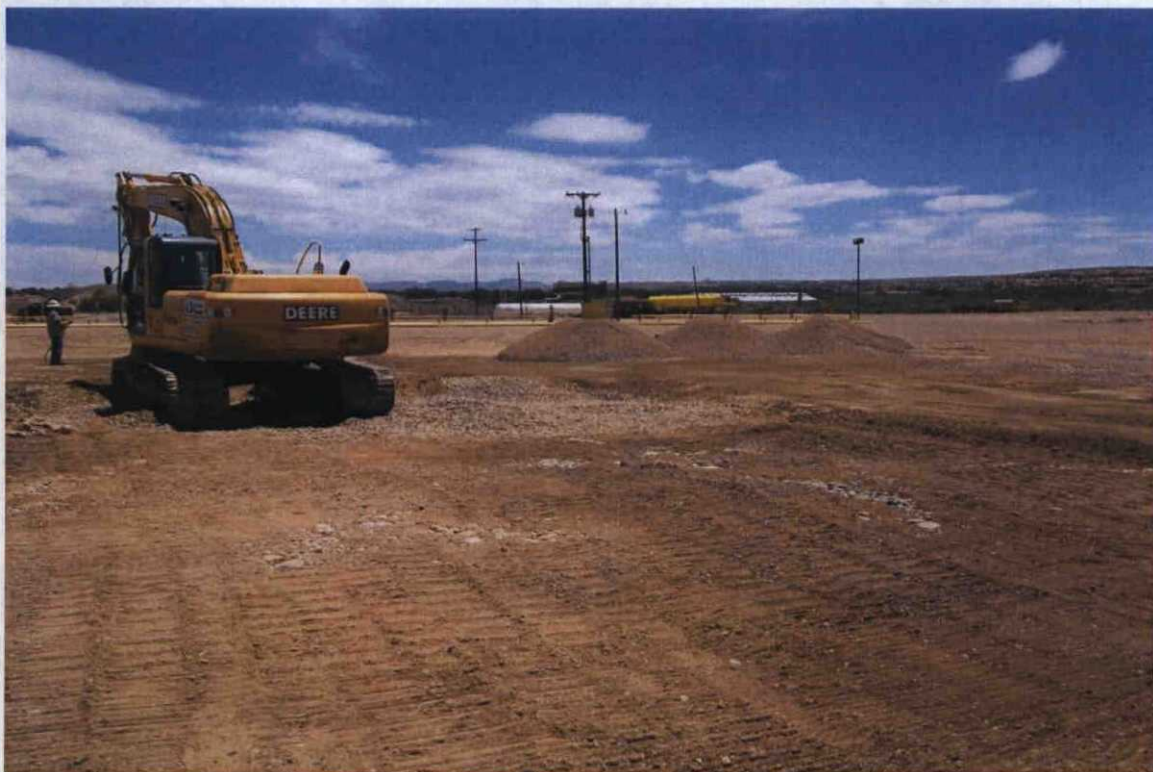
Photo 30: View of backfilling and compaction activities.

Photo 31: View of backfilling and compaction activities.

Photo 32: View of backfilling and compaction activities.

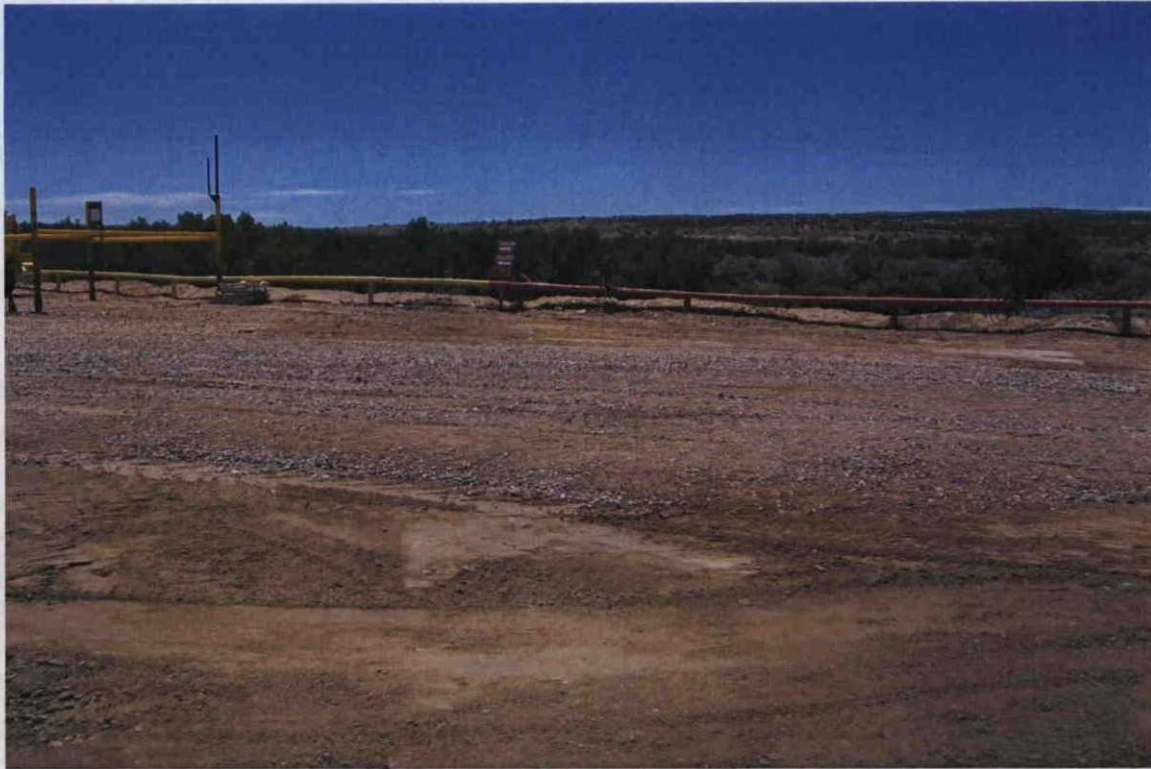
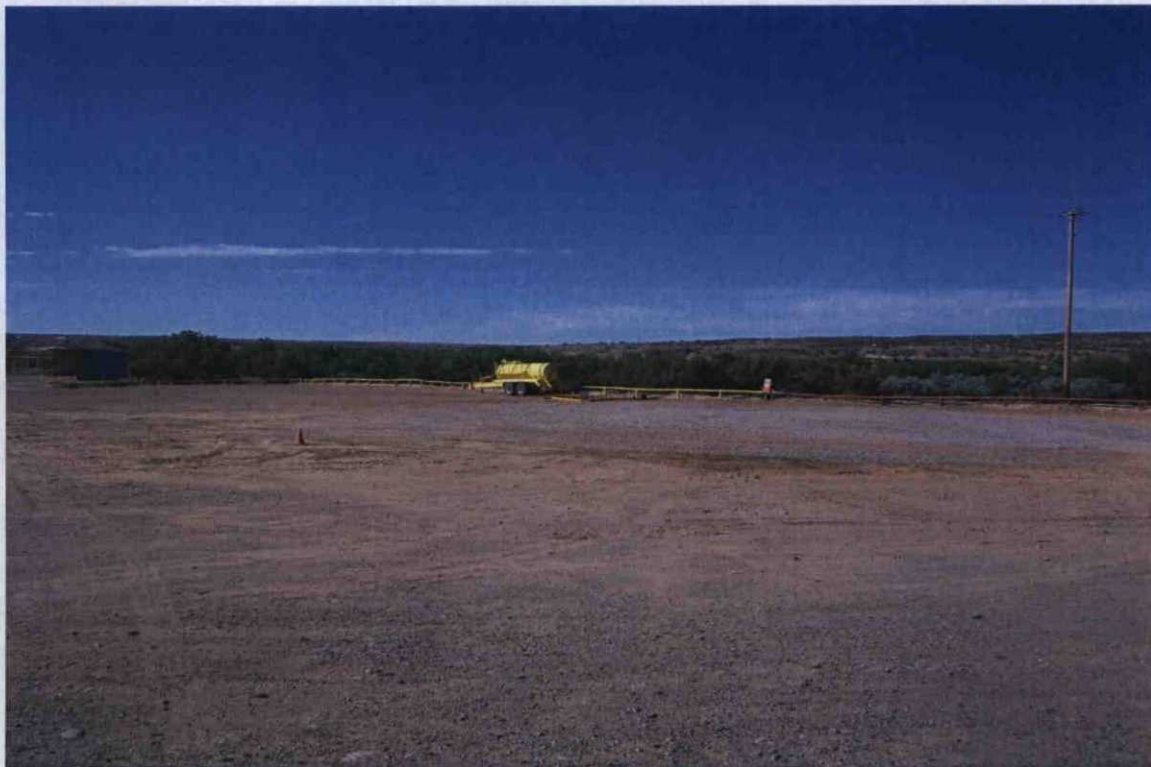
Photo 33: View of backfilled excavation.

Photo 34: View of backfilled excavation.

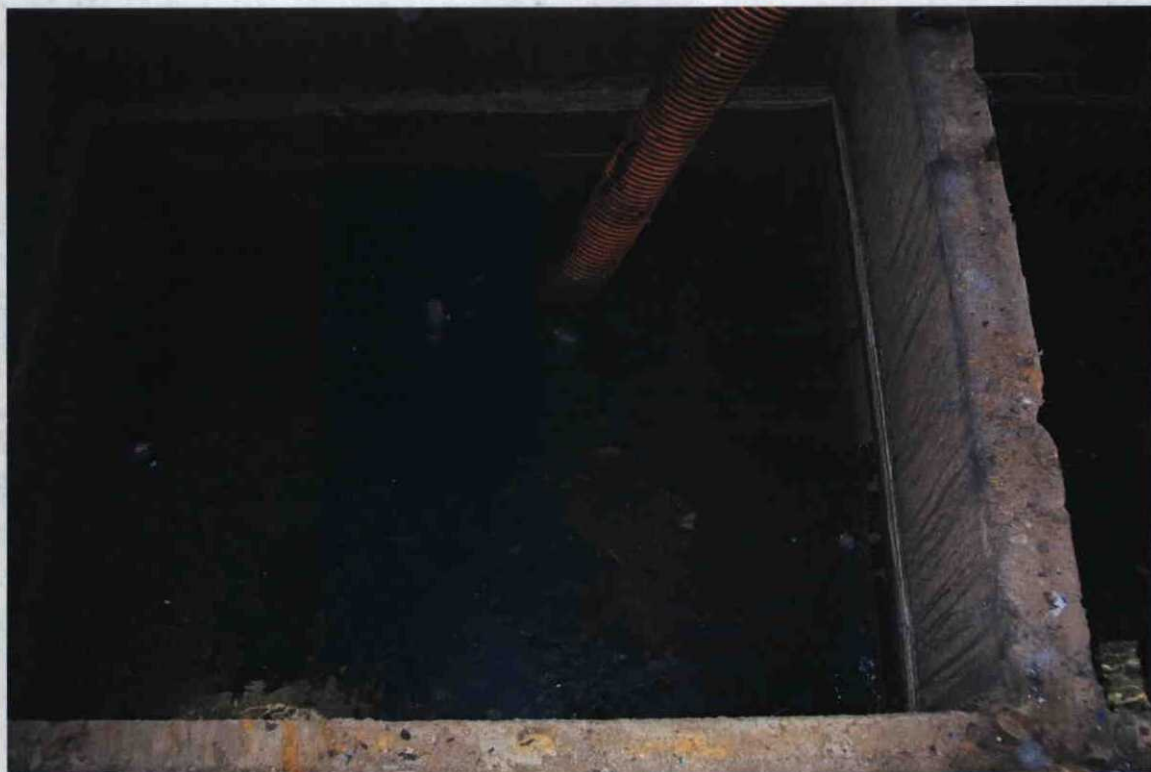
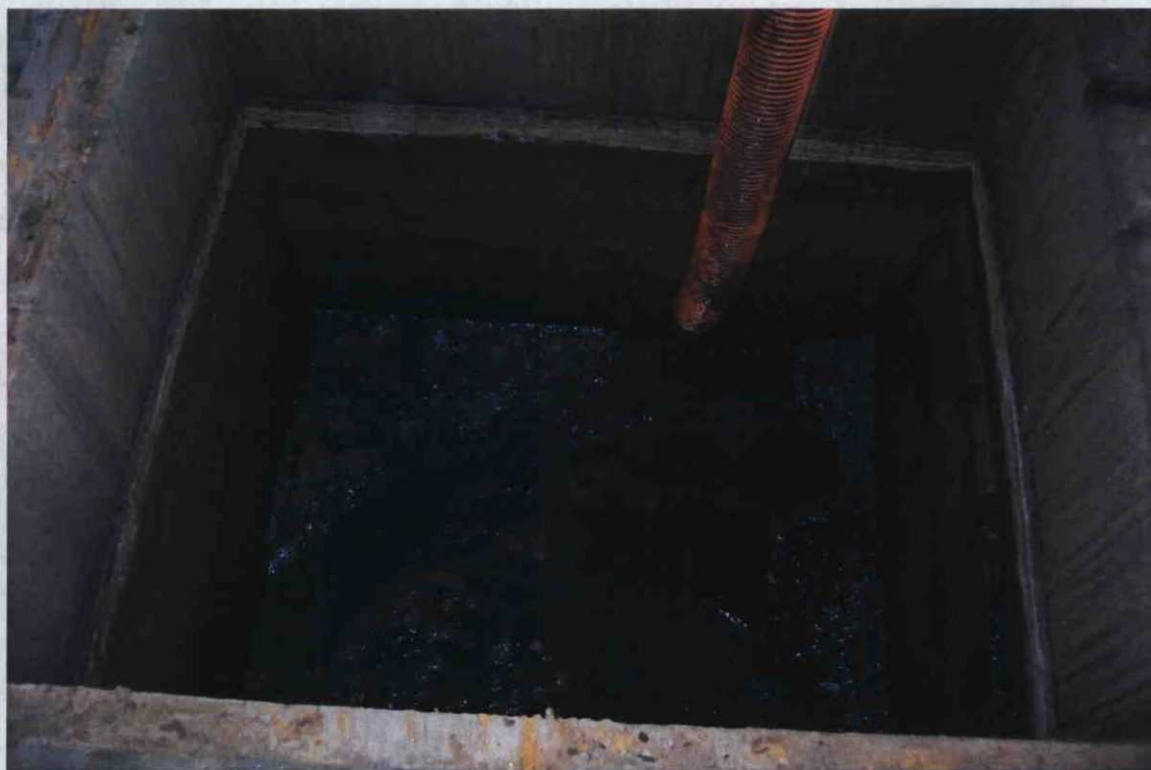
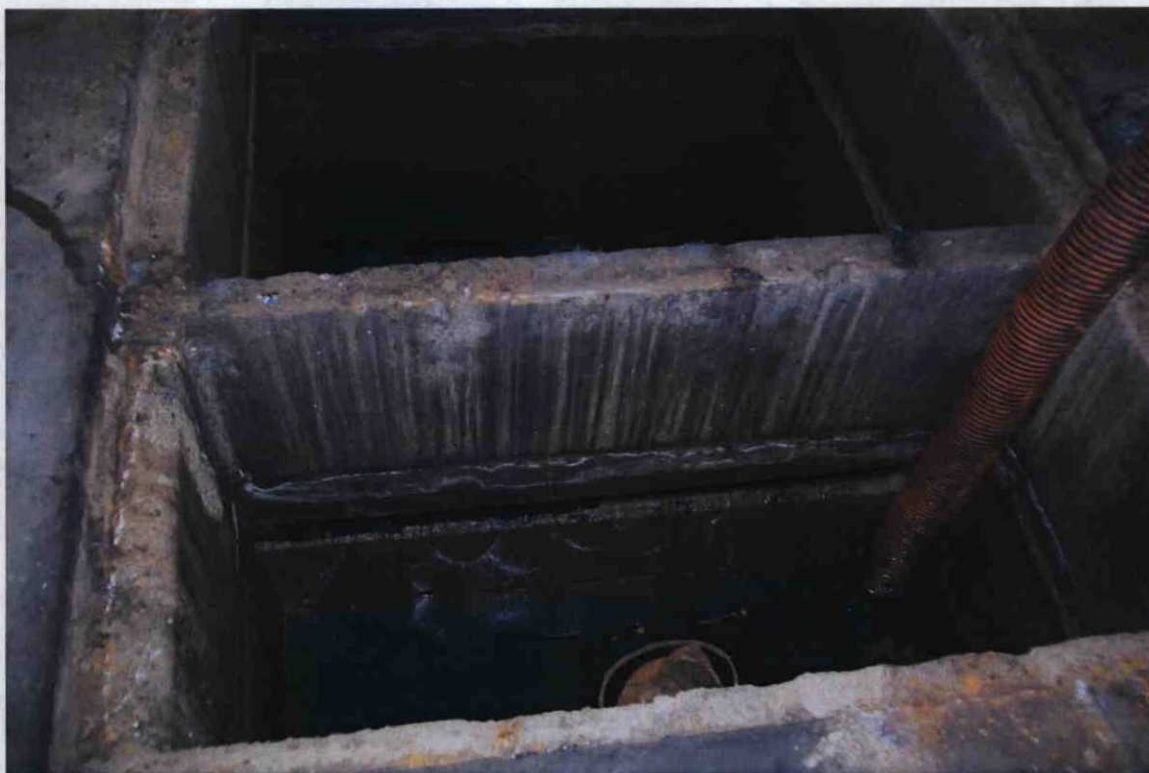
Photo 35: View of the cleaning of the wash bay sumps.

Photo 36: View of the cleaning of the wash bay sumps.

Photo 37: View of the cleaning of the wash bay sumps.

At the direction of Key Energy personnel, in order to decommission and permanently close the wash bay sumps in the building, SMA took two samples of the fluids and sludge remaining in two of the four wash bay sumps in the building. The samples were sent to HEAL for analysis for waste characterization to allow transport and disposal. Subsequently, July 15 through July 16, 2011, under the supervision of SMA, SWFS and IEI cleaned the sumps in the wash bays. The soil, fluids and sludge were removed from each 5' X 8' x 5' to 6' sump by a vacuum truck. After all materials were removed from the sumps, they were steam cleaned to remove any residual hydrocarbon materials. All soil, fluids and sludge removed from the sumps were transported to the IEI facility for proper disposal.

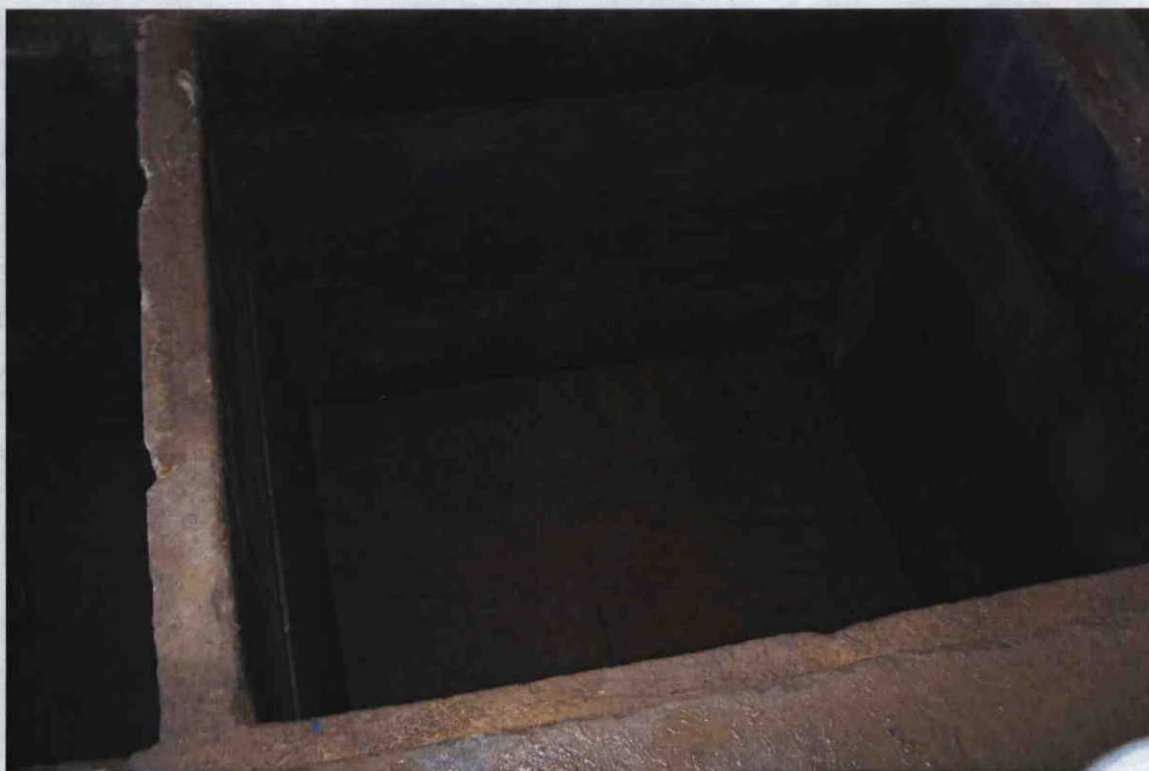
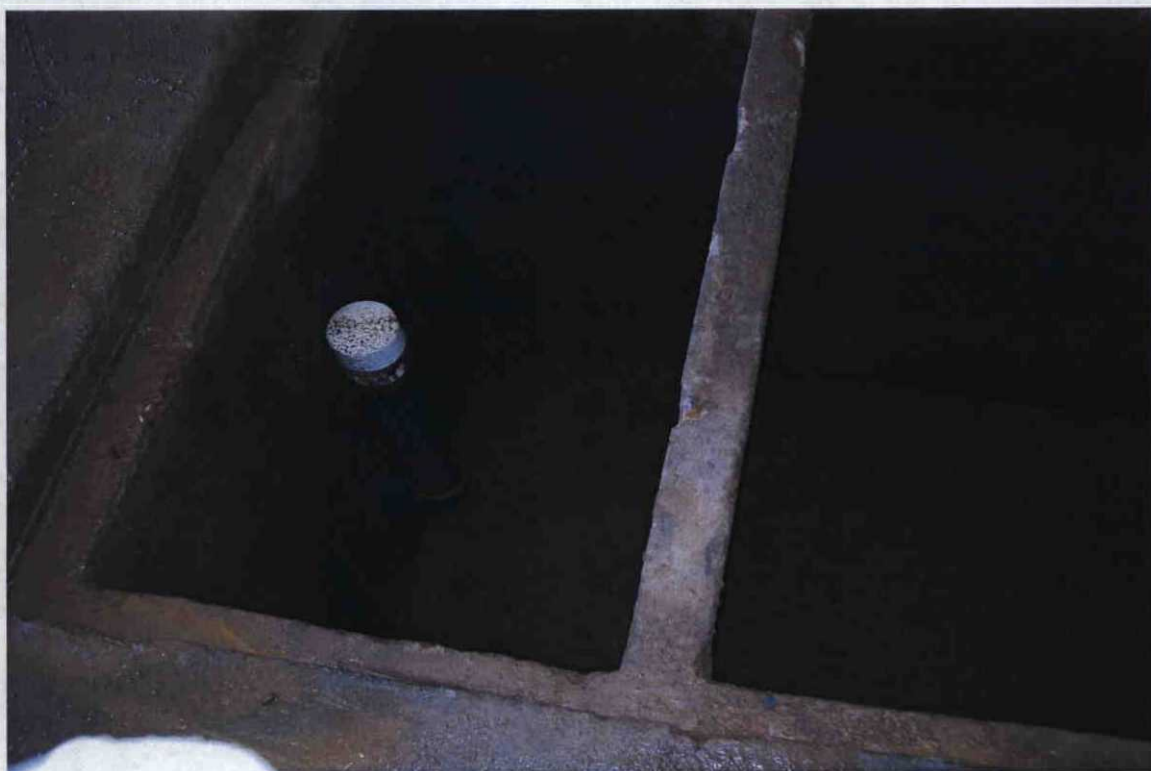
Photo 38: View of the cleaned wash bay sumps.

Photo 39: View of the cleaned wash bay sumps.

The three sumps in three wash bays and the one sump in the shop were cleaned. All soil, fluids and sludge was removed by a vacuum truck and transported to IEI land farm for proper disposal. Each sump was steam cleaned to remove any residual hydrocarbons. Finally, each

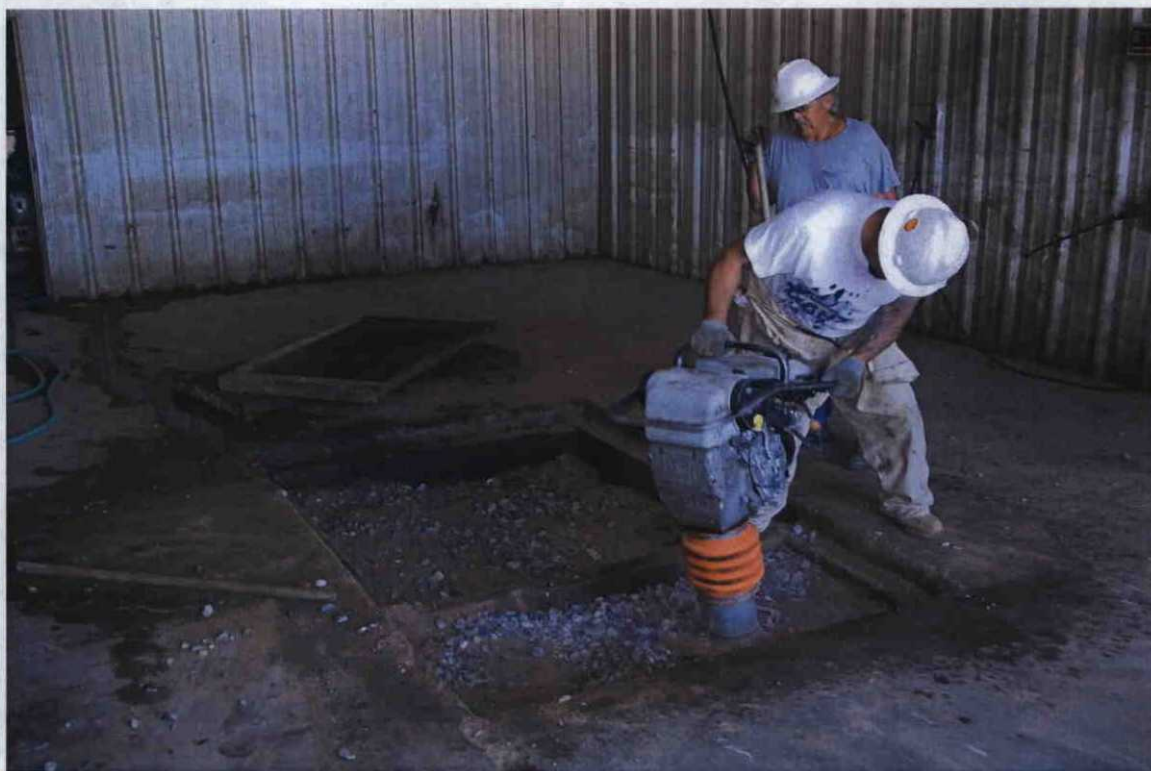
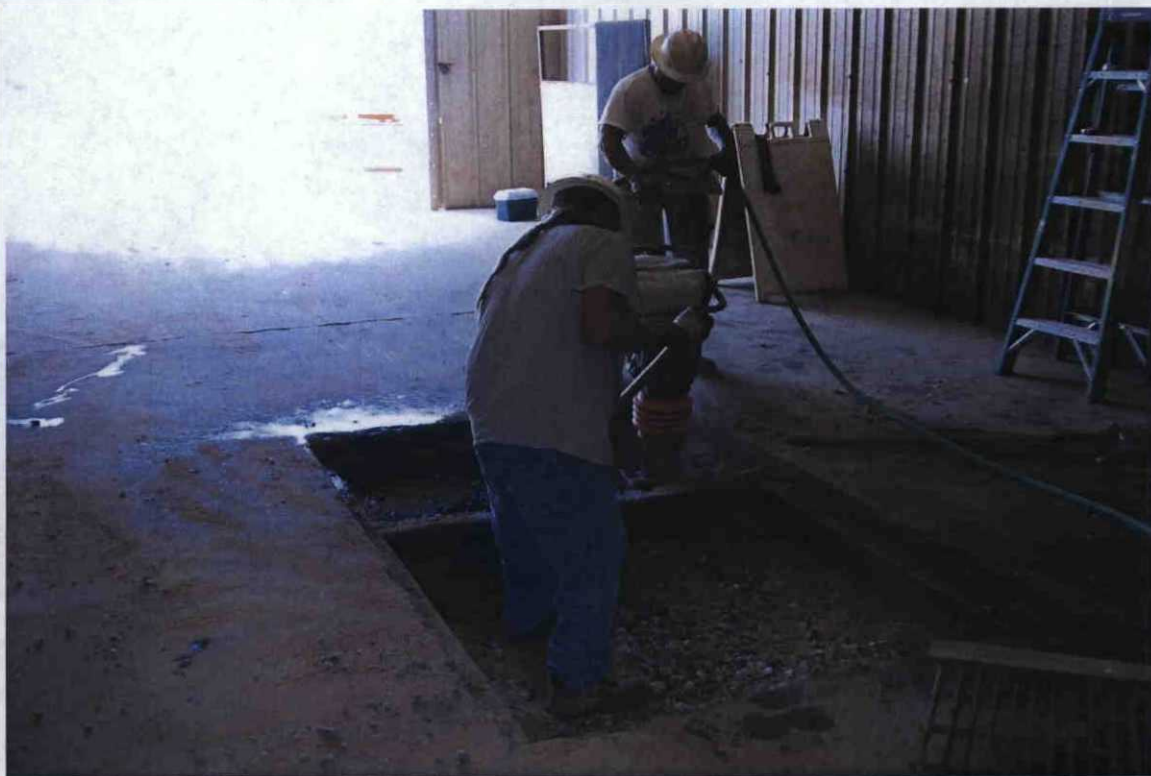
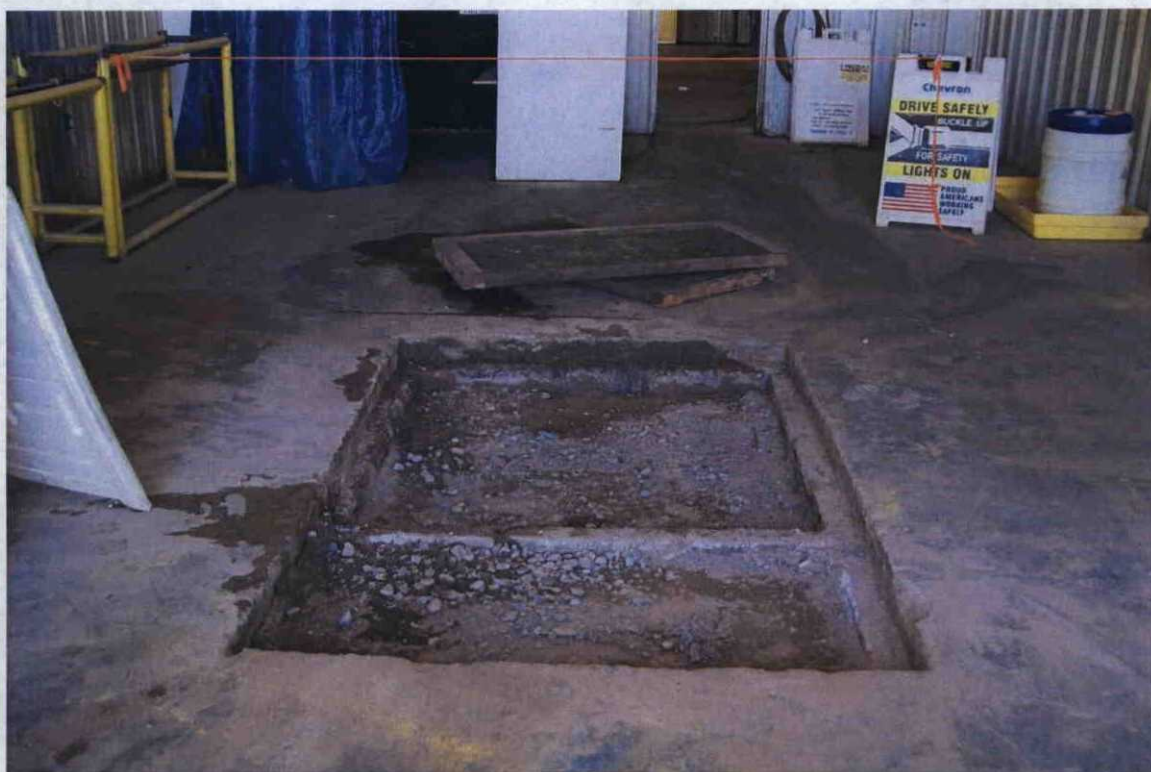
Photo 40: View of backfilling and compaction activities of the wash bay sumps.

Photo 41: View of backfilling and compaction activities of the wash bay sumps.

Photo 42: View of backfilling and compaction activities of the wash bay sumps.

Over the next two days, SWFS backfilled and compacted each sump in each wash bay with one-inch minus road base. Each sump was backfilled to a depth of approximately eight inches below the surface of the surrounding slab. The last eight inches was filled with concrete, packed and the surface smoothed to match the existing concrete slabs. Photographs of the backfilling and compacting activities are included in Appendix A. Disposal documents are included in Appendix C.
