**Removal of Wash
Bay Effluent
Holding Tank
Date:
5/2011**

**Key Energy Services
U.S. Highway 64 Truck Yard**

**Removal of Wash Bay Effluent Holding Tank
Remediation of Discovered Hydrocarbon Impacted Area
Decommissioning and Closure of Four Wash Bay Sumps**

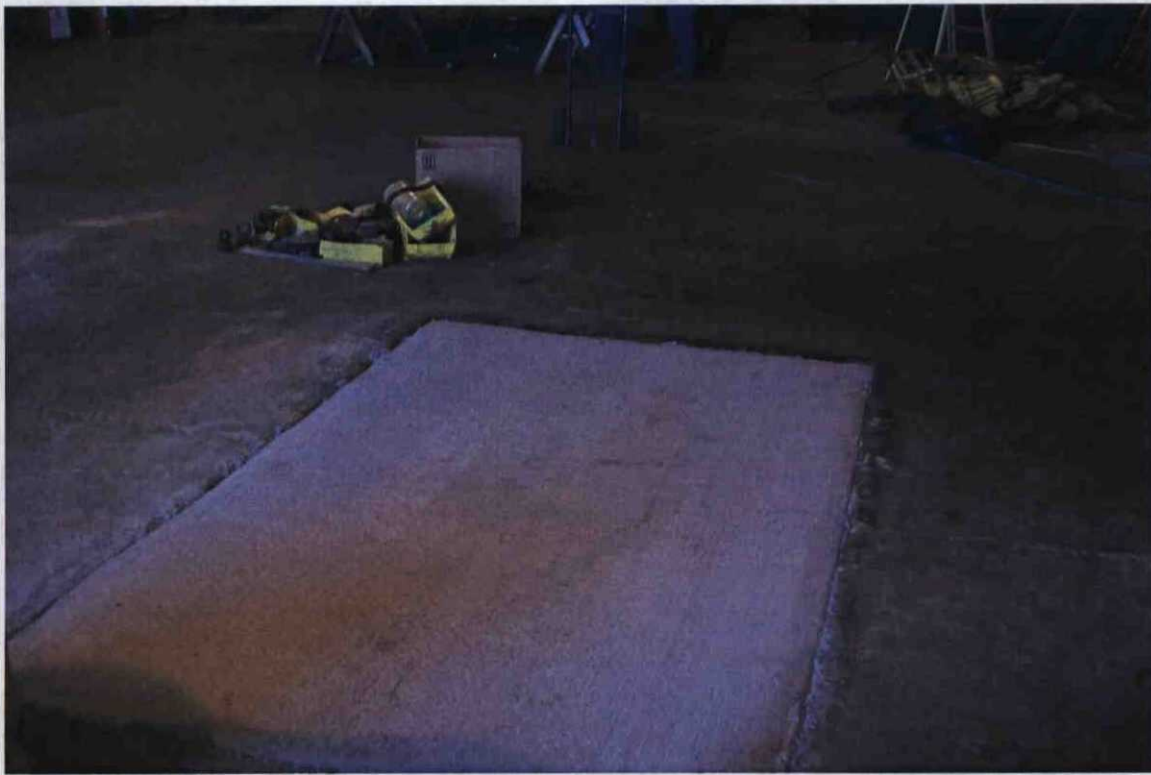
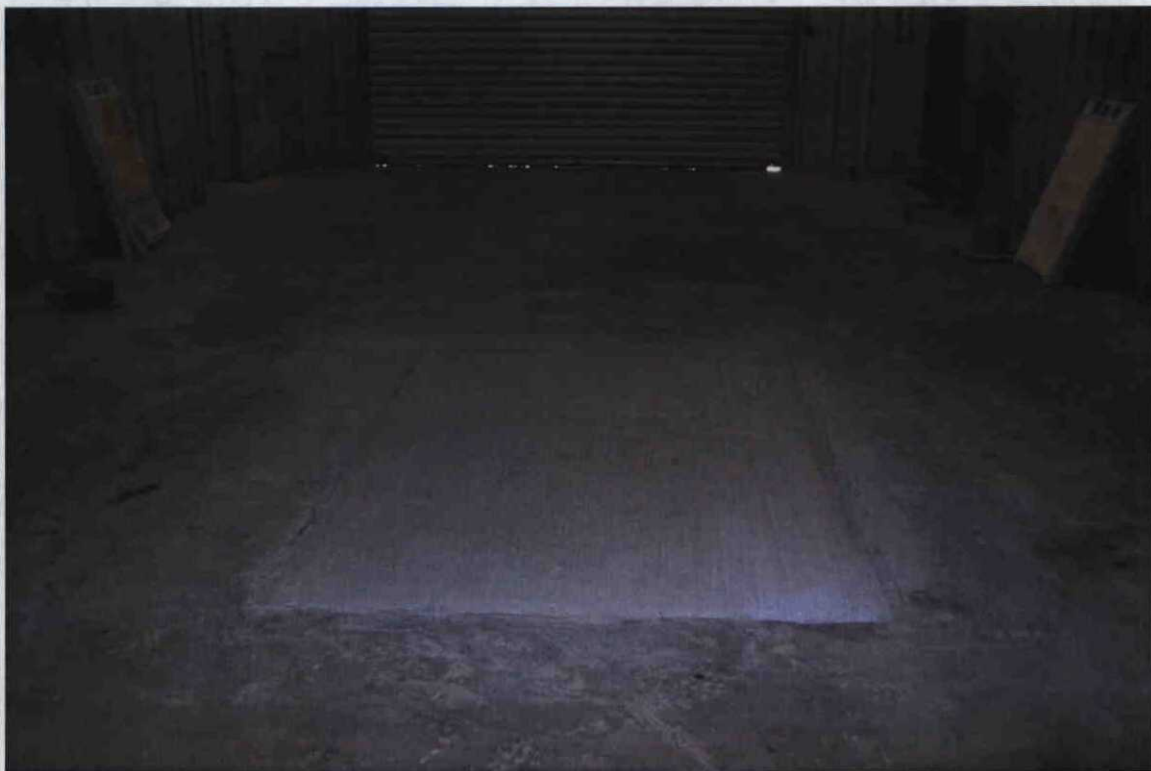
Photo 43: View of wash bay sumps after concrete completions.

Photo 44: View of wash bay sumps after concrete completions.

sump was abandoned by backfilling and compacting one inch road base until to a depth of approximately eight inches bgs. The last eight inches was backfilled with concrete, packed and the surface smoothed to match the existing concrete surface.
