RE: Remediation Closure Report
Exxon Mobil Corp. – Avalon Delaware Unit Well #238 Release Area
UL-K (NE ¼ of the SW ¼), Section 30, T 20 S, R 28 E
Longitude: 32° 32' 41.21"; Latitude: 103° 13' 15.65"
Eddy County, New Mexico
EPI Ref. #190037

The below *Remediation Closure Report (Report)* is an abbreviated version depicting prominent remedial activities conducted on the above referenced Release Area. However, for clarity and cross references elimination purposes, the *Report* includes *Release History, Site Background, Preliminary Field Work, Analytical Data and Procedures* and *Field Remediation Activities*.

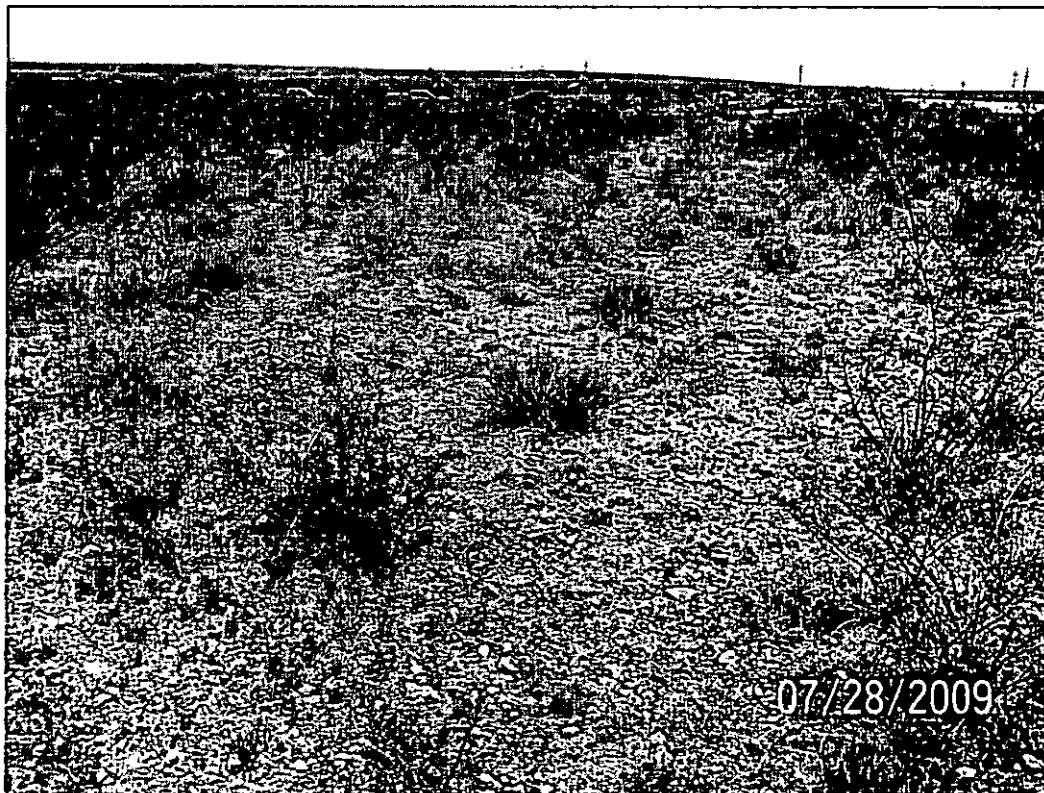
Photograph No. 2 – Looking easterly at original Release Area

On July 28, 2009 at 12:30 p.m., produced water was released from a ruptured fiberglass injection flow line (3" dia.). Approximately eighty-three (83) barrels of produced water were released with zero (0) barrels of fluid recovered. Fluids released impacted $\pm 7,300$ square feet of surrounding terrain (Ref. *Figure #3*). The New Mexico Oil Conservation Division (NMOCD) was notified of the release on July 28, 2009 at 4:15 p.m.

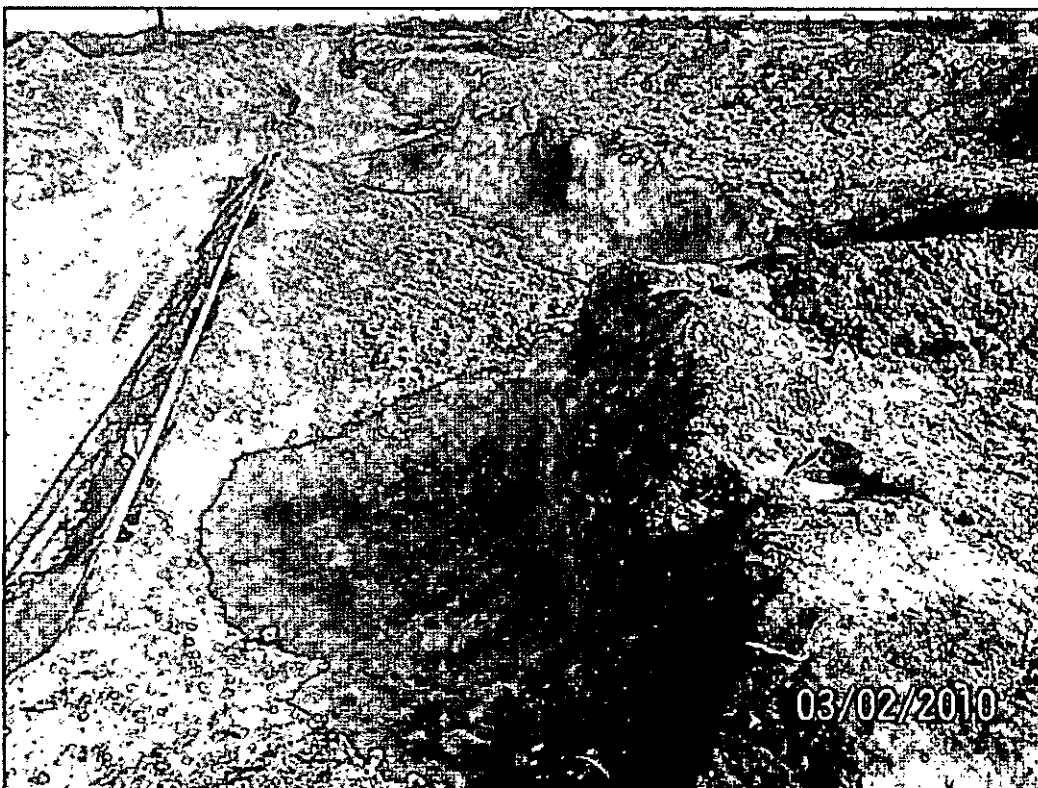
Photograph No. 3 – Looking northwesterly at preliminary excavation and 3" dia. FG Injection Line

On July 29, 2008 Environmental Plus, Inc., (EPI) reacted to an Emergency Response and started preventative remediation activities on the Release Area. During the period of July 28-29, 2009, the fiberglass injection line was located and exposed allowing roust-a-bout crews to repair it. However, eventually the fiberglass injection line was temporarily abandoned in favor of a shorter route. Initially impacted material surrounding the fiberglass injection line was excavated and stockpiled on plastic liners to prevent contamination of adjacent areas. From July 30-August 03, 2009 approximately 920-cubic yards of impacted material were transported to Sundance Services, Inc., (Permit No. NM-01-0003) for disposal. Remainder of impacted material was stockpiled on plastic liners.

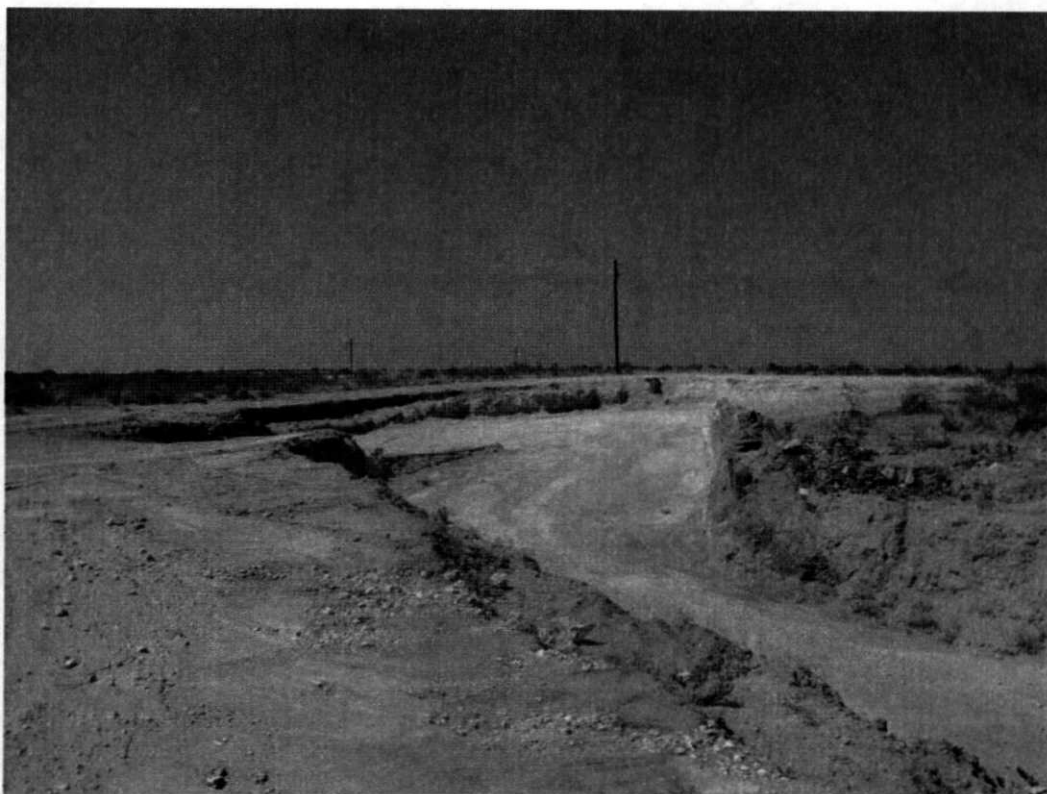
Photograph No. 5 – Looking westerly at final excavation and partially leveled bottom

From August 22-September 1, 2011, EPI excavated and transported approximately 2,600 cubic yards of impacted material from existing stockpiled material, bottom, inter-connecting bridged area and side walls of the excavation to Controlled Recovery, Inc., (CRI) for disposal. Finished excavation covered an area of 16,480 square feet and ranged from 5-15 feet in depth. Soil samples were collected from side walls and field analyzed for chloride concentrations. When field analyses indicated side walls were in conformance with NMOCD Goals, fifteen (15) representative soil samples were collected from side walls (Ref. *Figure #7* for locations and *Table #2* for analytical results), packaged as outlined in *Analytical Data and Procedures* section and remitted to Cardinal Laboratory, Hobbs, New Mexico under Chain-of-Custody protocol. Upon receipt of confirmatory lab results indicating soil samples were in compliance with NMOCD Goals for chloride concentrations, backfill activities commenced.

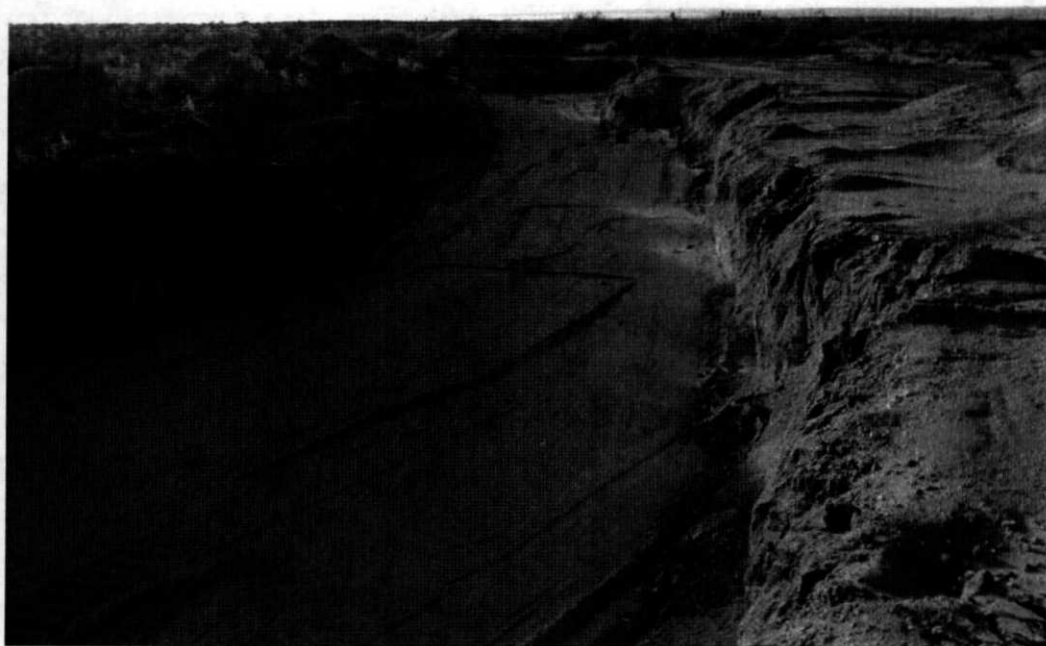
Photograph No. 6 – Looking easterly at final excavation and layer of cushion top soil across bottom for 40-mil polyethylene liner

From September 2-6, 2011, bottom of the excavation was backfilled with a minimum one (1) foot layer of clean top soil free of deleterious material, rocks and large clumps. On September 7, 2011, Akome Inc., Hobbs, New Mexico placed approximately 12,800 square feet of 40-mil polyethylene liner over the entire bottom section. A minimum two (2) feet of clean top soil was carefully placed over the 40-mil polyethylene layer as cushion protection from heavy equipment. The remaining excavation was carefully backfilled with clean top soil using acceptable procedures. From September 2 – September 19, 2011 approximately 4,000 cubic yards of top soil were used for backfill purposes. During this time frame, the backfilled and adjoining areas were contoured for natural drainage, preventing wind/water erosion and water pooling. However, as a precautionary measure, top soil was stockpiled for later surficial use in the event of minor erosion.

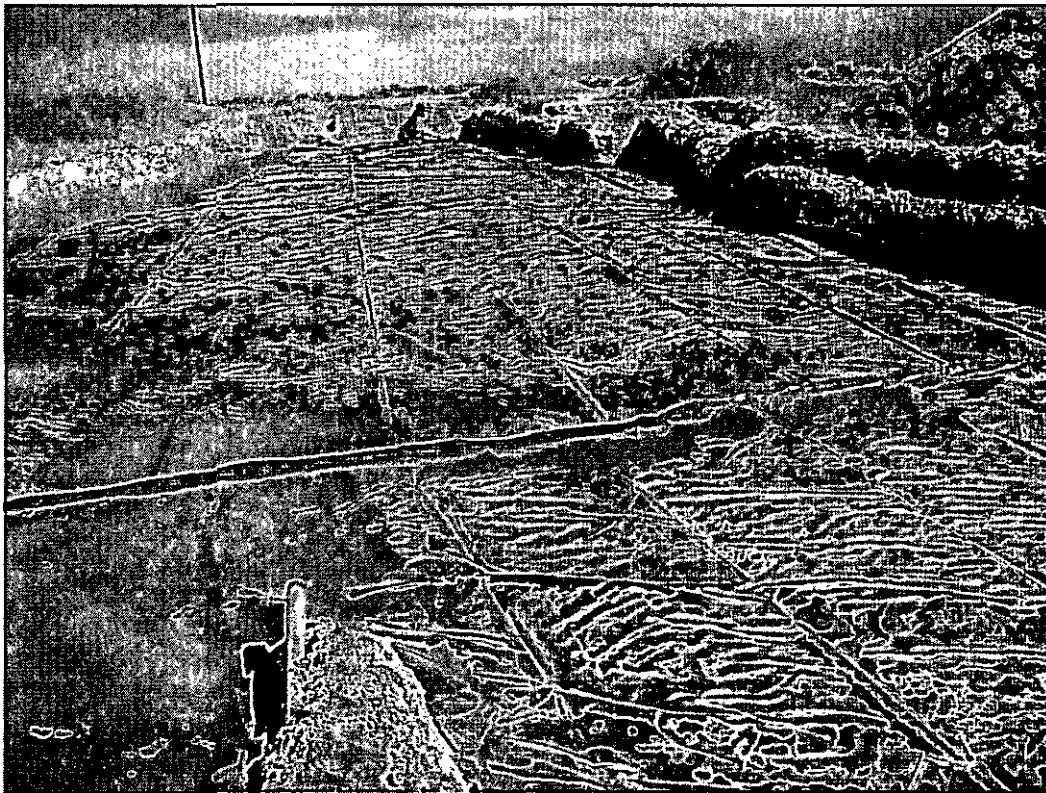
Photograph No. 7 – Looking northwesterly at 40-mil Polyethylene Liner on bottom of excavation

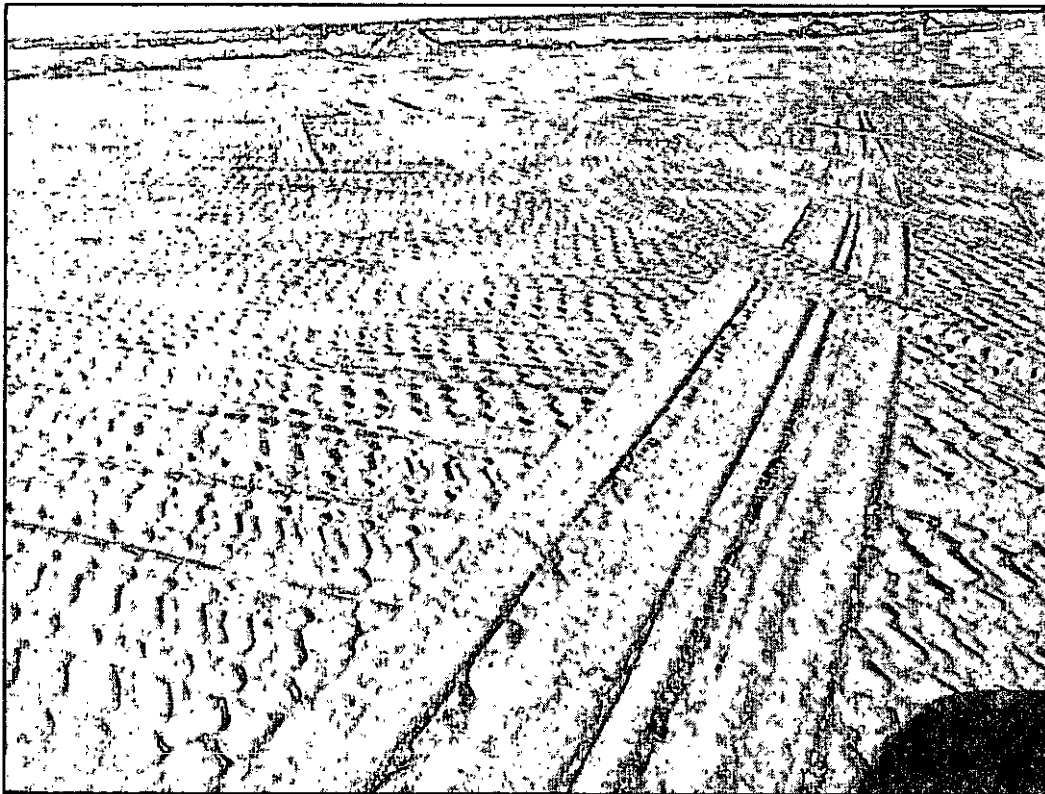
Photograph No.10 – Looking easterly at finished backfill gradient and stockpiled top soil

Remaining corrective activity is seeding of the disturbed areas with seed mixture acceptable to the NMSLO. Prior to seeding activity, the entire disturbed area will be disced to loosen the upper soil crust. Seed mixture will be deep drill seeded at a rate exceeding recommended application rate. However, due to the extreme drought conditions, EPI recommends delaying seeding operations until both ground and weather conditions are more conducive to vegetative growth. This may require postponement until late spring of 2012.
