**3R-1012**

**Release Report/ General  
Correspondence**

**Enterprise RA**

Release Notification and Corrective Action

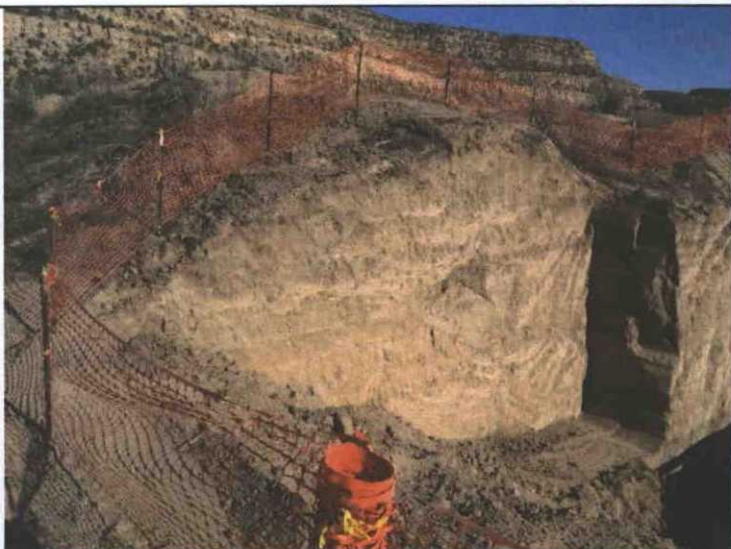
## Photograph 1

View of the final excavation, facing southeast.

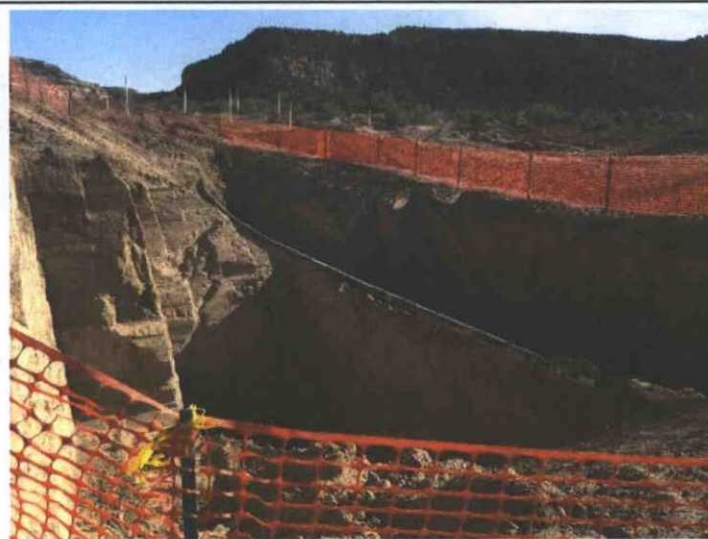
## Photograph 2

View of the final excavation, facing southwest. Soil "wall" beneath the pipeline was removed prior to backfilling the excavation.

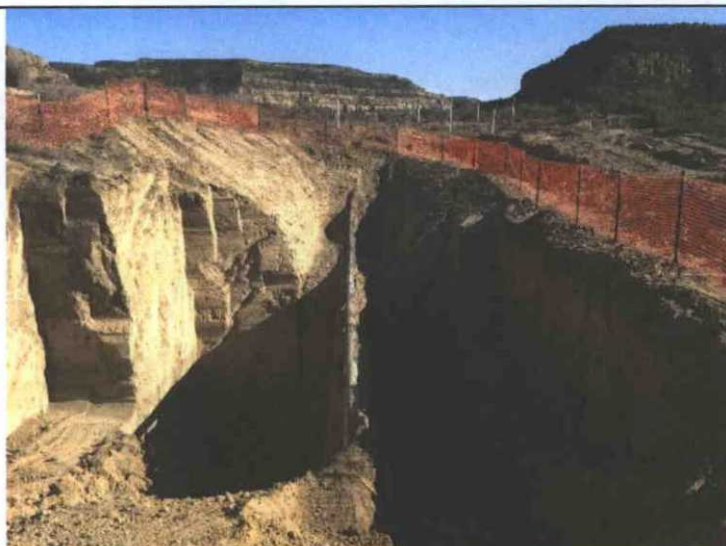
## Photograph 3

View of the final excavation, facing south. Soil "wall" beneath the pipeline was removed prior to backfilling the excavation.

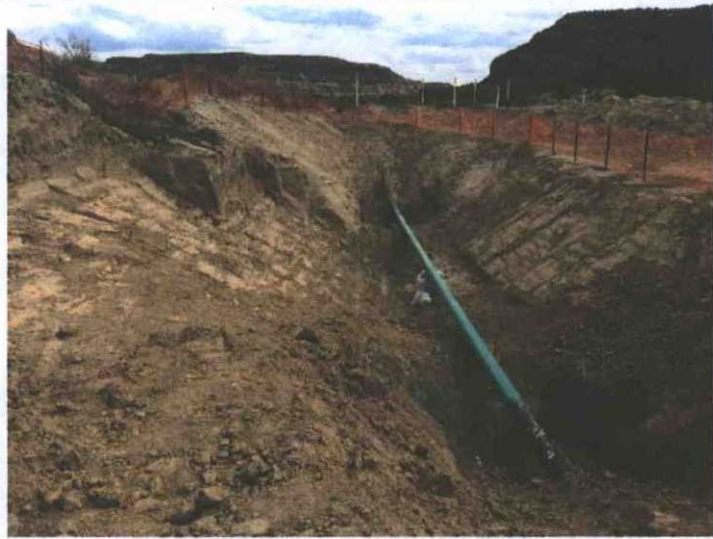
**Photograph 4**

View of the partially backfilled excavation and new pipeline section, facing southwest.

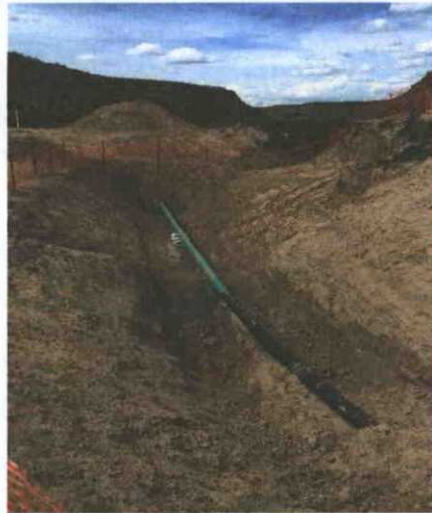
**Photograph 5**

View of the partially backfilled excavation and new pipeline section, facing north.

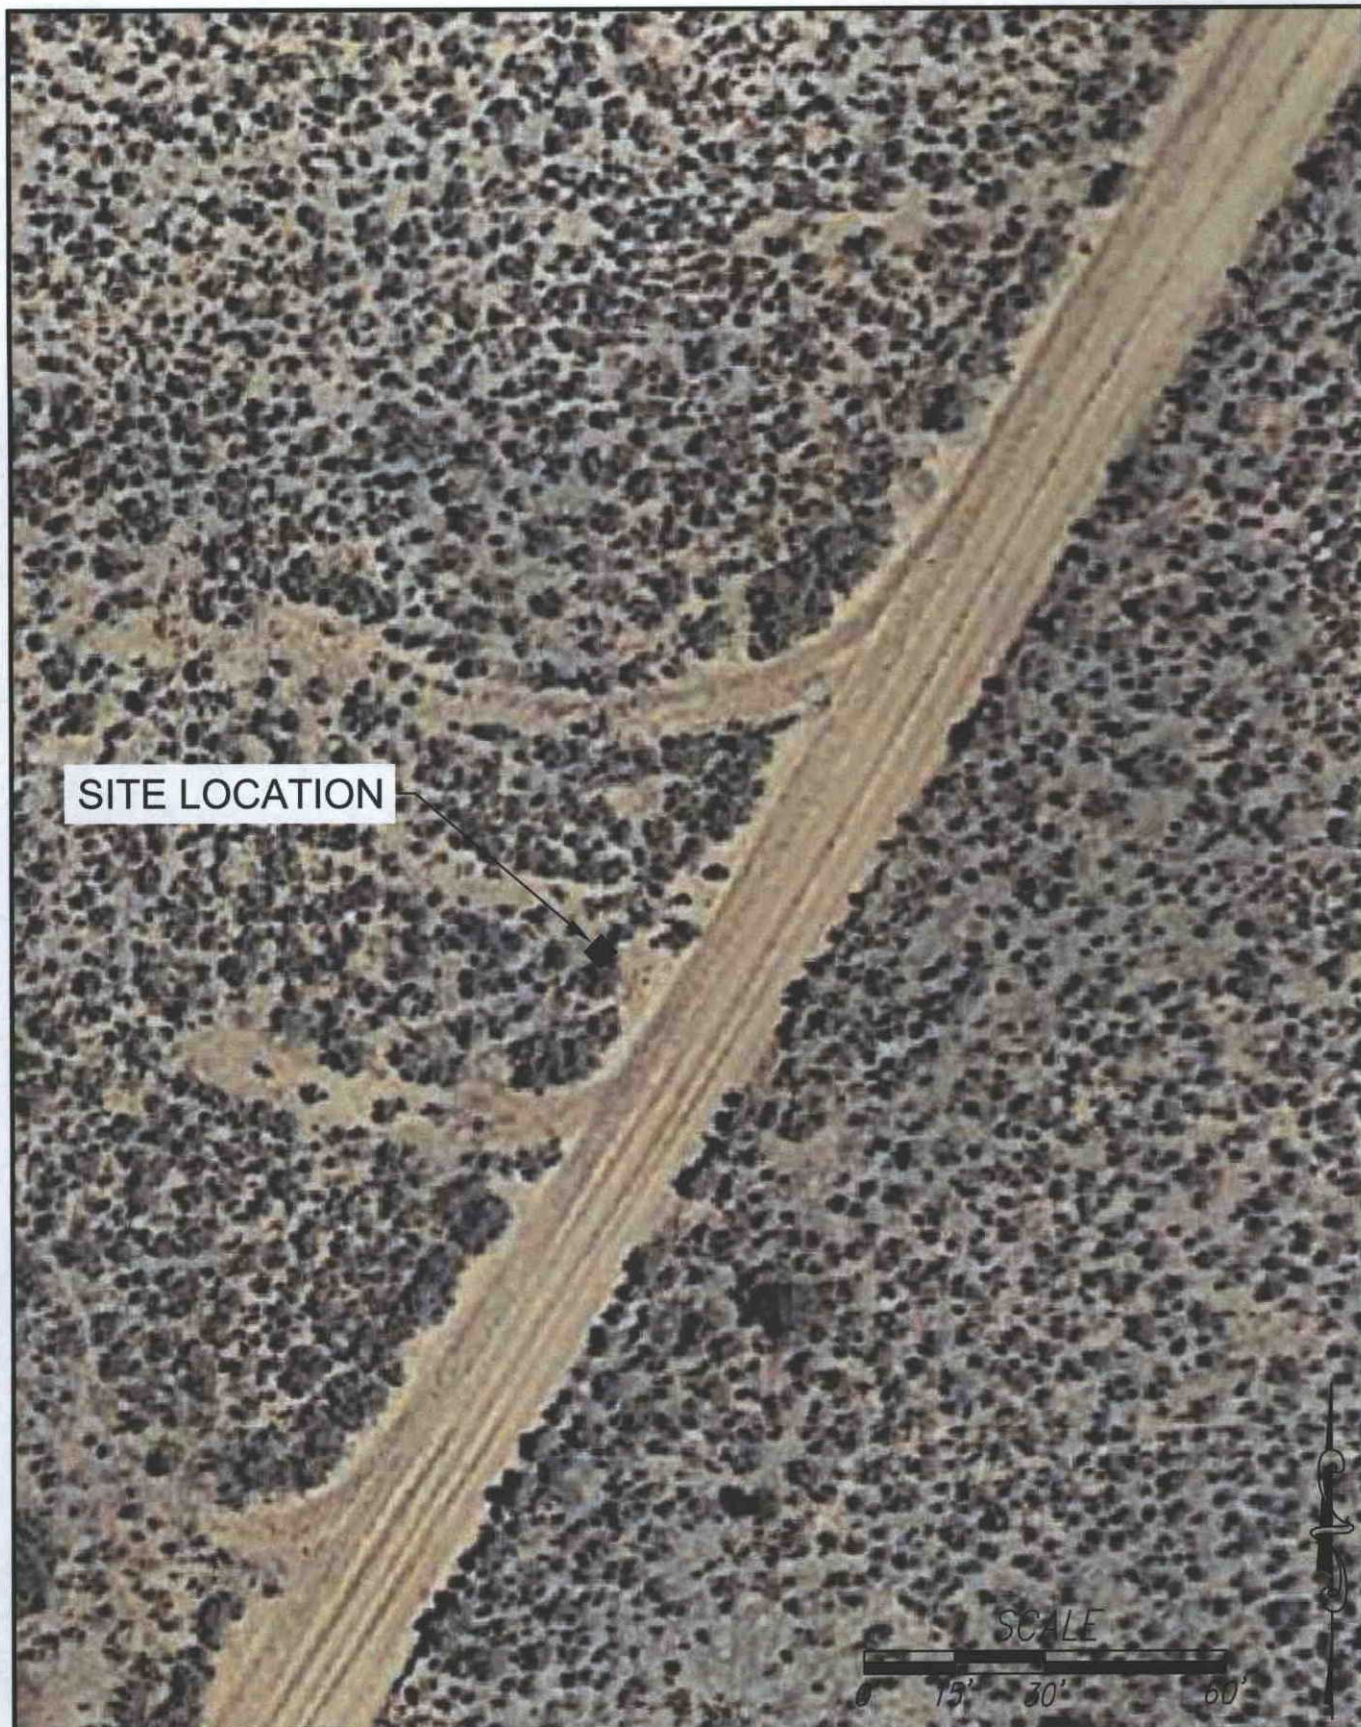
Designed JES	Drawn GJF	Checked RSA
Date: July 2015		
Scale: Horiz: 1" = 2000'		
Vert: NA		
Project No: 5123699		
Figure 1

On behalf of Enterprise Products Operating, LLC. (Enterprise), SMA has prepared this report that describes remediation of a hydrocarbon release associated with the Lateral 2C-85 pipeline release site. The site is located in SW/SE (Unit O), Section 4, T23N, R4W, 36.249718°, -107.258614°, Rio Arriba County, New Mexico, on land owned by the Jicarilla Apache Nation. Figure 1 illustrates the vicinity and location of the site.

VICINITY MAP  
 LATERAL 2C-85  
 SECTION 4, T23N, R4W

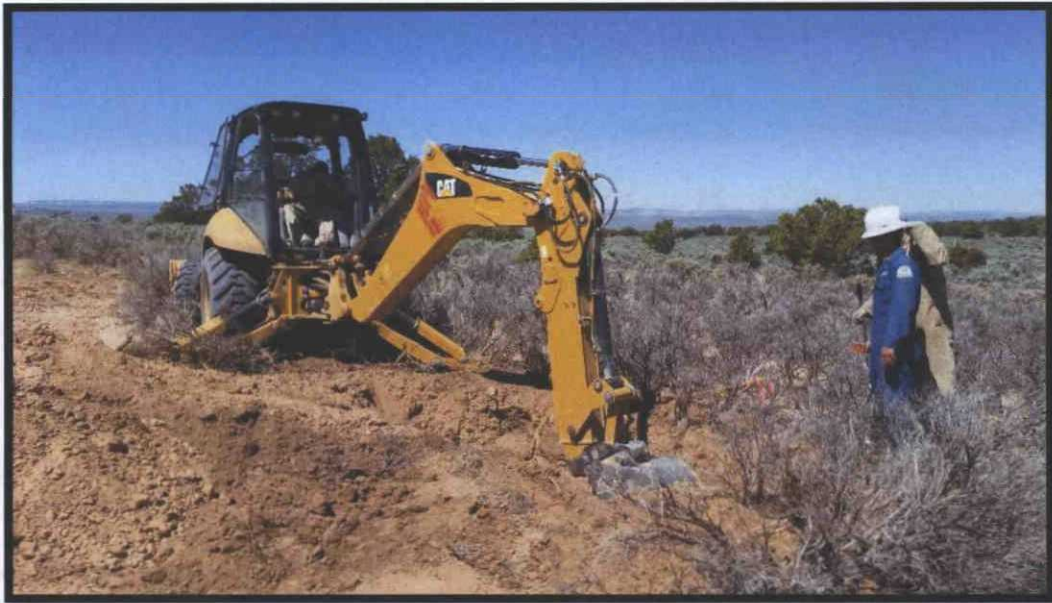
**Photo 1:** Lateral 2C-85 site during initial excavation for pipeline inspection and repair, photo aspect to south west.

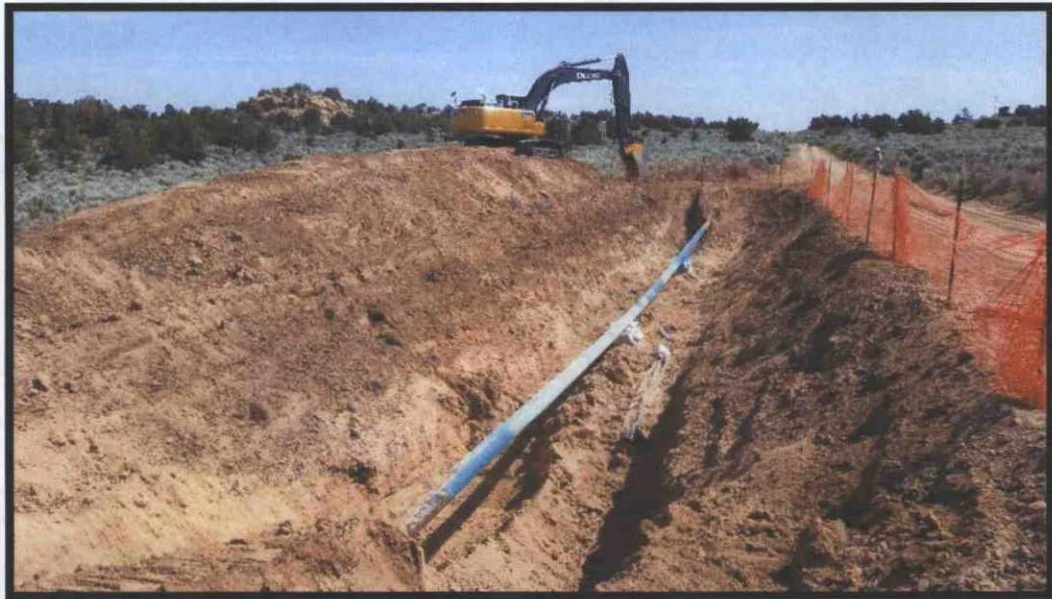
**Photo 2:** Track mounted excavator on site during sampling, final excavation extent pictured. Repair visible in foreground.

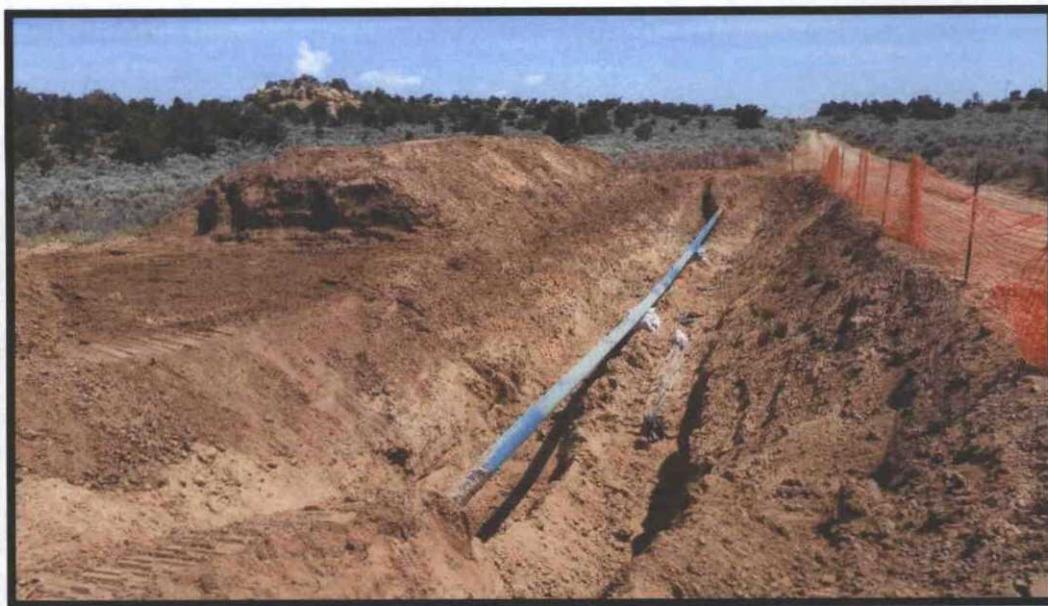
**Photo 3:** Deeper base section visible beneath repair, this area was excavated to 9 ft BGS.

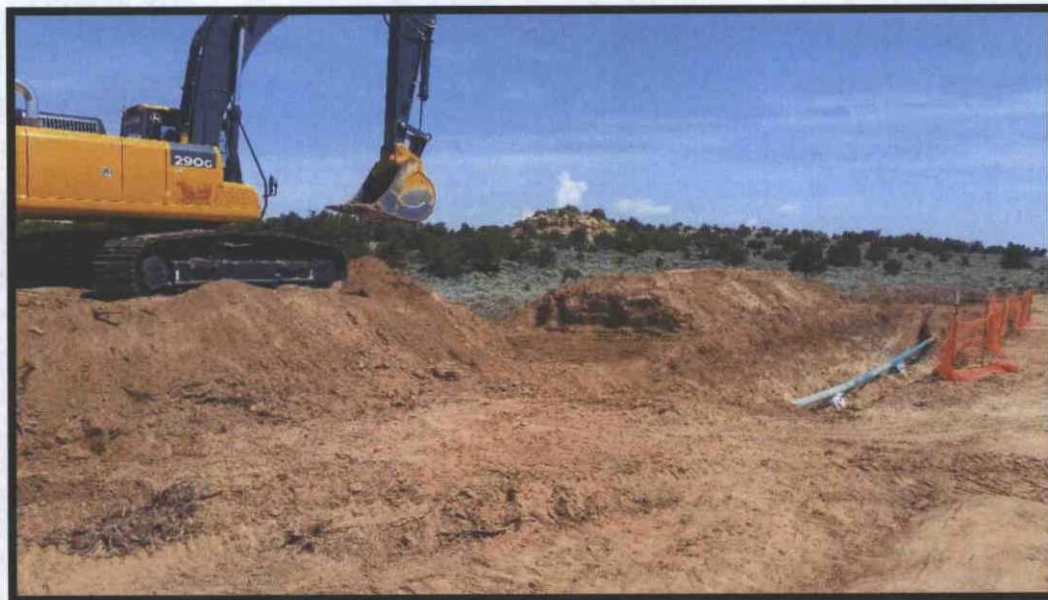
**Photo 4:** Track mounted excavator segregating stockpiles. The pile in the background (north) was sampled for use as backfill material.

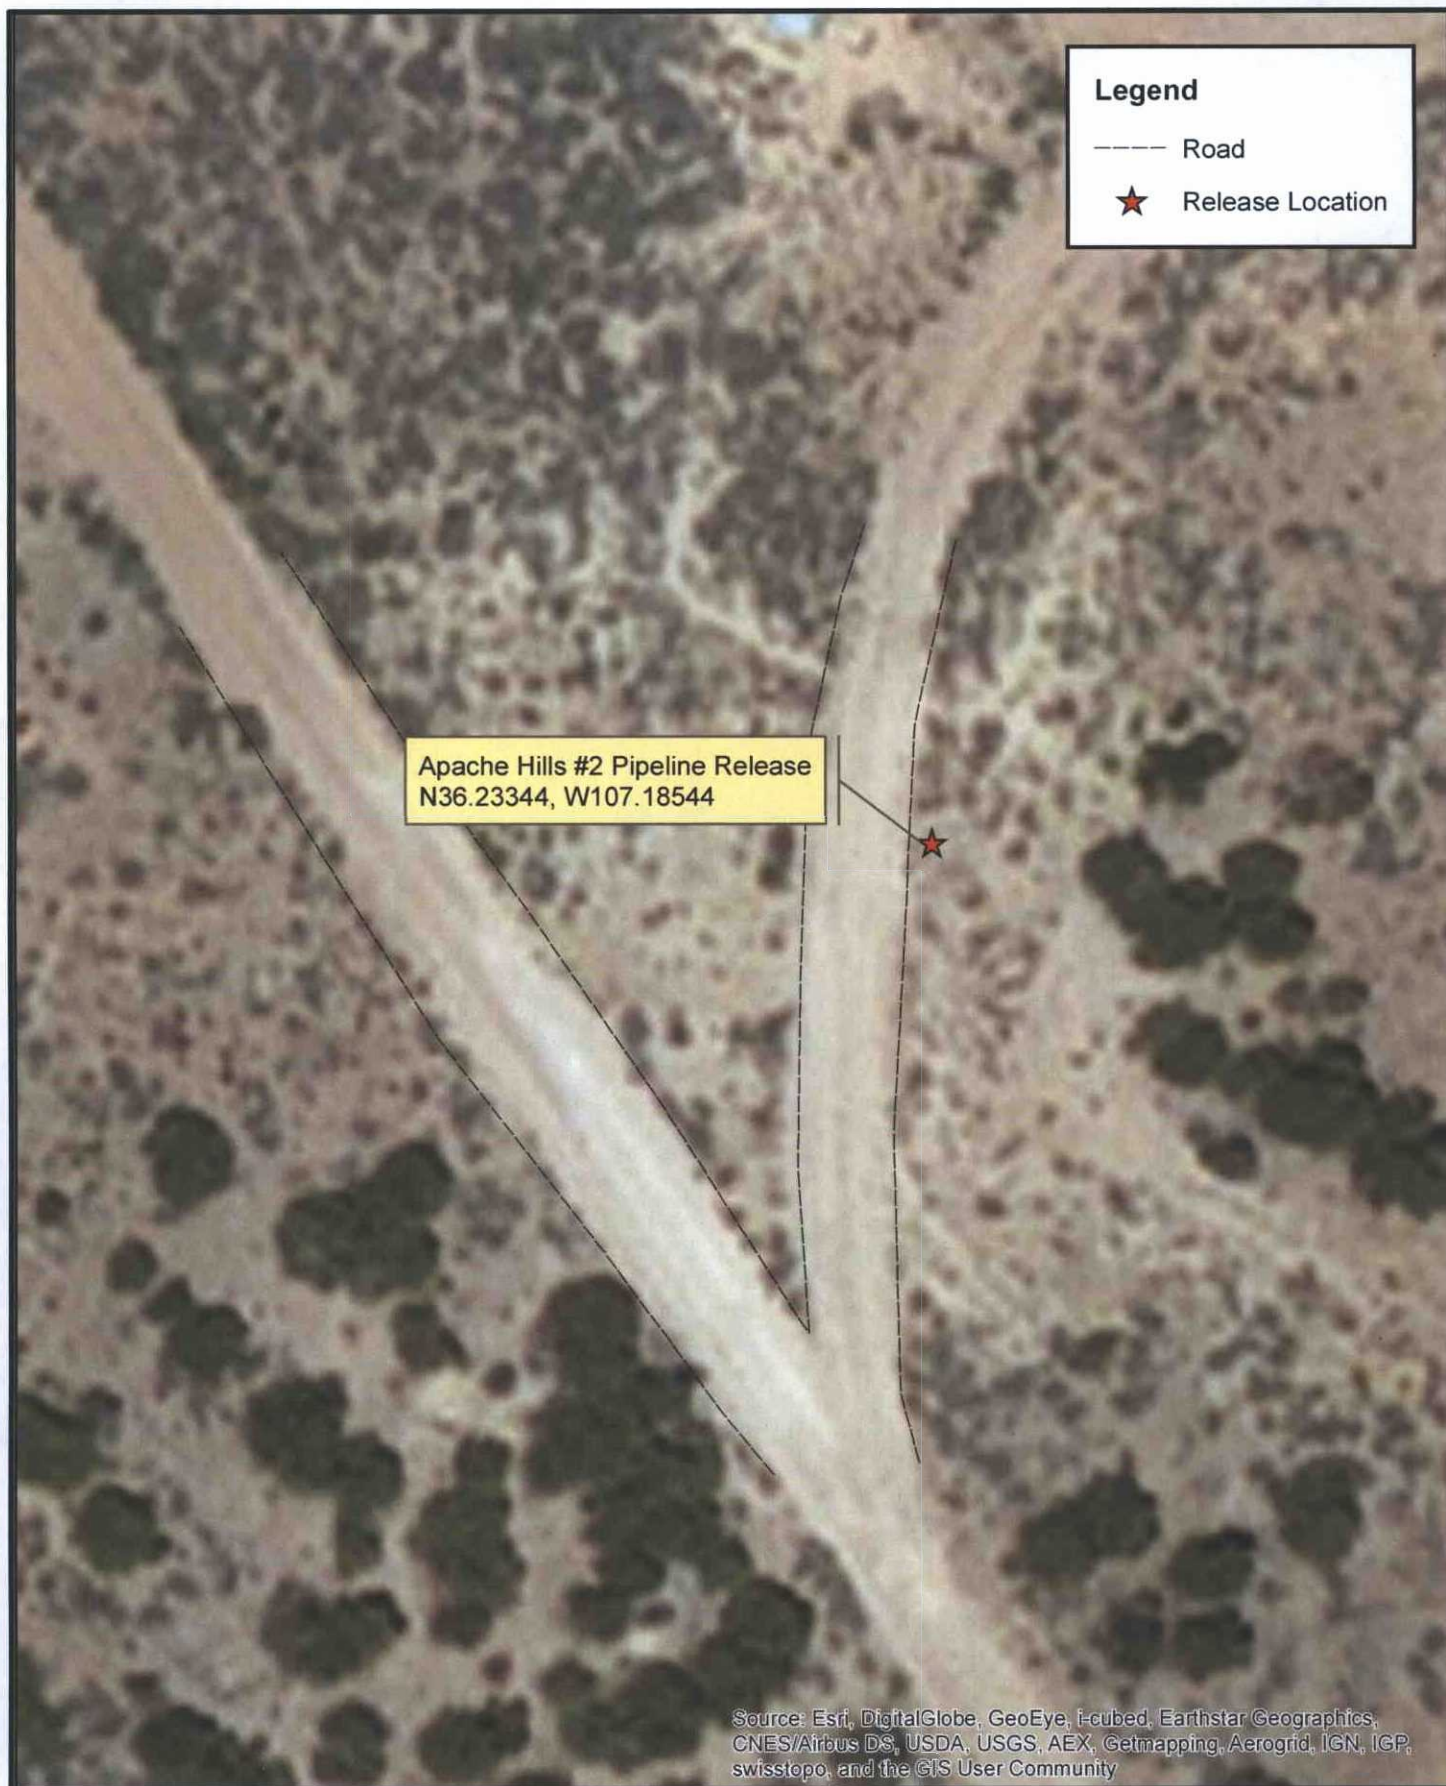
Figure: 1

A topographic map of the location is included as Figure 1 and an aerial site map is included as Figure 2.

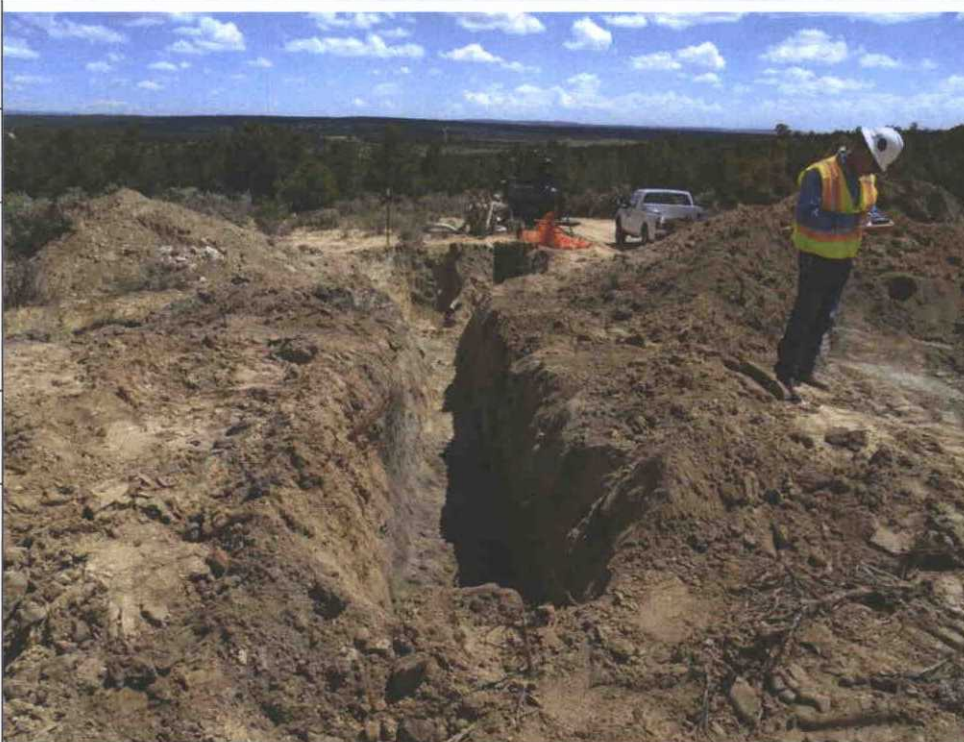
Photograph #1

Client: Enterprise	
Site Name: Apache Hills #2 Pipeline Release	
Date Photo Taken: July 21, 2015	
Location: N36.23344, W107.18544  Sec. 8, T23N, R3W Rio Arriba County, New Mexico	
Photo Taken by: Deborah Watson	Description: View of final pipeline repair excavation, looking south.

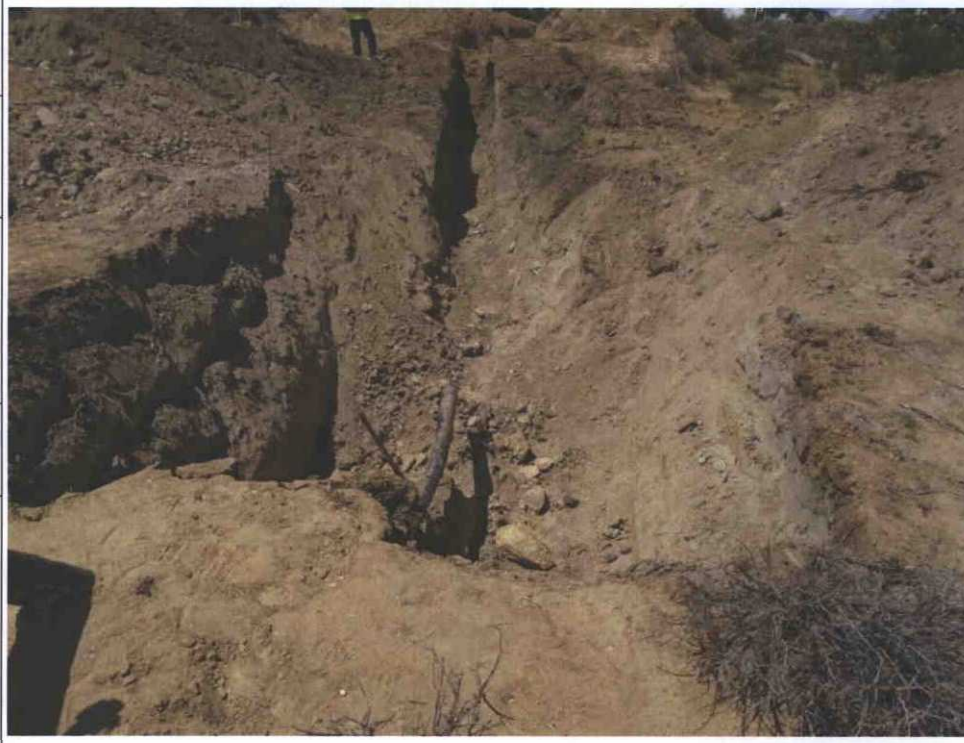
Photograph #2

Client: Enterprise Products	
Site Name:  Apache Hills #2 Pipeline Release	
Date Photo Taken: July 21, 2015	
Location: N36.23344, W107.18544  Sec. 8, T23N, R3W Rio Arriba County, New Mexico	
Photo Taken by: Deborah Watson	Description: View of final pipeline repair excavation, looking north.
