**Release Report/ General
Correspondence**

Enterprise RA

Release Notification and Corrective Action

Name of Company: Enterprise Field Services LLC	Contact: Thomas Long
Address: 614 Reilly Ave, Farmington, NM 87401	Telephone No. 505-599-2286
Facility Name: Lateral 2C-56	Facility Type: Natural Gas Gathering Pipeline

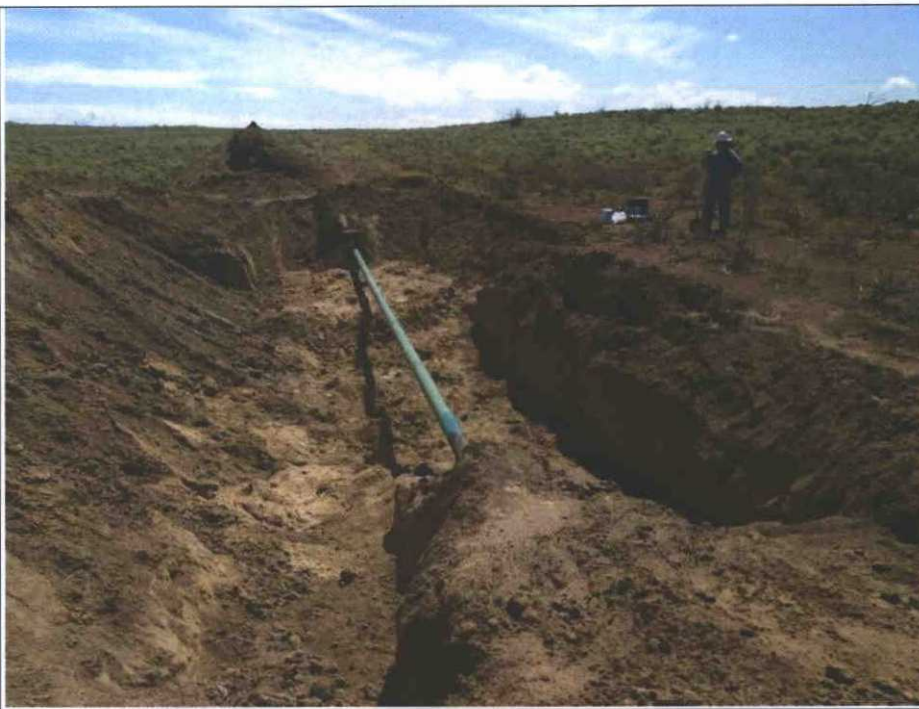
Photograph #1

Client: Enterprise	
Site Name: Lateral 2C-143 Pipeline Release	
Date Photo Taken: July 8, 2015	
Release Location: N36.26186, W107.30438 L-31-24N-4W Rio Arriba County, NM	
Photo Taken by: Deborah Watson	Description: Facing E, view of final excavation and repaired pipeline.

On July 6, 2015, Enterprise initiated repair activities at the location. The release consisted of an unknown quantity of natural gas and condensate. Site work included replacement of the segment of compromised pipeline with new pipe and excavation of hydrocarbon impacted soils.

On July 6, 2015, Enterprise, West States, and Rule Engineering, LLC (Rule) personnel were onsite for the initiation of pipeline repair activities. West States provided heavy equipment operation and pipeline repair support. Rule personnel provided excavation guidance and collected confirmation samples from the resultant excavation. The repair included the replacement of the segment of compromised pipeline with new pipe. Approximately 240 cubic yards of hydrocarbon impacted soils were removed from an area of excavation measuring approximately 44 feet x 12 feet x 7 feet in depth.

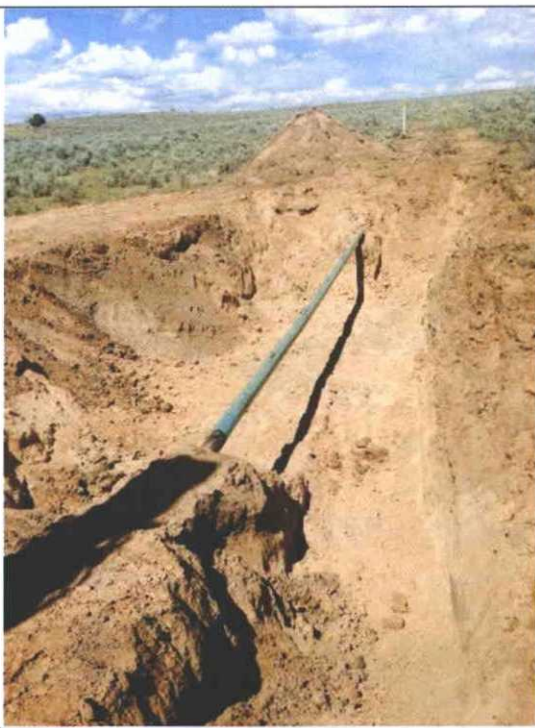
Photograph #2

Client: Enterprise	
Site Name: Lateral 2C-143 Pipeline Release	
Date Photo Taken: July 8, 2015	
Release Location: N36.26186, W107.30438 L-31-24N-4W Rio Arriba County, NM	
Photo Taken by: Deborah Watson	Description: Facing NE, view of final excavation and repaired pipeline

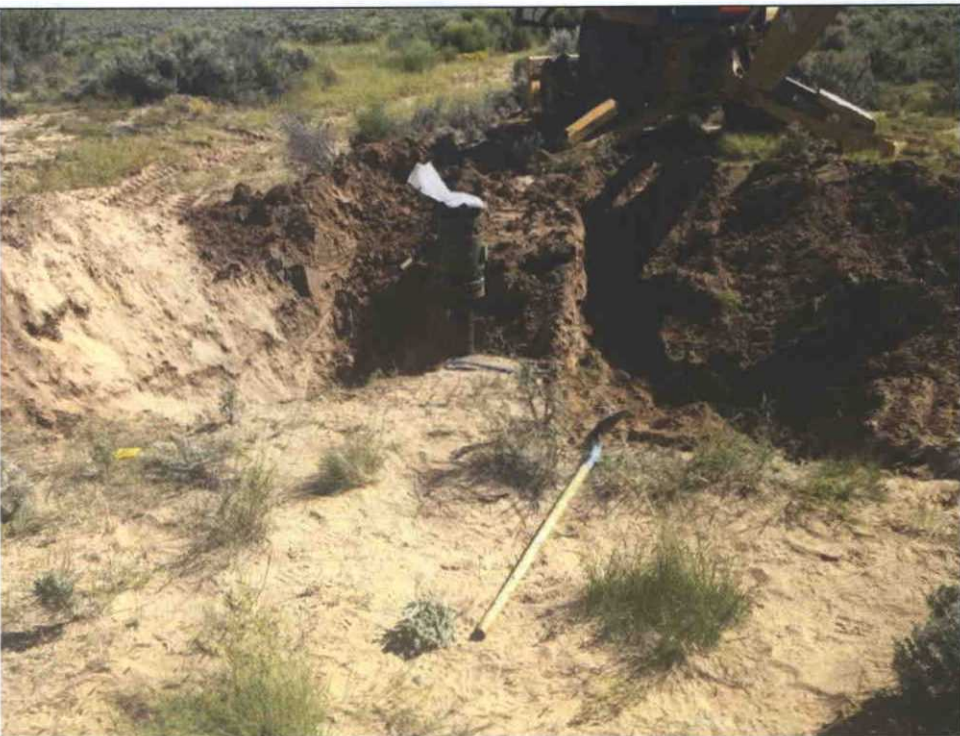
Photograph #1

Client: Enterprise	
Site Name: Jicarilla 126S #13 Well Tie Pipeline Release	
Date Photo Taken: August 28, 2015	
Release Location: N36.32306, W107.20283 L-12-24N-4W Rio Arriba County, NM	
Photo Taken by: Heather Woods	Description: Facing south, general view of initial excavation activities and end-of-line riser.

On August 28, 2015, Enterprise initiated repair activities at the location. The release consisted of an unknown quantity of natural gas and pipeline liquids. Site work included replacement the broken valve and excavation of hydrocarbon impacted soils.

On August 28, 2015, Enterprise initiated repair activities at the location. West States provided heavy equipment operation and repair support. Rule Engineering, LLC (Rule) personnel provided excavation guidance and collected confirmation samples from the resultant excavation. The repair included the replacement of the valve on the end-of-line riser. Approximately 322 cubic yards of hydrocarbon impacted soils were removed from an area of excavation measuring approximately 33 feet by 24 feet by 10 to 12 feet in depth.

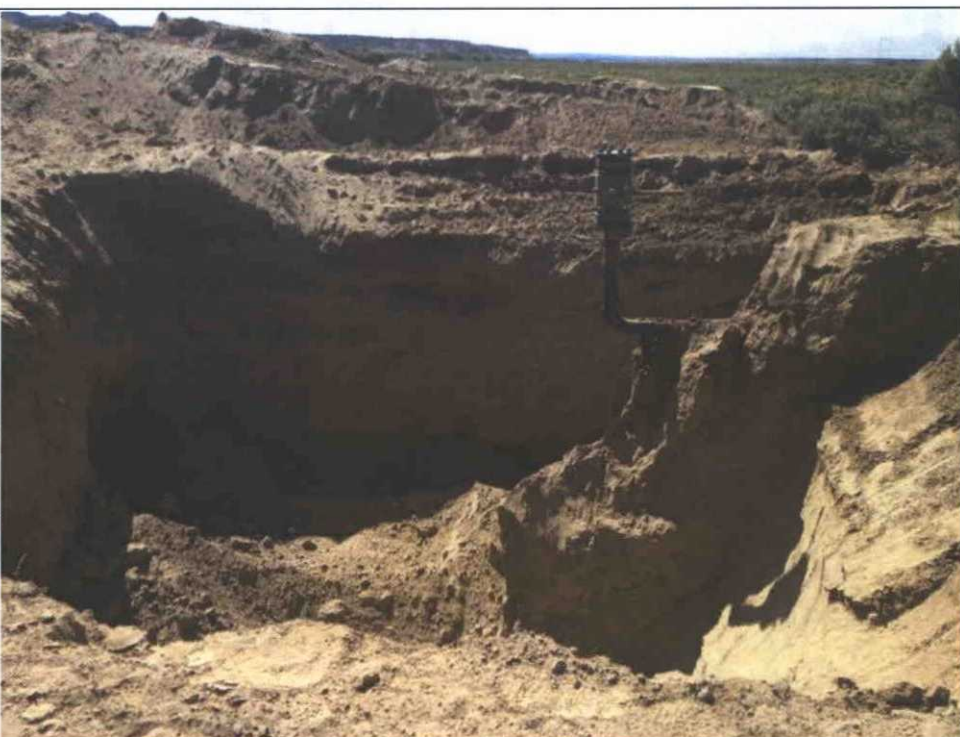
Photograph #2

Client: Enterprise	
Site Name: Jicarilla 126S #13 Well Tie Pipeline Release	
Date Photo Taken: August 31, 2015	
Release Location: N36.32306, W107.20283 L-12-24N-4W Rio Arriba County, NM	
Photo Taken by: Heather Woods	Description: Facing west, view of southern portion of final excavation.

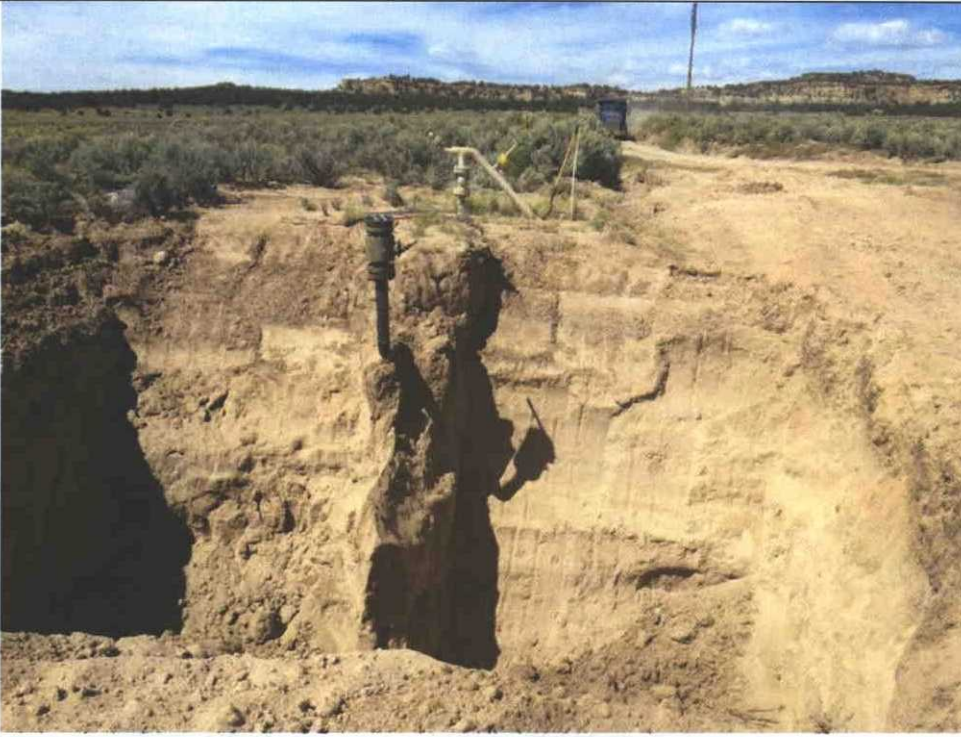
Photograph #3

Client: Enterprise	
Site Name: Jicarilla 126S #13 Well Tie Pipeline Release	
Date Photo Taken: August 31, 2015	
Release Location: N36.32306, W107.20283 L-12-24N-4W Rio Arriba County, NM	
Photo Taken by: Heather Woods	Description: Facing north, view of southern portion of final excavation.

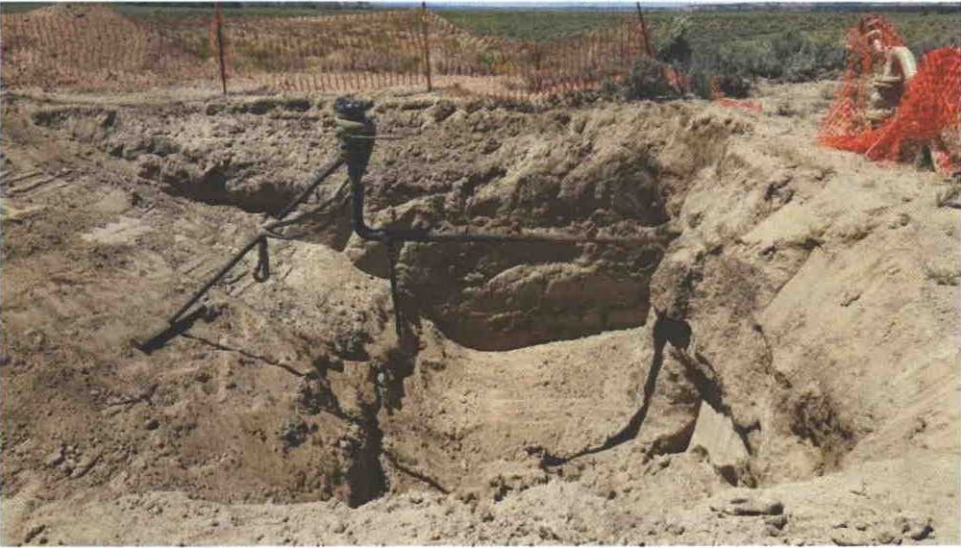
Photograph #4

Client: Enterprise	
Site Name: Jicarilla 126S #13 Well Tie Pipeline Release	
Date Photo Taken: September 8, 2015	
Release Location: N36.32306, W107.20283 L-12-24N-4W Rio Arriba County, NM	
Photo Taken by: Alexandra Price	Description: Facing west, view of northern portion of final excavation.

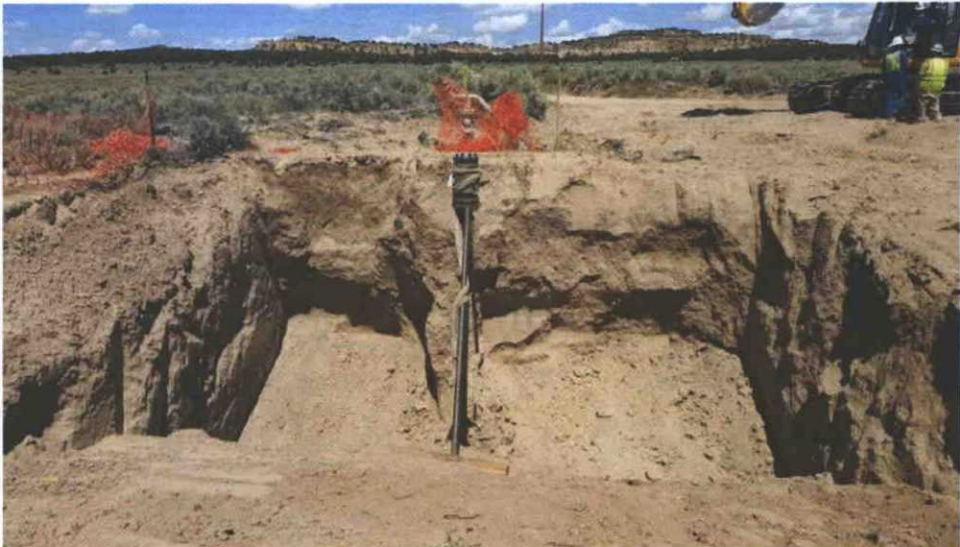
Photograph #5

Client: Enterprise	
Site Name: Jicarilla 126S #13 Well Tie Pipeline Release	
Date Photo Taken: September 8, 2015	
Release Location: N36.32306, W107.20283 L-12-24N-4W Rio Arriba County, NM	
Photo Taken by: Alexandra Price	
Description: Facing north, view of northern portion of final excavation.

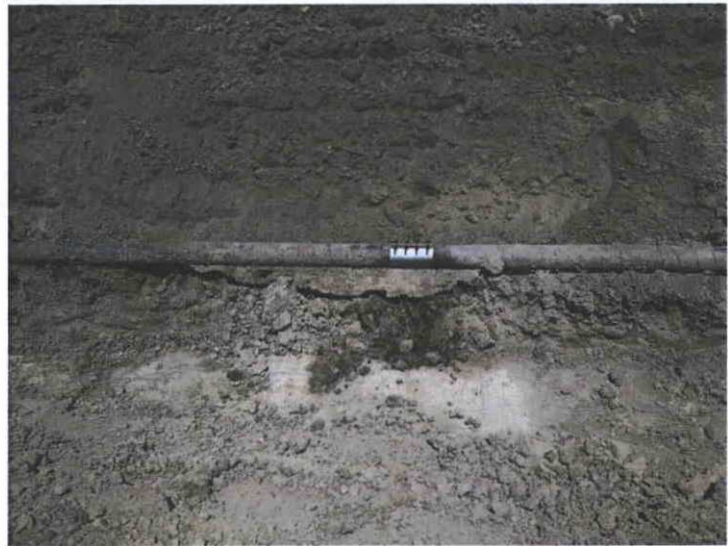
Photograph 1

View of the partially exposed Lateral K-51 pipeline and initial excavation, facing north.

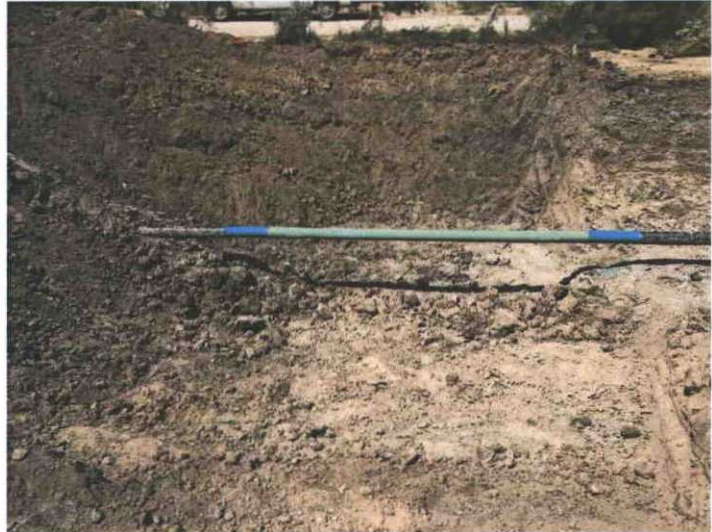
**Photograph 2**

View of the final excavation and repaired pipeline, facing north.

Describe Cause of Problem and Remedial Action: On July 31, 2015, Enterprise technicians confirmed a minor gas leak on the Lateral K-51 pipeline. The pipeline was isolated, blown down, locked out and tagged out for safety and environmental concerns. Repairs and remediation were completed on August 12, 2015.

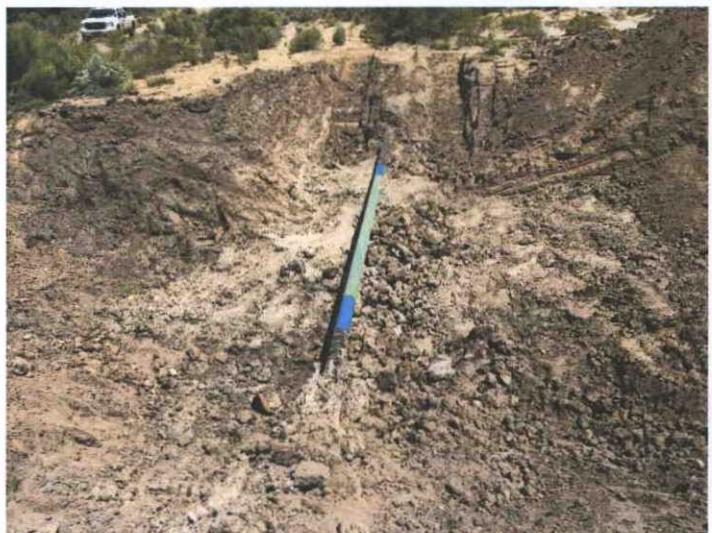
**Photograph 3**

View of the final excavation, facing east.

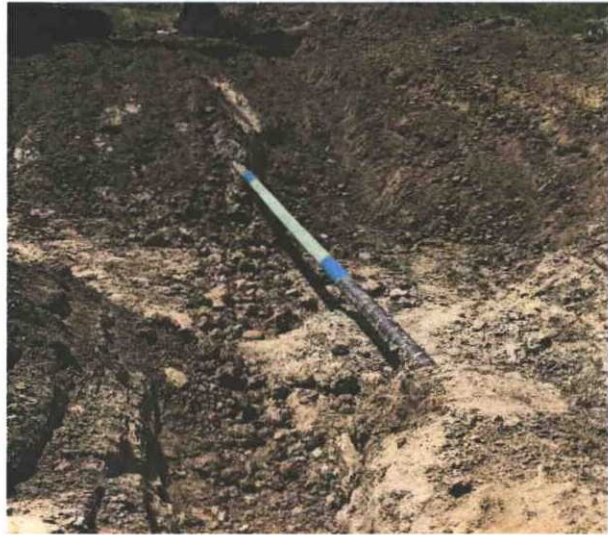
Photograph 4

View of the final excavation, facing west.

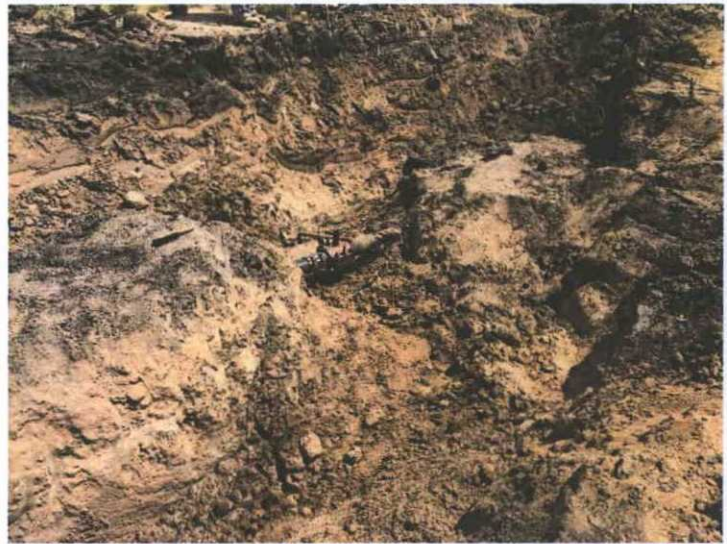
Photograph 1

View of the source area and the initial excavation, facing southeast.

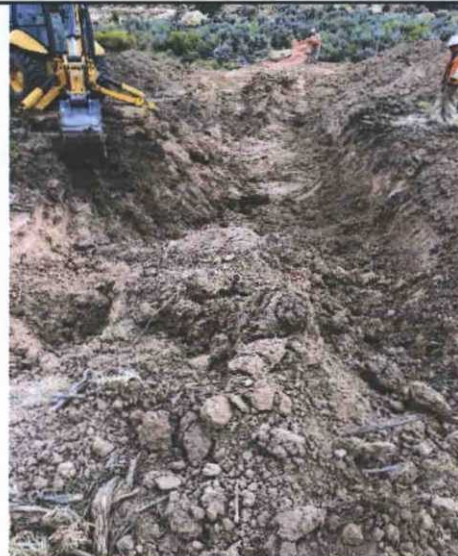
Photograph 2

View of the initial excavation and removed pipeline, facing north.

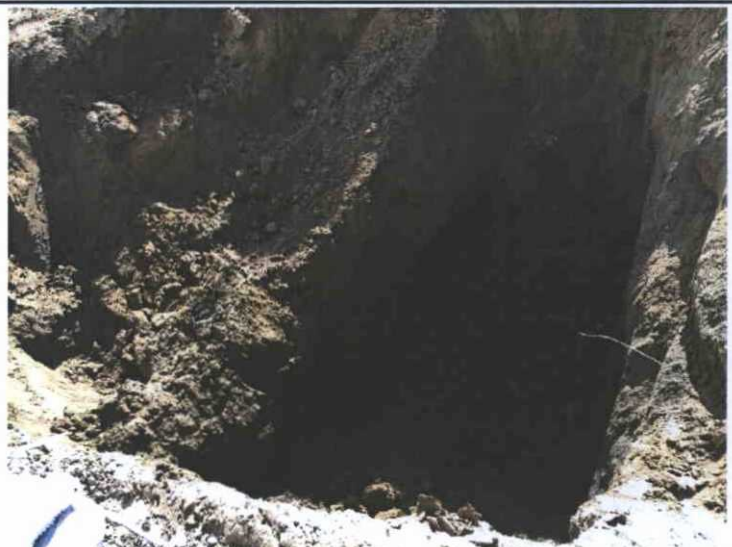
Photograph 3

View of the main release footprint, facing southeast.

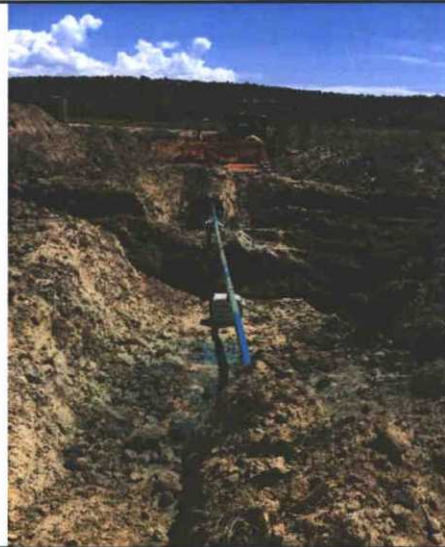
Photograph 4

View of the new pipe and final excavation, facing south.

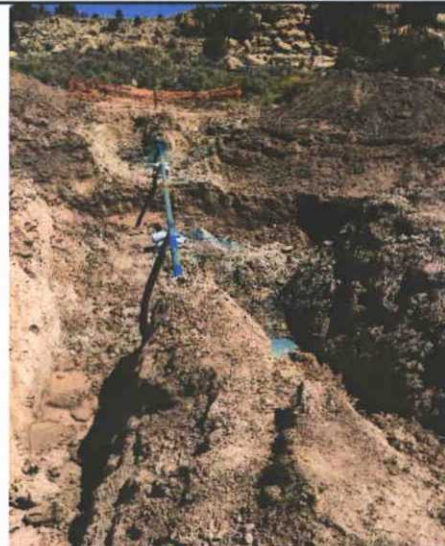
Photograph 4

View of the final excavation, facing north.

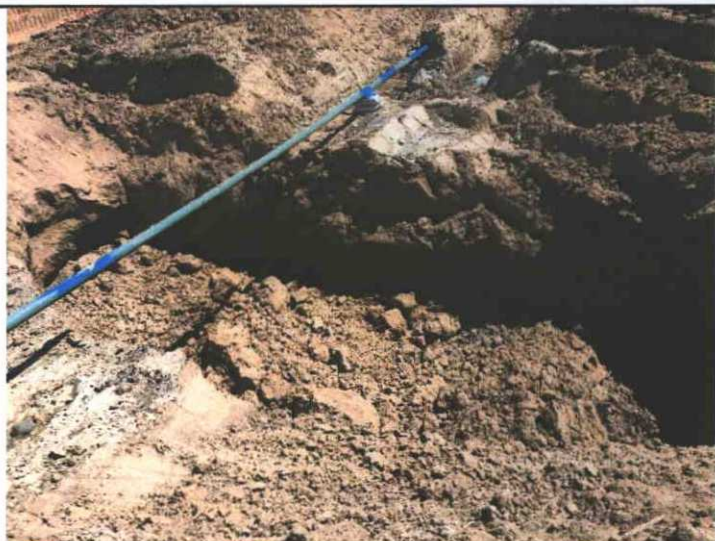
Photograph 4

View of the final excavation, facing southeast. Note: Sidewall caved into the excavation after affected soil removal was completed.
