Release Notification and Corrective Action

Re: Work Plan for the COG Operating LLC., FEE MA B #4 Tank Battery, Unit H, Section 31, Township 17 South, Range 32 East, Lea County, New Mexico.

FEE MA B #4 Tank Battery

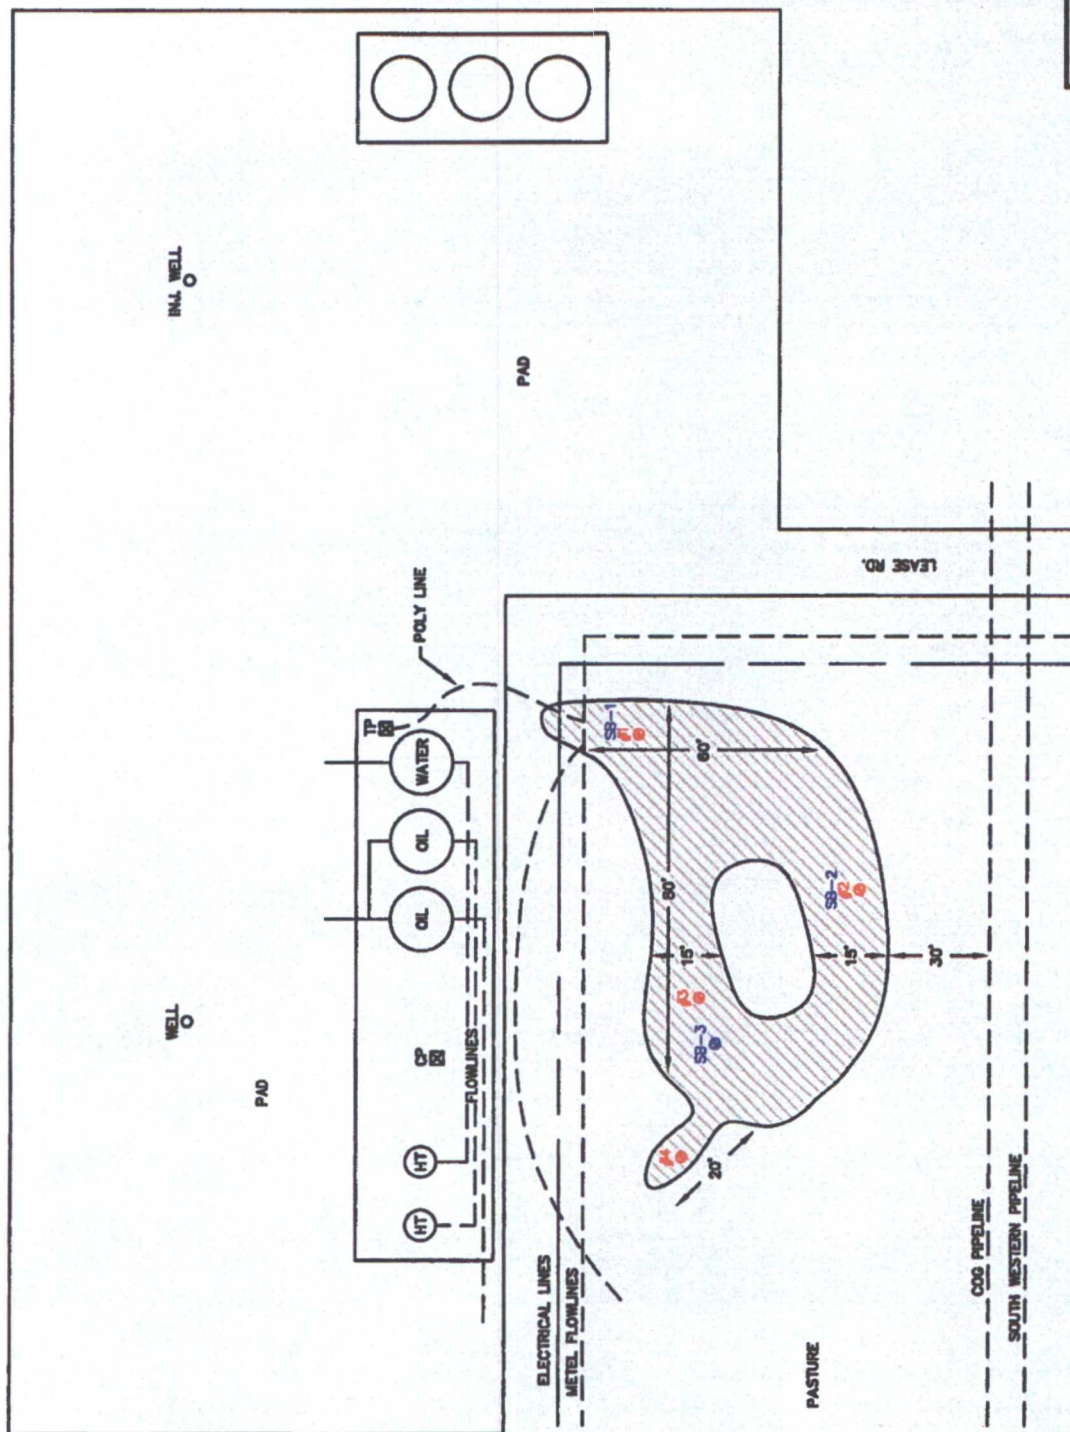
FIGURE NO. 3

On March 30, 2010, Tetra Tech personnel inspected and sampled the spill area. A total of four (4) auger holes (AH-1 through AH-4) were installed using a stainless steel hand auger to assess the impacted soils. Select samples were analyzed for TPH analysis by EPA method 8015 modified, BTEX by EPA Method 8021B and chloride by EPA method 300.0. Copies of laboratory analysis and chain-of-custody documentation are included in Appendix B. The results of the sampling are summarized in Table 1. The auger hole locations are shown on Figure 3.

To delineate the chloride impact, Tetra Tech supervised the installation of three (3) soil boreholes (SB-1 through SB-3) utilizing an air rotary drilling rig on May 10, 2010. SB-1 and SB-2 were installed in the vicinity of AH-1 and AH-2, respectively. SB-3 was installed between AH-3 and AH-4. Soil samples were collected to a total depth of 80', where the upper sand sequences started slumping in not allowing deeper penetration or samples. The soil boring results are summarized in Table 1. The soil boring locations are shown on Figure 3.

- SPILL AREA
- SAMPLE LOCATIONS
- SOIL BORING LOCATIONS

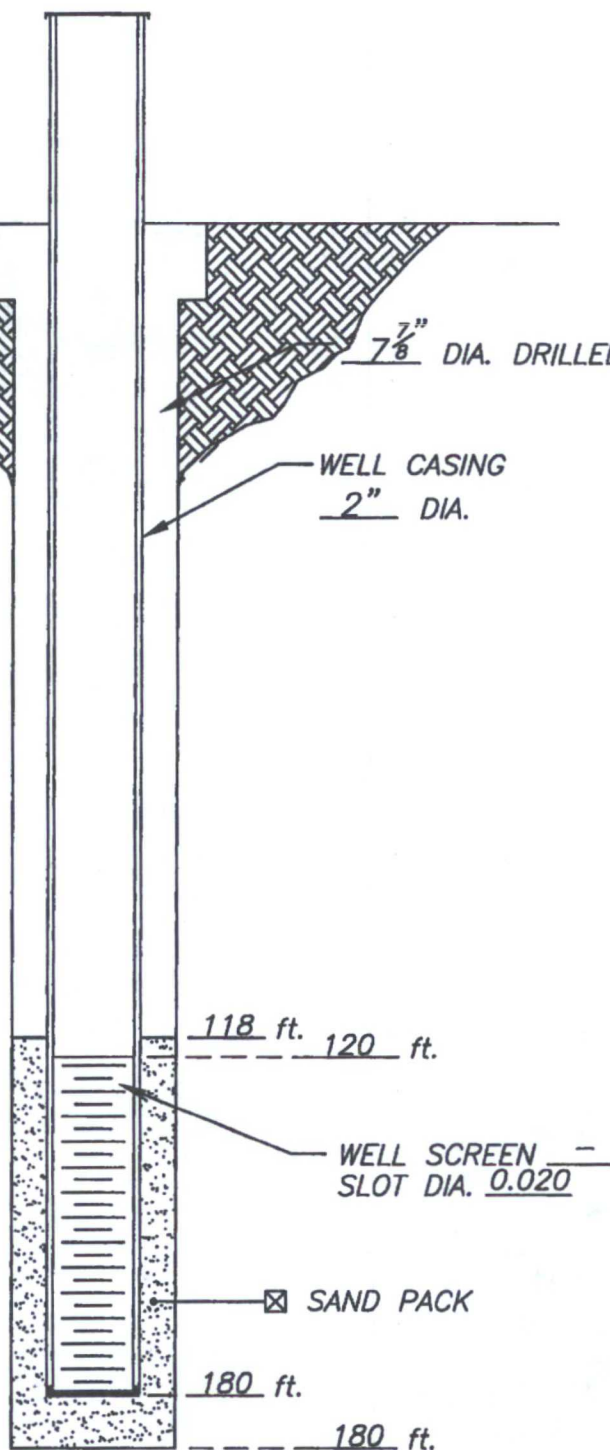
TEMPORARY WELL CONSTRUCTION LOG

$7\frac{7}{8}$ " DIA. DRILLED HOLE

WELL CASING
2" DIA.

Installation Date(s) JULY 14, 2009
Drilling Method AIR ROTARY
Drilling Contractor SCARBOROUGH DRILLING
Development Technique(s) and Date(s) PUMP

Water Removed During Development 0 gals.
Static Depth to Water DRY ft. below
Ground Level
Well Purpose TEMPORARY MONITOR WELL

installed a temporary monitor well (TMW) in Section 30 to a depth of 180' bgs and did not encounter groundwater. The groundwater data is shown in Appendix A.

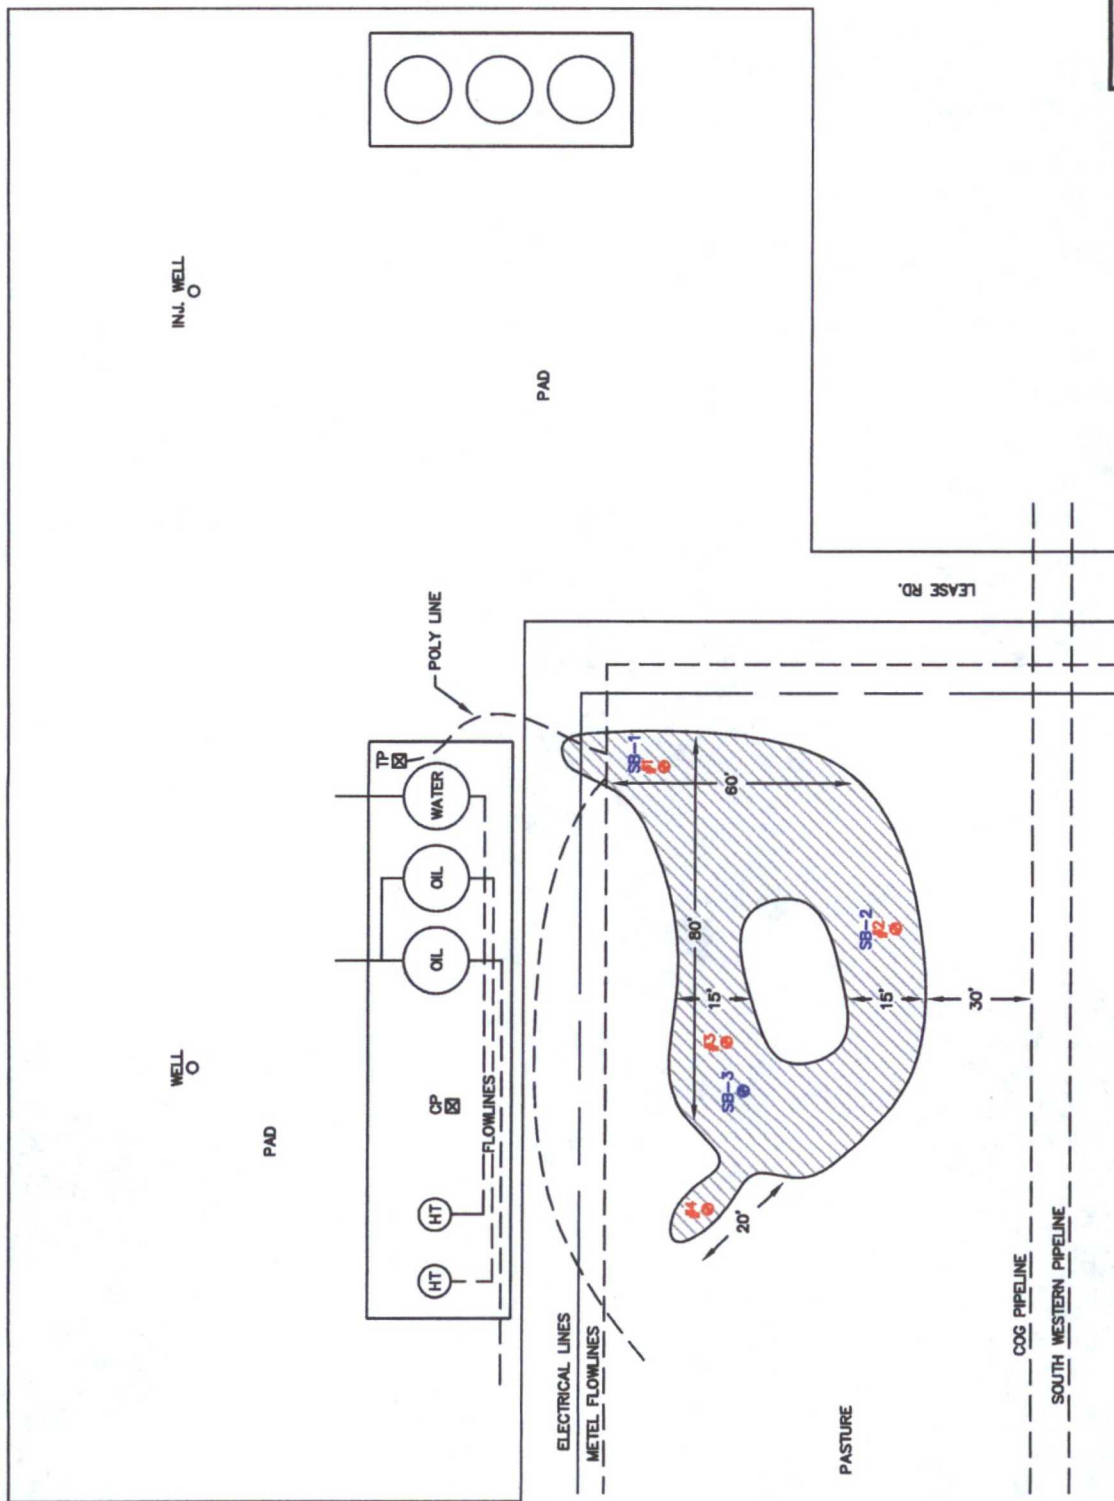
FIGURE NO. 3

On March 30, 2010, Tetra Tech personnel inspected and sampled the spill area. A total of four (4) auger holes (AH-1 through AH-4) were installed using a stainless steel hand auger to assess the impacted soils. Select samples were analyzed for TPH analysis by EPA method 8015 modified, BTEX by EPA Method 8021B and chloride by EPA method 300.0. Copies of laboratory analysis and chain-of-custody documentation are included in Appendix B. The results of the sampling are summarized in Table 1. The auger hole locations are shown on Figure 3.

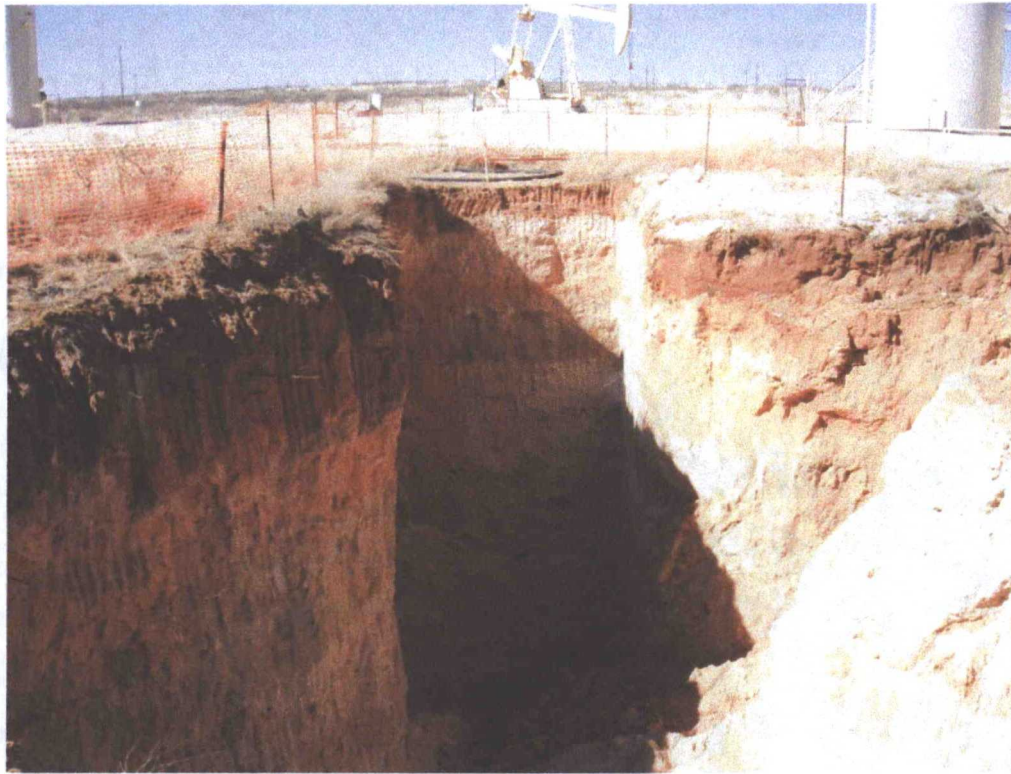
Excavated area near SB-2

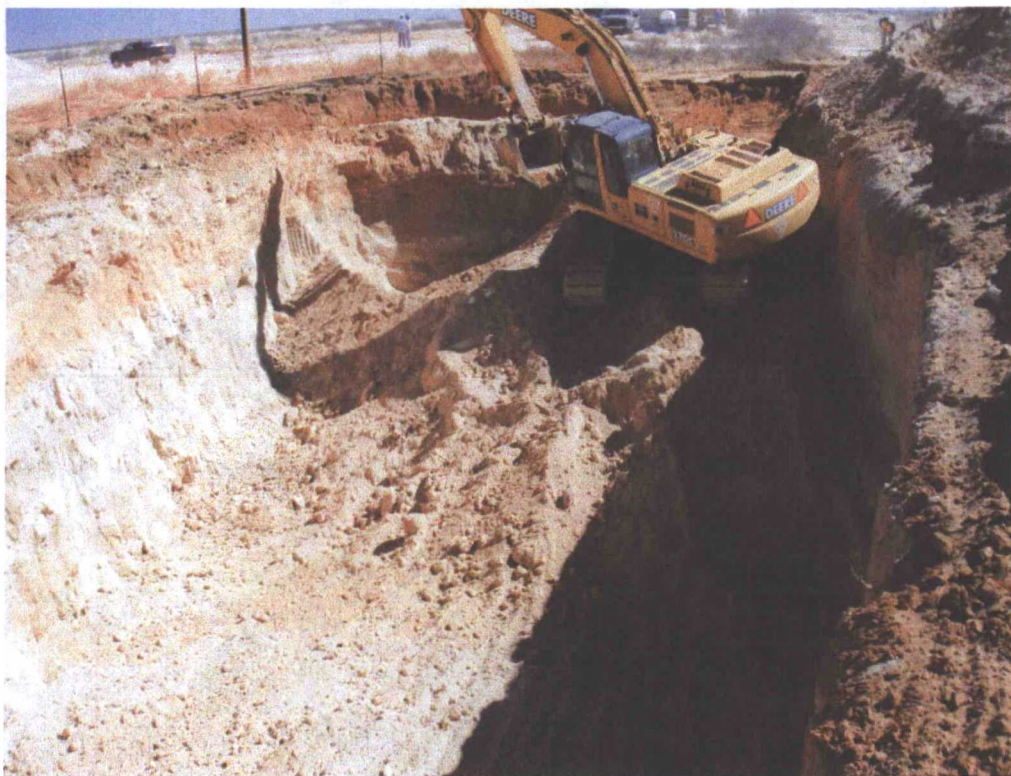
Excavation pit near SB-3 and SB-2

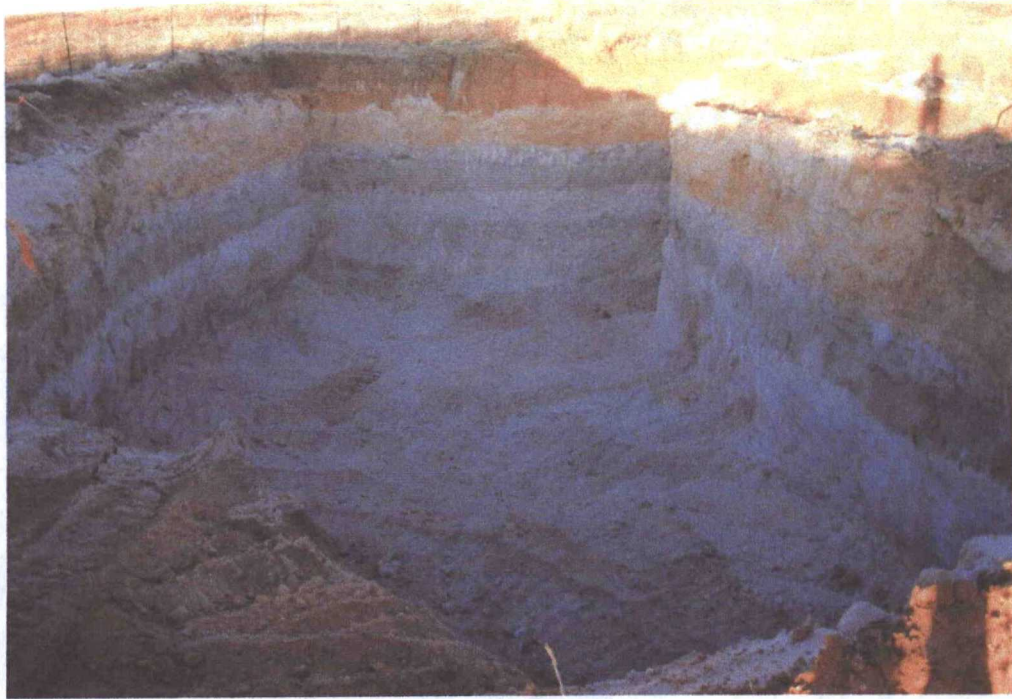
Final excavation depth ~20' BGS

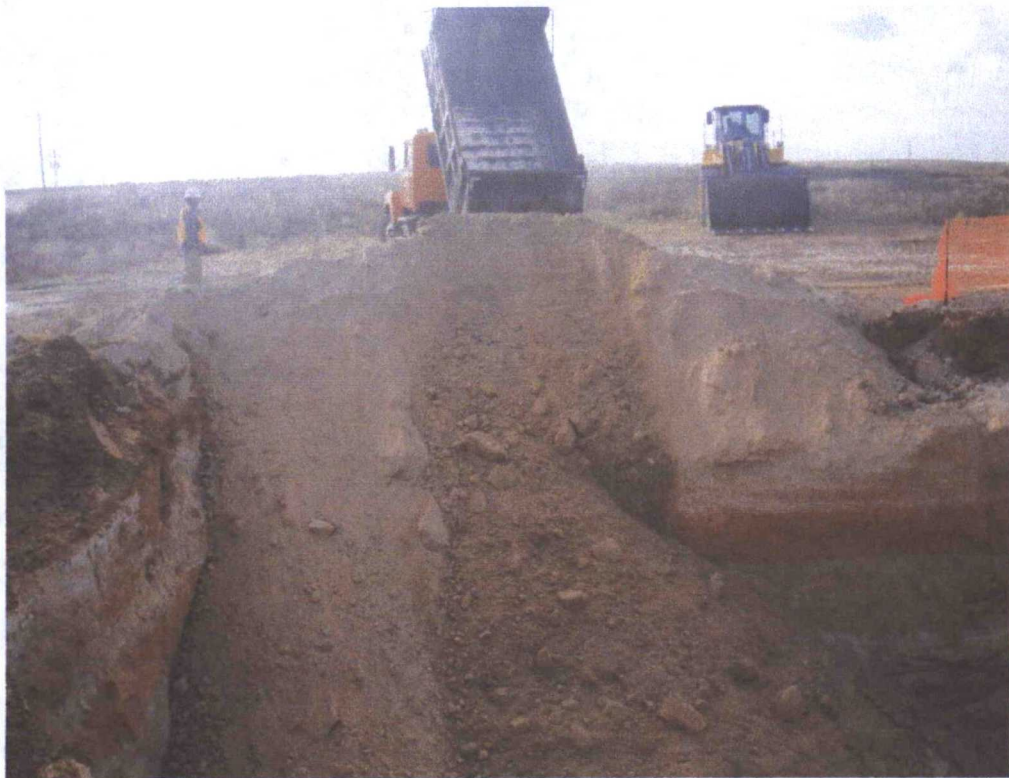
Backfilling with clean material

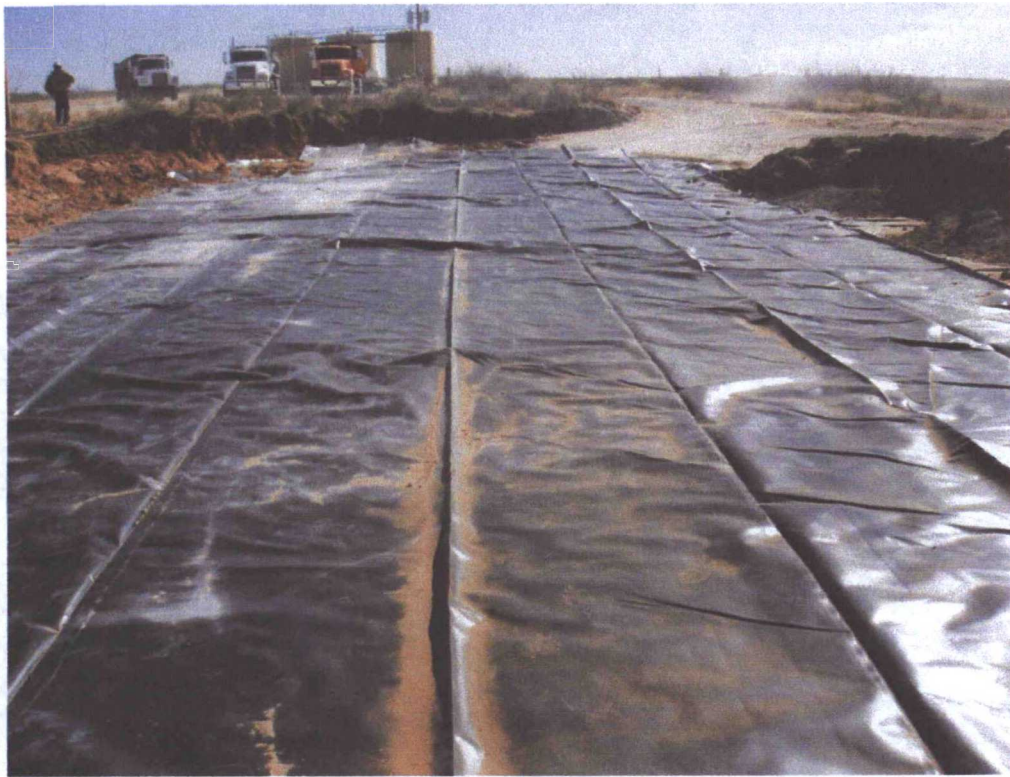
Installation of liner after excavation is backfilled to 4'

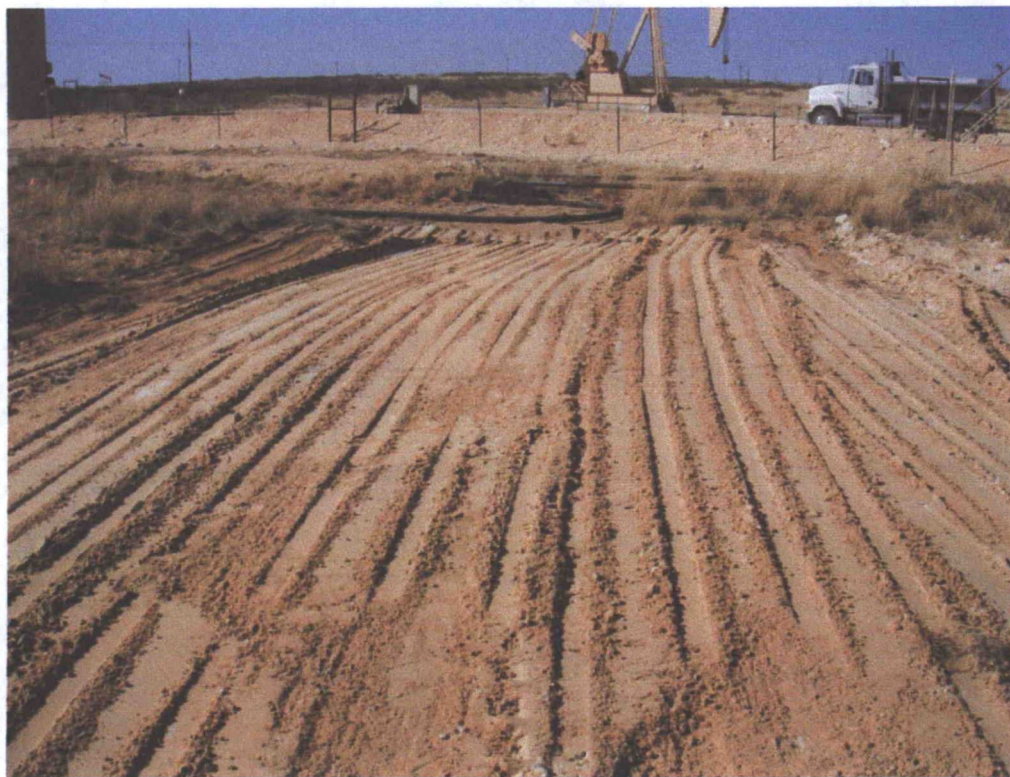
After liner was installed and clean material backfilled to surface grade
