Release Notification and Corrective Action

EVGSAU Central Tank Battery (1RP-11-12-2867)

CAP Report & Termination Request

**RE: Corrective Action Plan Report & Termination Request
ConocoPhillips – EVGSAU Central Tank Battery (1RP-11-12-2867)
UL/A&B sec. 33 T17S R35E**

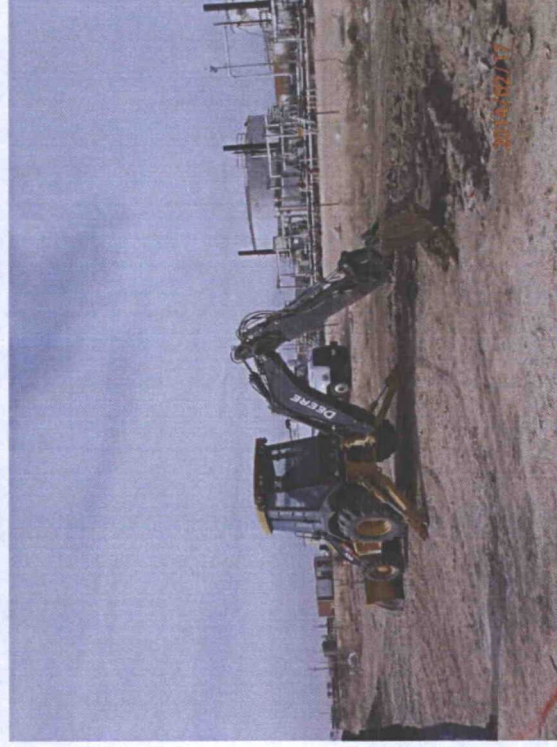
2/17/2014

Excavating vertical, facing southwest

A vertical at Point 2 was installed on February 17th, 2014, with soil samples collected every 6 inches. The samples were sent to a commercial laboratory for analysis of chloride and hydrocarbons. The 4 ft sample resulted in a chloride concentration of 95 mg/kg, which decreased to 64 mg/kg at 4.5 ft. GRO and DRO concentrations were near or below detectable limits in both samples (Appendix B).

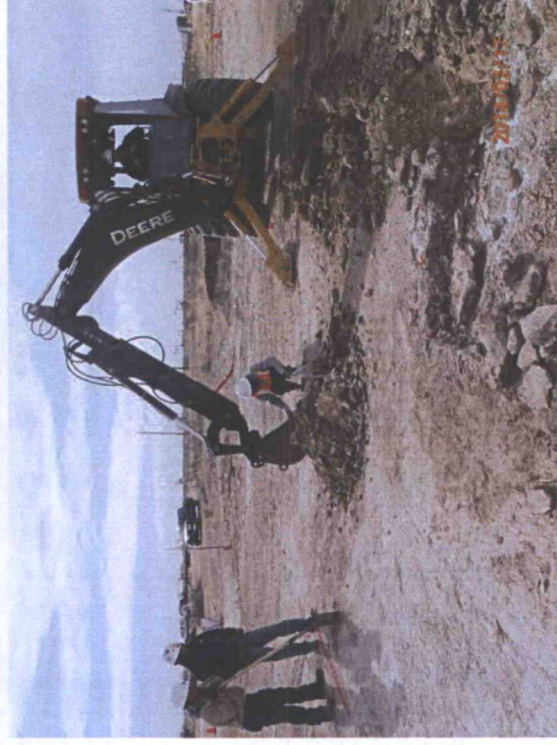
2/17/2014

Collecting sample, facing south

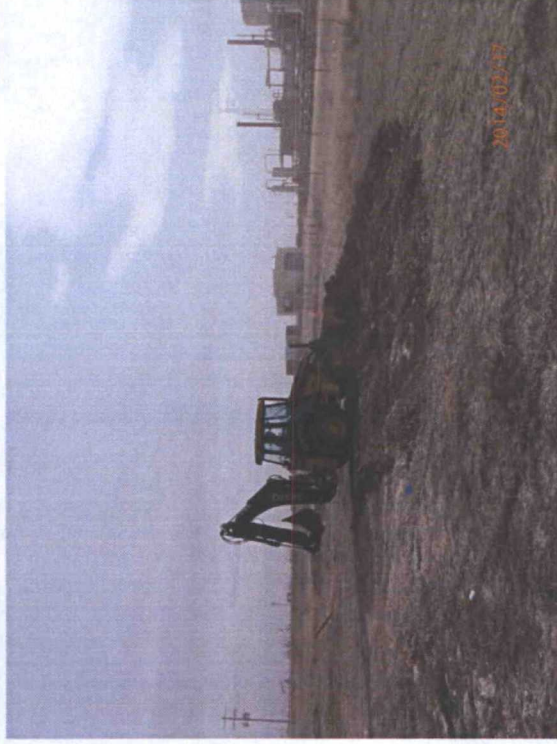
2/17/2014

Scraping site, facing south

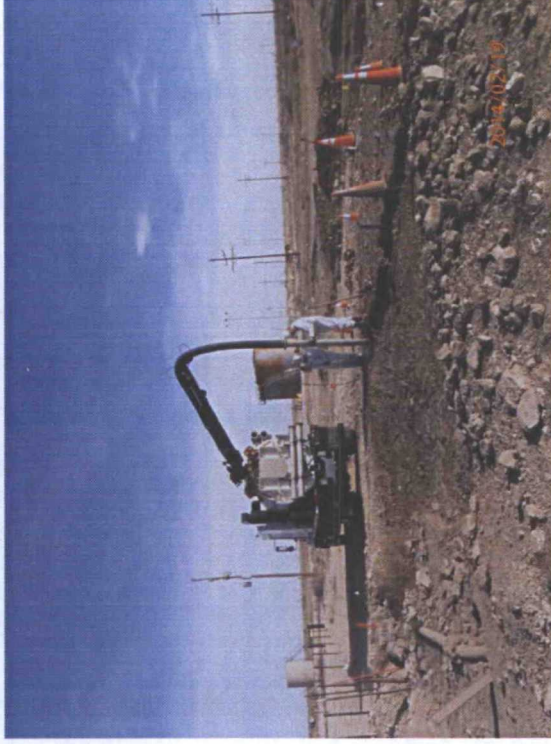
2/19/2014

Utilizing hydro-vac for scrape, facing northeast

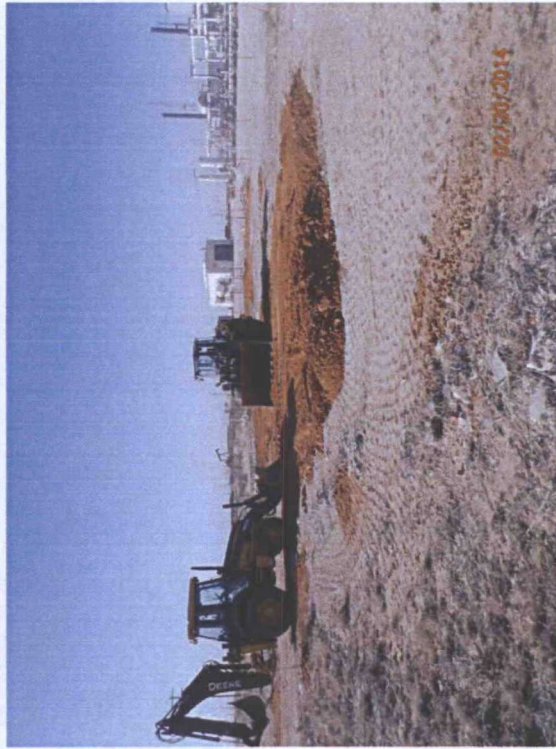
2/20/2014

Backfilling scraped area with clay, facing north

Beginning on February 20th, 2014, the entire release area was covered with 1 foot of clay, followed by an overlay of 6 inches of base coarse. A total of 490 yards of clay and a total of 334 yards of base coarse were imported to the site. An eight point composite of the imported soil was taken to a commercial laboratory for analysis and returned a chloride value of 32 mg/kg (Appendix C). The base coarse was contoured such that the area sloped down to the east toward the adjacent pad. A berm was created around the site to prevent future release from exacerbating the site.

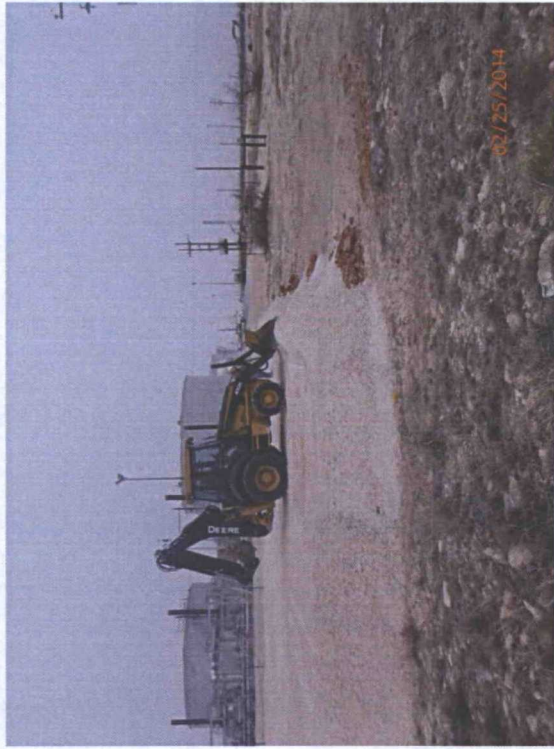
2/25/2014

Building berms, facing west

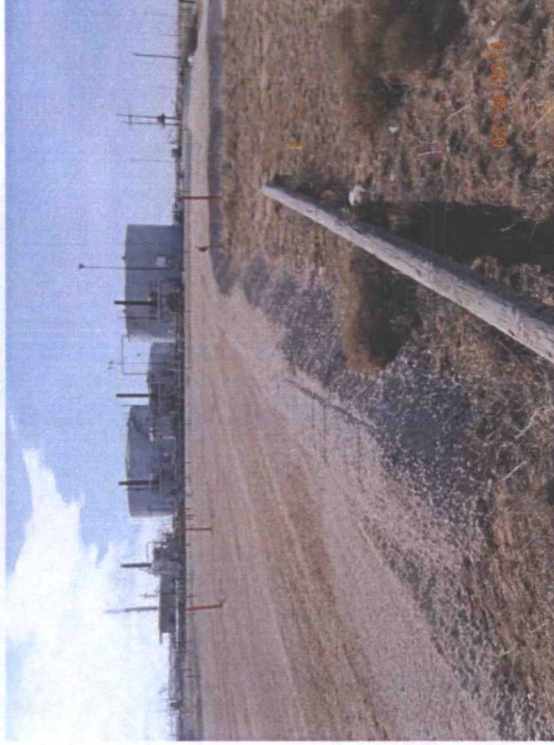
2/26/2014

Site completed, facing west

Given that the site was capped with clay and base coarse, and the area contoured to move further releases from the site, Linn respectfully requests 'remediation termination' and site closure. A final C-141 for the site can be found in Appendix E.
