### Release Notification and Corrective Action

Work Plan for the COG Operating LLC., LPC 31 Federal #1, Unit G, Section 31, Township 18 South, Range 32 East, Lea County, New Mexico.

## COG Operating LLC LPC 31 Federal #1 Lea County, New Mexico

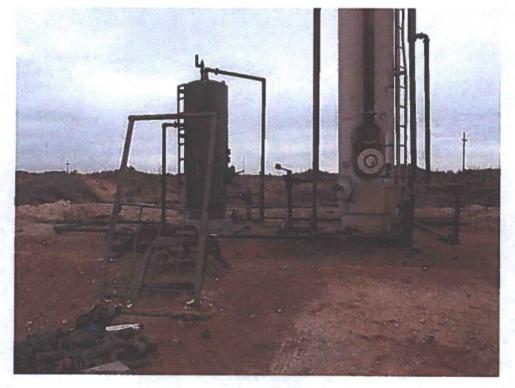
Referring to Table 1, none of the auger hole samples were above the RRAL's for TPH or BTEX. The area of AH-1 did show a chloride high of 4,670 mg/kg at 0-1' and declined to 231 mg/kg at 1.1.5' below surface. The deeper samples showed chloride spikes to 2,700 mg/kg at 7'-7.5', 1,260 mg/kg at 8-8.5' and 1,490 mg/kg at 9-9.5' below surface.

View South - Area of AH-1

COG proposes to remove all depths highlighted (green) in Table 1. The areas will be excavated to depths of approximately 1.0' to 3.0' below surface. The areas of AH-1 and AH-2 will be excavated to a depth of 1.0' and 2.0', respectively. The area of AH-3 (BH-1) will be excavated to a depth of 3.0' and then capped with either liner or clay material. All of the excavated material will be transported offsite for proper disposal. Once final excavation depths are achieved, the site will be backfilled with clean material and brought to grade.

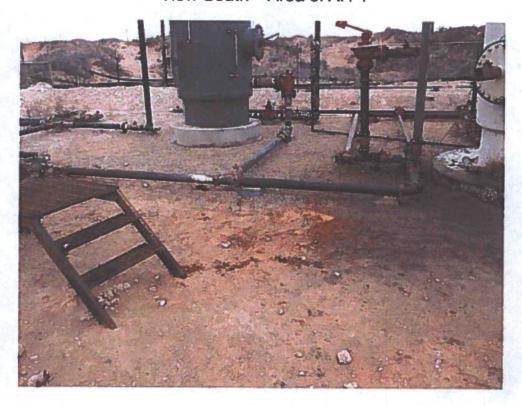
The area of auger hole (AH-2) showed elevated chloride concentrations down to 2' to 3' below surface and declined with depth, then spiked to 1,420 mg/kg at 6'-6.5' below surface. The area of auger hole (AH-3) showed elevated chloride concentrations with a chloride high of 4,700 mg/kg at 6'-6.5' below surface. None of the auger holes were vertically defined

View East - Area of AH-2

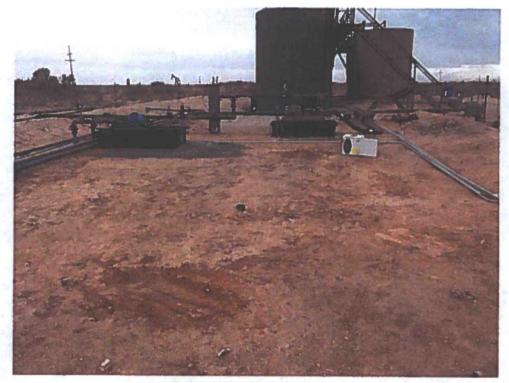
View Southwest - Area of AH-3

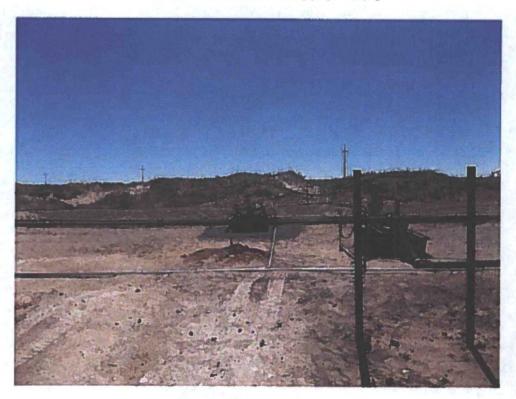
Borehole (BH-1) showed elevated TPH and BTEX concentrations above the RRAL which then declined with depth to below the RRAL, at 6'-7' below surface. Borehole (BH-2) did not show TPH or BTEX concentrations above the RRAL.

Borehole (BH-1) did not show any significant chloride impact to the soils, with a chloride high of 952 mg/kg at 2'-3' below surface. In addition, the area of borehole (BH-2) also did not show a significant chloride impact to the soils. However, the sampling did show a chloride spike of 1,090 mg/kg at 6'-7' below surface.

View South - Area of BH-1

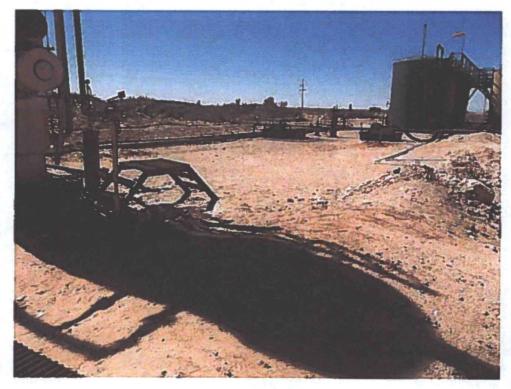
View Southwest - Area of BH-2
