Release Notification and Corrective Action

Name of Company: Targa Midstream Services, L.P.	Contact: Cal Wrangham	
Address: 6 Desta Drive, Suite 3200, Midland, Texas 79705	Telephone No.: (432) 688-0452	
Facility Name: R. D. Sims 8" (West Location)	Facility Type: Natural Gas Pipeline	
Surface Owner: William Sims	Mineral Owner	Lease No.

Describe Cause of Problem and Remedial Action Taken.* ☐ Twin 8" natural gas lines developed leaks at two locations (west and east) from corrosion. Steel lines were shut-in, leaks clamped and 300 feet of 6 inch poly line was inserted into each of the steel lines.

Describe Area Affected and Cleanup Action Taken.* Two (2) leaks were observed on the same line approximately 40 feet (west and east) apart. The west excavations measures approximately 45'L x 65'W x 27'D and the east excavation measures approximately 20'L X 25'W X 15'D. Approximately 1,624 cubic yards of contaminated soil was excavated and hauled to Parabo Disposal (NM-01-0003). Highest in-situ TPH concentration in 82.6 mg/Kg in the bottom of the east excavation at approximately 15' bgs and is below RRAL of 1,000 mg/Kg. Highest in-situ chloride concentration is 783 mg/Kg from north side of th

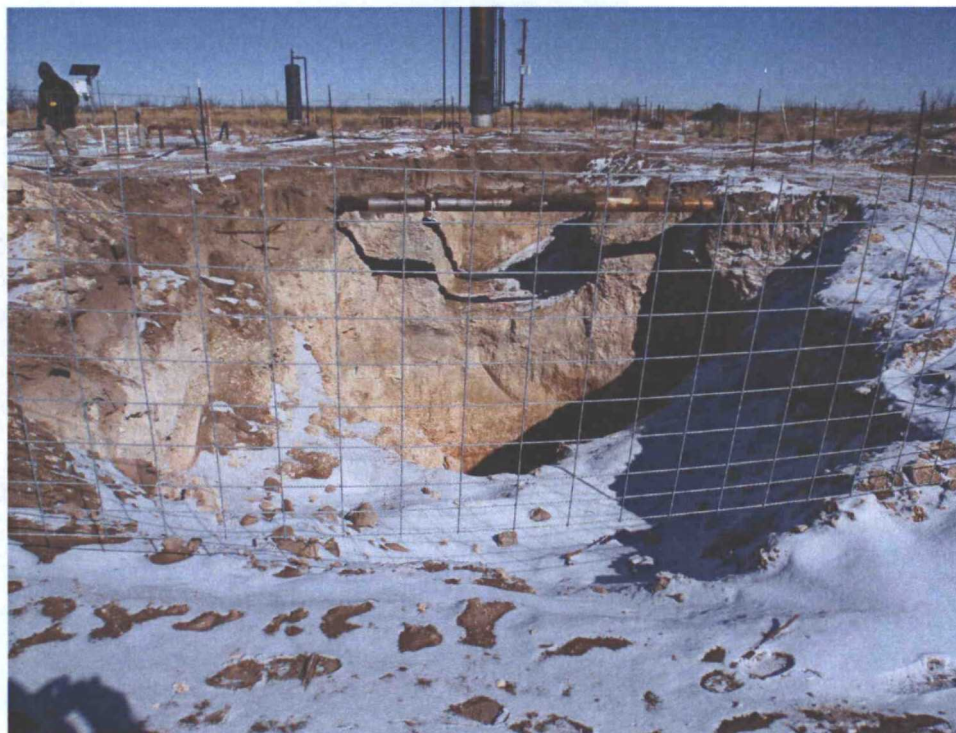
West Excavation Viewing North, February 4, 2011

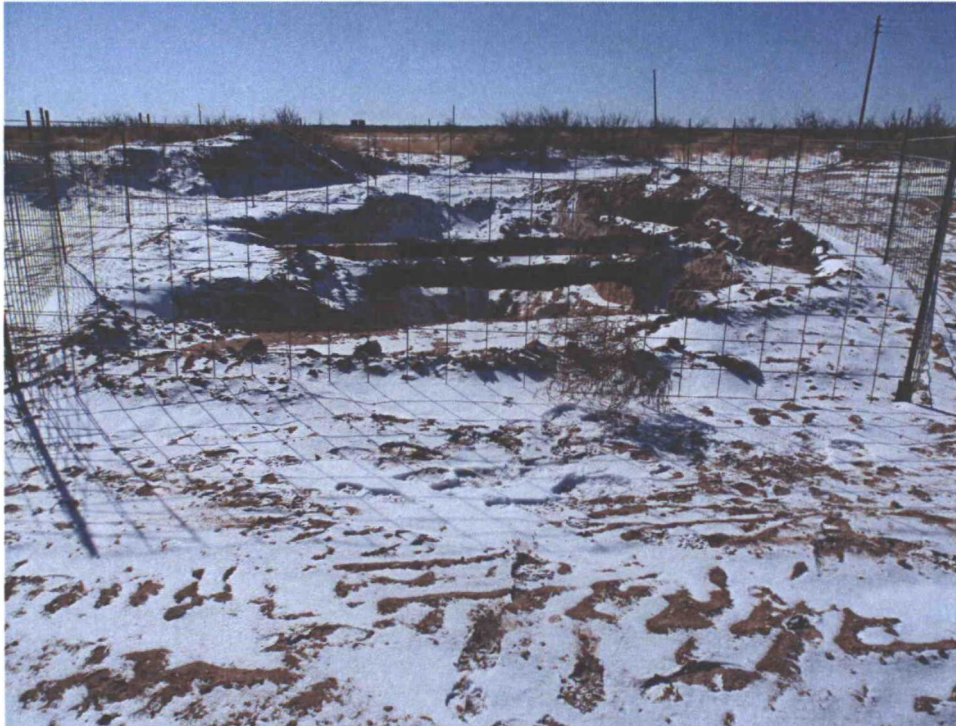
West Excavation Viewing South, February 4, 2011

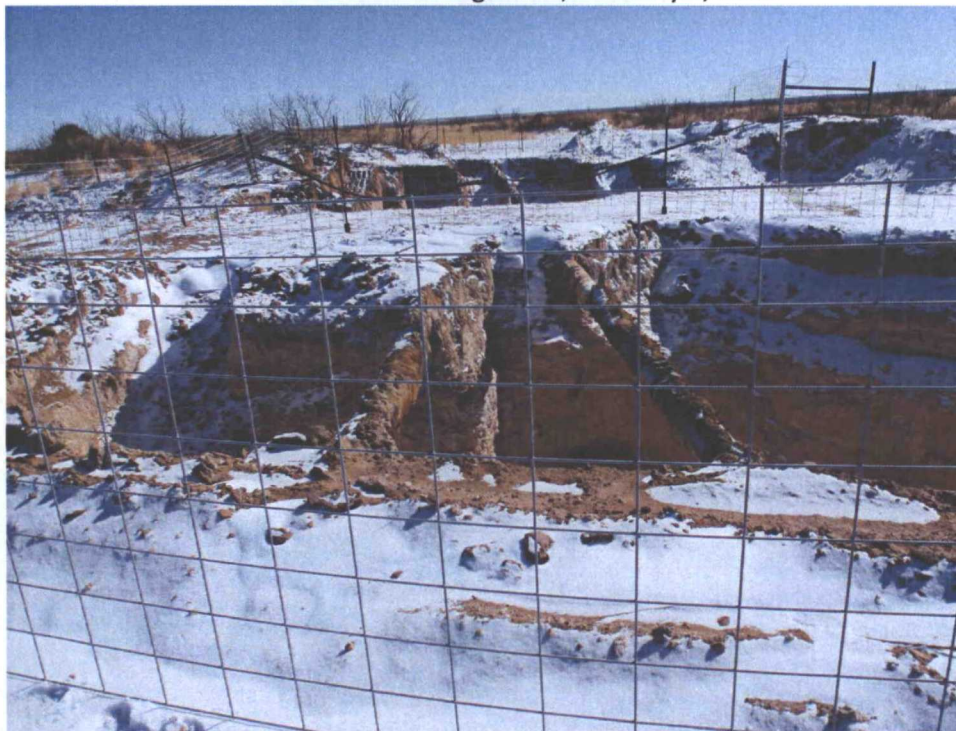
West (Foreground) and East (Background) Excavations Viewing East, February 4, 2011

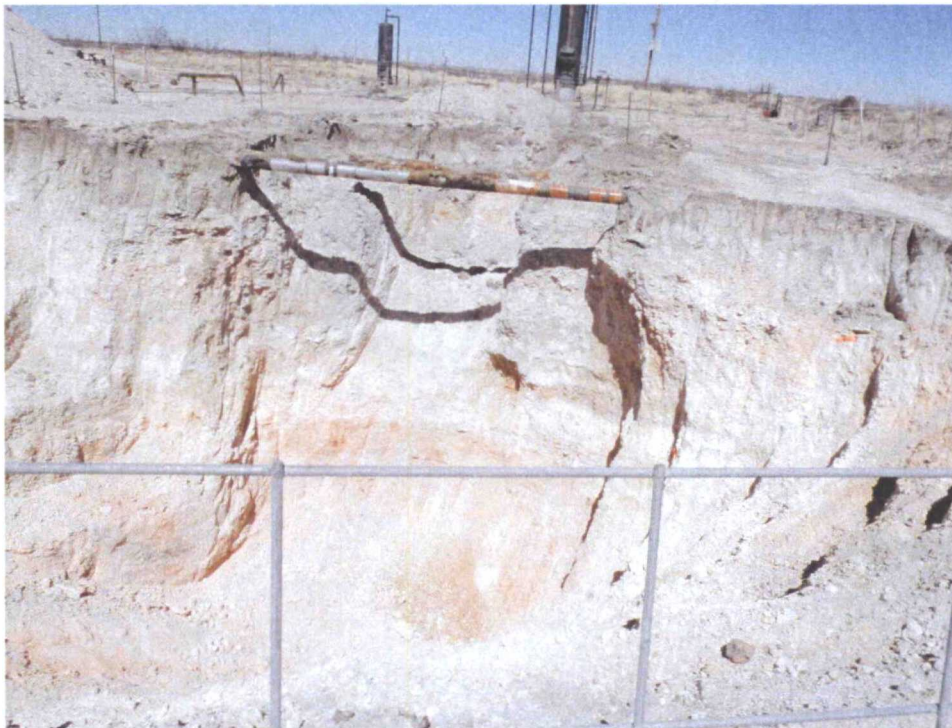
West Excavation after Benching Viewing North, March 2, 2011

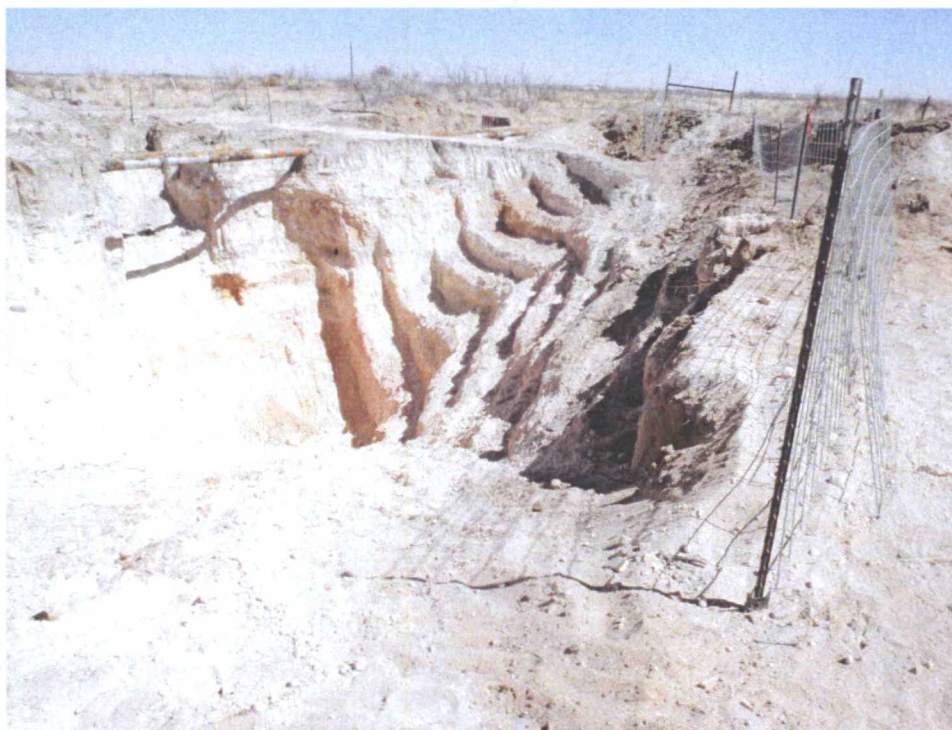
West Excavation after Benching Viewing Northeast, March 2, 2011

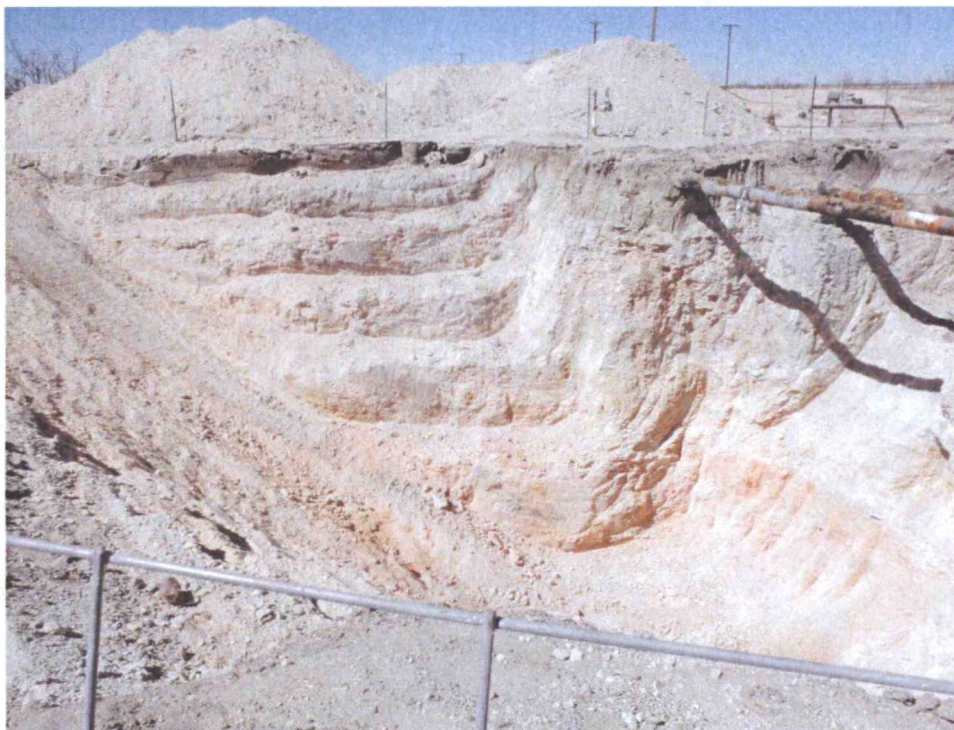
West Excavation after Benching Viewing West, March 2, 2011

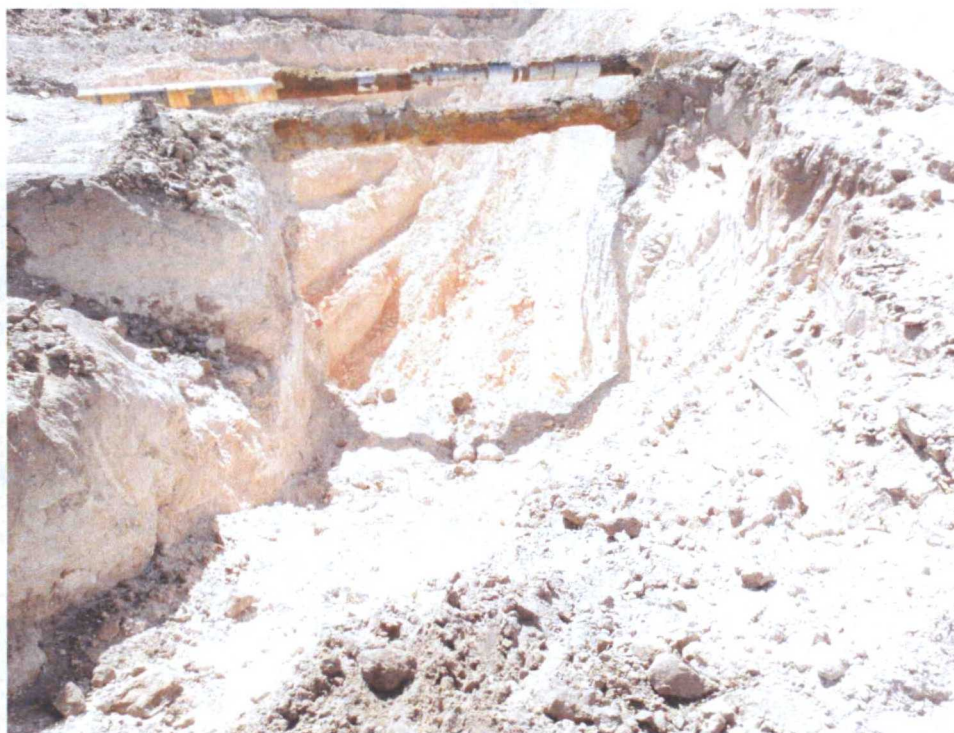
West Excavation after Benching Viewing South, March 2, 2011

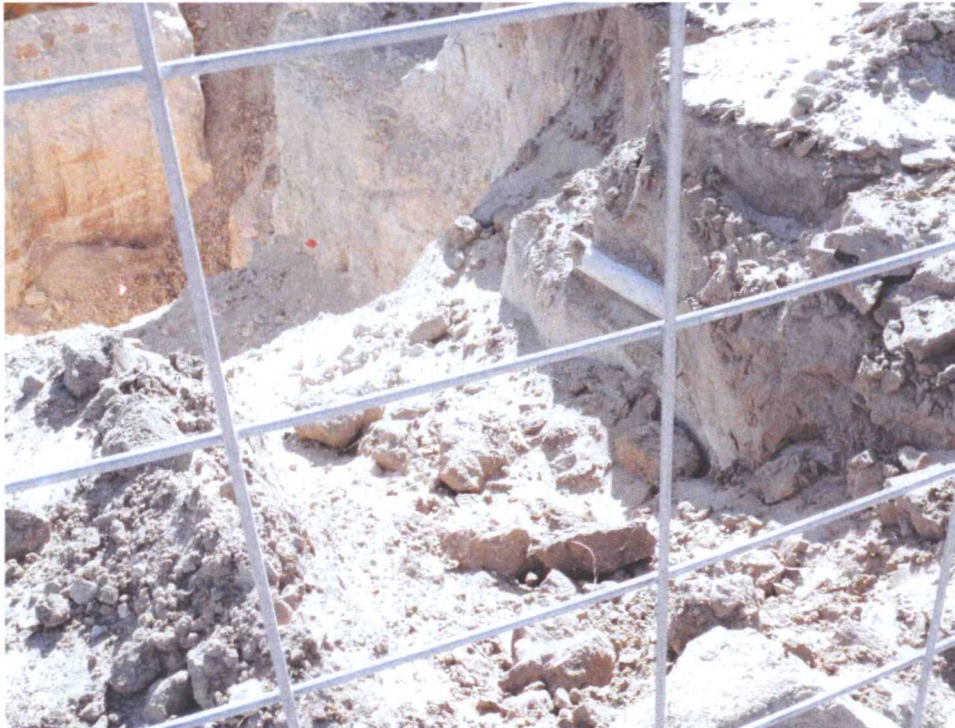
A 4 inch polyvinyl chloride (PVC) line that crossed the west excavation from north to south is believed to be the source for the chloride. A third party previously used the PVC line, which is out of service, to convey produced water south of the Site from a heater treater located about 100 feet north of the Site. The PVC line was not identified during the utility notification but was encountered near the center of the west excavation at approximately 3 feet bgs where a dresser sleeve was observed. The PVC pipe joints were glued and the line was capped near the south side of the excavation.

Produced Water (PVC) Line Exposed on North Side of West Excavation, March 2, 2011

Since soil has been remediated below the OCD recommended remediation action level (RRAL) for TPH (1,000 mg/Kg), Targa respectfully requests approval to fill the excavation with soil from the piles and clean soil from an offsite source. Targa will commence cleanup at the east location upon filling the west exaction and submit a separate report to the OCD.

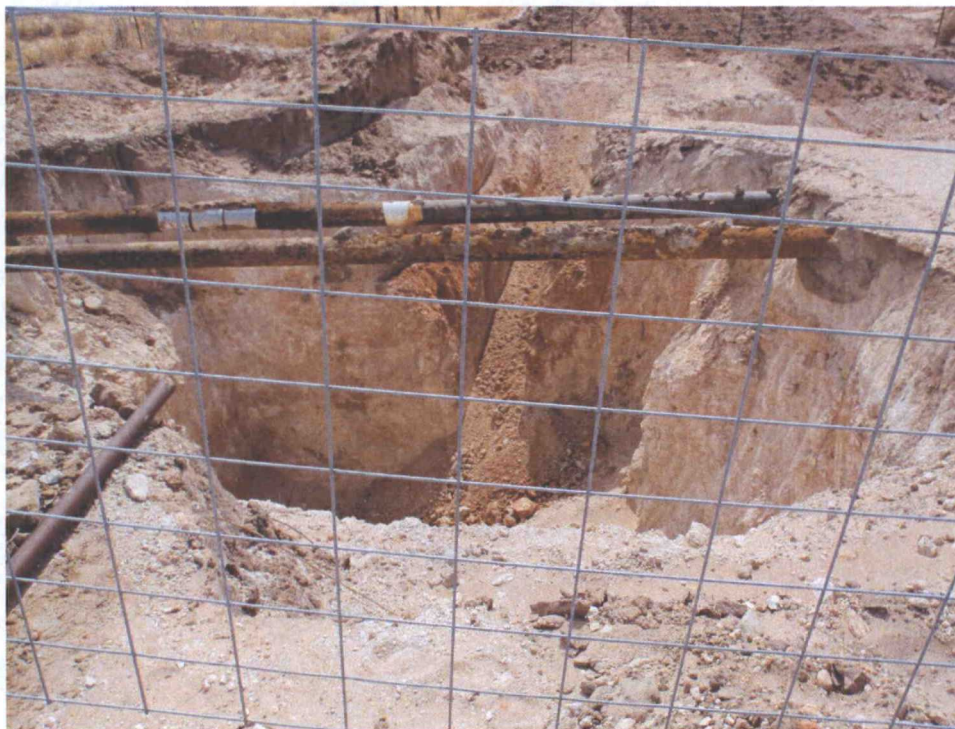
East Excavation Viewing South, March 22, 2011

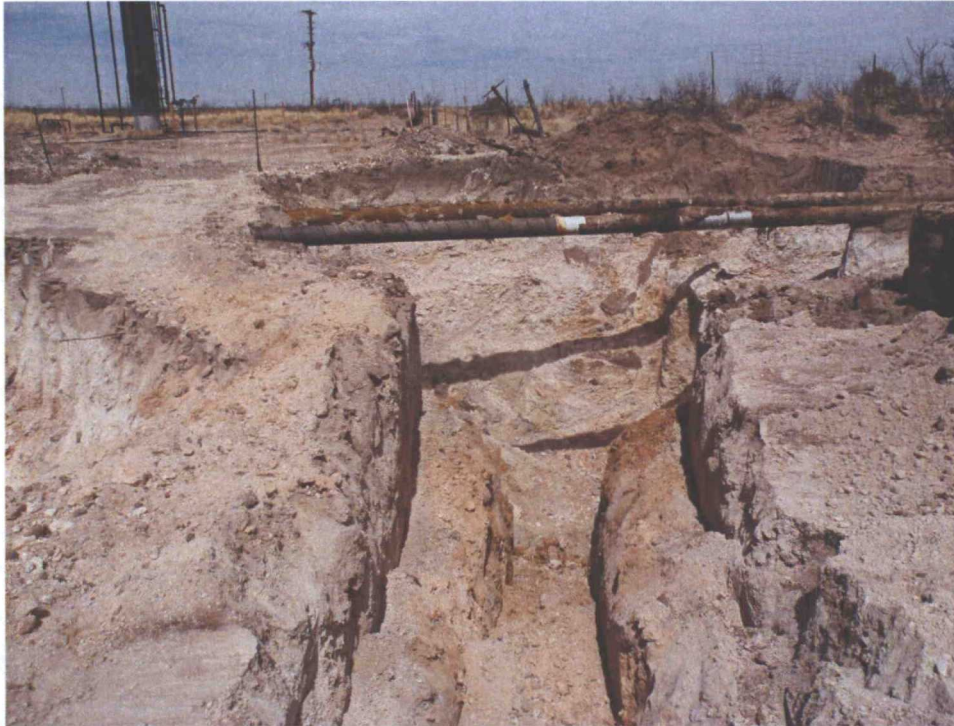
East Excavation Viewing North, March 22, 2011

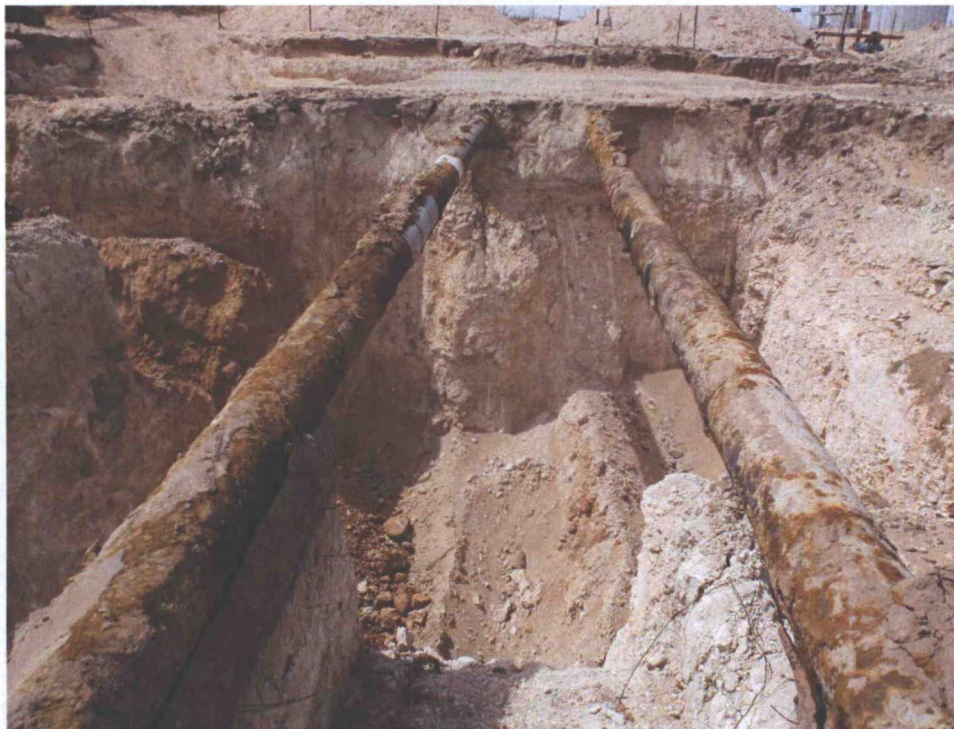
East Excavation Viewing West, March 22, 2011

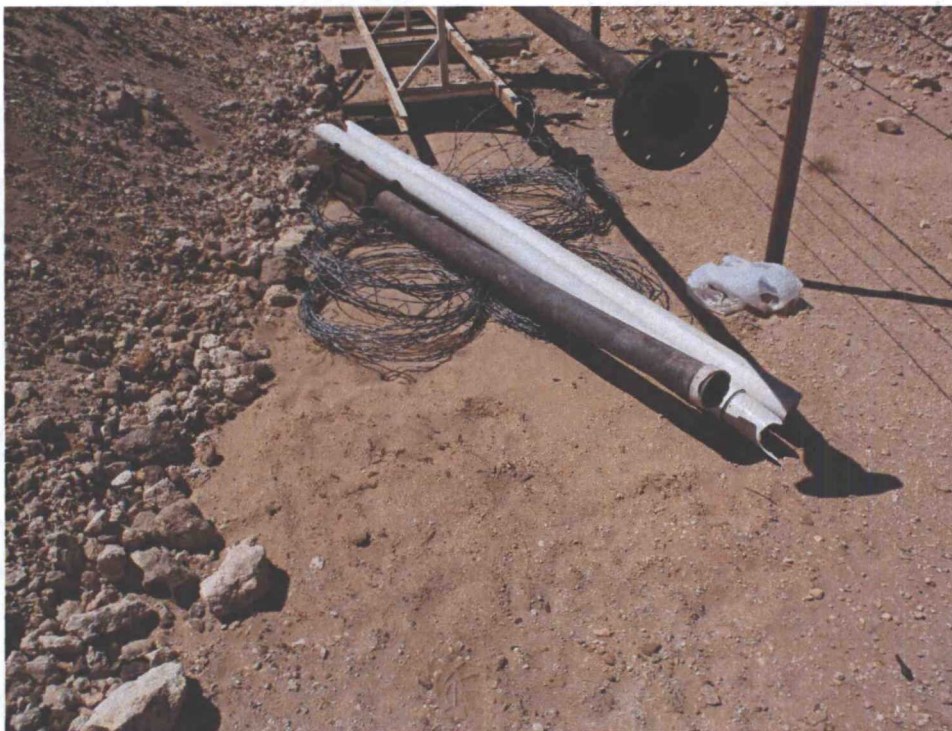
The chloride is believed to be from a 4 inch PVC line that a third party previously used to convey produced water from a heater treater located about 100 feet north of the Site. The PVC line extended across the west excavation and was not identified during utility notification. However, the PVC line was encountered about 3 feet bgs near the center of the west excavation where a dresser sleeve was observed on the line.

4 Inch PVC Line and Dresser Sleeve from West Excavation, March 22, 2011

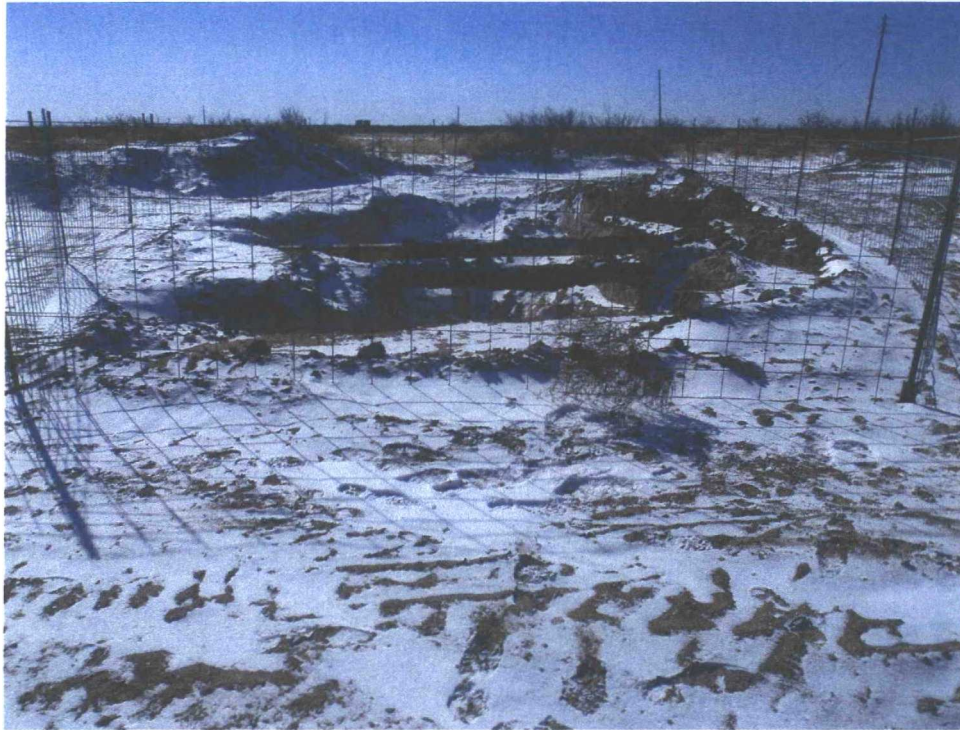
West Excavation Viewing South, February 4, 2011

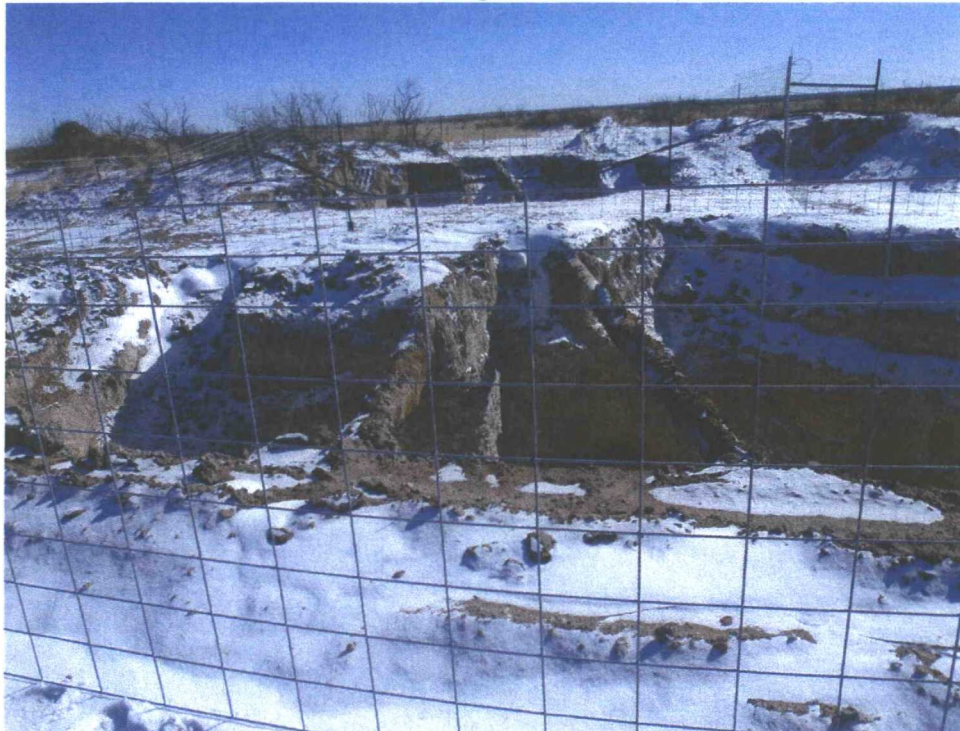
West (Foreground) and East (Background) Excavations Viewing East, February 4, 2011

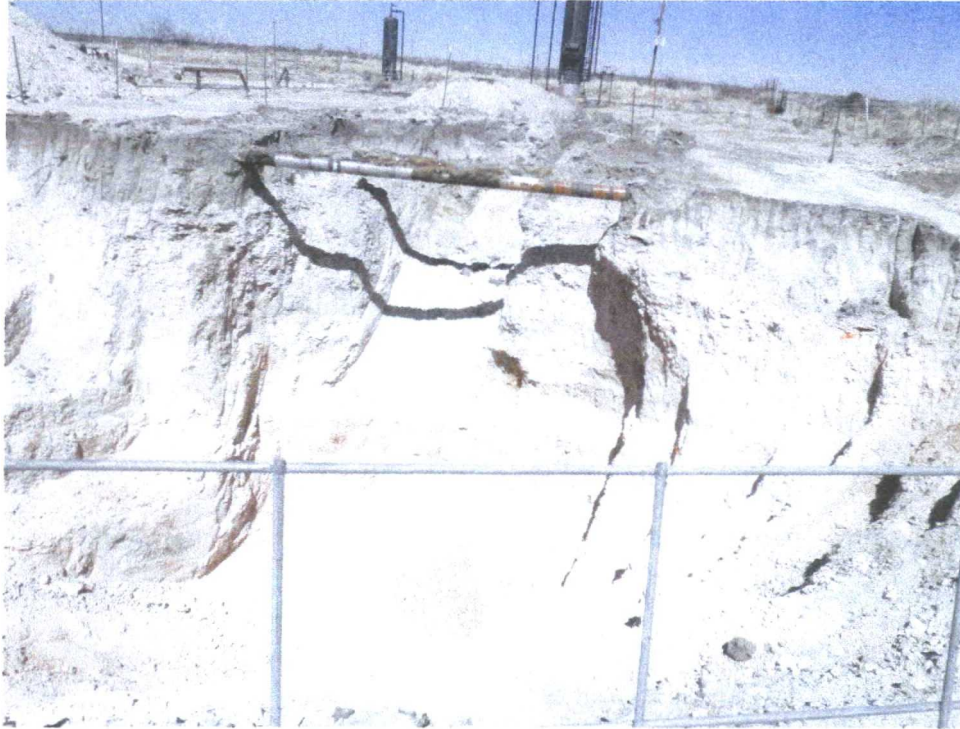
West Excavation after Benching Viewing North, March 2, 2011

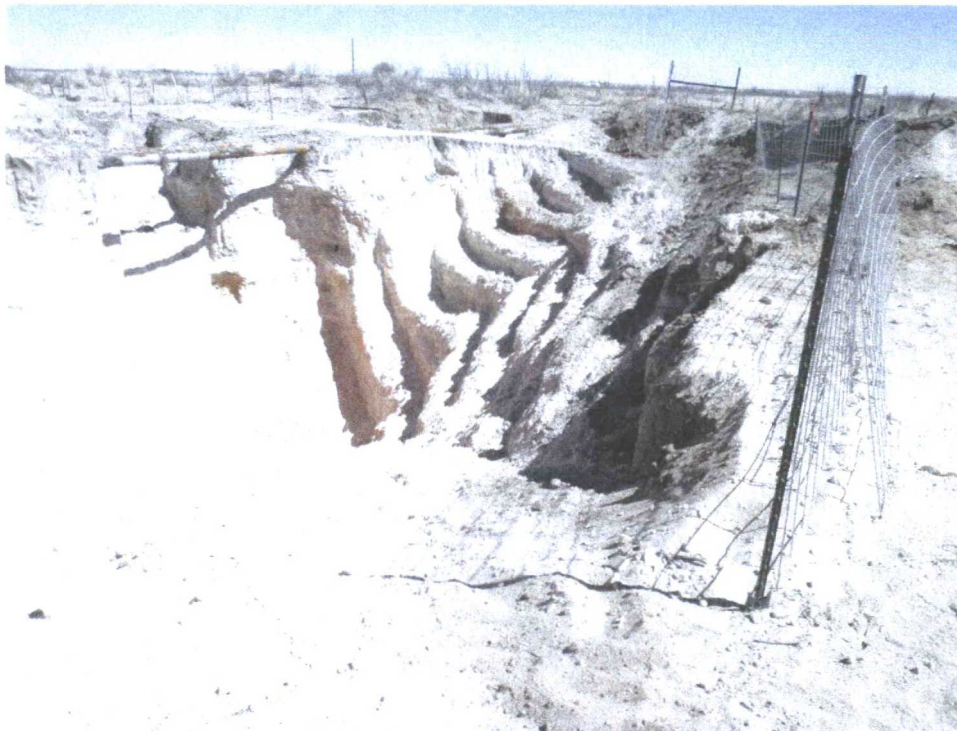
West Excavation after Benching Viewing Northeast, March 2, 2011

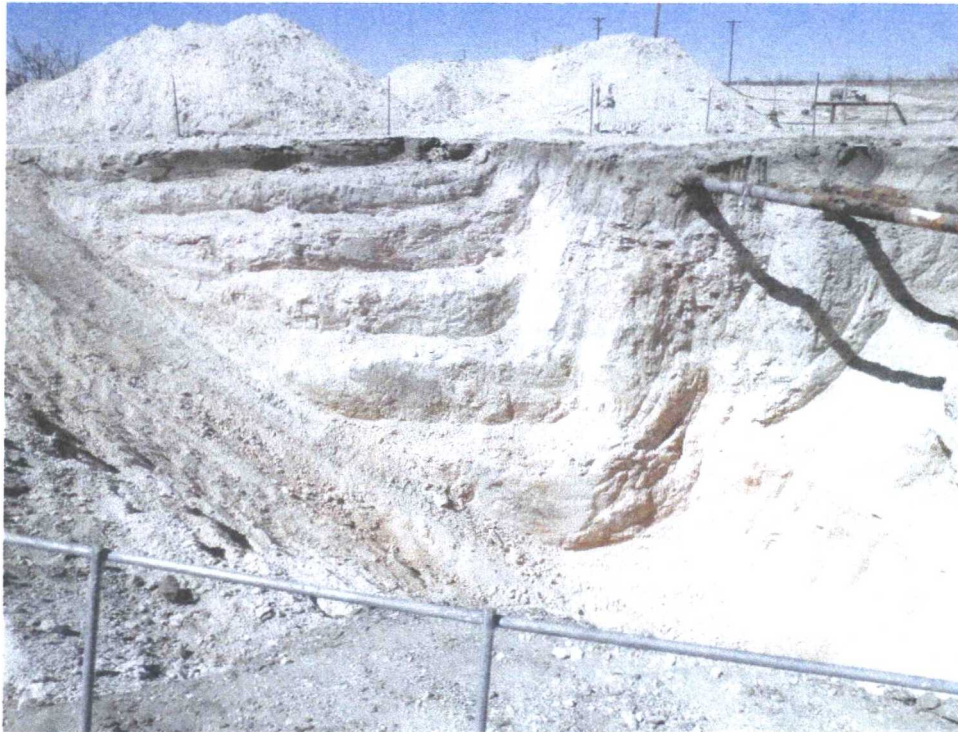
West Excavation after Benching Viewing West, March 2, 2011

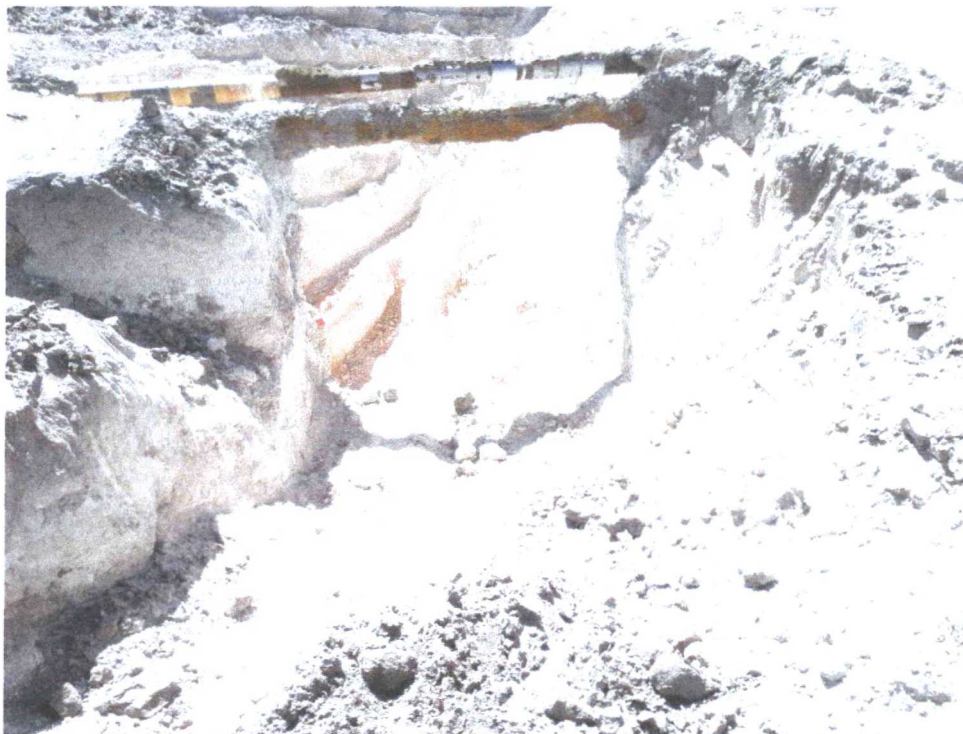
West Excavation after Benching Viewing South, March 2, 2011

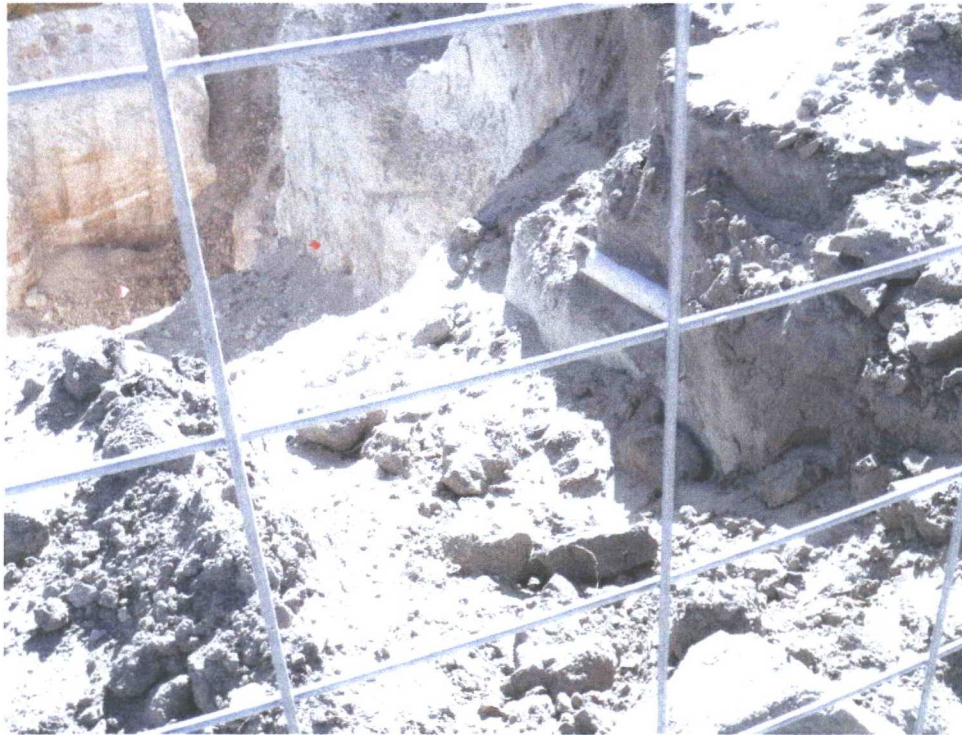
Produced Water (PVC) Line Exposed on North Side of Excavation, March 2, 2011
