Release Notification and Corrective Action

Humphrey Queen Battery Pipeline Leak

Closure Report

Unit Letter K, Section 3, Township 25S, Range 37E

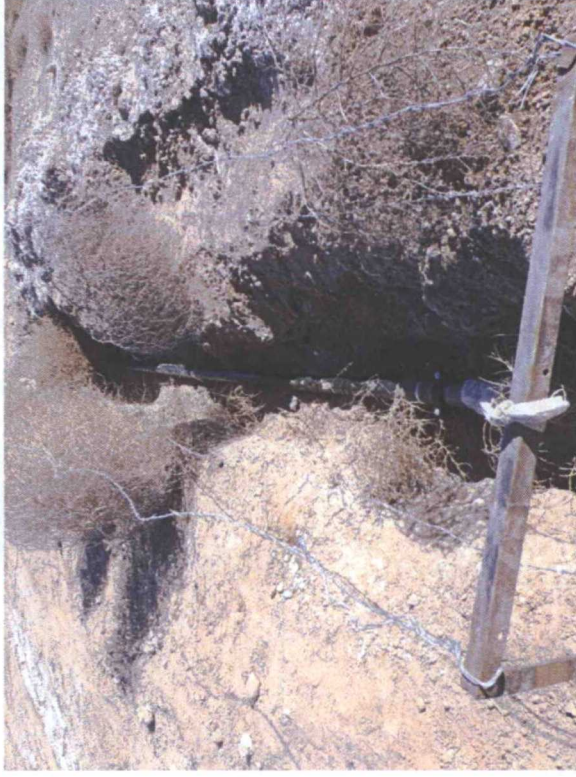
Release source, facing east

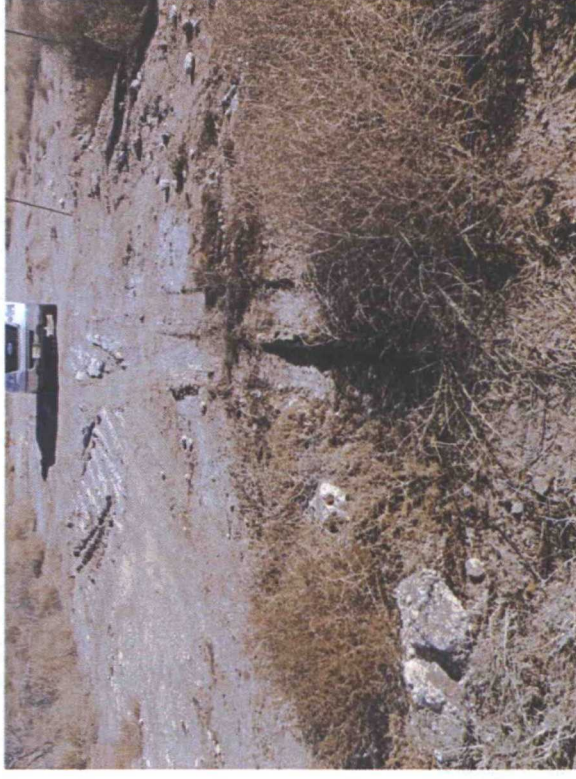
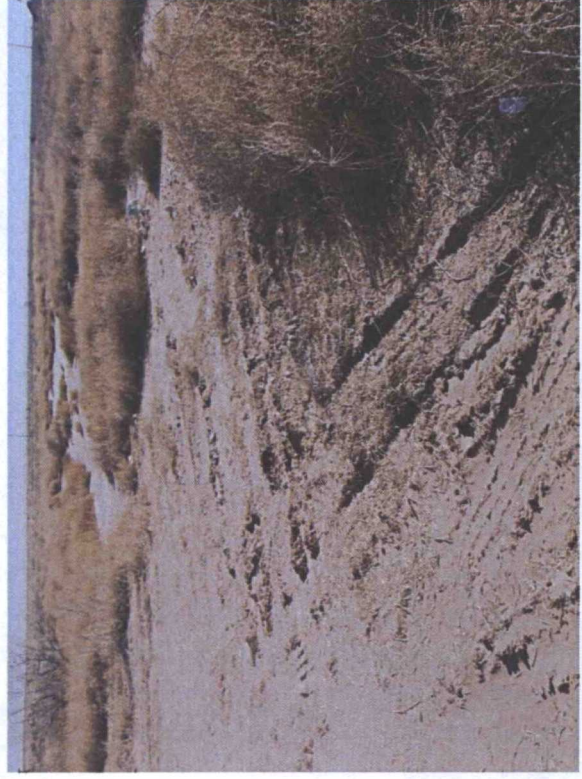
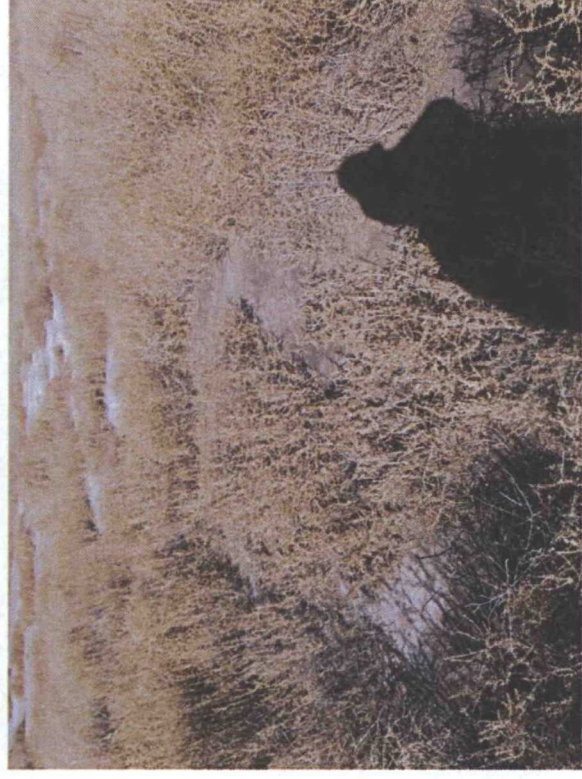
Initial release area, facing east

Initial release area, facing north

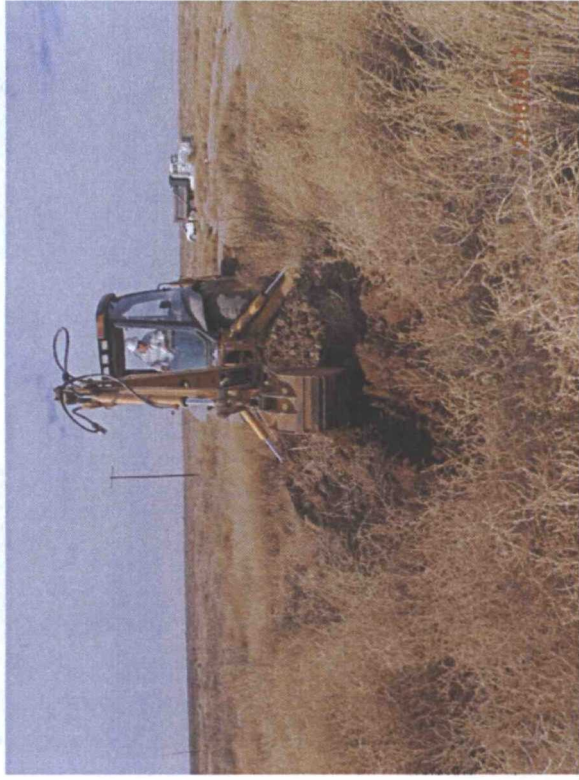
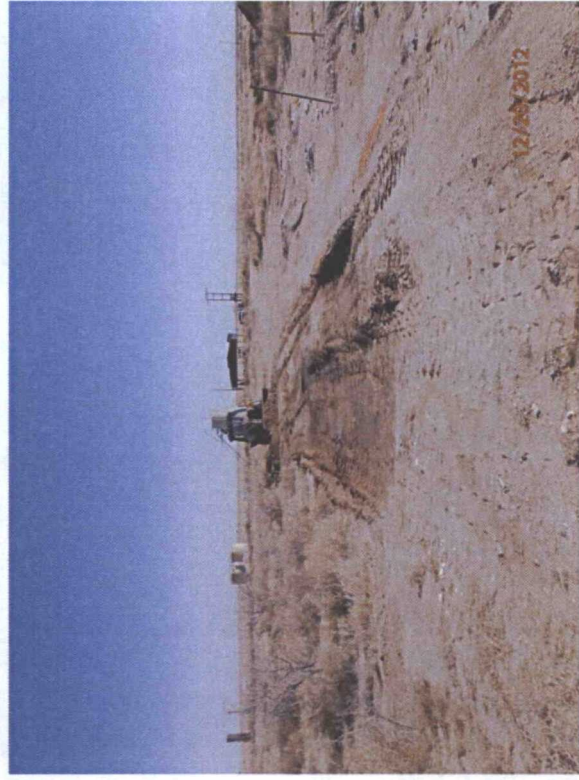
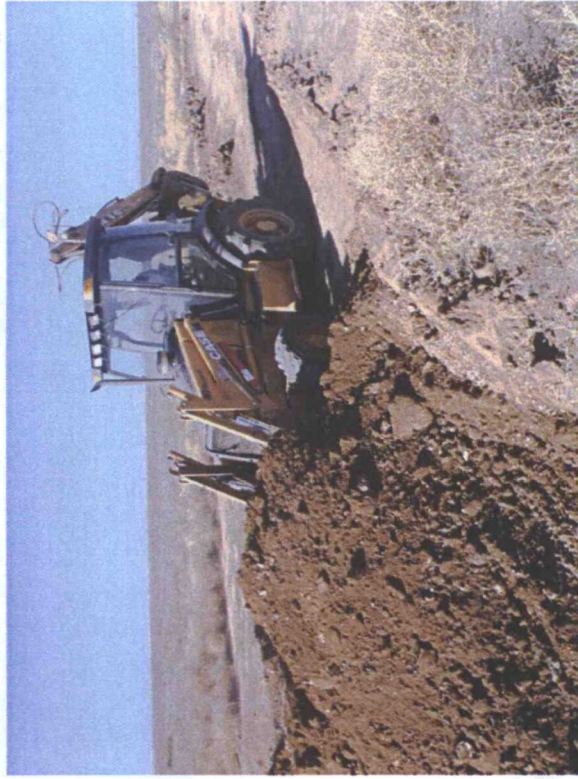
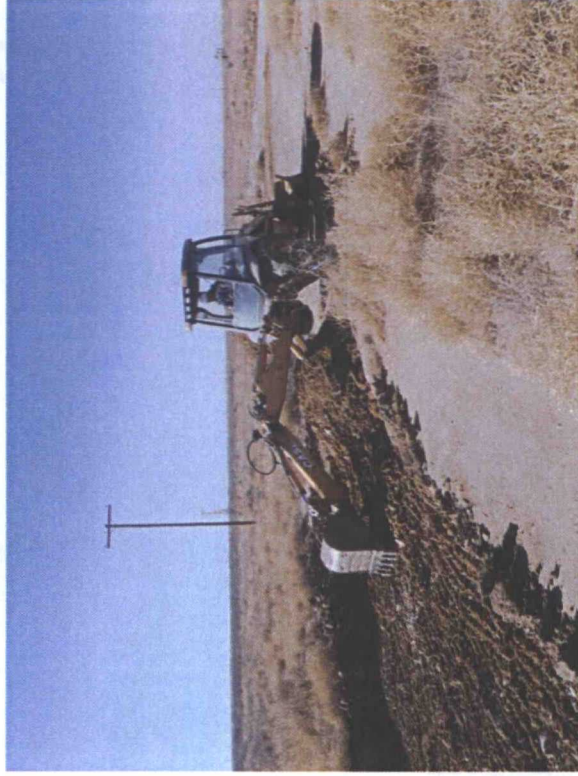
Excavating, facing north

Excavating, facing east

Excavating, facing southwest 12/28/12

Excavating, facing west 12/28/12

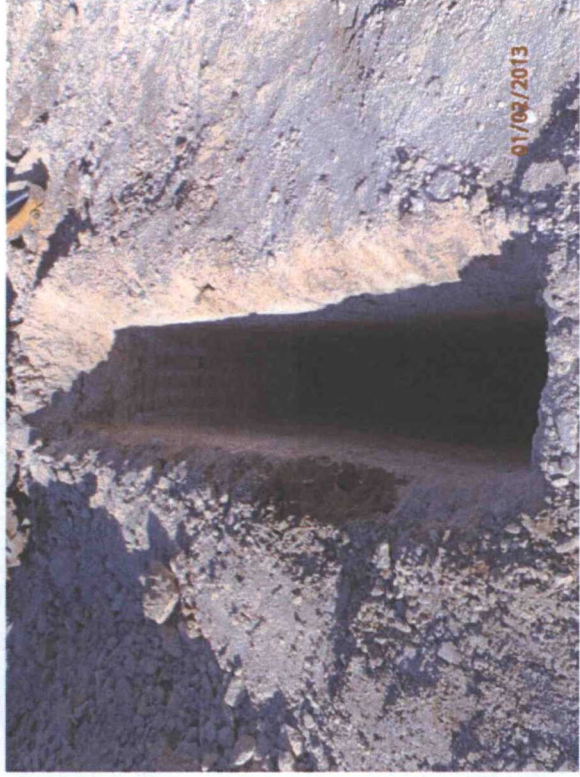
Digging vertical #2, facing northwest

Digging vertical #3, facing northeast

Vertical #3 completed

Three verticals were installed at the site to determine the depth of contamination. Vertical #1 was dug to a depth of 15 ft bgs, Vertical #2 was dug to a depth of 8 ft bgs and Vertical #3 was dug to 10 ft bgs where the backhoe encountered a hard rock stratum and could not continue. Sampling was conducted at regular intervals and the samples were field tested for chlorides and hydrocarbons. In all three verticals, chloride levels remained consistent to depth and PID readings were low. A soil bore was advanced at the site on February 15th, 2013 to delineate the vertical chloride contamination (Figure 2). Samples were taken every five feet and field tested for chlorides and hydrocarbons. Representative samples were taken to a commercial laboratory for analysis and returned chloride results of 3,840 mg/kg at the surface and 2,080 mg/kg at 55 ft bgs.

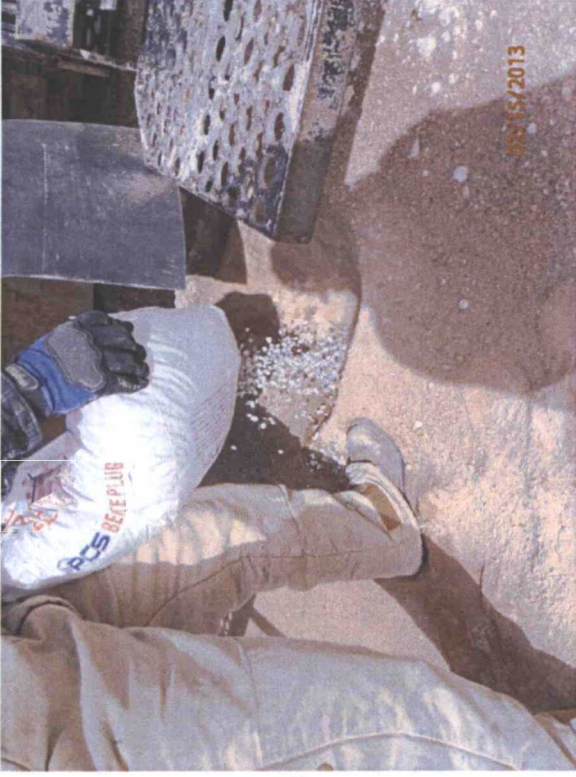
Installing SB-1, facing west

Plugging SB-1 in total with bentonite

Completed SB-1, facing north

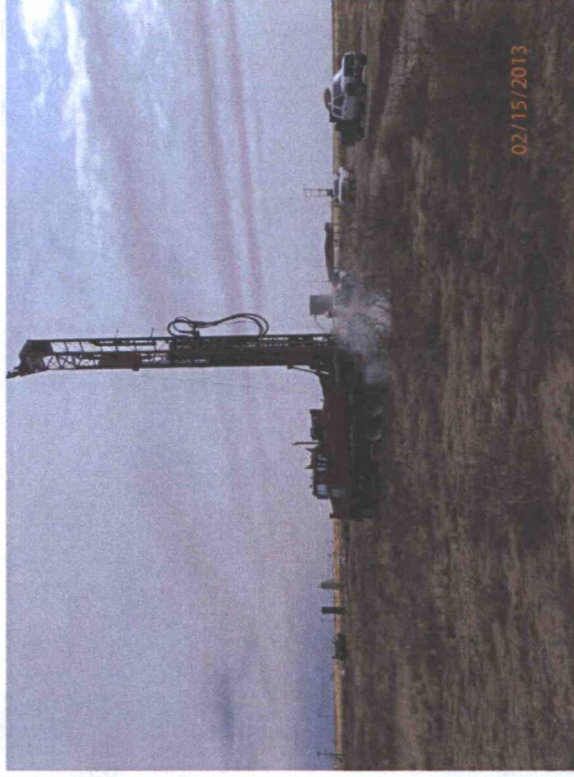
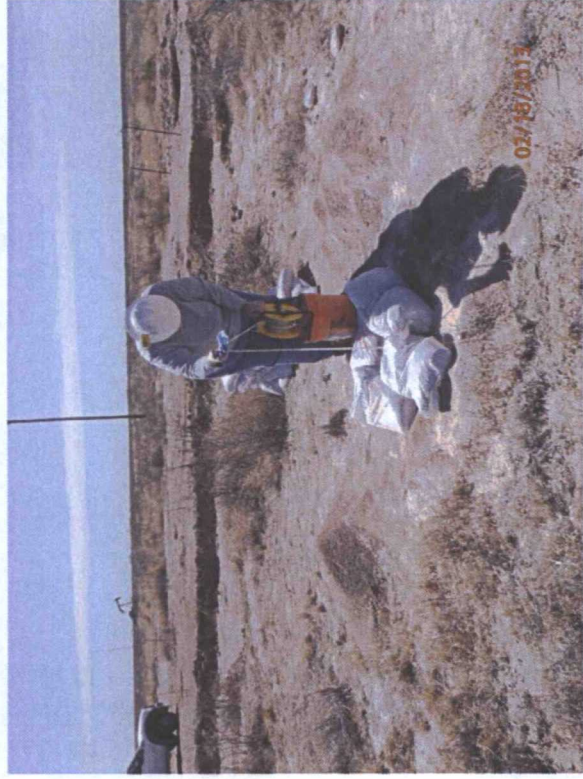
Installing Temp MW, facing east

Checking Temp MW for water, facing south 2/18/13

Plugging Temp MW in total with bentonite 2/18/13

Completed Temp MW, facing east

A temporary monitor well was installed up-gradient of the site to determine if groundwater was present. The bore was sampled only for lithology as it was being installed. Red bed clay was encountered at the depth of 50 ft bgs, which indicates the bottom of the aquifer. The bore was drilled another 25 ft into the red bed clay and left

open for over 48 hours to see if groundwater accumulated. ARC Environmental checked the bore for water accumulation on February 20th, 2013 and found no water to a depth of 70.58 ft (Appendix B).

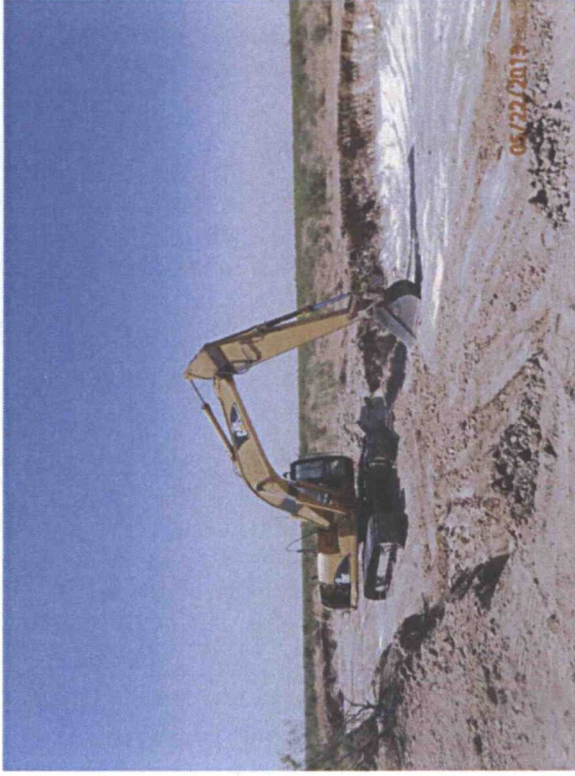
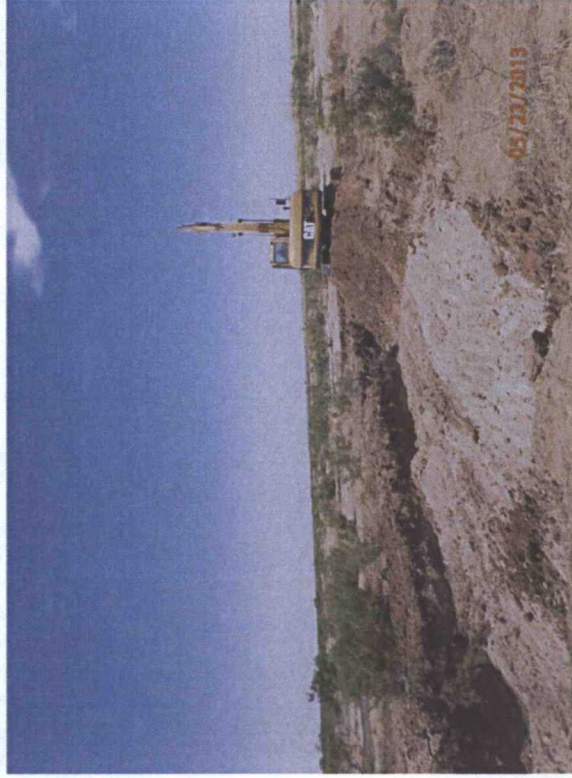
South scrape, facing southwest

Southwest scrape, facing northeast
