### Release Notification and Corrective Action

**FINAL REPORT**

## **Site Closure Report**

SITE LOCATION MAP  
NEW MEXICO "O" STATE #40 PIT  
SECTION 36, T17S, R34E (RP#2673)  
*Chevron Environmental Management Company*

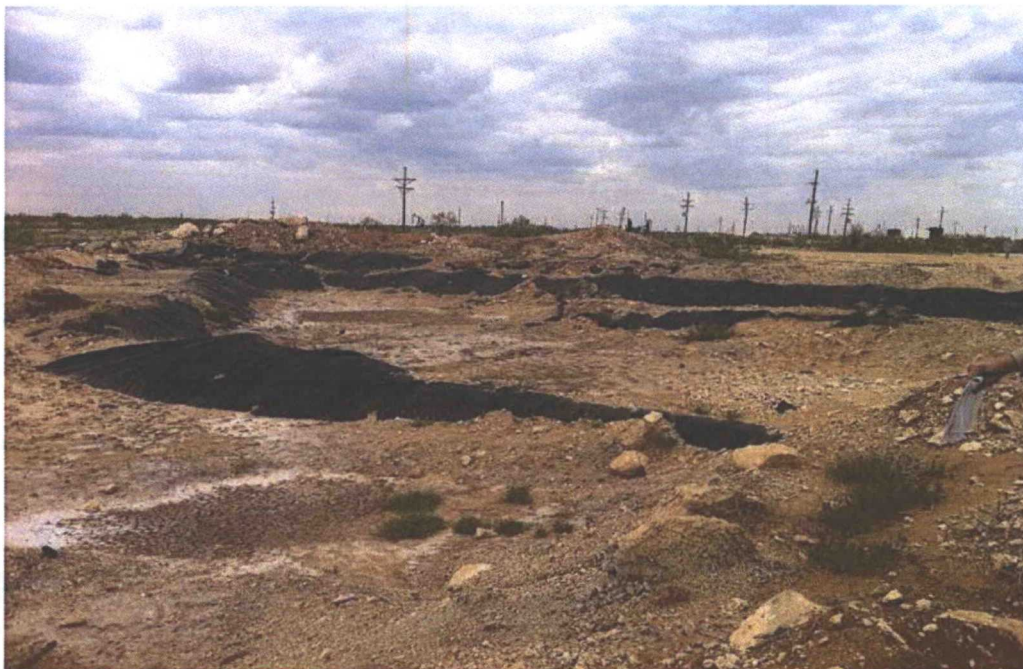
PHOTO 1: View of reserve pit facing north before any remedial work activities

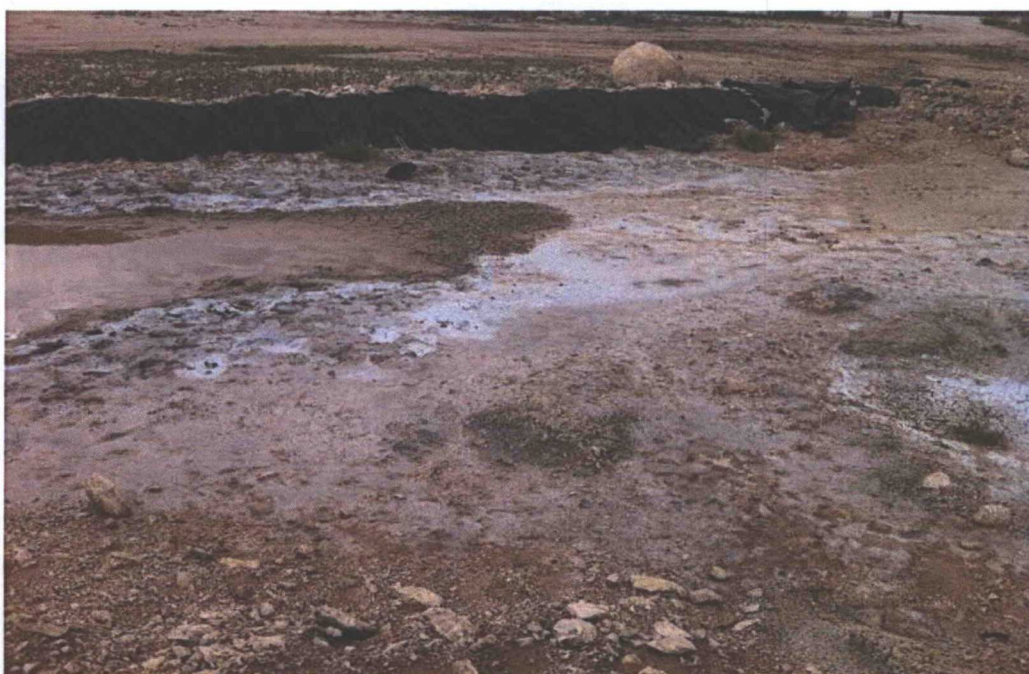
PHOTO 2: View of reserve pit facing south before any remedial work activities

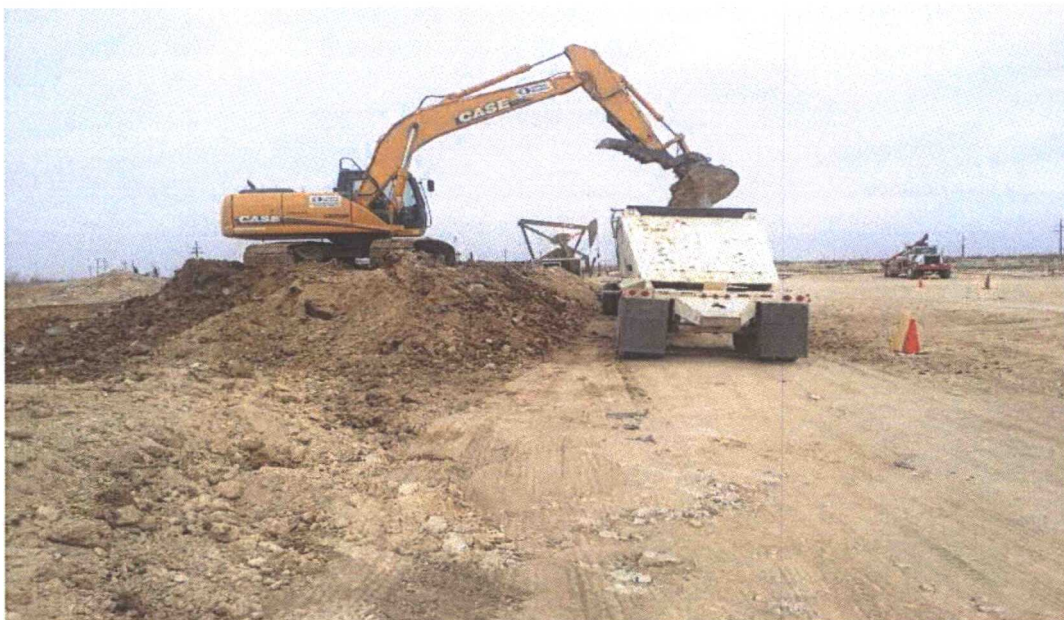
PHOTO 3: View of excavation/waste removal activities

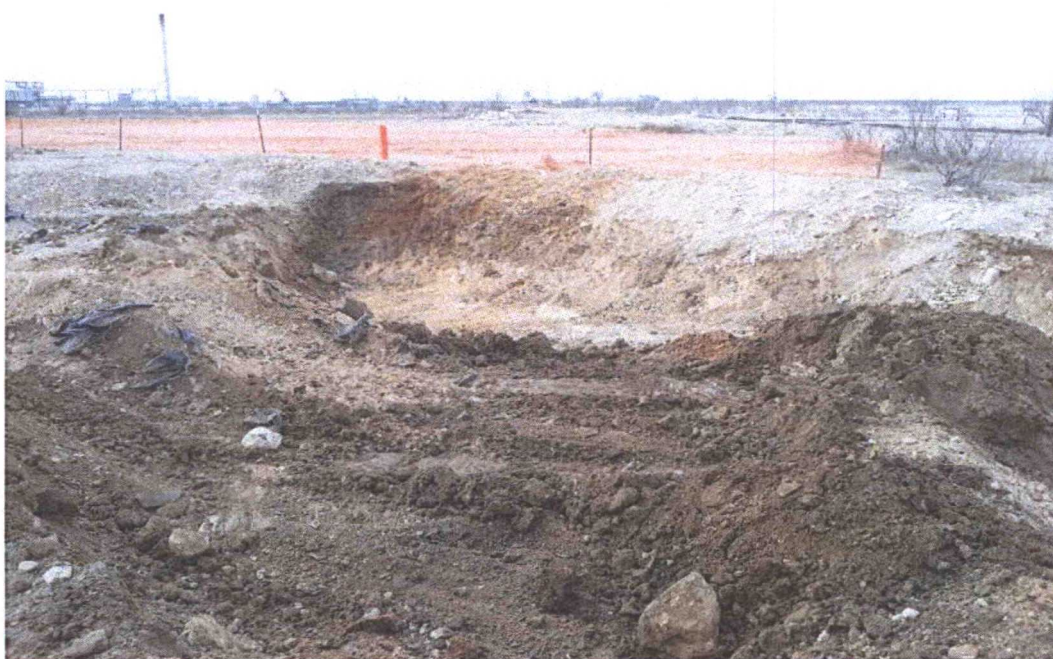
PHOTO 4: View of excavation/waste removal activities facing southwest

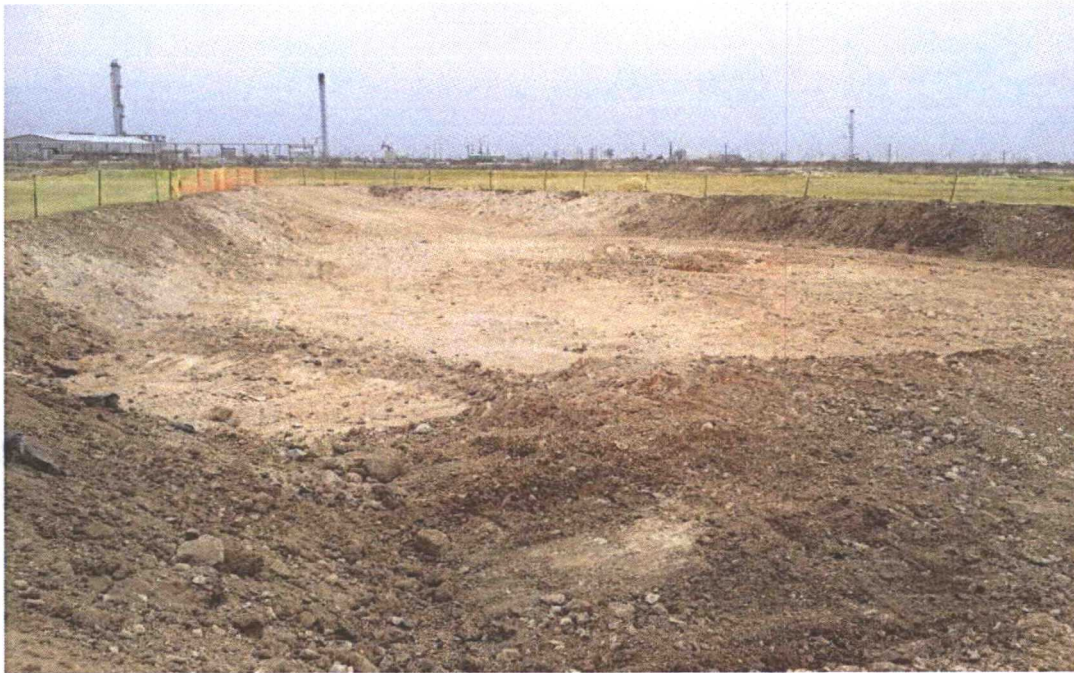
PHOTO 5: View of excavated reserve pit facing south

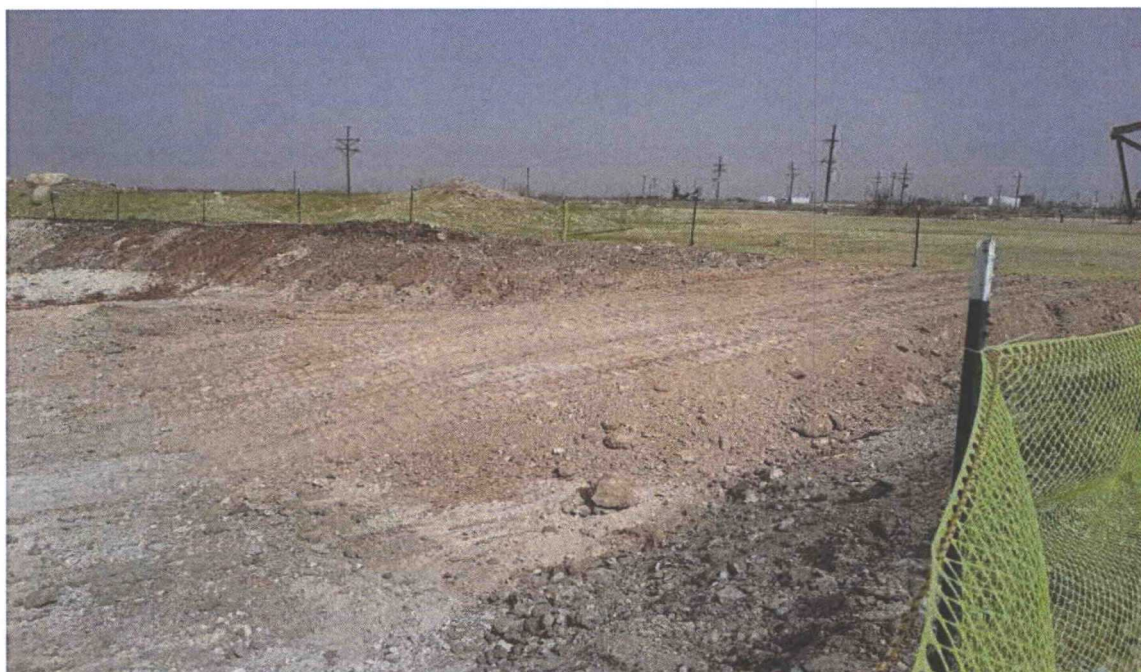
PHOTO 6: View of excavated pit and entrance ramp facing north

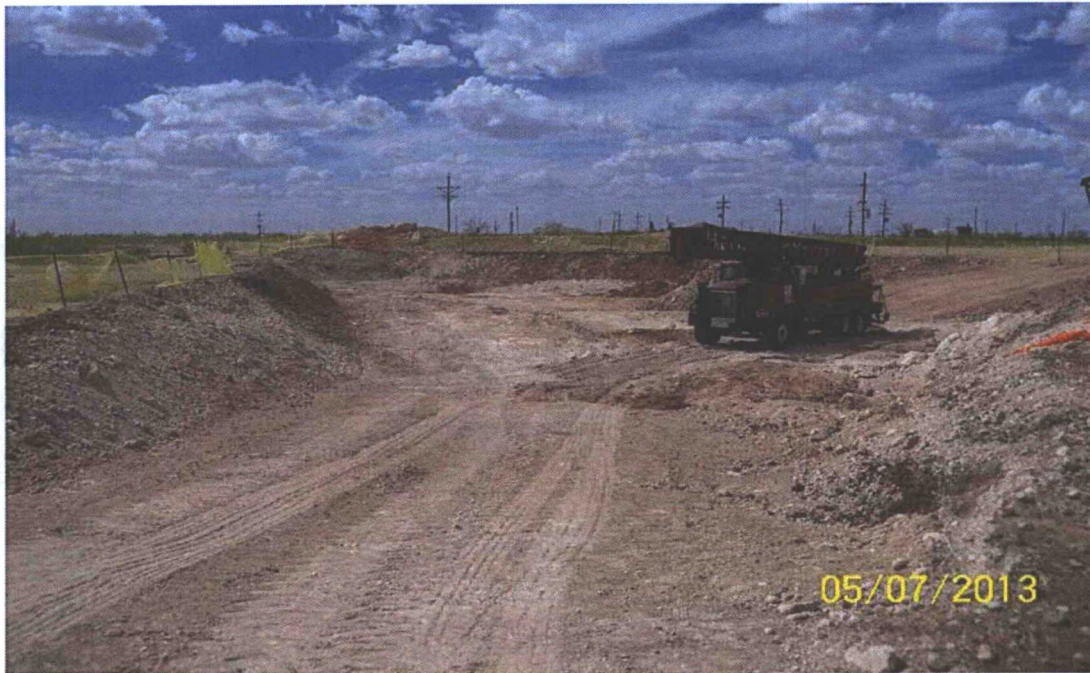
PHOTO 7: View of drill rig inside excavated reserve pit facing north

In May 2013, after discussions and approval from the NMOCD Hobbs District I office, three soil borings (SB-1, SB-2, and SB-3) were installed within the existing remedial excavation to a depth of 100 feet below ground surface bgs. Soil samples were collected at 5 to 10 foot intervals in an effort to horizontally and vertically evaluate the extent of chloride impacts. All three soil borings SB-1 (70'-69.8 mg/kg), SB-2 (70'-108 mg/kg), and SB-3 (70'-29.8 mg/kg) demonstrated decreasing chloride levels with depth to well below recommended remediation and delineation levels. A soil boring analytical summary is provided in Table I. A soil cross section depicting subsurface conditions is provided in Figure 2. Certified Laboratory Reports for the 2013 soil sampling events are provided in Appendix E.

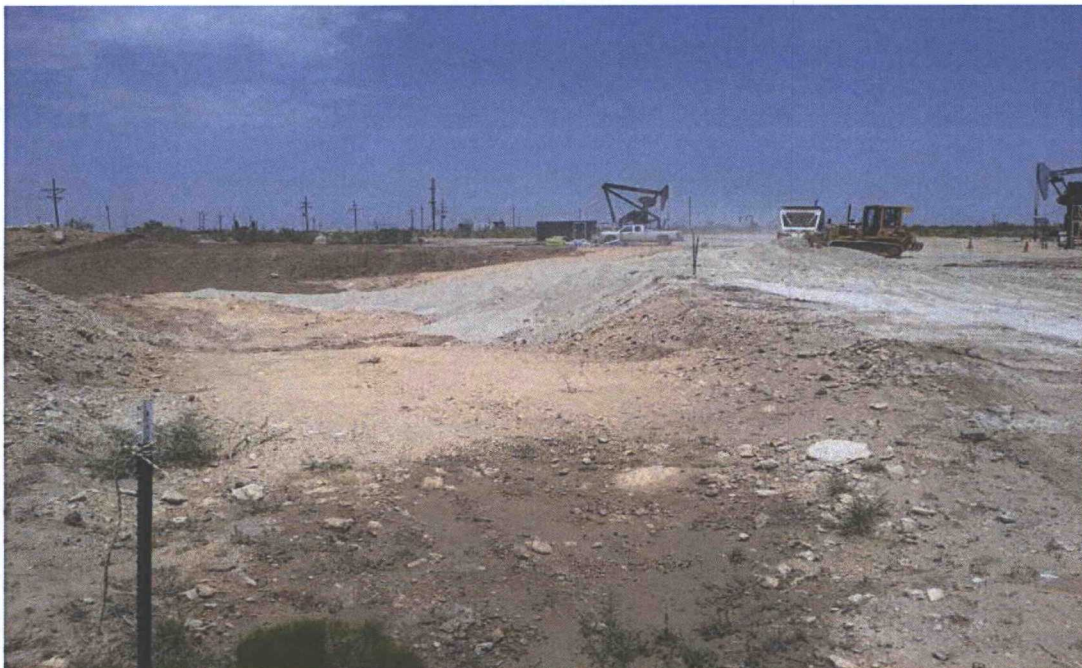
PHOTO 8: View of backfill activities facing north

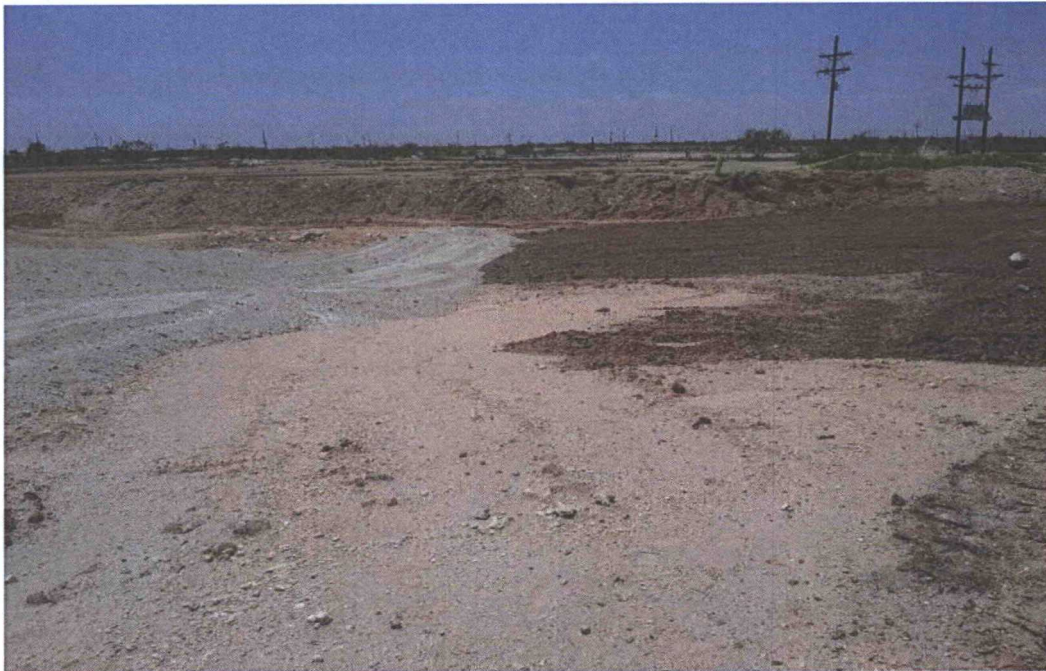
PHOTO 9: View of backfill activities facing west

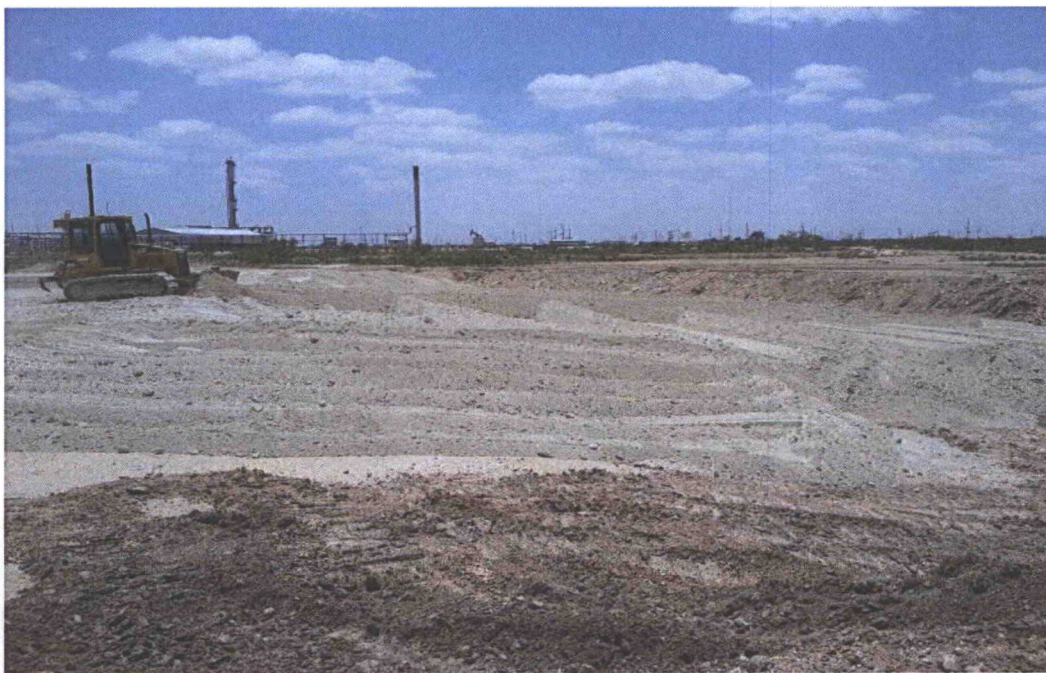
PHOTO 10: View of backfilling activities facing south

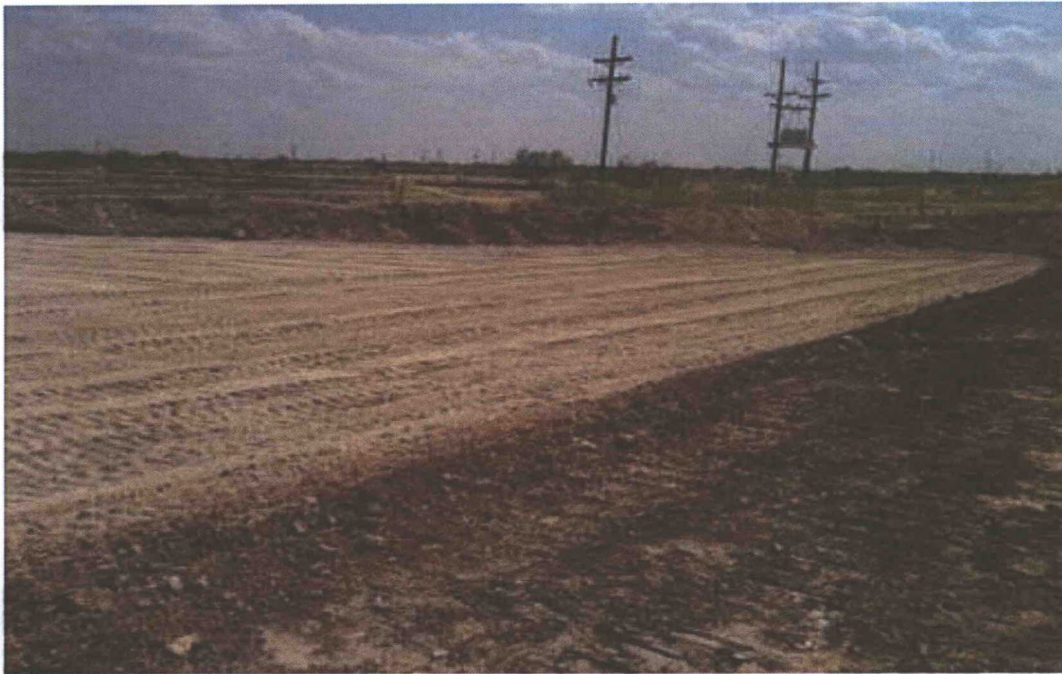
PHOTO 9: View of backfill ready for 20 mil poly liner installation facing northwest

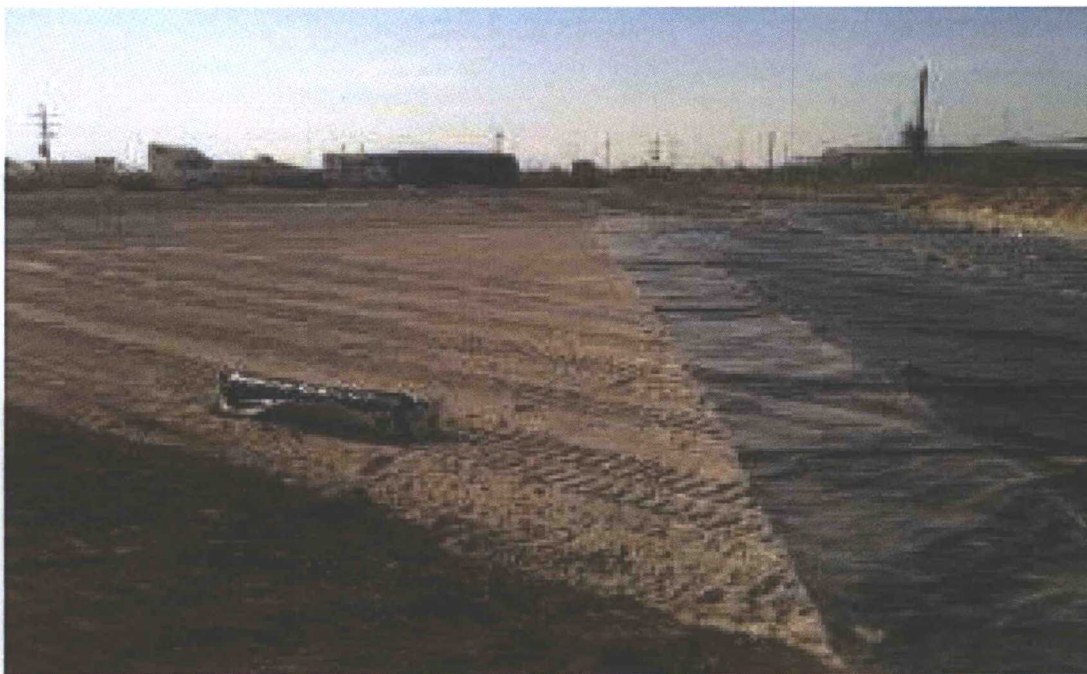
PHOTO 11: View of 20 mil poly liner installation facing southeast

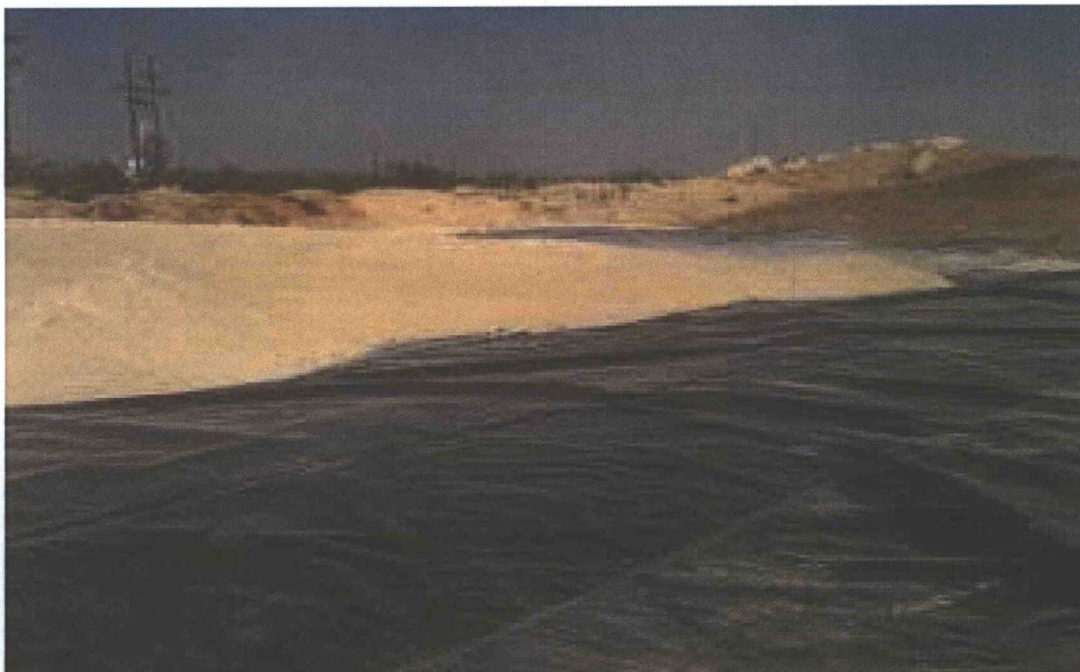
PHOTO 12: View of 20 mil poly liner installation/backfill facing northwest

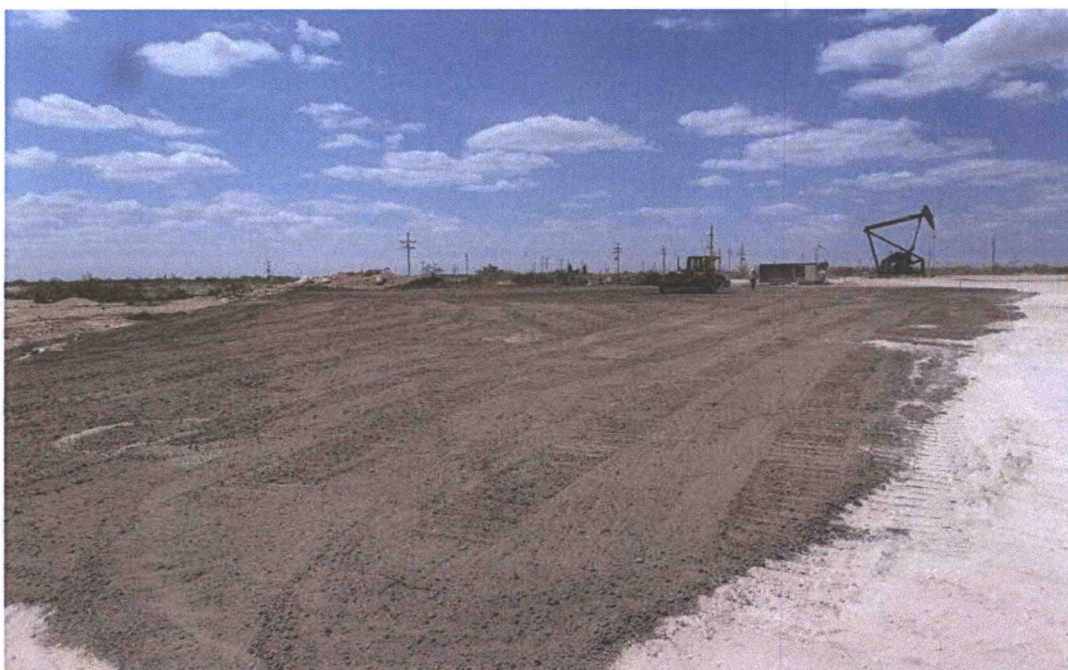
PHOTO 13: View of final grading and seeding activities facing north
