## **REMEDIATION SUMMARY AND SITE CLOSURE REQUEST**

**SOUTHERN UNION GAS SERVICES  
Line 2B (2010-055)  
Lea County, New Mexico  
Unit Letter "O" (SW/SE), Section 31, Township 24 South, Range 37 East  
Latitude 32° 10.212' North, Longitude 103° 11.978' West  
NMOCD Reference # 1RP-2586**

Prepared By:  
Basin Environmental Service Technologies, LLC

**March 2011**

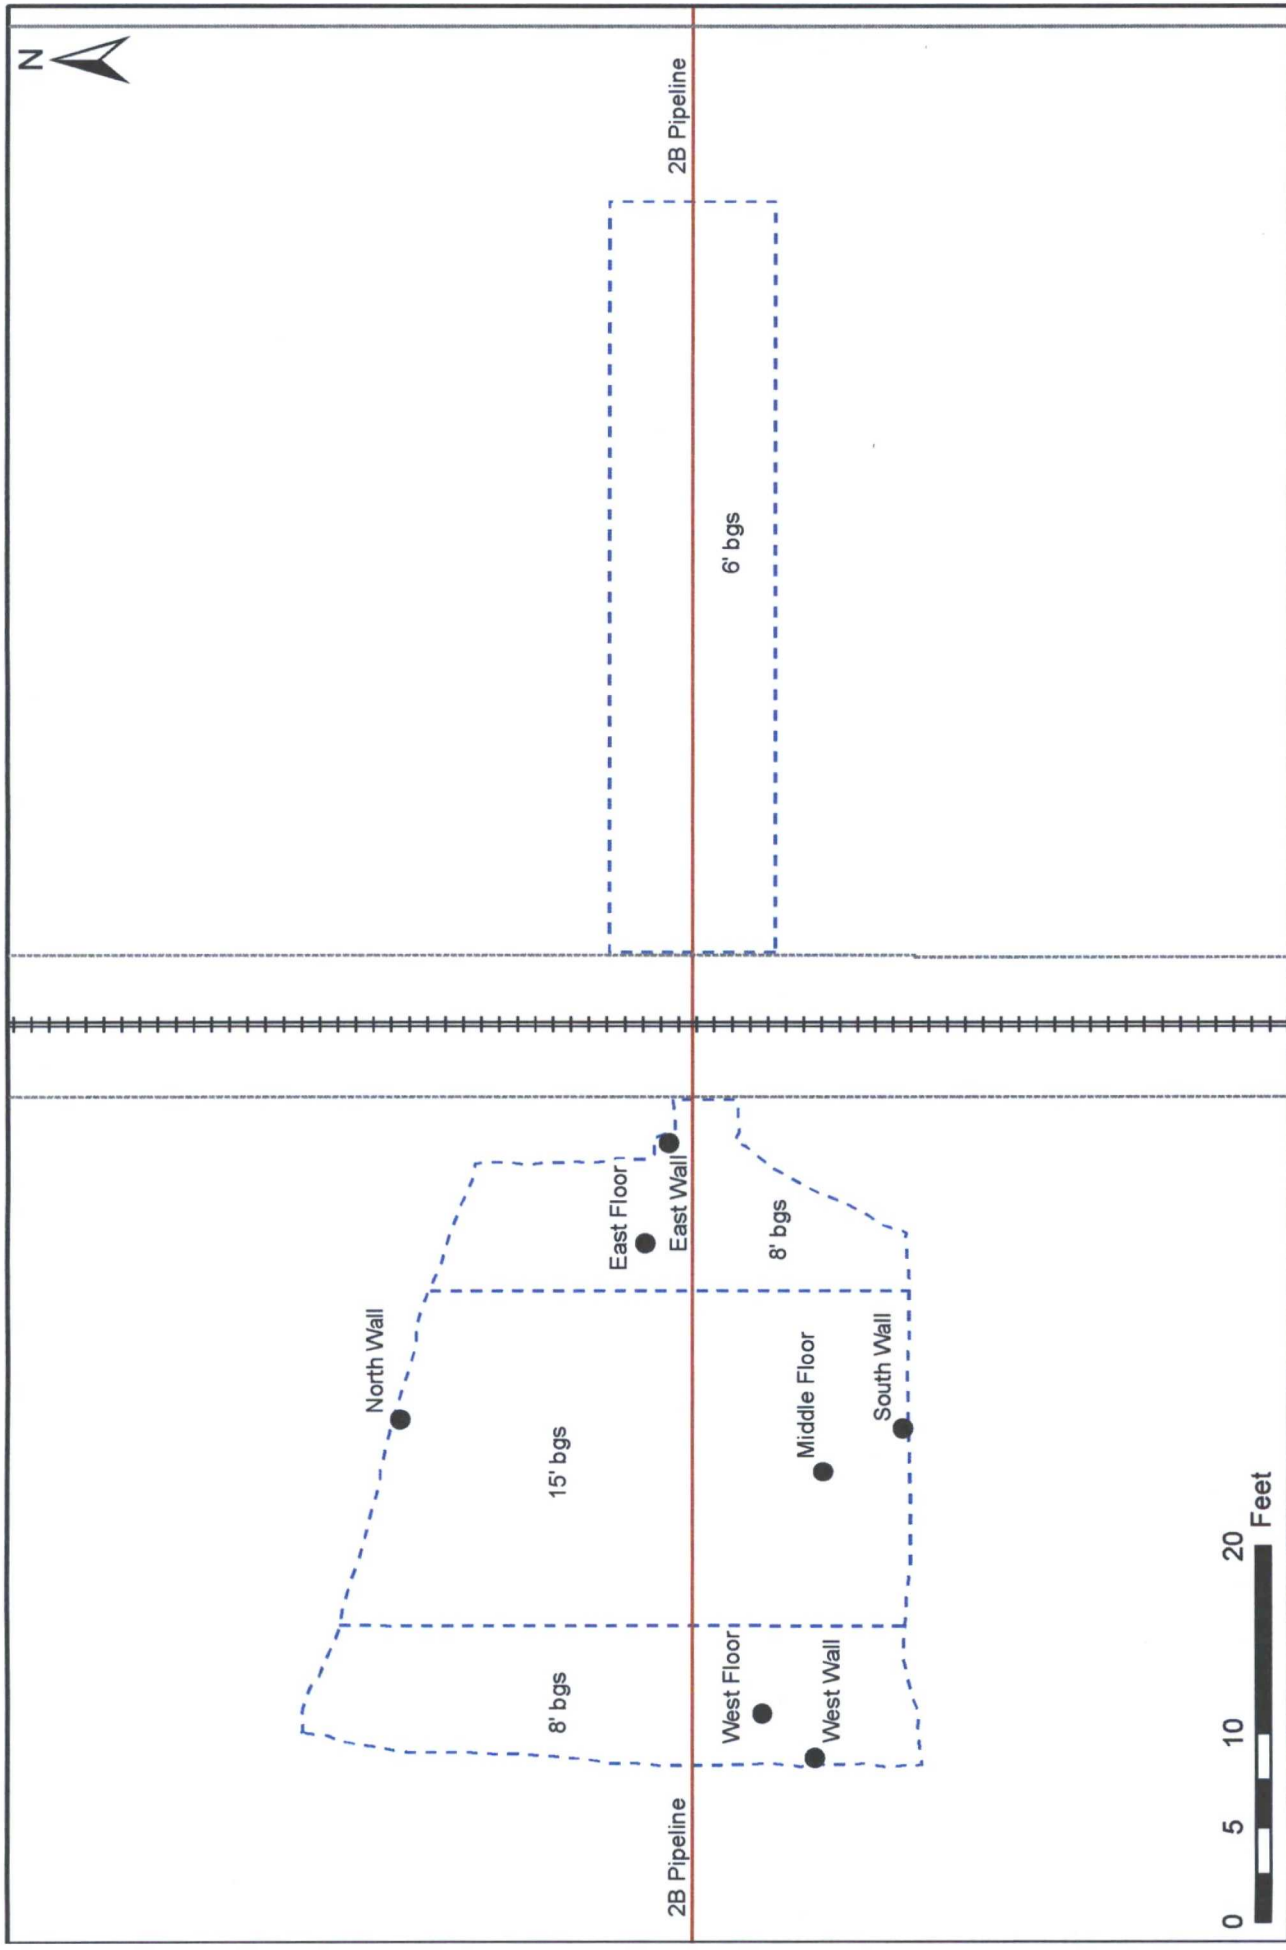
**Figure 2**

Laboratory analytical results indicated benzene and BTEX concentrations were less than the appropriate laboratory (MDL) for all soil samples submitted. TPH concentrations ranged from less than the laboratory MDL for soil samples East Wall, Middle Floor, South Wall, North Wall, West Floor, and West Wall to 20.4 mg/Kg for soil sample East Floor. Chloride concentrations ranged from 9.55 mg/Kg for soil sample West Floor to 58.3 mg/Kg for soil sample East Floor. A "Site & Sample Location Map" is provided as Figure 2.

**Site & Sample Location Map**

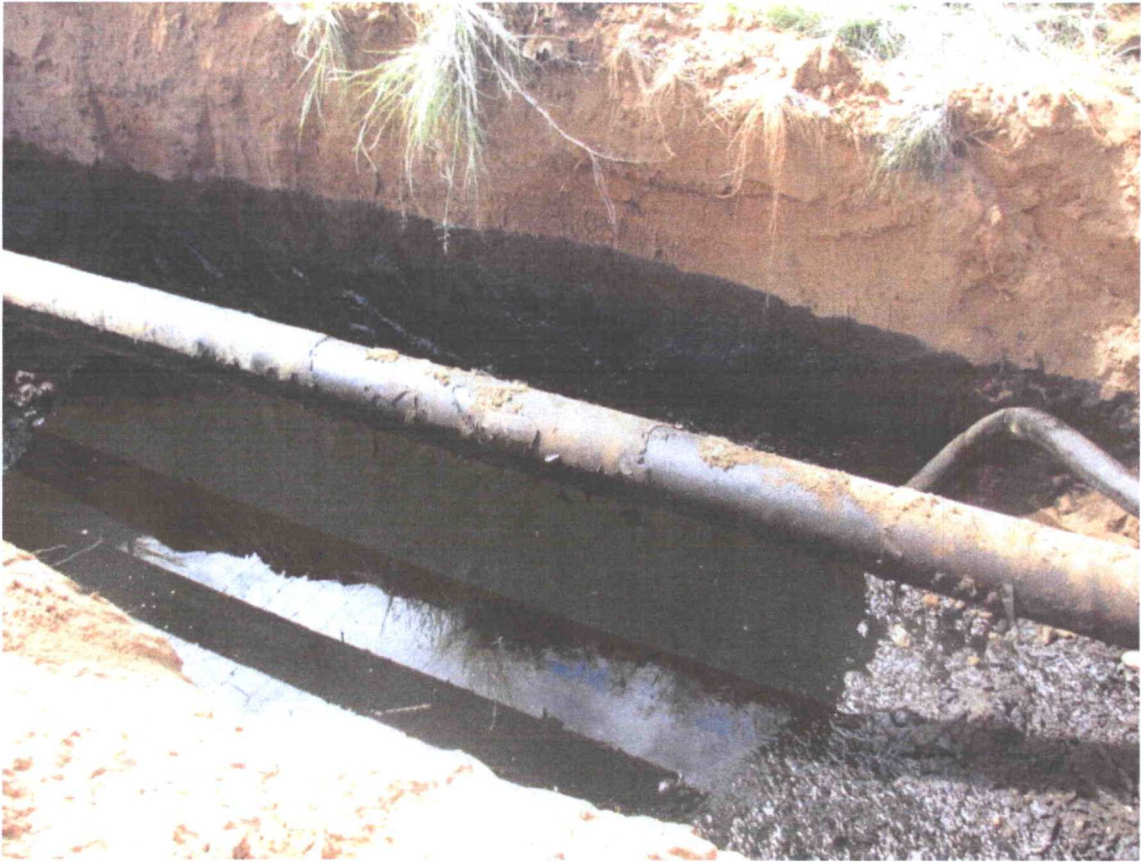
Line 2B Release Site

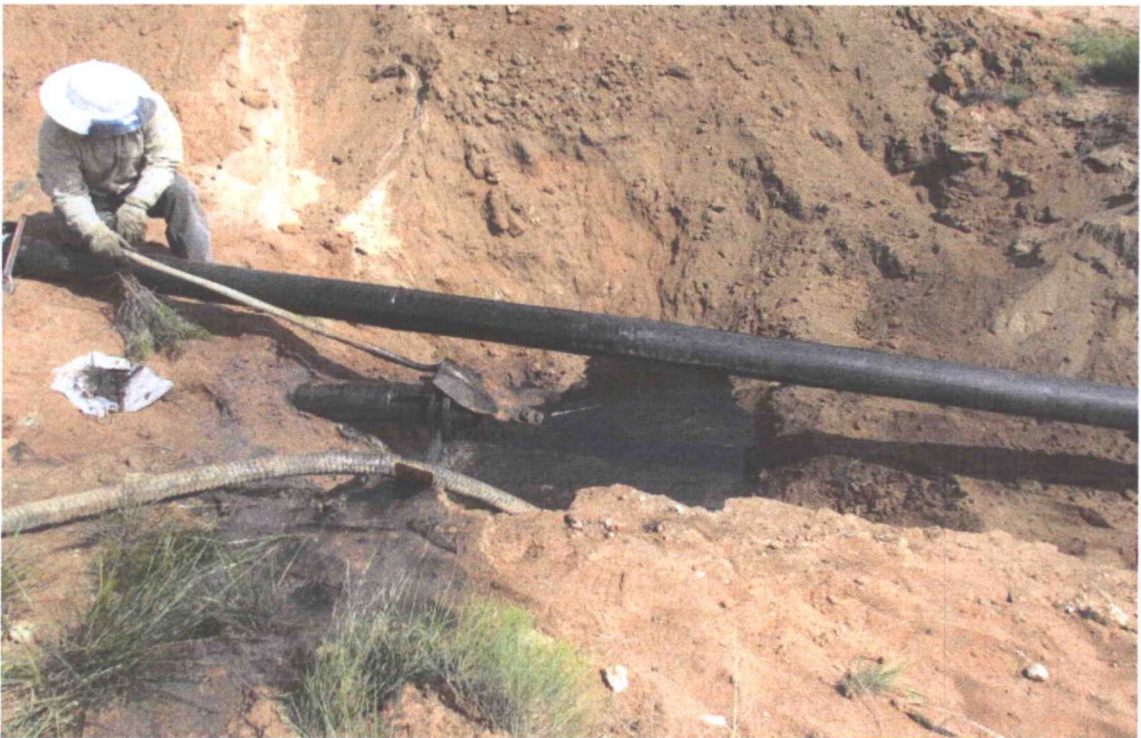
Line 2B Release Site - Initial Response Activities

On December 14, 2010, remediation activities began at the site. Impacted soil from the initial response activities was stockpiled on-site pending final disposition. Hach Quantab Chloride Low Range (30-600 mg/Kg) Titrators were used to field-screen the horizontal and vertical extent of impacted soil and to guide the excavation. The excavation was divided into two sections: "East" and "West".

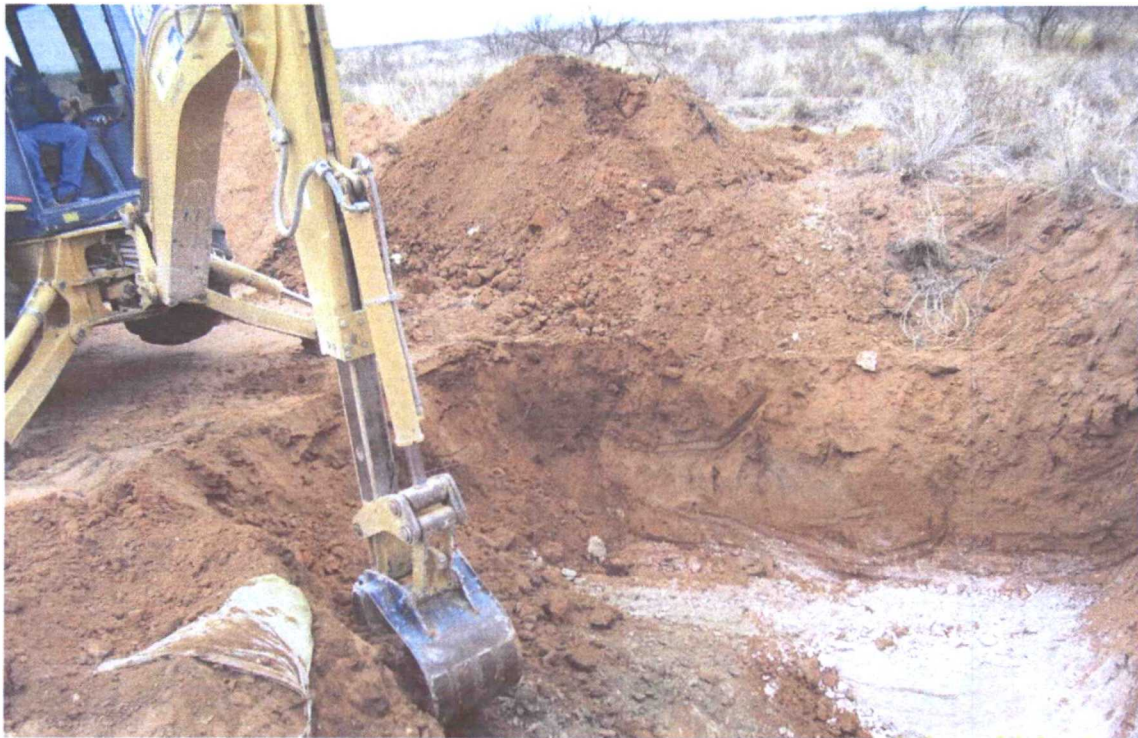
Line 2B - West Excavation

On December 16 through 21, 2010, excavation of hydrocarbon-impacted soil commenced at the site. Approximately two hundred and forty (240) cubic yards (cy) of impacted soil was excavated from the "West" excavation and transported to Sundance Services, Inc. ("Sundance", NMOCD Permit # NM-01003), for disposal. Approximately fifty-six (56) cy of stockpiled material was transported to Sundance from the "East" excavation.

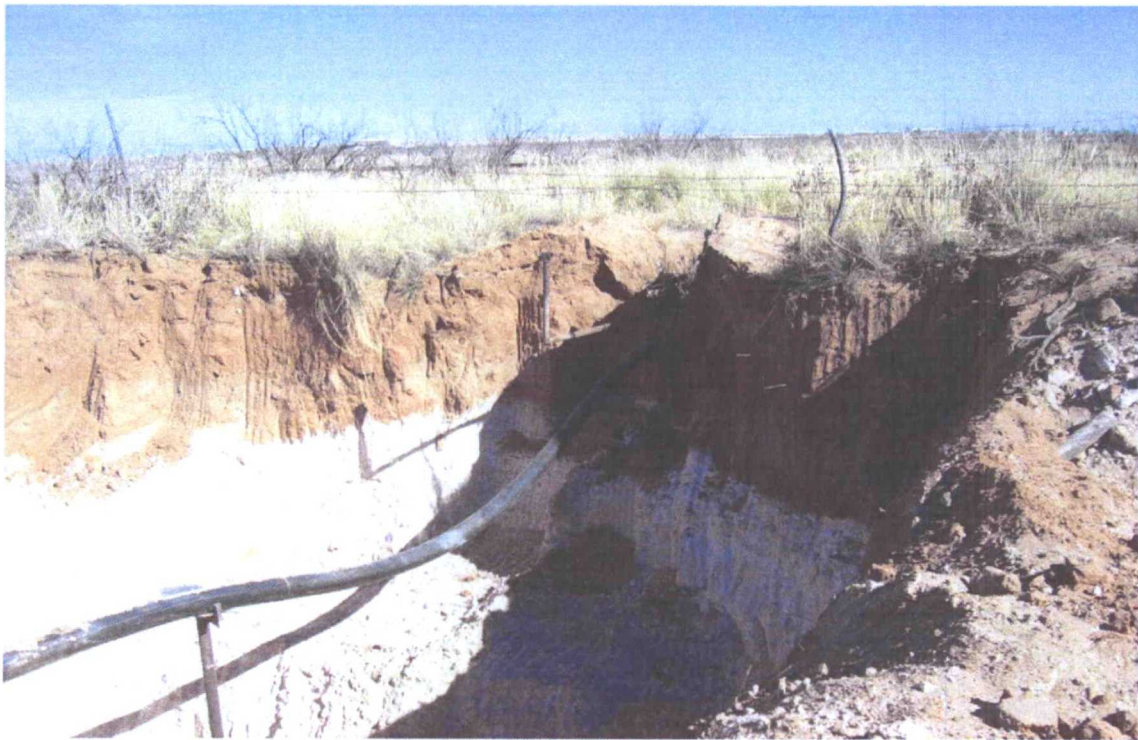
Line 2B - West Excavation (looking North-northeast)

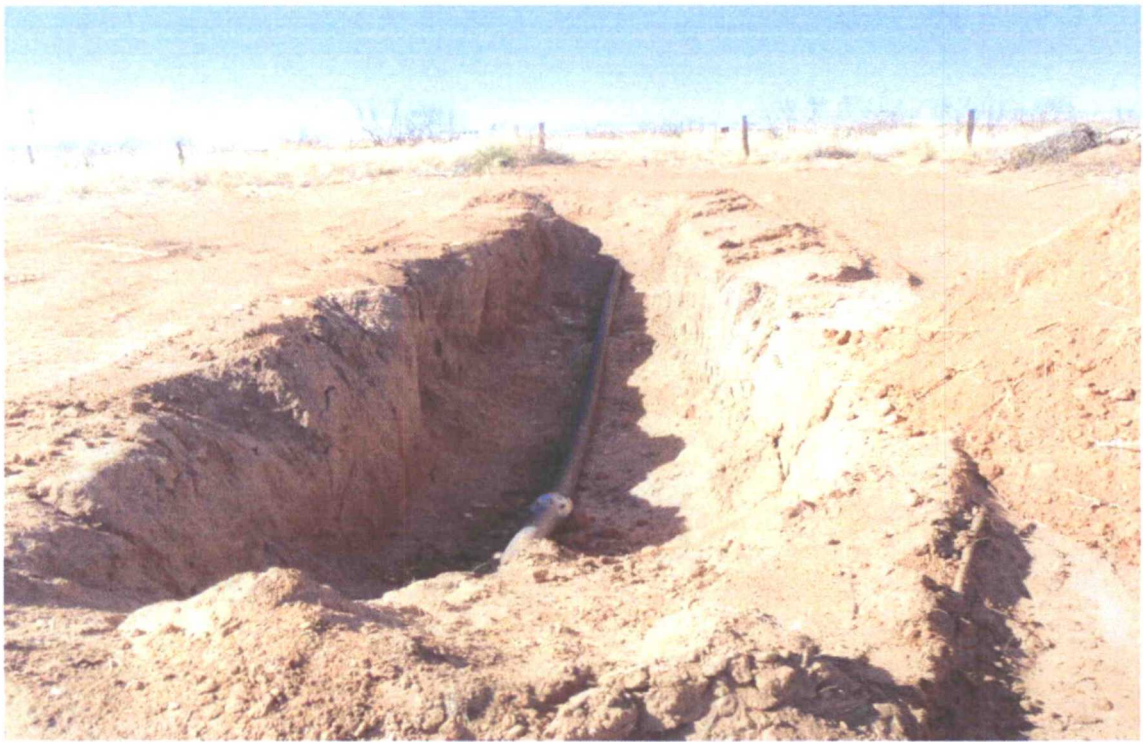
Line 2B Release Site - East Excavation (looking West)

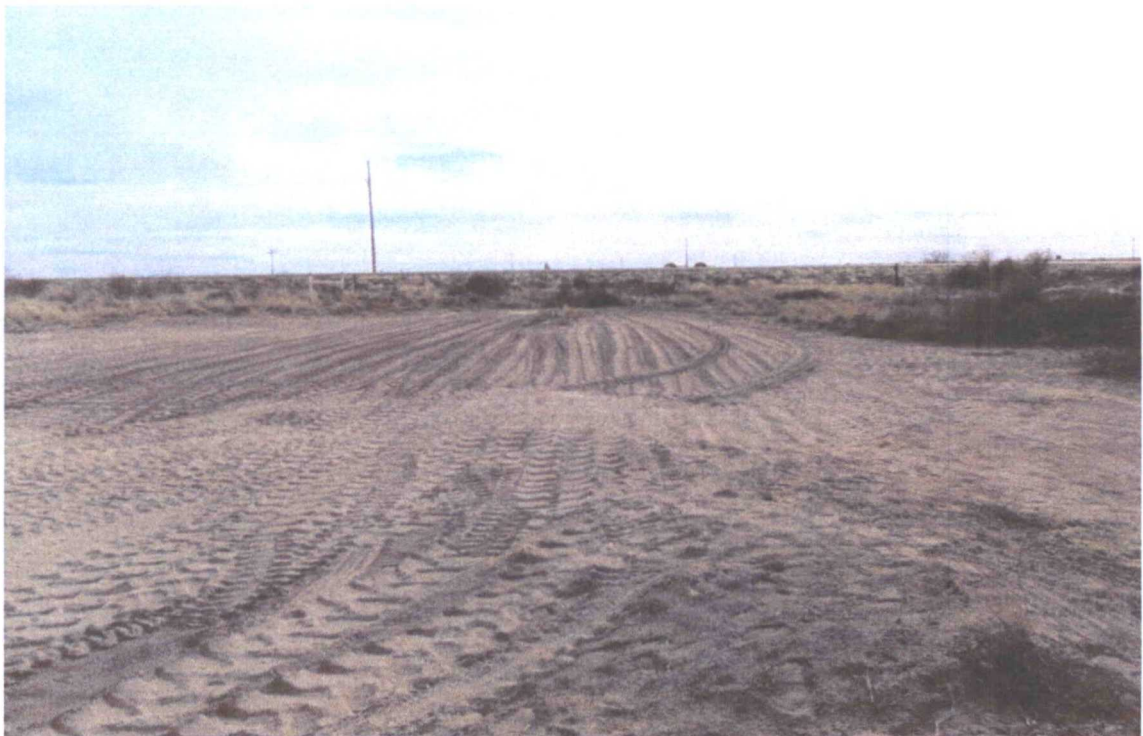
Line 2B Release Site (following backfilling)

Based on laboratory analytical results, and with NMOCD approval, on January 3 and 4, 2011, the excavation was backfilled in eighteen (18)-inch lifts, compacted, and contoured to fit the surrounding topography. Prior to backfilling, the final dimensions of the East excavation were approximately forty (40) feet in length, approximately eight (8) feet in width, and approximately six (6) feet in depth. The West excavation measured approximately thirty-four (34) feet in length, approximately thirty-six (36) feet in width, and ranging in depth from approximately eight (8) feet to approximately fifteen (15) feet.
