Release Notification and Corrective Action

Name of Company	Southern Union Gas Services	Contact	Rose Slade
Address	801 S. Loop 464, Monahans, TX 79756	Telephone No.	817-302-9716
Facility Name	6" Lateral (5/22/08)	Facility Type	Natural Gas Gathering

Final Form C-141 Supporting Documentation**Site Name: 6" Lateral****RP #: 1877****I. Clean-up Criteria Based on Ranking Analysis**

Southern Union Gas Services
6" Lateral
2008-016

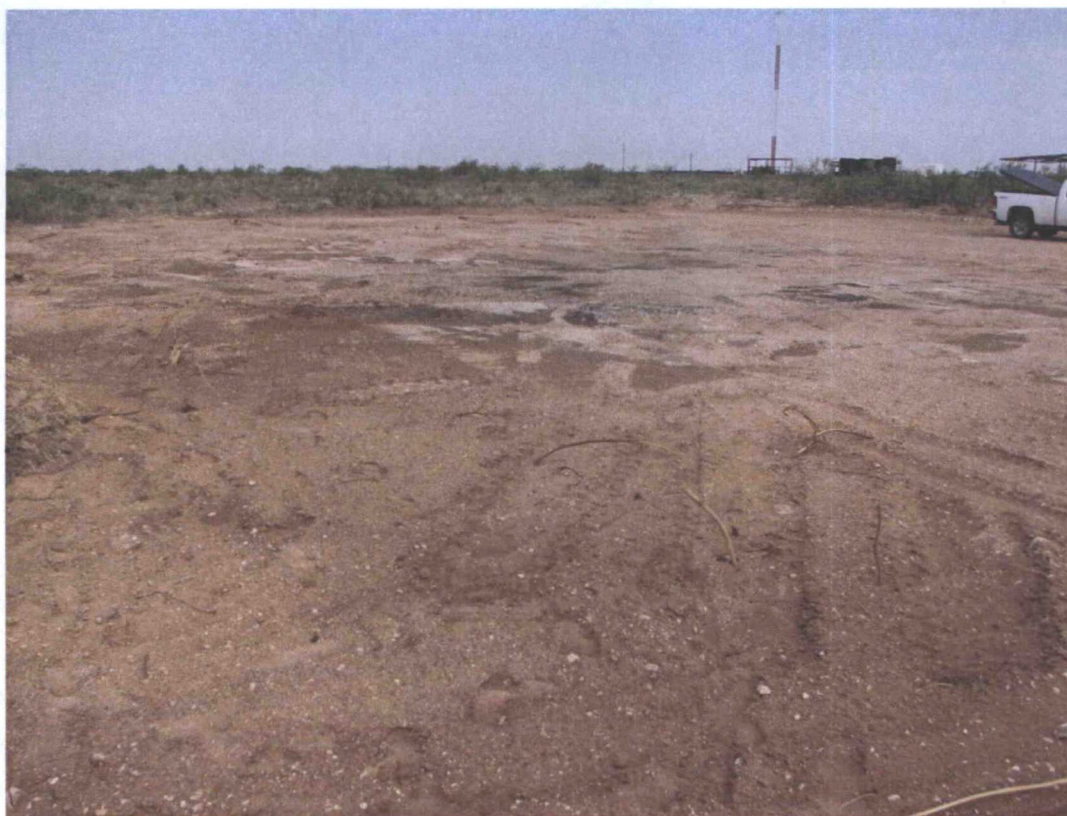
Photo 1

Southern Union Gas Services Site: 6" Lateral
Job # 2008-016
Site Assessment 5/29/08

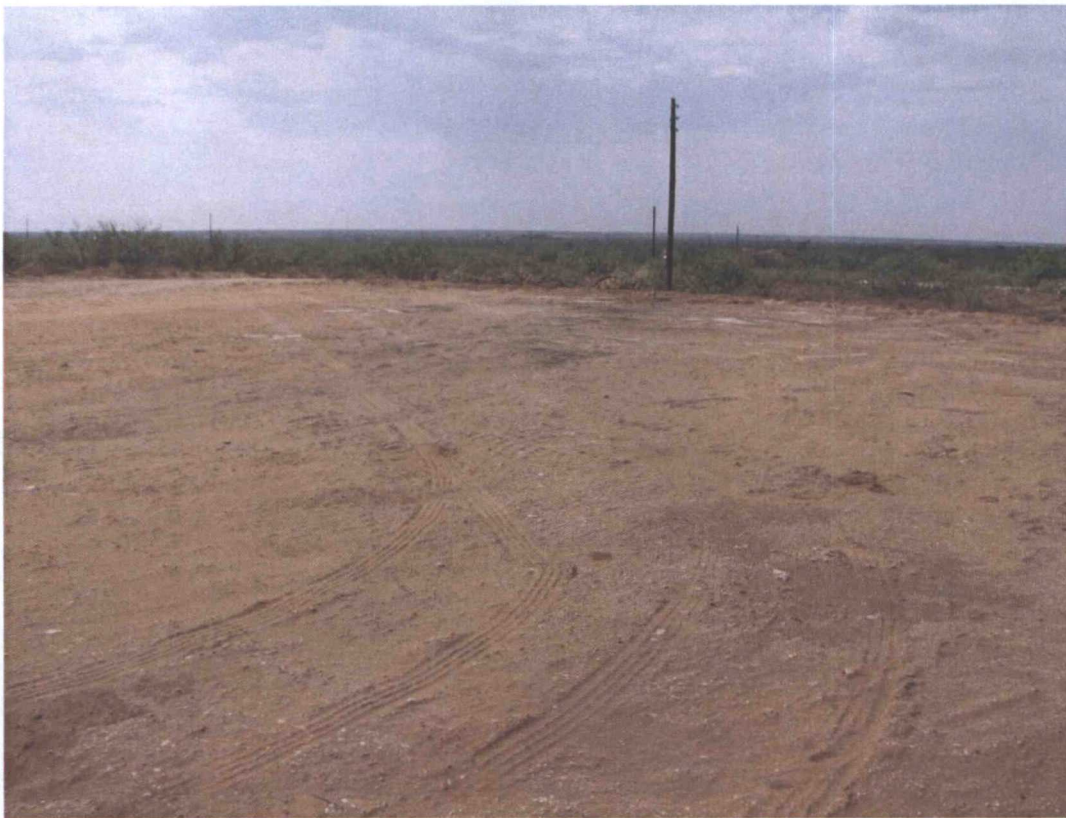
Photo 3

Southern Union Gas Services Site: 6" Lateral
Job # 2008-016
Site Assessment 5/29/08
