## Caprock Maljamar Unit #98

### Closure Report

**RE: TERMINATION REQUEST**

**Linn Energy – Caprock Maljamar Unit #98 AD**

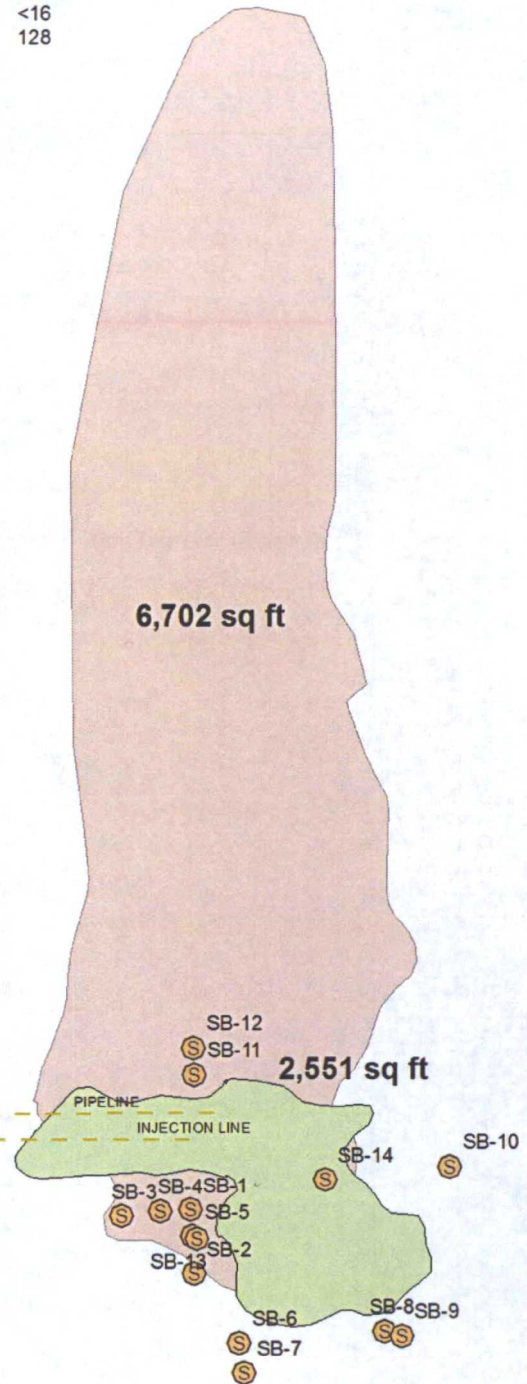
Figure 2

The second leak event, due to a failed flange, further impacted the portion of the initial leak area surrounding Point #4 (Figure 2). From May 17 through June 12, 2012, soil bore sampling was used to determine the lateral and vertical extent of the secondary impact. Soil samples were similarly field tested and representative samples were submitted to a commercial laboratory for chloride and TPH analyses (Appendix C). Lab analysis confirmed that chloride levels decreased to less than 250 mg/kg at 65 ft. bgs. All soil bores were plugged in full with bentonite.

On June 11, 2012, a temporary groundwater monitoring well was installed approximately 90 ft. west of the leak area to a depth of 160 ft. to determine the existence of groundwater (Figure 2).

SB-1			SB-3			SB-9			SB-10			
Depth	CI-	PID	Depth	CI-	PID	Depth	CI-	PID	Depth	CI-	PID	LAB CI-
2	850	2.5	1	222	0.2	1	85	5.6	1	85	1.5	<16
4	2690	0.9	2	536	0.4	2	85	4.8	2	169	1.4	128
6	5374	4.9	3	123	0.3							
8	5303	6.5	4	117	0.5							
10	7572	8.7										
12	7838	4.1	SB-4			SB-11						
14	7784	7.1	Depth	CI-	PID	LAB CI-	Depth	CI-	PID	LAB CI-		
16	10143	6.3	1	883	0.3	880	1	1510	1.4			
18	12497	10	2	466	0.4		2	4241	1.6			
20	7364	8.2	3	141	0.2	32	3	5810	2.1	6160		
22	5886	5.4	4	117	0.3	64	4	1565	1.1			
24	5393	3.8					5	2336	2.7			
26	4953	2.9	SB-5			SB-12						
28	6307	3.6	Depth	CI-	PID	LAB CI-	Depth	CI-	PID	LAB CI-		
30	4774	7.1	1	285	0.2		1	627	1.4			
32	5185	9.6	2	4739	0	5200	2	5200	1	1020		
34	6624	5.2	3	118	0.5	<16	3	3261	0.5			
36	7988	6	4	120	0.4	32	4	118	1.5	<16		
38	9277	10.5					5	140	2.4	<16		
40	8449	5.2	SB-6			SB-13						
42	6853	5.5	Depth	CI-	PID	LAB CI-	GRO	DRO				
44	6707	6.4	1	500	1.9		SS	1501	8.7

SB-14					
Depth	CI-	PID	LAB CI-	GRO	DRO
SS	3970	1.5			
5	4697	2			
10	3919	3			
15	7490	5.9	3840	<10	<10
20	4325	2.2			-
25	4468	4.2		-	-
30	4272	1.8			
35	1151	3.3			
40	543	3.9			
45	1454	5.9			
50	2056	5.1			
55	365	0.8			
60	218	2.9	128	<10	<10
65	178	4.1	32	<10	<10

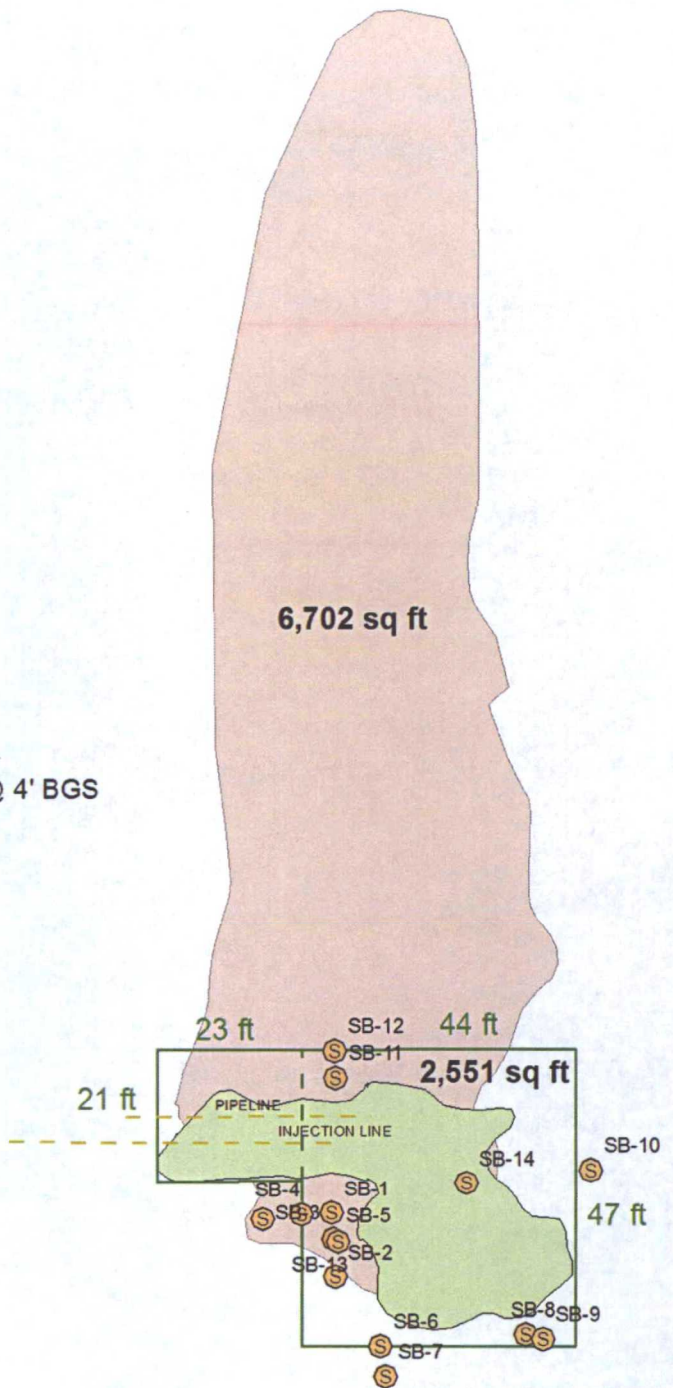
**Figure 3**

Succeeding these activities, NMOCD approved the following implementation. The area encompassing the second leak event was excavated to a depth of 5 ft. bgs (Figure 3). The bottom of the excavation was lined with a 20 mil reinforced plastic liner, and the remaining space was backfilled with clean soil to ground surface. The larger area encompassing the first leak event was excavated to 1.5 ft. bgs, and was backfilled with clean soil to ground surface as well. The entire affected area was contoured to the surrounding vicinity and was reseeded with Klein grass seed.

PROPOSED 20-MIL REINFORCED POLY LINER @ 4' BGS
-

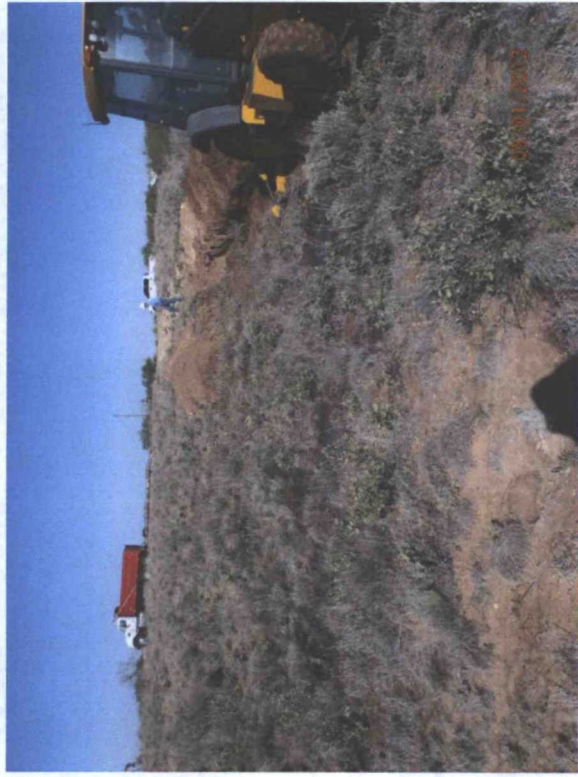
Initial release in pasture, facing west

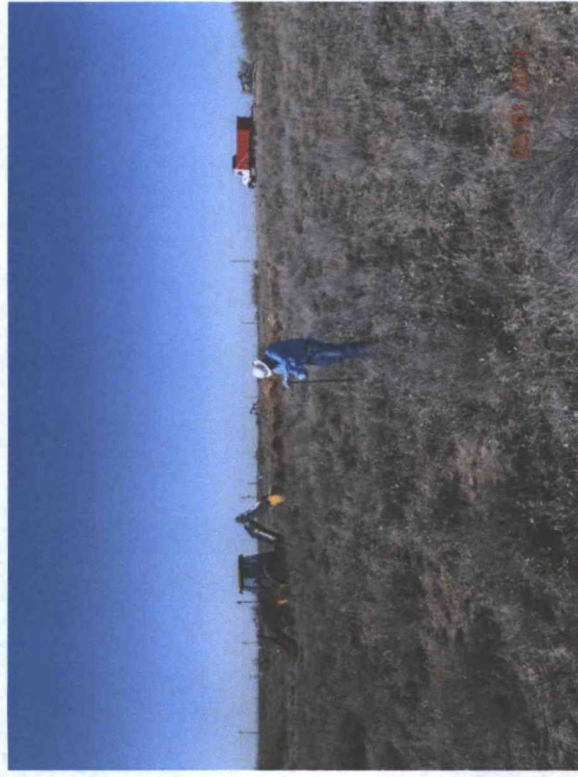
Collecting sample, facing south

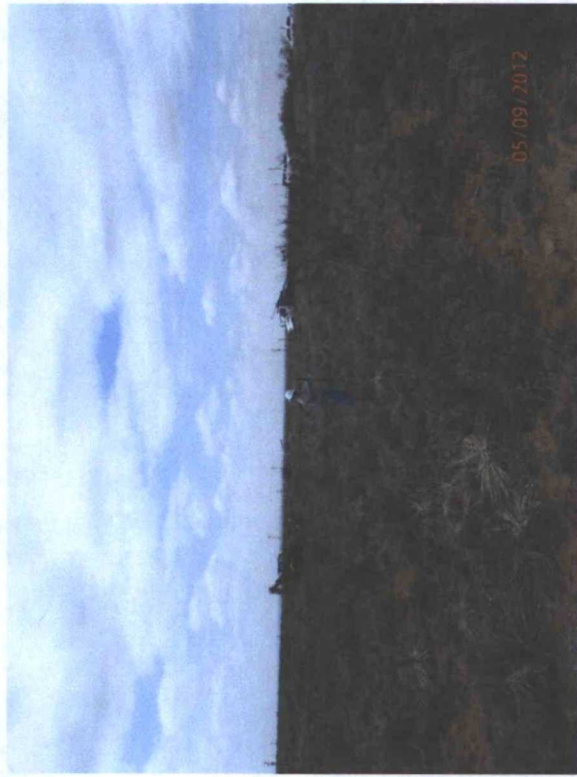
Collecting sample, facing south

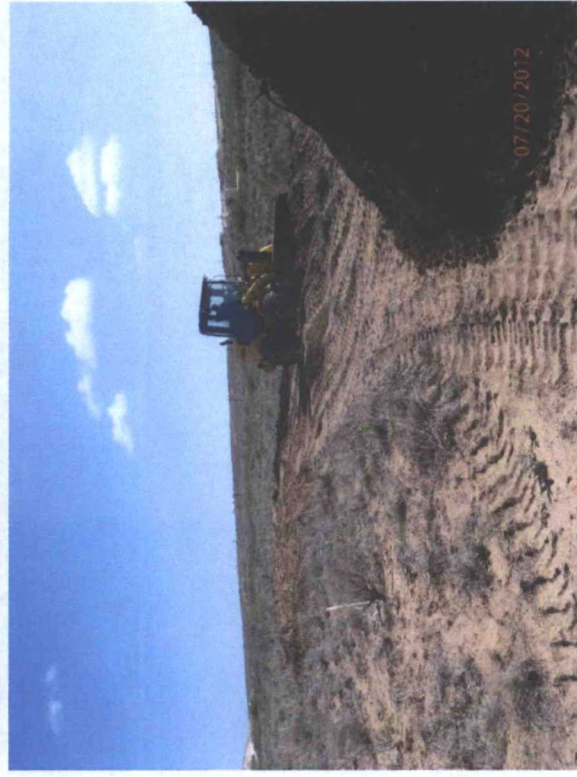
Beginning excavation, facing north

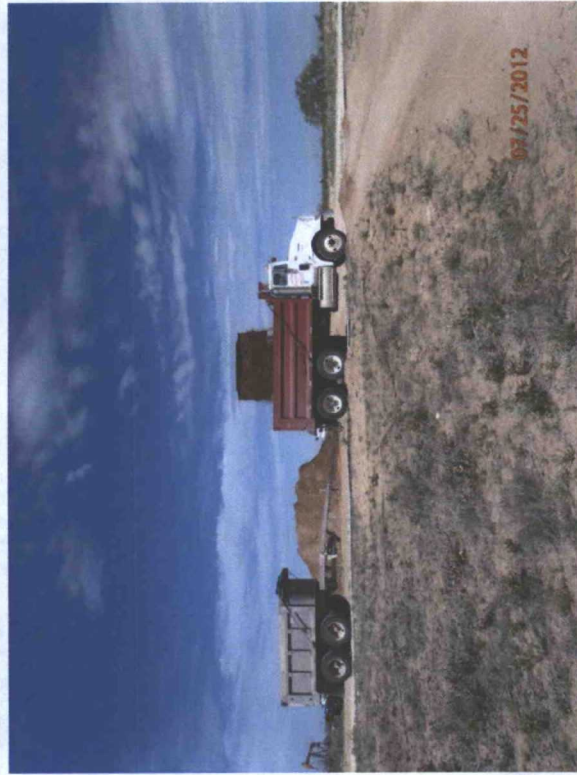
Exporting spoil pile, facing west

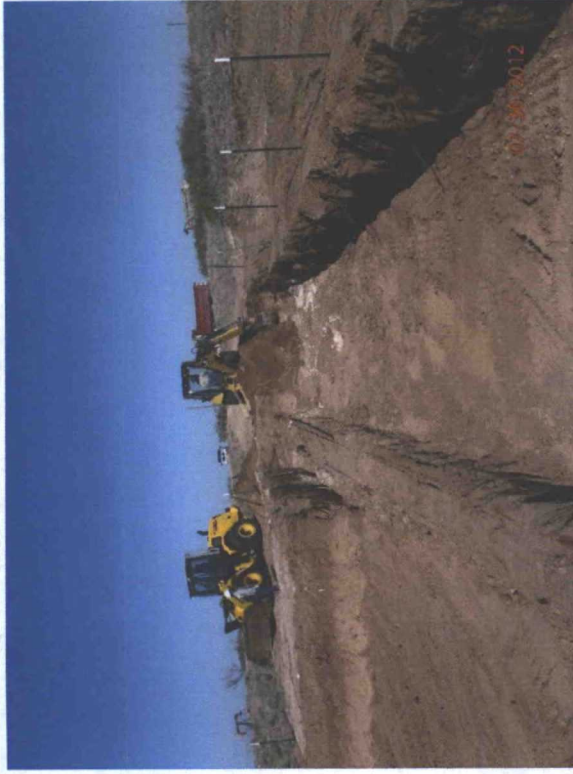
Excavating, facing south

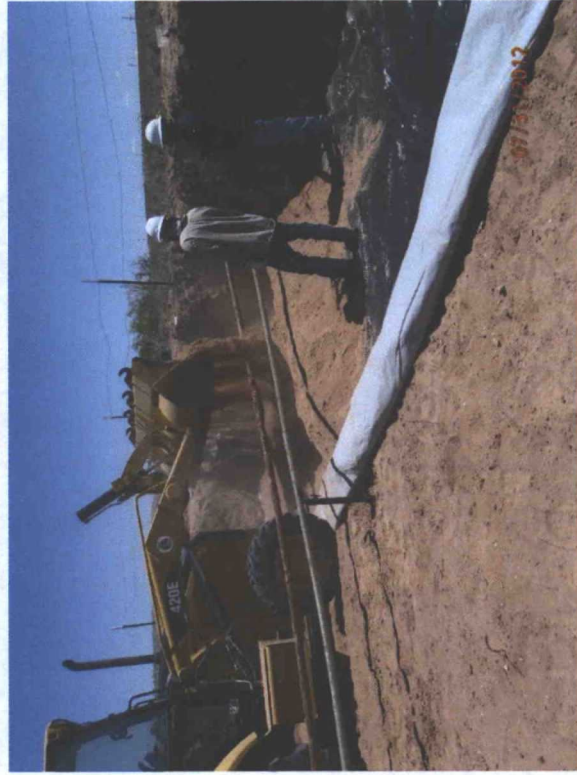
Backfilling above liner, facing north

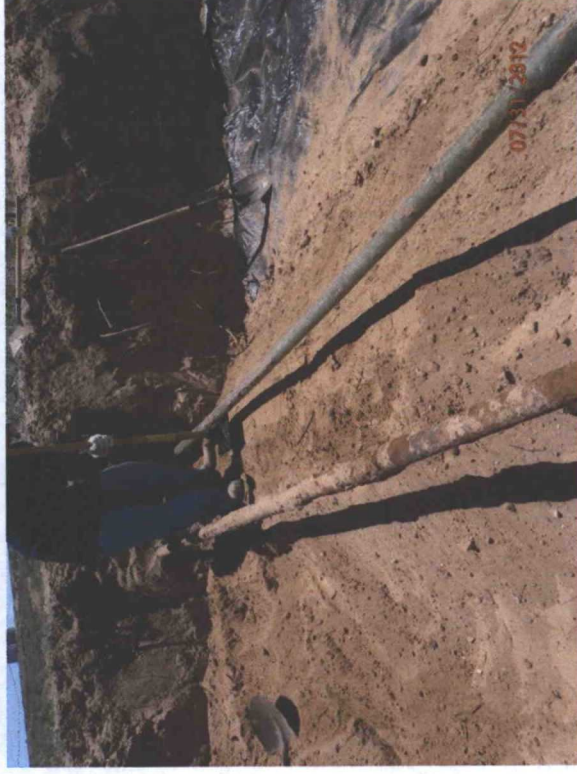
Packing soil under lines, facing east

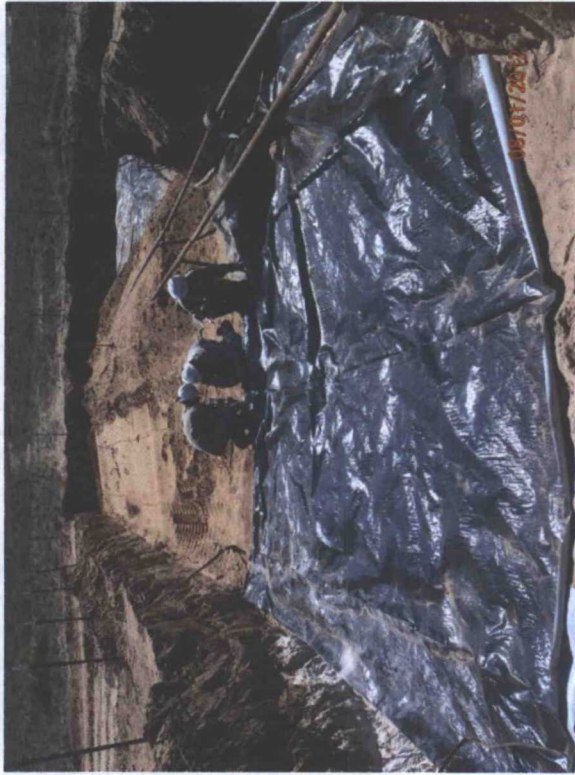
Seaming liner, facing east

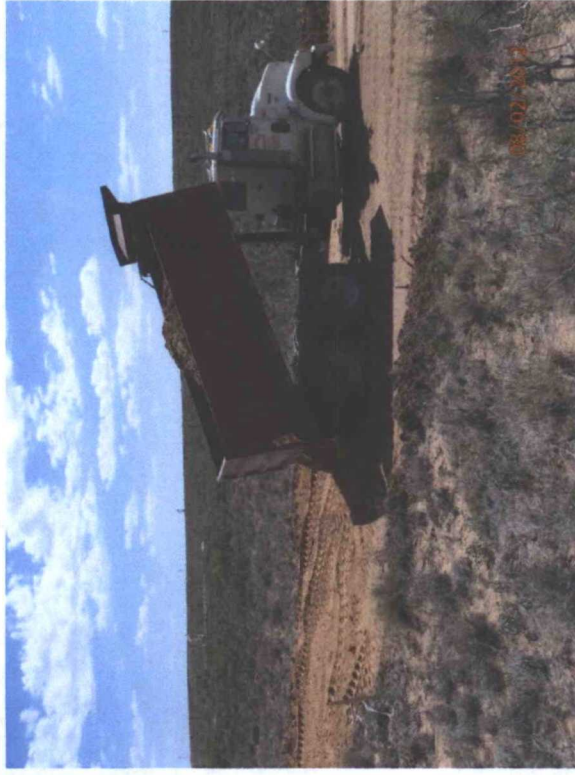
Importing clean soil, facing west

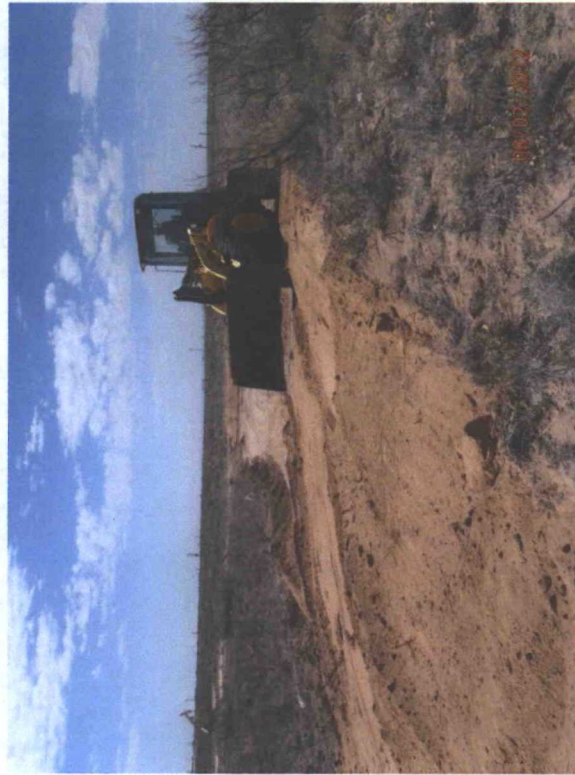
Backfilling site, facing south

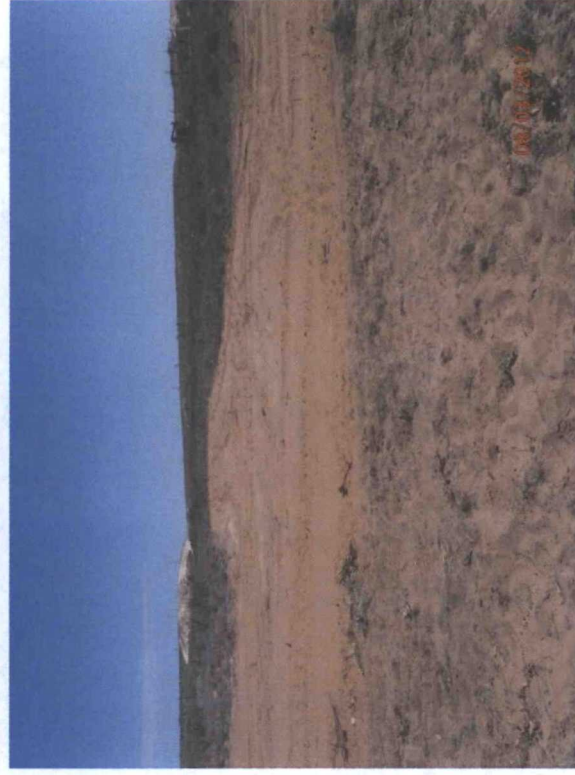
Site backfilled, facing north

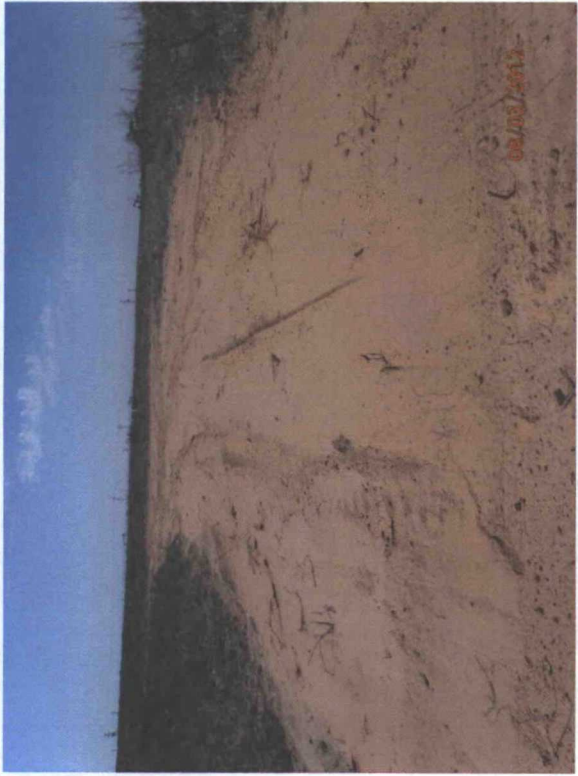
Site backfilled, facing south

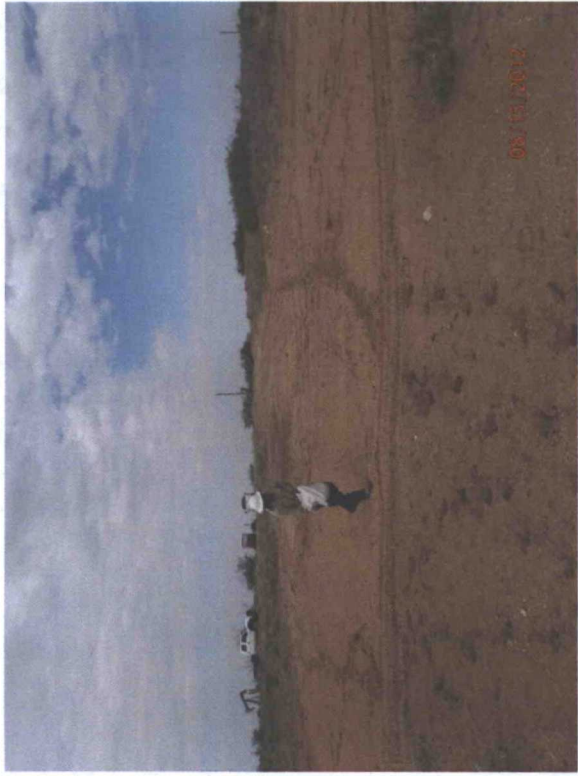
Spreading seed, facing north

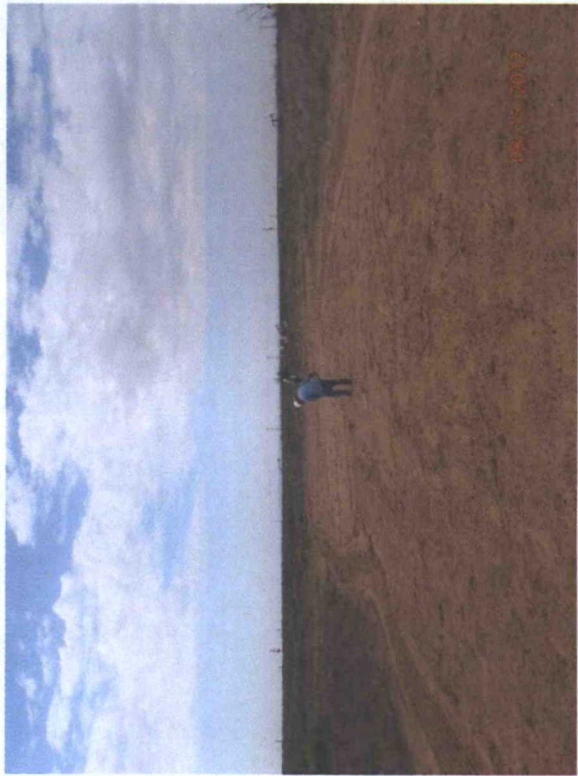
Raking seed, facing east

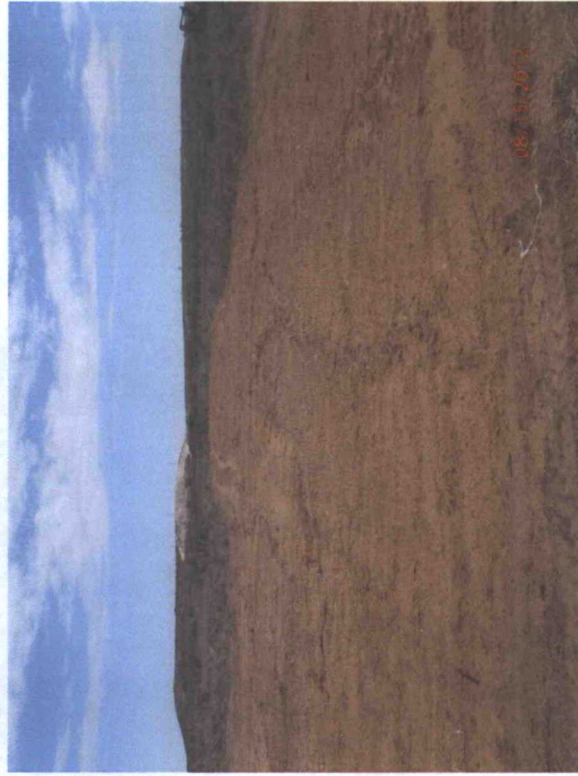
Site complete, facing east

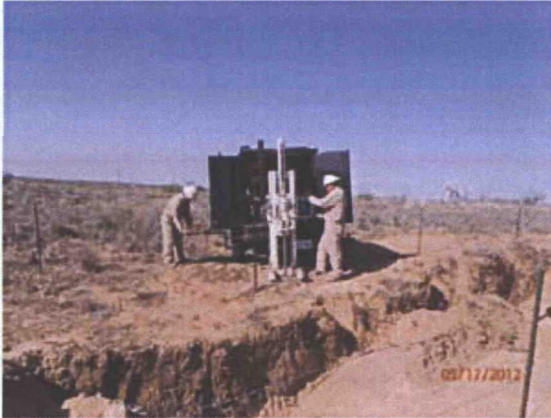
Drilling SB-1, facing south 5/17/12

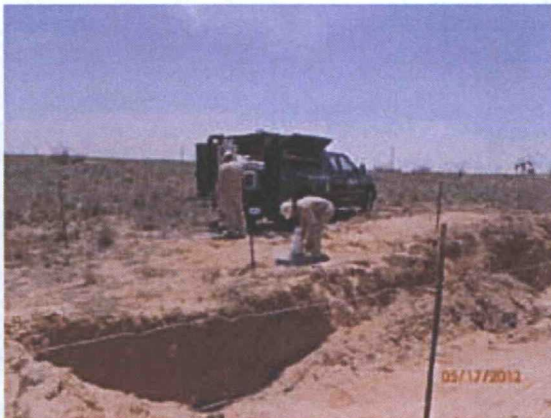
Plugging SB-1 in total with bentonite 5/17/12

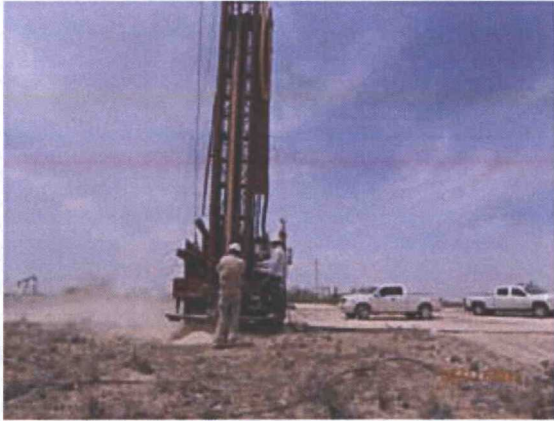
Drilling temporary MW, facing west 6/11/12

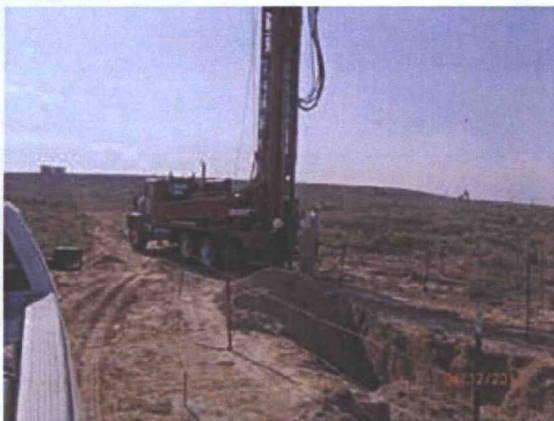
Drilling SB-14, facing east 6/12/12

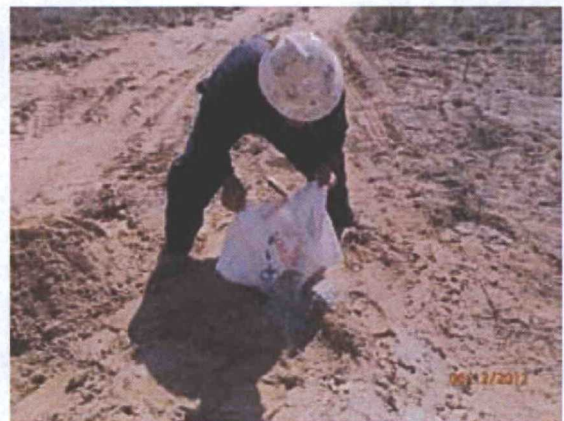
Plugging SB-14 in total with bentonite 6/12/12
