Release Notification and Corrective Action

Closure Report

CHAPARRAL ENERGY LLC,
Yates State #2 LEAK
UL/H SEC 16 - T12S - R38E
GPS LAT & LON WGS84
WN33.279669° / 103.094595°
NMOCD 1RP-2781

Reference: 1RP-2781 Chaparral Yates State #2 Leak

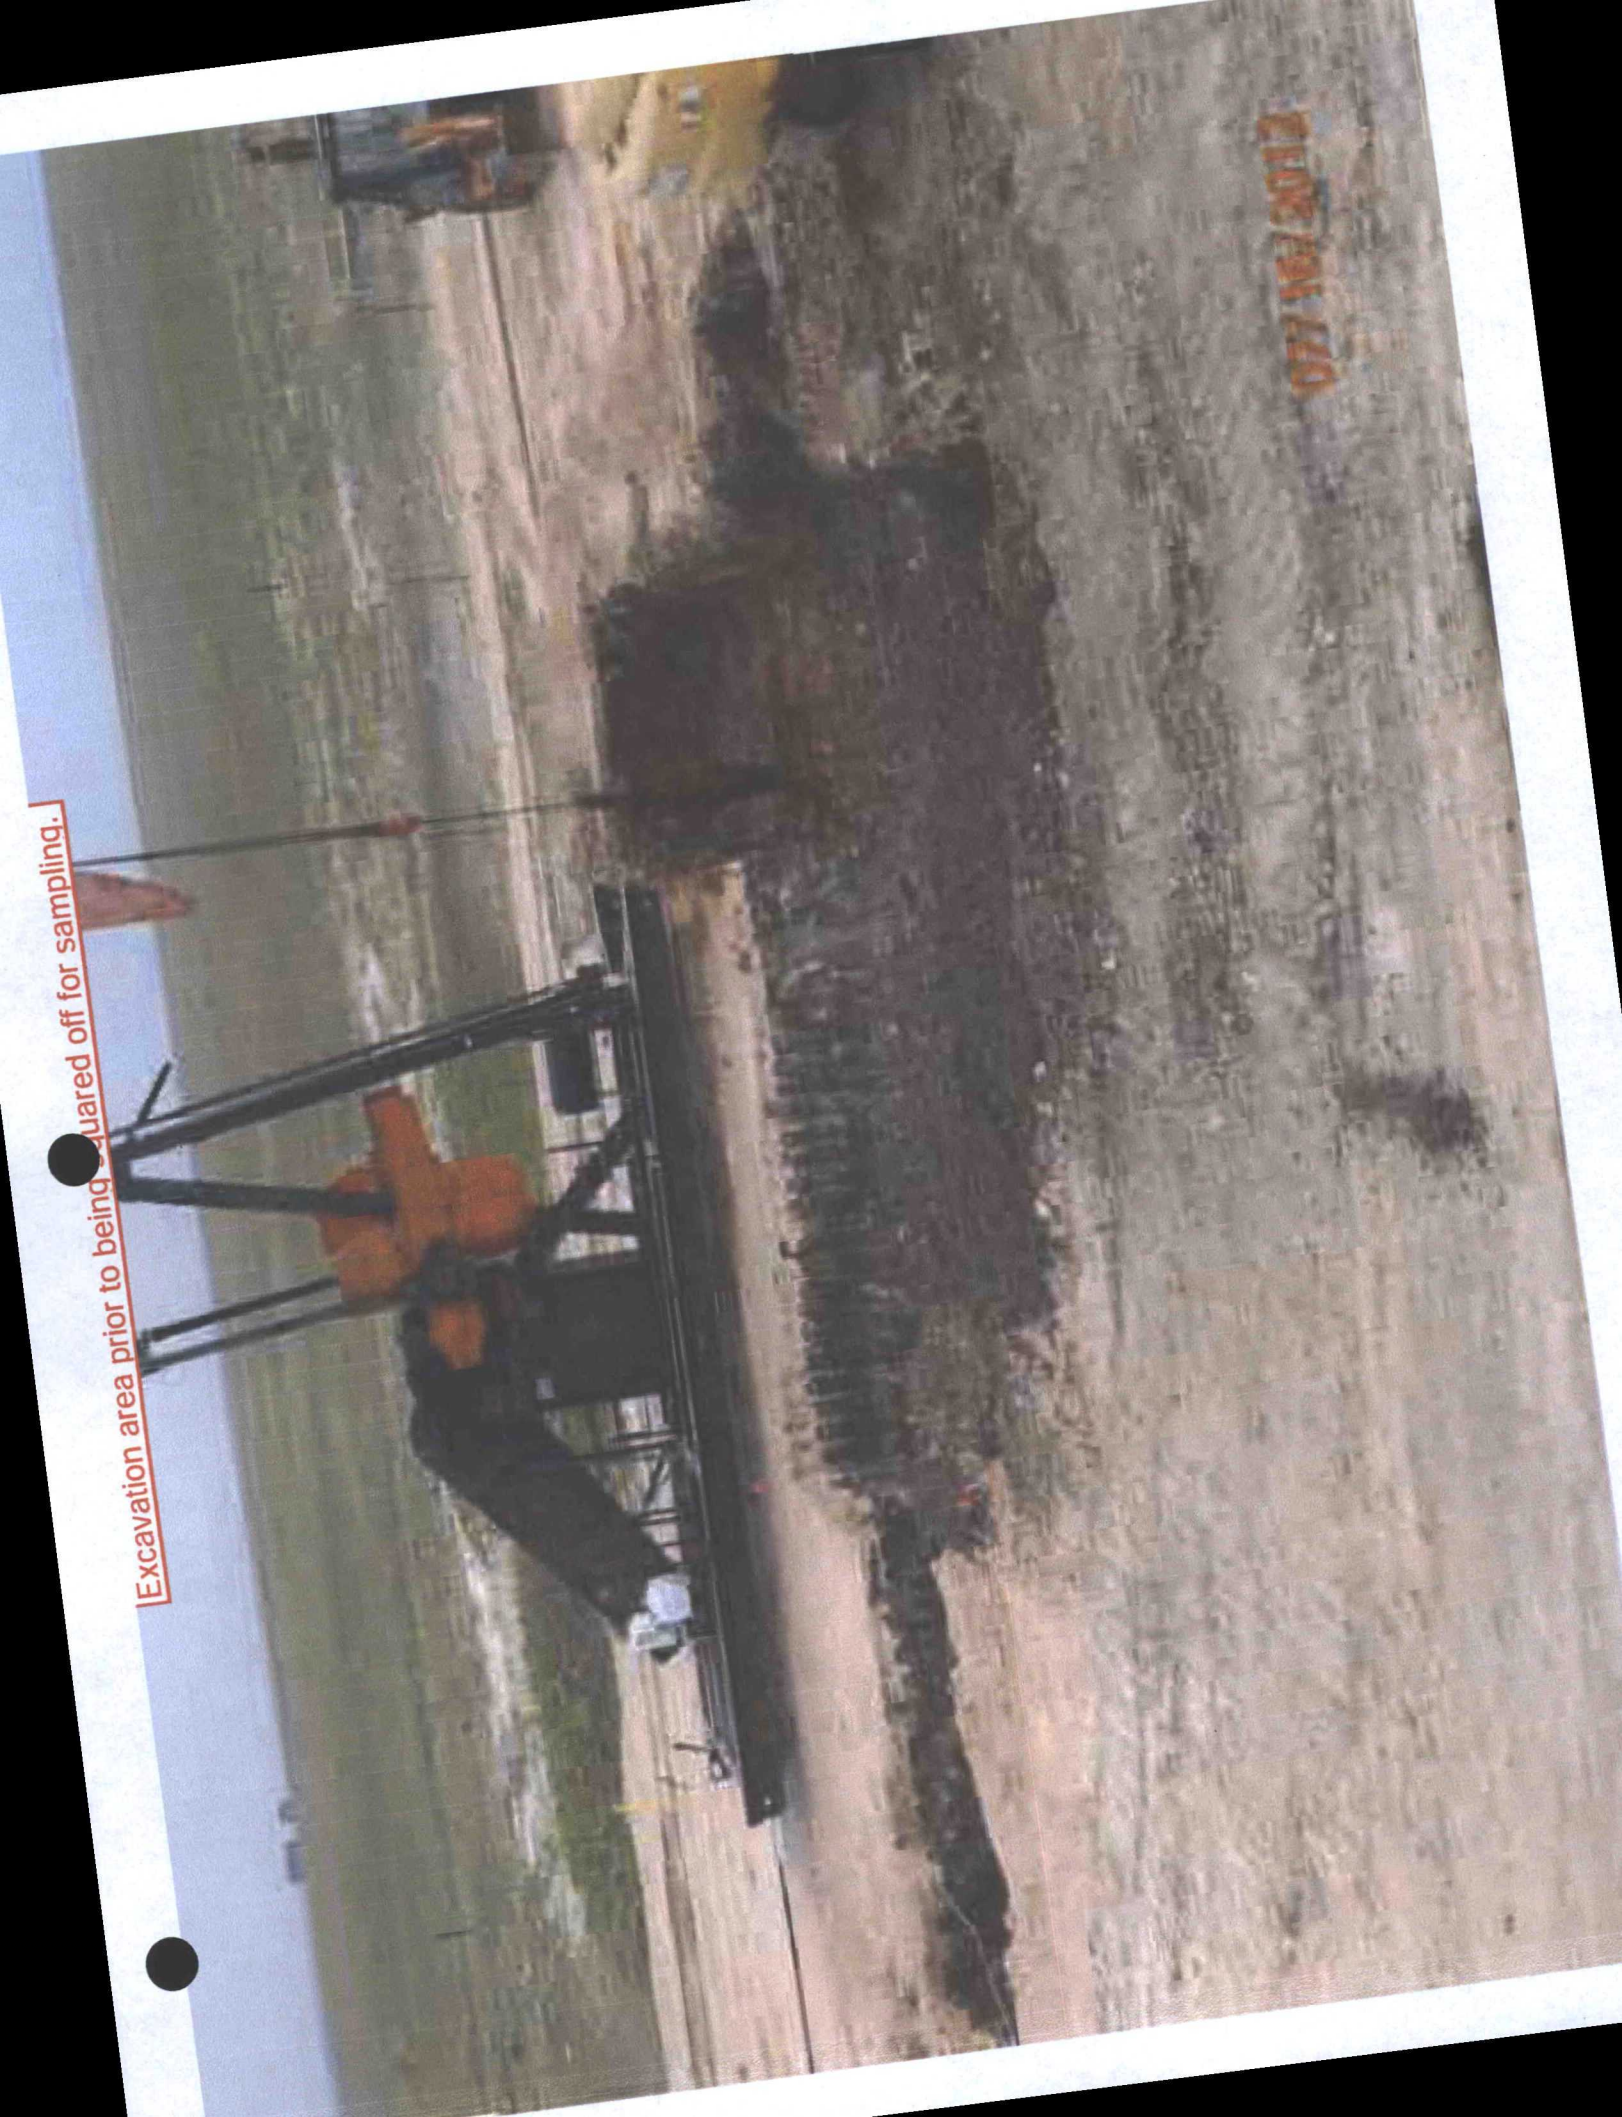
Excavation area prior to being squared off for sampling.

The highly cl- impacted area was excavated using a trackhoe and backhoe. The excavated material was hauled off to an approved NMOCD disposal Gandy Marley Inc. Disposal, with the return trip of clean caliche to be used as a mix and blend matrix for any of the remaining excavated material which was field titrated for cl- and third party confirmed to be within acceptable cl- limits for the NMOCD. The bottom of the excavation was lined using a Geo-Synthetic Bentonite liner, and then backfilled using the mixed and blended excavated material which met NMOCD requirements. Due to the very sandy consistency of the caliche hauled in from GMI Inc. disposal additional better quality caliche was hauled in to cap off the location pad. The berm surrounding the location was improved on, especially on the south side of the location where no berm was present to prevent any spills from escaping out into the pasture. The berm surrounding the battery was also improved on.
