## **REMEDIATION SUMMARY & SITE CLOSURE REQUEST**

**SOUTHERN UNION GAS SERVICES**

**L-5 (8" Line) (1RP-2334)**

**NMOCD Reference # 1RP-2334**

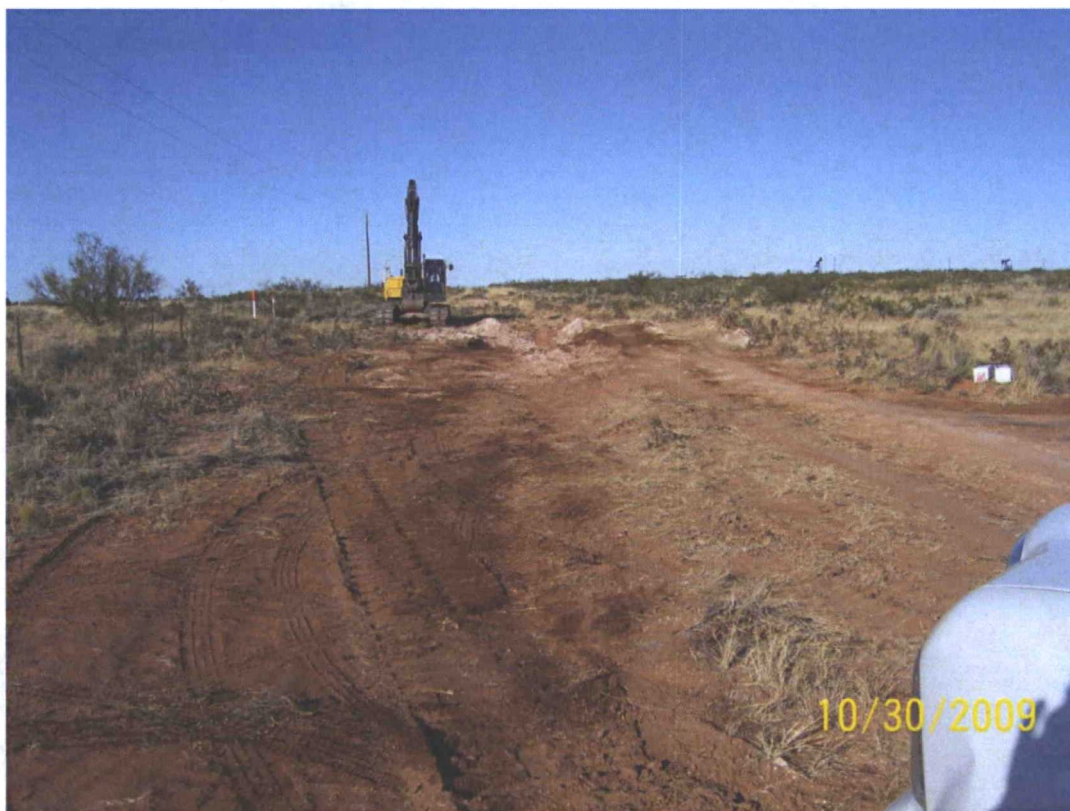
Photograph of initial release at the L-5 (8" Line) Historical Release Site.

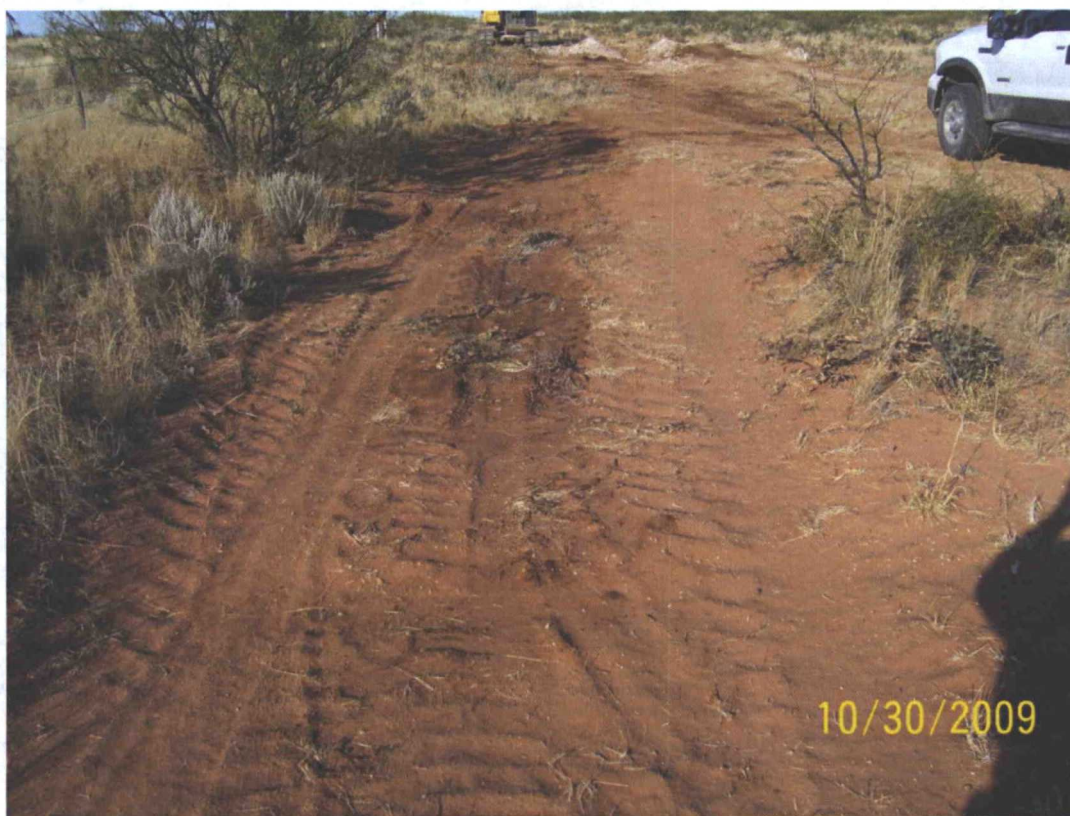
Photograph of initial release at the L-5 (8" Line) Historical Release Site.

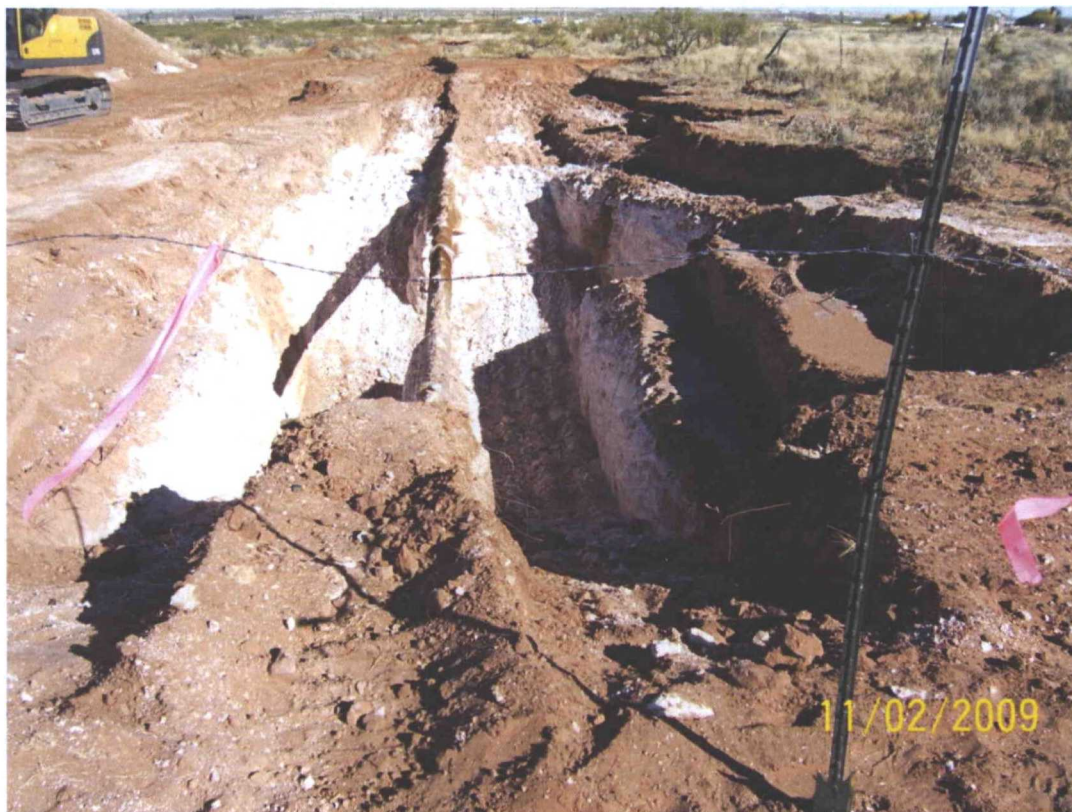
Photograph of excavation activities at the L-5 (8" Line) Historical Release Site.

On October 30, 2009, Basin began remediation activities at the L-5 (8" Line) Historical Release Site. Visually impacted material was excavated and stockpiled on location, pending final disposition. The excavation was advanced until photo-ionization detector (PID) readings and chloride field test results suggested soil containing concentrations of BTEX, TPH and chloride above NMOCD regulatory standards had been removed.

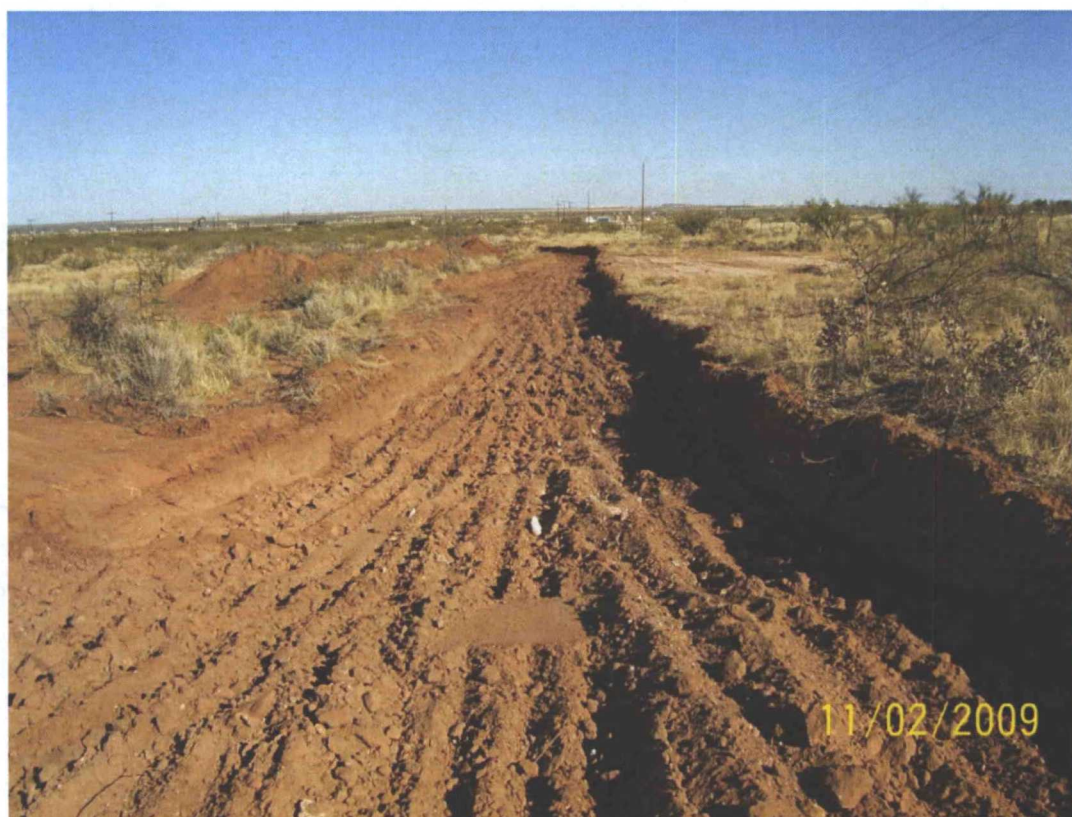
Photograph of excavation activities at the L-5 (8" Line) Historical Release Site.

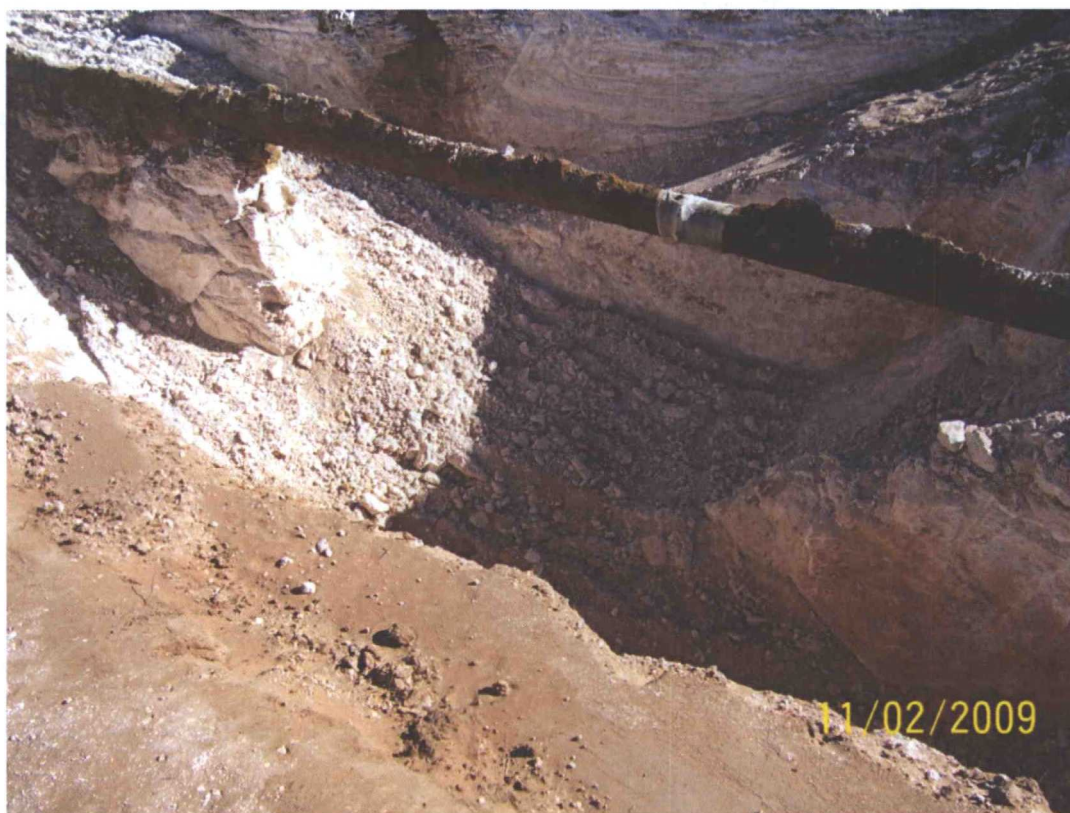
Photograph of excavation activities at the L-5 (8" Line) Historical Release Site.

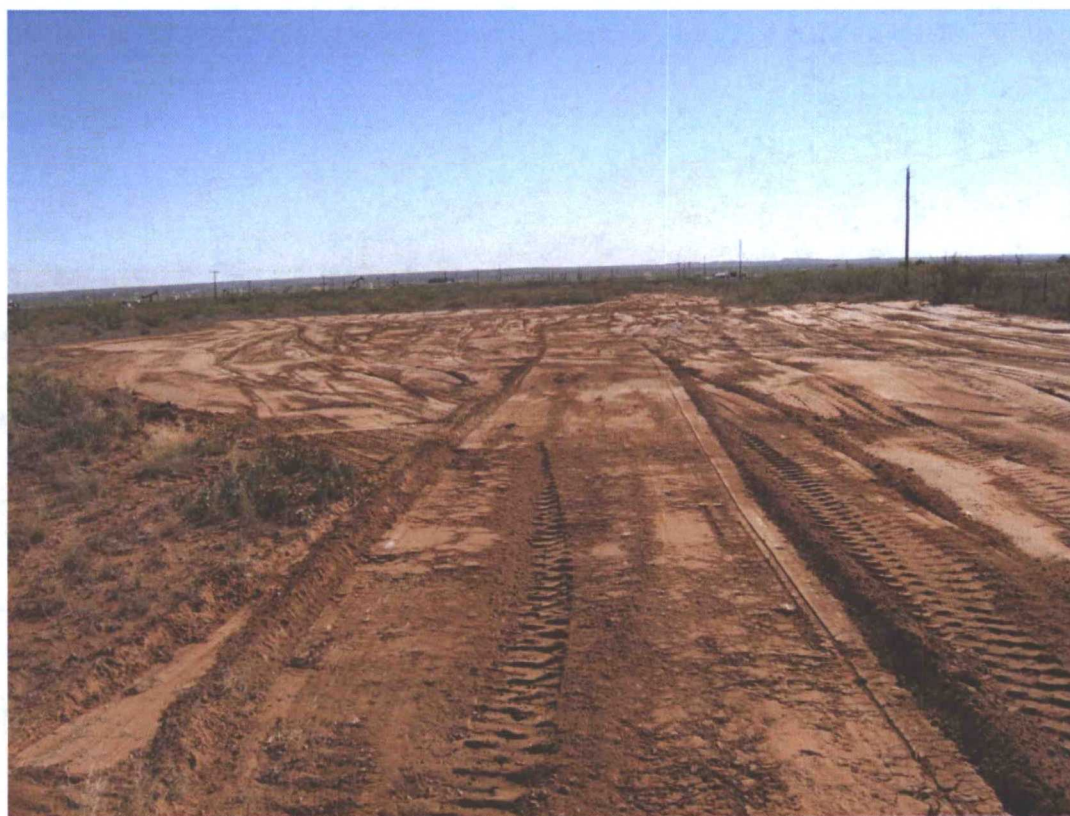
Photograph of backfill activities at the L-5 (8" Line) Historical Release Site.

On October 8, 2012, on receiving approval from an NMOCD representative, the excavation was backfilled with the on-site stockpile material. Excavation backfill was compacted in twelve-inch (12") lifts and contoured to fit the surrounding topography. Prior to backfilling, the final dimensions of the excavation were approximately four hundred feet (400') in length, eight feet (8') to thirty feet (30') in width, and ranged in depth from approximately two feet (2') to twelve feet (12') bgs.

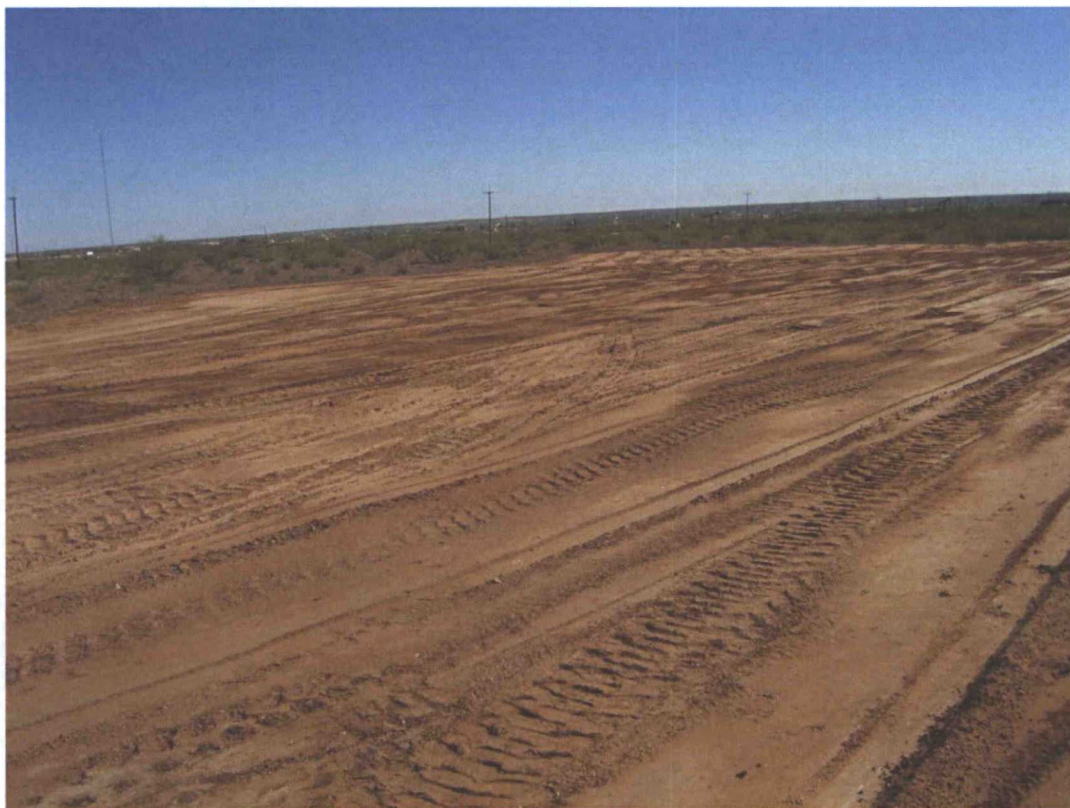
Photograph of backfill activities at the L-5 (8" Line) Historical Release Site.

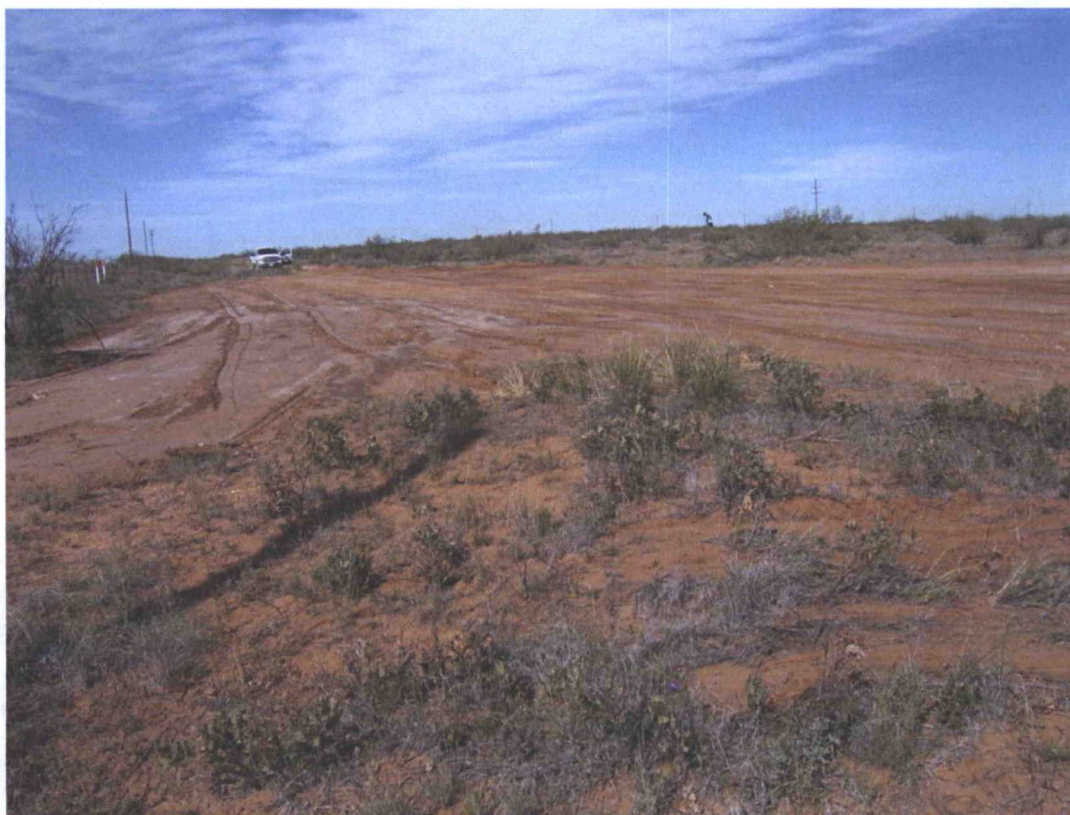
Photograph of L-5 (8" Line) Historical Release Site after remediation activities.

The site will be reseeded at the request of the landowner.
