Release Notification and Corrective Action

RE: **Quantum Resources**
Northeast Pearl Queen Central Tank Battery
Accidental Discharge 1RP-1210-2665
TERMINATION REQUEST
Unit Letter D, Sec. 23, T19S, R35E
Lea County, New Mexico

**NE Pearl Queen Central Battery
Unit D, Section 23, T-19-S, R-35-E**

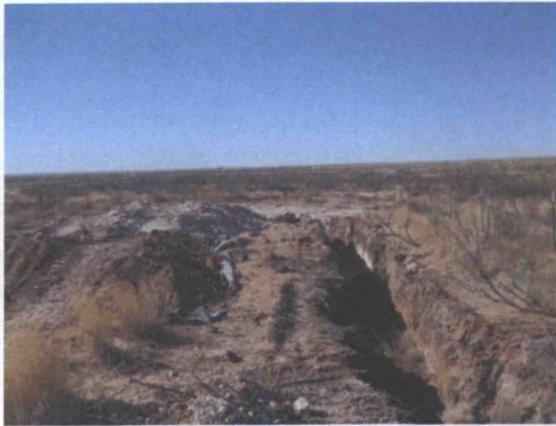
Site prior to excavation, facing southwest

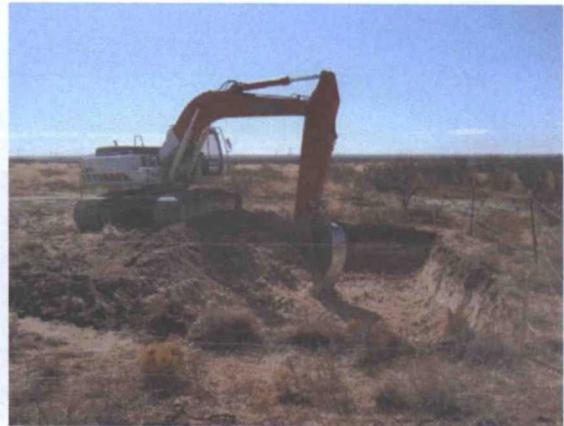
Excavating, facing south

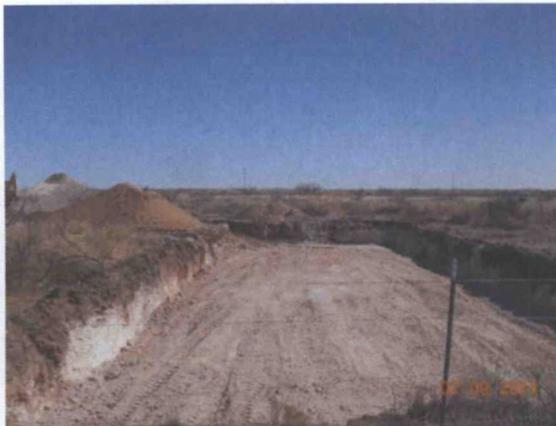
Final Excavation, facing east

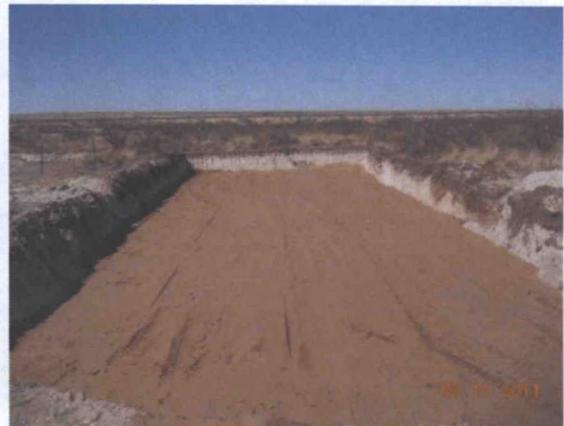
Excavation with sand padding, facing west

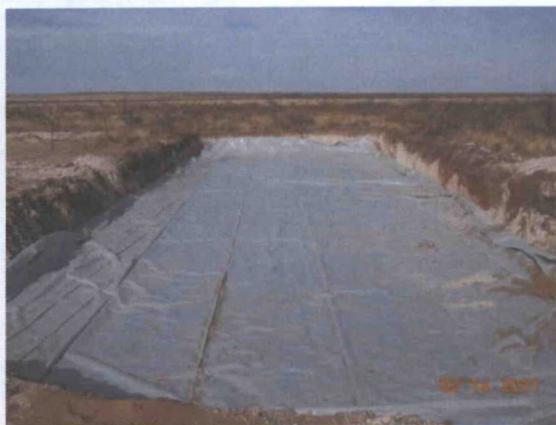
Poly liner installed, facing west

- Because of the high concentrations of chlorides beneath Point Four, RECS recommends that a poly liner measuring 35 ft x 96 ft be placed at 4 ft bgs. The liner will be sand packed 6 inches above and below the liner.

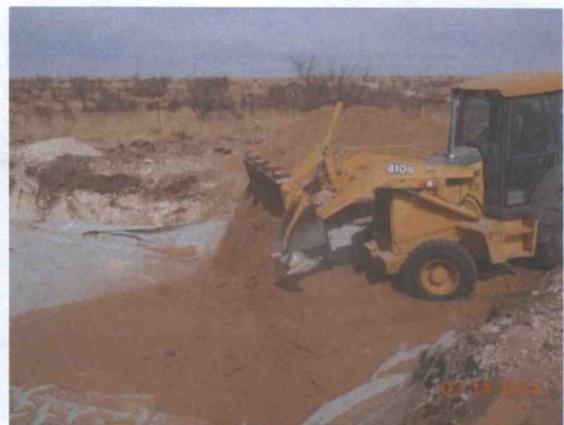
Padding on top of Poly liner with sand, facing north

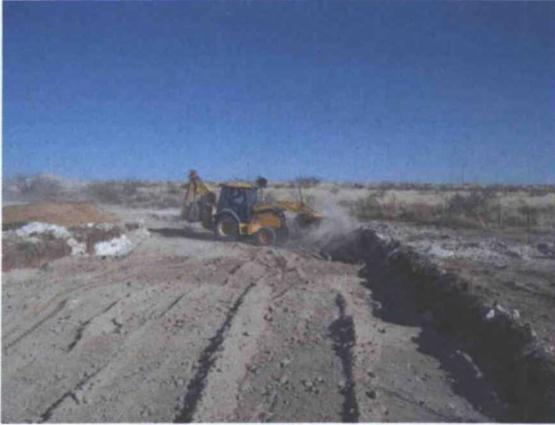
Backfilling excavation, facing east

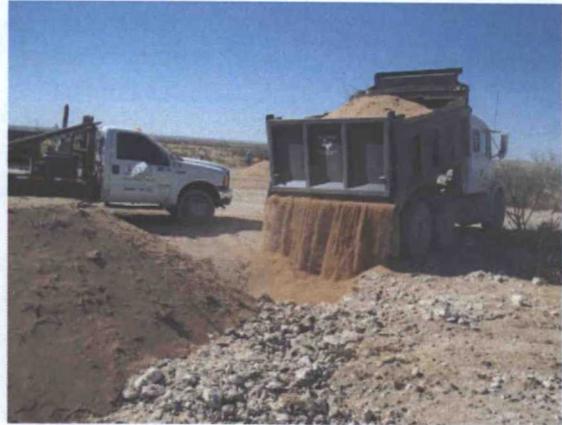
Importing soil facing southwest

On February 24th, 2011, 120 yards of clean blow sand was imported to complete the backfill of the site (Appendix C). The site was contoured to match the surrounding area. On February 25th, 2011, eleven bags of Bio-Nhance were blended into the topsoil to add soil nutrients. A fence lined with silk netting was installed around the site to reduce wind erosion of the soils and to keep the seed from blowing away. On February 28th, 2011, the site was seeded with a native vegetative mix.

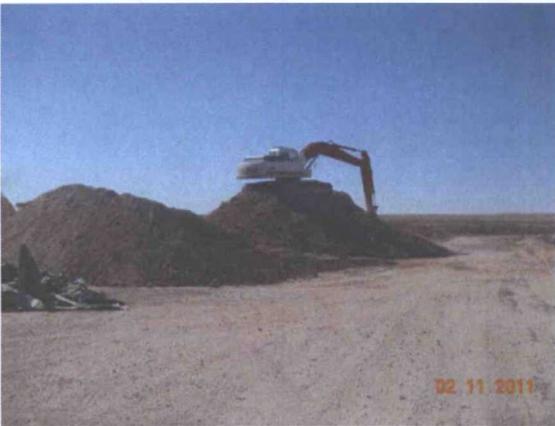
Blending Backfill, facing west

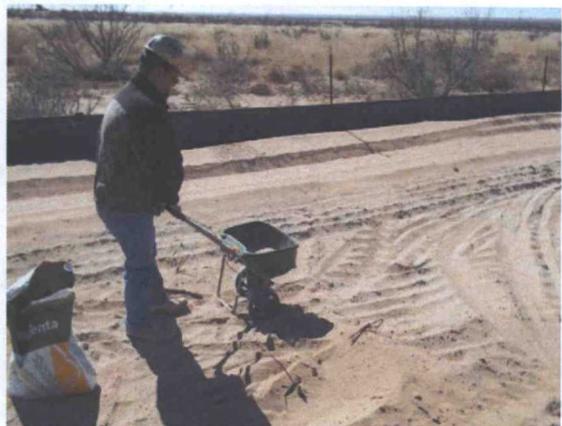
Seeding site, facing south

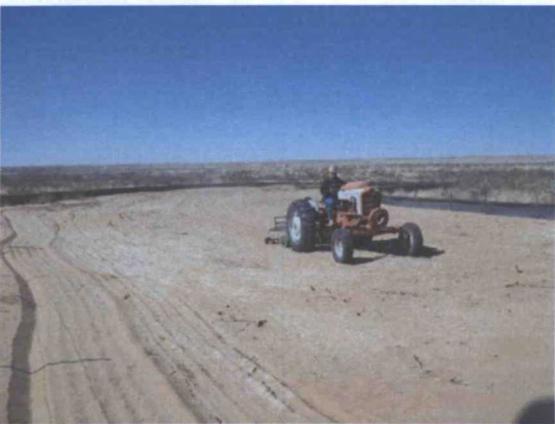
Tilling the seed into the soil using a tractor,
facing southwest

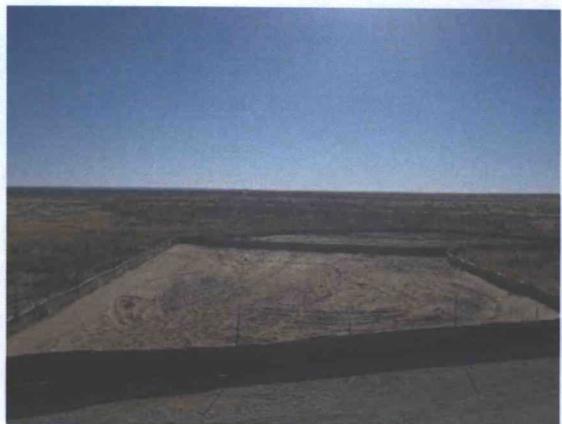
Site completed, facing southwest
